Hurricane Irma: Consequences of Intense Rainfall and Storm Surge from a Tropical Storm in North and Central Florida

ABSTRACT: Hurricane Irma affected the Florida peninsula from September 9-11, 2017, with high winds, rainfall, and storm surge. Although the storm made landfall on the west coast of Florida, impacts of the rainfall and storm surge affected central and northeast Florida. A GEER team mobilized on September 23, 2017, spent three days documenting sinkhole damage in central Florida, coastal scour and erosion along the northeast coast of Florida, and infrastructure damage in northeast Florida. Numerous sites with geotechnical damage were documented but this case history focuses specifically on sinkhole damage in The Villages, erosion and scour at Vilano Beach, failure of a concrete cover earth dam at Hampton Lake, and bridge embankment damage on US-17 over the Trout River. The most notable challenges to reconnaissance were the widespread and varied nature of the damages from Hurricane Irma and the rapid repair of damaged infrastructure that required the team to work closely with local, state, and federal officials to obtain documentation of the damage prior to repair.

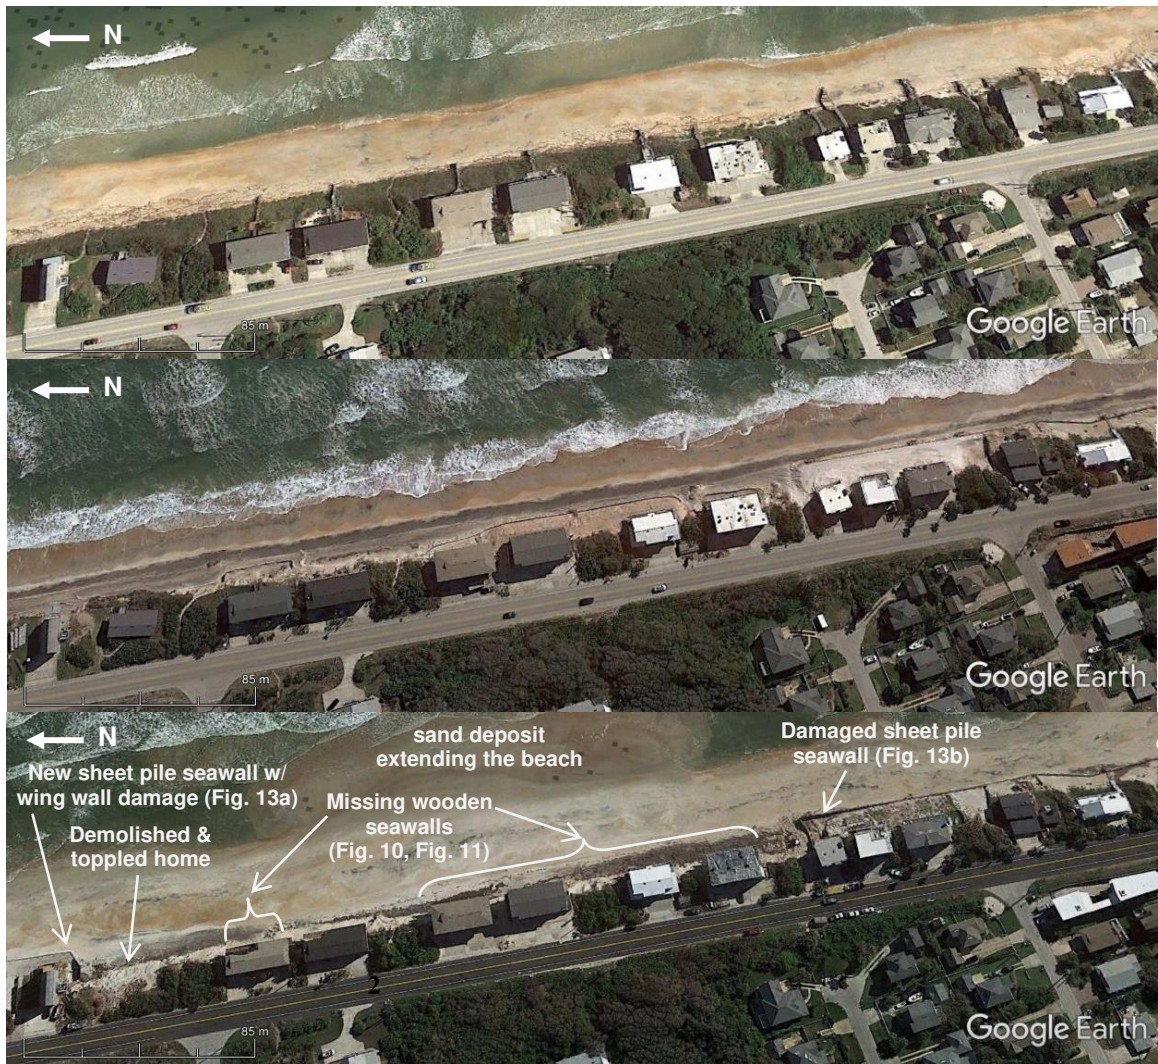
Vilano Beach has been experiencing consistent dune erosion during major storm events since 1994. Figure 9 illustrates how significantly and quickly the seemingly stable dune system changed because of extreme storms. The majority of erosion occurred after 2015 from both Hurricane Matthew (October 16, 2016) and Hurricane Irma (September 11, 2017). Figure 9c is annotated to show Hurricane Irma damage identified by the GEER team. To prevent erosion, seawalls of varying types were installed to protect residences from destructive wave action. The walls ranged from simply constructed walls to more complex walls with anchors. Many of the more complex systems were vinyl sheet pile walls anchored by either helical or dead man anchors connected to either pressure-treated wooden wales 100 mm (4 in) square in cross-section or cylindrical wooden piles secured at the front of the sheet piles. Several residences with more complex seawalls still experienced some damage and scour. The unprotected areas adjacent to seawalls were at greater risk of erosion and scour as the wave energy was directed around the seawalls and focused on the unprotected beach, dunes, and structures. Several residential structures with limited or no seawalls had their timber pile foundations exposed. In one extreme case, a residence supported by shallow foundations was completely undermined and toppled onto the beach.

Figure 9: Changes to the Vilano Beach coastline from 4020 to 3880 Coastal Highway, St. Augustine, Florida, at 29°56'49.30"N latitude and 81°18'9.37"W longitude dated: (a) November 2015, with few seawalls present; (b) March 2017, with seawalls installed following 2016 Hurricane Matthew, and; (c) October 2018, following damage from 2017 Hurricane Irma (Google Earth, 2018).

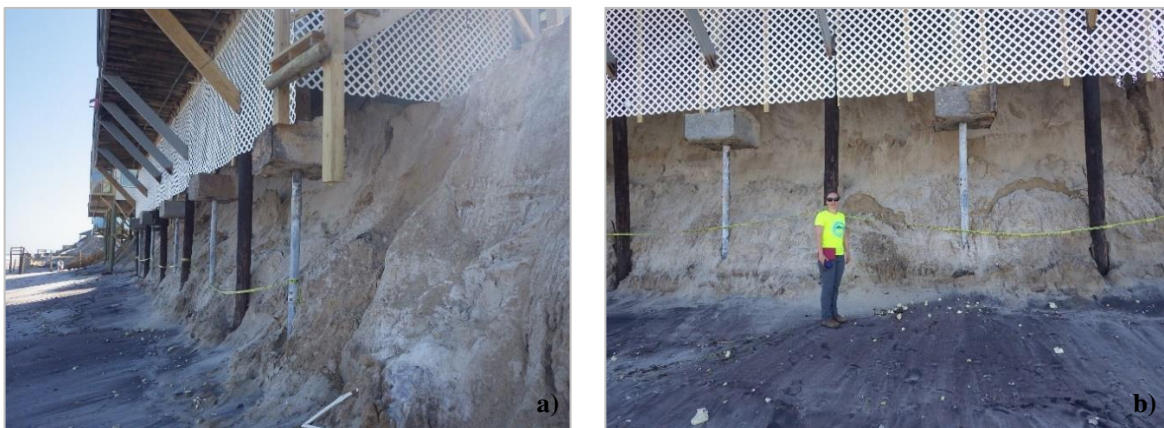
Figure 10 provides an example of damage to a residence that had been constructed on the dunes and protected by a wooden seawall of unknown design installed a distance away from the structure on the beach. The residence and its balcony are supported by alternating deeply embedded pressure-treated timber piles and pressure-treated lumber columns supported by concrete footings, presumably at the previous ground level, and micropiles. This structure experienced substantial erosion, where foundation elements became exposed over more than 10 m (~30 ft) height and both the footprint of the balcony area and structure itself were undercut. The seawall was itself destroyed (see Figure 9c). Minor slope failures were evident on the remaining dune face (Figure 10b). Drying and loss of capillary suction in the sand during the heat of the day made the exposed slopes more prone to sloughing and put the structures at greater risk of being undermined.

Figure 10: Erosion undercutting both the timber pile supports and micropile supported concrete footings for a beach house with continued slope failures in drying sand at 29°56'47.00"N latitude and 81°18'8.10"W longitude after Hurricane Irma.

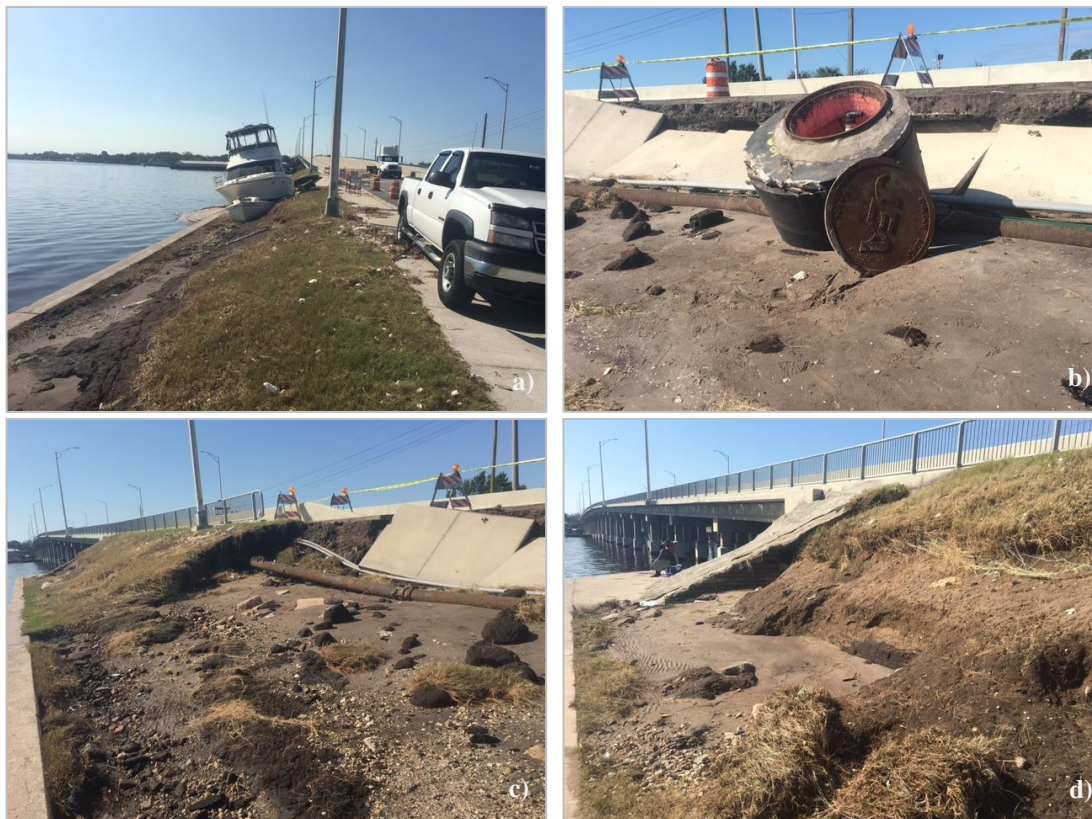
Figure 21. Erosion along the northeast embankment of the US 17 bridge over the Trout River at $30^{\circ}23'45.44''N$ latitude and $81^{\circ}38'53.95''W$ longitude shown from the north southward, including: (a) vessel washed ashore exacerbating scour, (b) an exposed sewer pipe and access structure, (c) exposed sewer pipe and electrical conduit and failed sidewalk, and (d) the terminus of scour at the stacked concrete sack wall where embankment cover was present (Hudyma et al., 2017).

The storm surge generated by Hurricane Irma ranged from 1.2 m to 1.6 m (3.9 ft to 5.2 ft) (Cangialosi et al., 2018) in height and extended into the Trout River, elevating water levels, overtopping the embankment support wall at the river level, and subjecting the northern embankments to erosion. Significant erosion occurred along the northeast bridge embankment on September 10, 2017, extending from the concrete cover of the embankment to approximately 140 m (459 ft) north into the grass- and brush-protected area embankment. The northernmost section of the embankment was protected by woody brush and small trees, and experienced minimal scour. The grass-protected, taller section of the embankment was scoured significantly into the slope (Figure 21b, c, d) to the extent that the edge of the road was undermined, concrete sidewalk panels were dislodged, and underground utilities were exposed and unsupported. The embankment section nearest the transition between the grass and concrete cover experienced the most scour, where the concrete cover was undermined to the stacked concrete sack wall and toward the bridge abutment (Figure 21d, Figure 22a). Localized scour also occurred along the northwest embankment at, and just beyond, the transition between the grass and concrete cover (Figure 22b), likely caused by an eddy current that developed after the high winds and surge accelerated the water through the constriction in the river. During the hurricane, several vessels broke free from their moorings and washed up on the embankment (Figure 21a), which created additional erosion as turbulent water flowed around these obstacles.
