Hurricane Irma: Consequences of Intense Rainfall and Storm Surge from a Tropical Storm in North and Central Florida

ABSTRACT: Hurricane Irma affected the Florida peninsula from September 9-11, 2017, with high winds, rainfall, and storm surge. Although the storm made landfall on the west coast of Florida, impacts of the rainfall and storm surge affected central and northeast Florida. A GEER team mobilized on September 23, 2017, spent three days documenting sinkhole damage in central Florida, coastal scour and erosion along the northeast coast of Florida, and infrastructure damage in northeast Florida. Numerous sites with geotechnical damage were documented but this case history focuses specifically on sinkhole damage in The Villages, erosion and scour at Vilano Beach, failure of a concrete cover earth dam at Hampton Lake, and bridge embankment damage on US-17 over the Trout River. The most notable challenges to reconnaissance were the widespread and varied nature of the damages from Hurricane Irma and the rapid repair of damaged infrastructure that required the team to work closely with local, state, and federal officials to obtain documentation of the damage prior to repair.

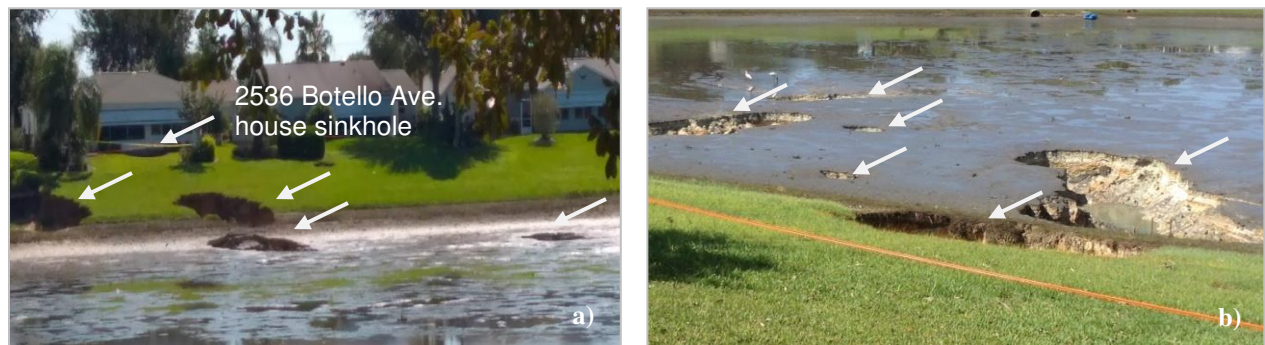
Residents graciously provided the GEER team with an account of the sinkhole events and photographs taken prior to the GEER team's arrival. On September 11, the water level in the pond was above the inlet pipes. On September 12, the water level decreased to approximately the midpoint of the inlet pipes. By the morning of September 13, the pond was empty. Digital photographs from residents show five sinkholes in the retention pond basin and two sinkholes on the bank behind the house at 2536 Botello Avenue (Figure 5). During the site visit 14 days following Hurricane Irma on September 25, repair of

the sinkholes within the basin and along the bank was being completed. Repair was performed using a Caterpillar D4 bulldozer to end dump granular fill near the holes, infill them, and then compact the fill with the machine's weight. The dimensions of the sinkholes themselves could not be estimated from either the pre-repair photos or the repairs.

Figure 5. Sinkholes on the bank of and within the retention pond between Alhambra Way and Botello Avenue at $28^{\circ}57'11.92''N$ latitude and $81^{\circ}59'31.49''W$ longitude (Images courtesy of Sheila Huffman Dailey, Dan Snyder, and Barbara Beveridge; from Hudyma et al., 2017).
