# Post-2017 Hurricane Season Assessment of Civil Infrastructure Impacts on Beach and Near-Beach Environments

**ABSTRACT:** *This paper presents an overview of observations and preliminary measurements of coastal infrastructure in the aftermath of Hurricanes Harvey and Irma in 2017. Two teams mobilized by the Geotechnical Extreme Events Reconnaissance (GEER) Association were sent to document perishable data along the Texas coastline (Port Aransas, Holiday Beach, East Matagorda Peninsula, and Follets Island) and Florida Keys (Simonton Beach, Sombrero Beach, and Coco Plum Beach). Significant damage from sediment overwash and road undercutting was observed at beach access paths and roads that transect dune fields. It was also observed that beach access points weaken the line of coastal defense provided by dunes, vegetation, and structures. The lessons learned from these field reconnaissance missions indicate that longshore non-uniformity in the dune system should be well-documented. Measurements of the geometry of beach access pathways and dunes, including the height, width, length, and vegetation coverage, should be collected prior to recovery of the system post-storm.*

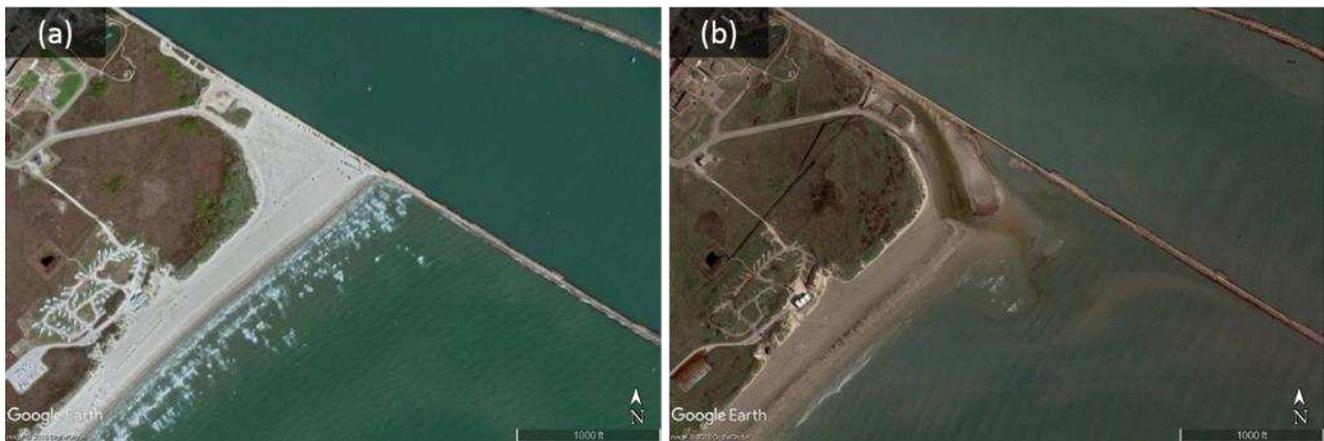
Southwest of the jetties that protect Port Aransas Pass, several paths transect the dune system to provide beach access to Port Aransas. The closest of these beach access points at the end of East Cotter Avenue experienced severe undercutting and paralleled a newly-formed eroded runnel that extended from the road, around a large dune, to the beach (Figure 3). This breach was observed to start at a small culvert under East Cotter Avenue, extend northwest toward the jetty, follow the jetty for approximately 120 m (394 ft), then turn southwest toward the GoM. At the beginning of the breach, a maximum undercut depth of 0.4 m (1.2 ft) was measured on the west side of East Cotter Avenue (Figure 4). The toe of the large dunes between the jetty and East Cotter Avenue and at the end of the beach access road were severely eroded (Figure 5). A scarp measuring approximately 0.9 m (3 ft) was observed and a thick wrack line of debris was deposited at the toe of the scarped dune. This location, along with several other beach access points in Port Aransas, provides evidence that these transects through the dune system provide a pathway for flow channelization, resulting in increased erosion.

Figure 3. (a) Pre-storm satellite imagery (imagery date February 22, 2017) and (b) post-storm satellite imagery (imagery date August 29, 2017) show the eroded runnel created during Hurricane Harvey near Port Aransas Pass (location  $27^{\circ}50'6.39''N$ ,  $97^{\circ}2'50.56''W$ ). Map data: Google Earth, Digital Globe.

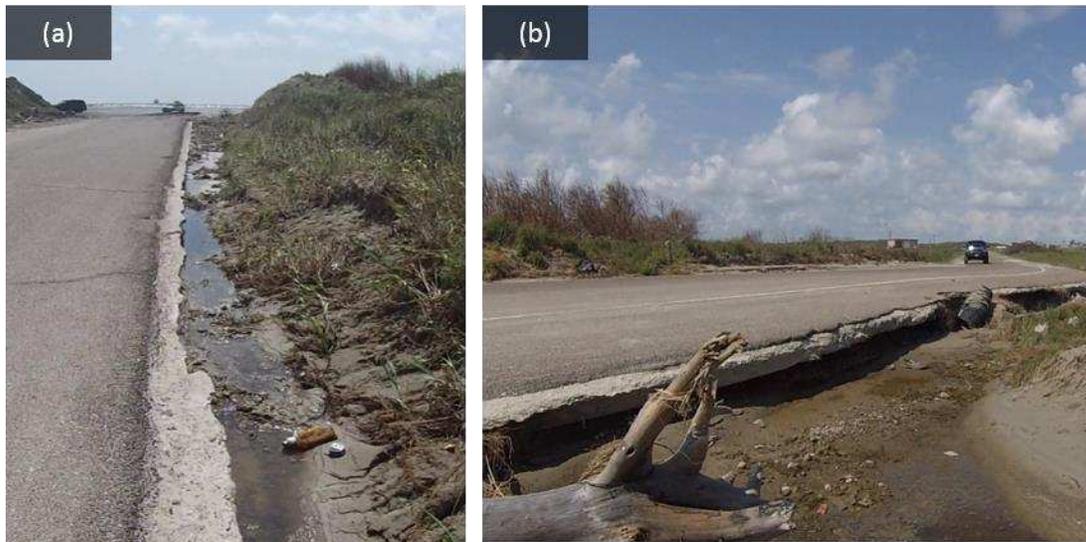
Figure 4. (a) Road undermining due to erosion and scour was observed on both sides of East Cotter Avenue, and (b) a 0.4 m undercut was measured at the beginning of a newly formed breach (collected September 3, 2017; location  $27^{\circ}50'8.53''N$ ,  $97^{\circ}2'55.00''W$ ).

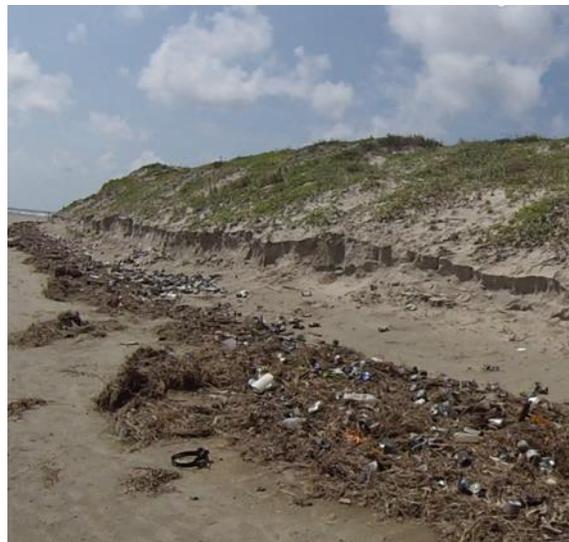
Figure 5. The dune near East Cotter Avenue was eroded and a thick wrack line of debris was deposited at the toe of the scarped dune (collected September 3, 2017; location  $27^{\circ}50'6.60''N$ ,  $97^{\circ}2'51.64''W$ ).

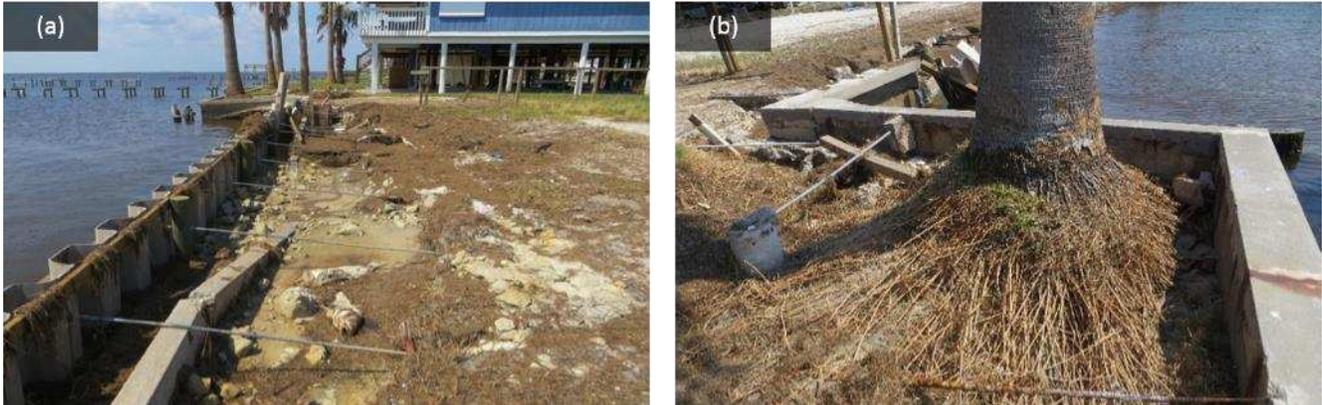
During the reconnaissance survey, houses in Holiday Beach were found heavily damaged by wind and bay surge, particularly those located on the bayfront street that parallels the canals. Anchored bulkhead retaining walls constructed along the bayfront property line were overtopped during Hurricane Harvey and severely eroded on their backsides, exposing supporting steel rods (Figure 6a). Scouring around trees and other fixed obstacles was also observed (Figure 6b). Although Holiday Beach is located on Copano Bay and is not subject to GoM wave action, the damage due to hydrodynamic forces in this region was extensive. Observations show the bulkhead was overtopped during Hurricane Harvey, leaving fish and other debris on land. As the water levels retreated, sediment appeared to be transported from the backside of the bulkhead and around the base of fixed objects, leaving these structures damaged and in need of repair. The condition of the bulkheads and service life

Figure 6. (a) Supporting steel rods were exposed after storm surge retreat scoured the backside of a bulkhead, and (b) scour was also observed around other fixed objects (collected September 3, 2017; location  $28^{\circ}10'11.24''N$ ,  $97^{\circ}1'2.03''W$ ).

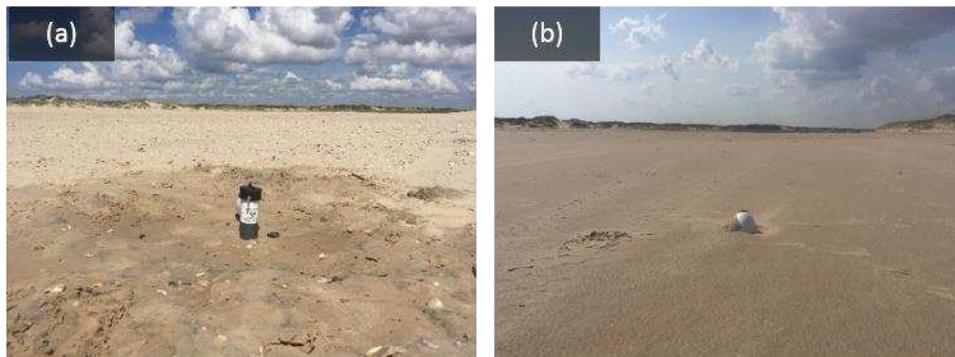
The infilled storm cut through East Matagorda Peninsula hydraulically connects GoM and bay surface waters only during elevated storm water levels. During Hurricane Harvey, the maximum water surface elevation at the backshore (GoM side of the cut) was 1.8 m above Mean Sea Level (MSL) and 1.0 m above MSL at the back-barrier location (bay side of the cut) as measured by rapid response field measurement units containing pressure transducers. The dunes at this site were not overtopped. Surface hydraulic connection through the cut lasted for approximately six hours. During this time, up to 0.50 m (1.6 ft) of GoM sediment was deposited in the backshore (back-barrier) region of the cut as a result of onshore-directed transport of sediment eroded from the shoreface by hurricane wave action. Figure 7 shows before and after photos of the backshore area on the GoM side of the cut, clearly indicating the accretion that occurred at this location. The cut serves as a roadway to access the back-barrier areas and is an example of what can happen to shore-perpendicular gaps in the dune line during hurricane impact.

Figure 7. (a) Pre-storm (collected August 23, 2017) and (b) post-storm observations (collected August 30, 2017) of the backshore area fronting the East Matagorda cut where 0.5 m of sediment accretion was observed (location  $28^{\circ}36'43.57''N$ ,  $95^{\circ}56'24.88''W$ ).

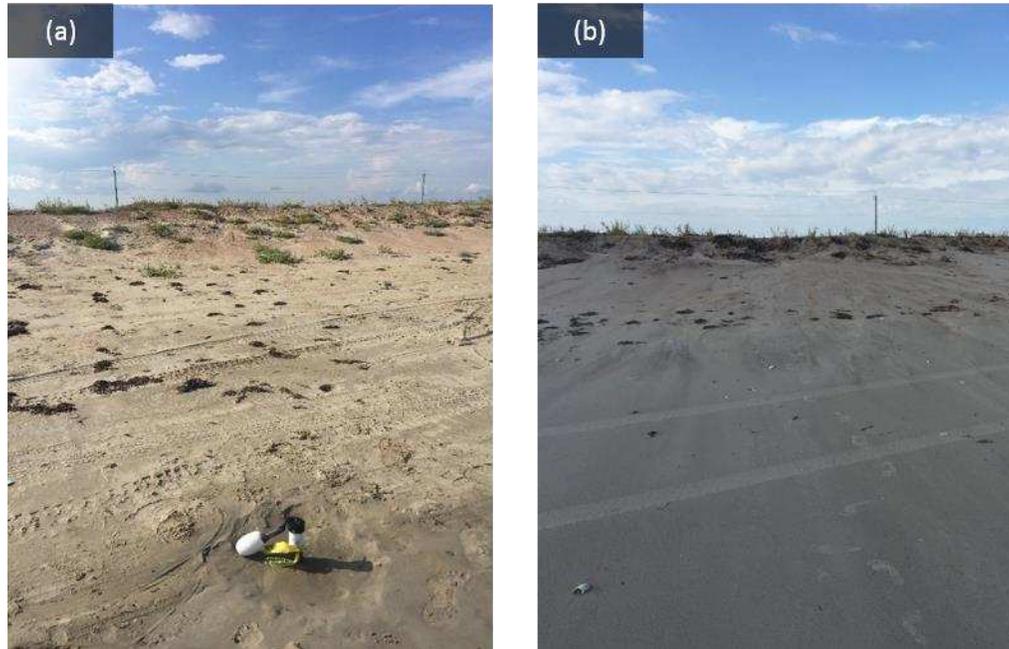
Figure 8. (a) Pre-storm (collected August 24, 2017) and (b) post-storm observations (collected August 31, 2017) of the dune show regrading of the beach profile and washout from heavy rainfall on the dune peak (location  $29^{\circ}1'27.93''N$ ,  $95^{\circ}11'24.93''W$ ).

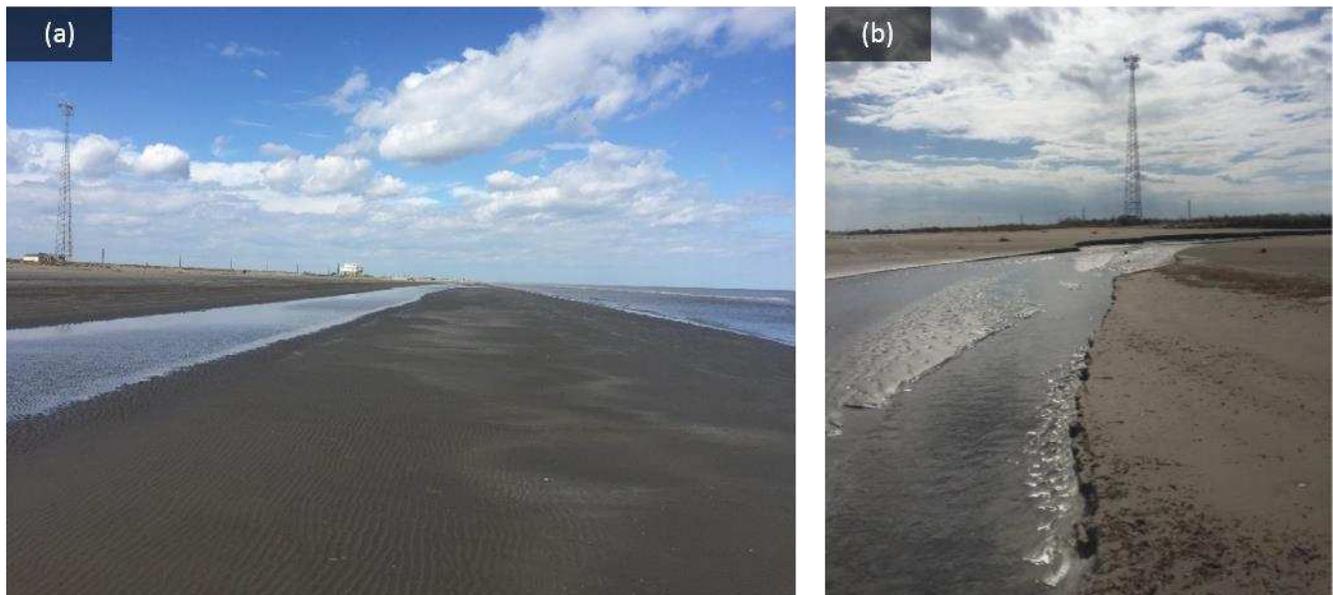
deposits were observed on the road (257R) and a channel was formed connecting the flooded backbarrier region to the beach along the eastern and western flanks of the dunes (Figure 9b). This study location on Follets Island shows the protection afforded by dunes against storm flooding, but it also demonstrates damaging erosion along the sides of roadways. It also highlights that beach access points can serve as a funnel as rainwater and storm surge retreat, allowing the channelization of sediment transport.

Figure 9. (a) A ridge-runnel system formed parallel to the shore, and (b) a channel was eroded from the beach access point to the GoM (location  $29^{\circ}1'27.93''N$ ,  $95^{\circ}11'24.93''W$ ).

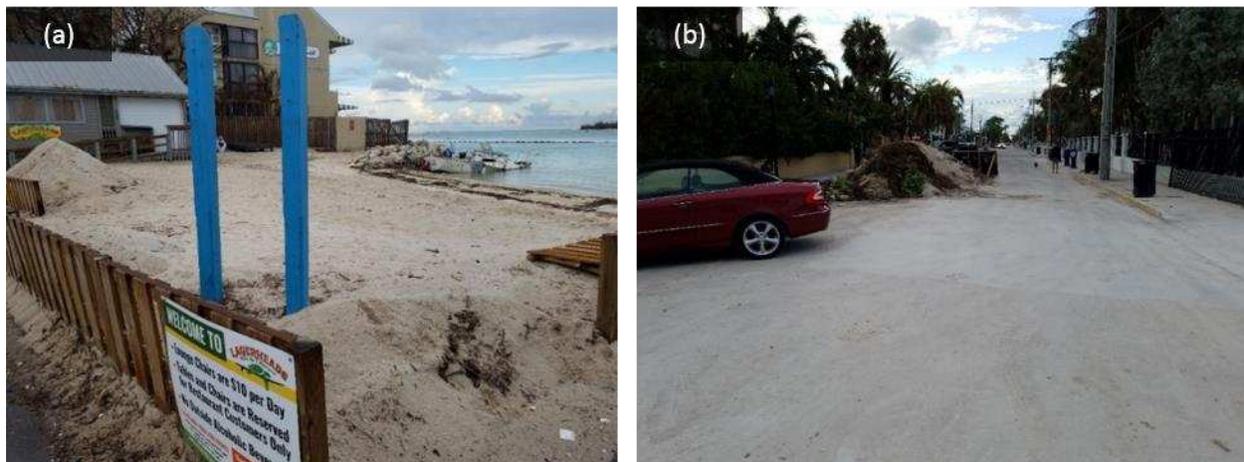
According to a representative of the Engineering Division for the City of Key West, Simonton Beach experienced some of the greatest beach impacts within the City of Key West due to Hurricane Irma. This very small beach was severely eroded, causing sand to be transported either offshore or deposited in the parking lot behind the beach. The beach width was reduced by nearly 4 m and the beach face was noticeably steepened due to the erosion (Figure 10). Additionally, the concrete groin/walkway located on the east side of the beach was damaged by scour and undermining, causing the structure to drop slightly in elevation (Figure 11). Simonton Beach provides evidence that beaches with small sediment volumes can be particularly impacted by storm surge and waves. Also, the lack of a dune system and the beach's location in an area characterized by mostly impervious surfaces and little natural vegetation are both factors that cause sediment to be eroded from the beach and transported further inland. Because the concrete structure is impermeable, the flow is funneled along its length, focusing flow energy and leading to larger erosion potential.

Figure 10. (a) Simonton Beach was severely eroded and (b) sediment was deposited in the parking lot backing the beach (collected September 27, 2017; location  $24^{\circ}33'42.85''N$ ,  $81^{\circ}48'19.64''W$ ).

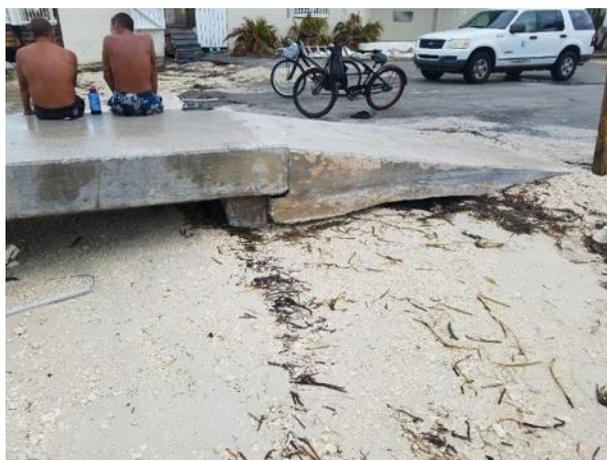
Figure 11. A concrete structure located on the eastern edge of Simonton Beach was undermined due to scour around the structure (collected September 27, 2017; location  $24^{\circ}33'43.32''N$ ,  $81^{\circ}48'20.22''W$ ).

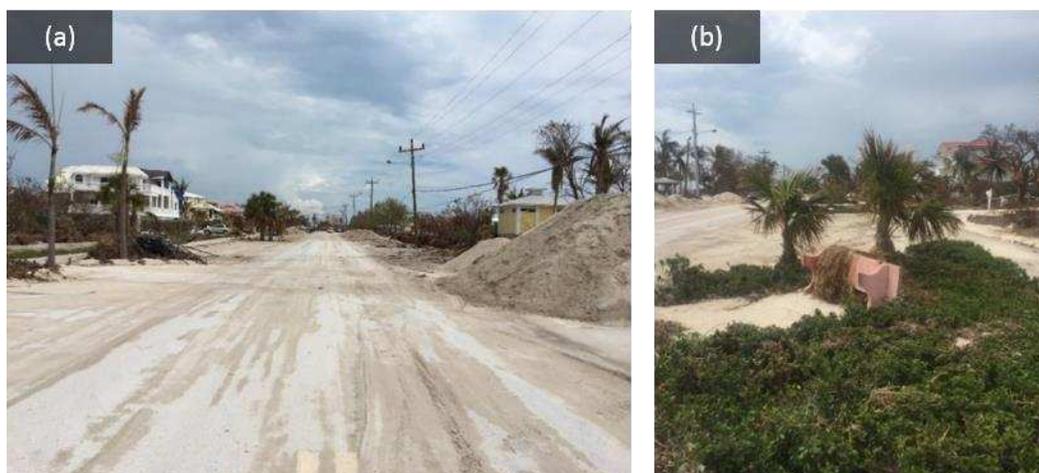
At the time of reconnaissance, sections of Sombrero Beach Road were still covered with sand deposits (Figure 12) that were transported from the small nourished beach in Sombrero Beach Park. Homeowners were removing sand from inside their houses (Figure 13), which were buried with up to about 1 m (3 ft) of sediment. Additional evidence of damage by storm surge and waves was observed as structural and flood damage to houses, including the collapse of a wall located in front of an oceanfront home (Figure 14). Undermining of another home was observed to expose the foundation, likely causing structural damage in the form of large cracks in the floor slab to the beach house (Figure 15).

Figure 12. (a) Large volumes of sediment were deposited on Sombrero Beach Road (facing east) and (b) a concrete bench was overturned, trapping debris on its side (collected September 26, 2017; location  $24^{\circ}41'33.01''N$ ,  $81^{\circ}5'5.57''W$ ).

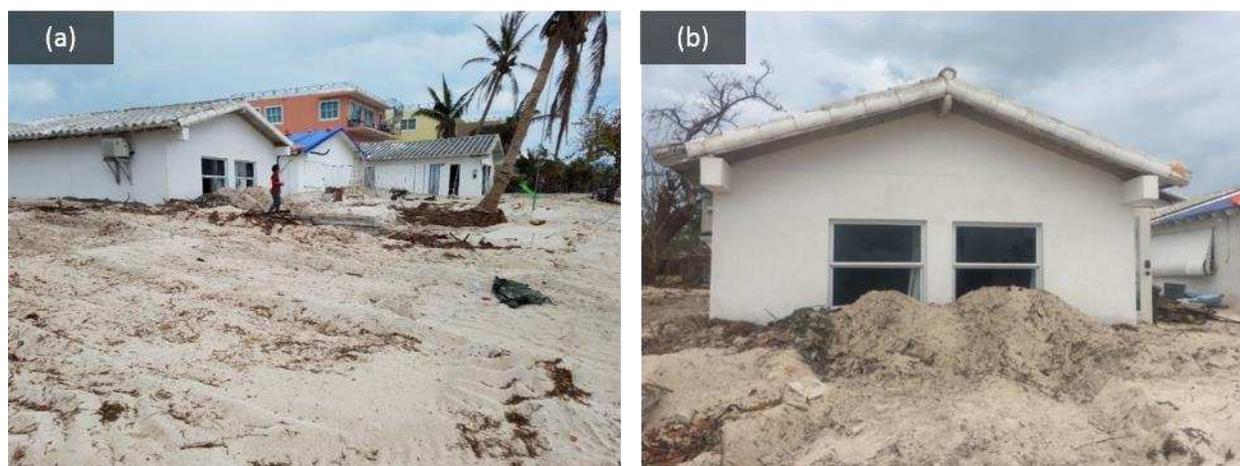
Figure 13. (a) Large volumes of sediment were deposited around houses and other structures and (b) buried them with approximately 1 m of sand, reaching the bottom of window sills (collected September 26, 2017; location  $24^{\circ}41'31.52''N$ ,  $81^{\circ}4'56.31''W$ ).

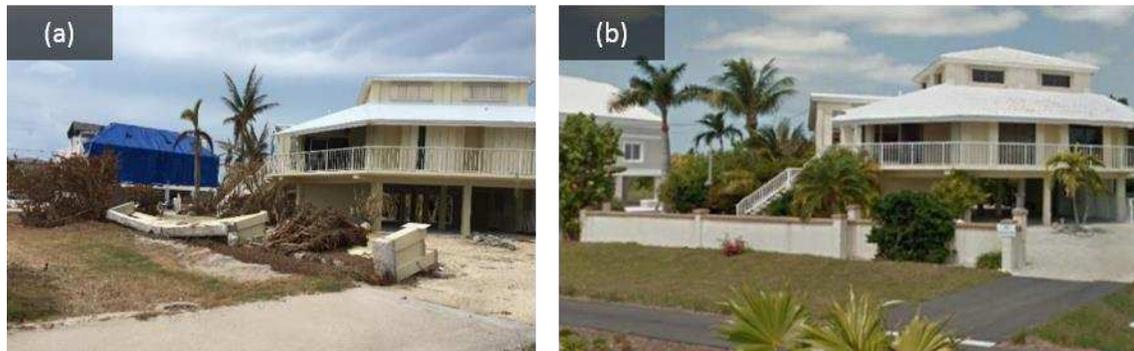
Figure 14. (a) A wall located in front of a home on Sombrero Beach Road collapsed during Hurricane Irma (collected September 26, 2017; location  $24^{\circ}41'34.26''N$ ,  $81^{\circ}5'0.93''W$ ); (b) the pre-existing structure appeared to be intact prior to the storm. Map Data: Google (2018).

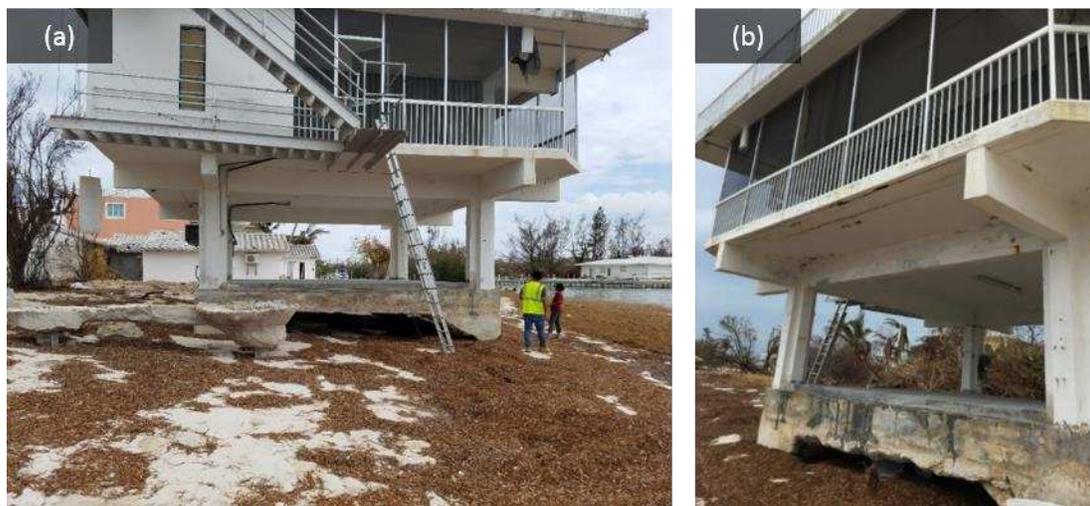
Figure 15. (a) The foundation of an elevated home was undermined due to scouring around the structure; (b) a close-up view shows damage to the structural integrity of the home (collected September 26, 2017; location  $24^{\circ}41'31.86''N$ ,  $81^{\circ}4'57.29''W$ ).

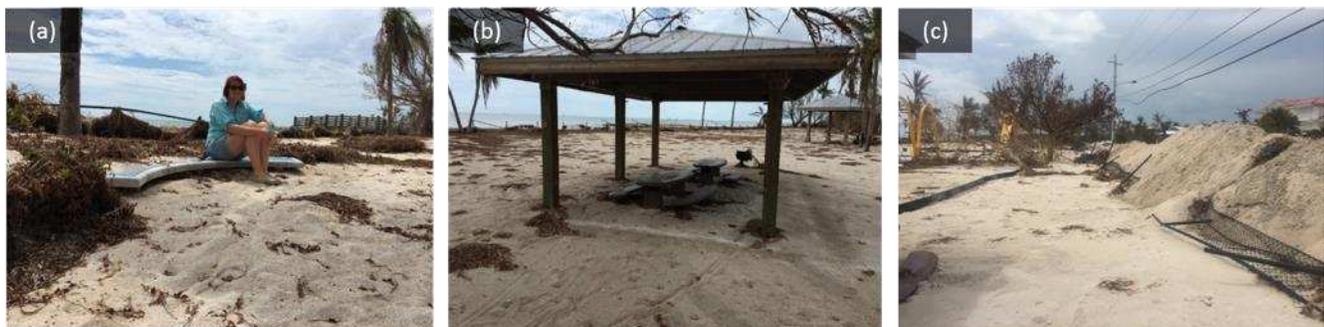
At Sombrero Beach Park, most of the park structures, such as fences, walking paths, and a beach access ramp, were damaged, and playground equipment was buried by about 0.6 m (2 ft) of sediment (Figure 16). Observations at this location further indicate that geotechnical impacts resulting from storm surge and waves are magnified by the surrounding infrastructure. At the park locations, sediment freely moved and deposited around park structures and on the roadway. However, at the walls and foundations of homes, which are impermeable fixed structures, sediment was eroded from around and beneath the structures. Sombrero Beach is another example that civil infrastructure can direct sediment erosion by interfering with the flow and natural sediment transport paths. Furthermore, it also highlights that small sediment-volume beaches, particularly those with no pre-existing dune structure, can be heavily damaged during extreme events.

Figure 16. (a) Concrete park benches were nearly buried with sand (approximately 2 m), (b) some park structures were only mildly damaged and buried with sediment, (c) while others were severely damaged and in need of repair (collected September 26, 2017; location  $24^{\circ}41'32.20''N$ ,  $81^{\circ}5'4.09''W$ ).

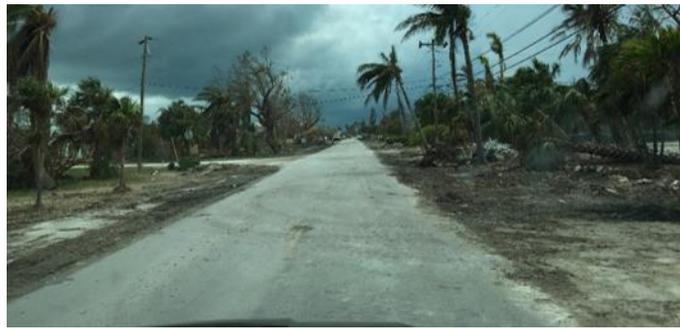
On Coco Plum Drive, evidence of wind and inundation by storm surge was observed from the debris deposited onto the roadway (Figure 17). At Coco Plum Beach Park, large volumes of sediment were transported from the beach, narrowing its

Figure 17. Sand and debris were deposited on Coco Plum Drive (collected September 26, 2017; location  $24^{\circ}43'34.52''N$ ,  $81^{\circ}0'36.53''W$ ).

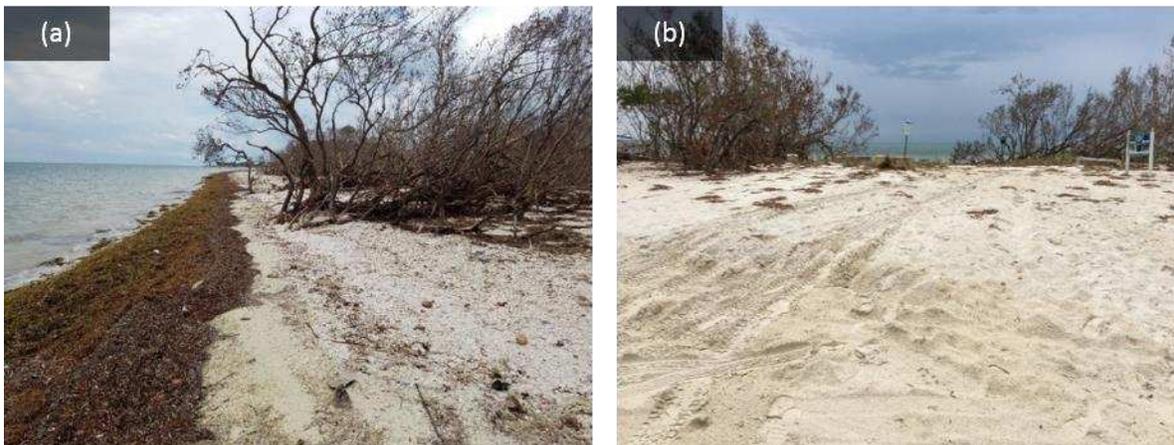
width, and deposited in the parking area (Figure 18). From the observations, the densely vegetated regions of the island trapped much of the sediment in a 20 m to 25 m zone, except at the beach access point where the transect in the vegetation served as a transport pathway through which sediment was channelized.

Figure 18. (a) The beach width was narrowed due to erosion and algae washed up on the beach, and (b) sediment approximately 0.3 m in depth was deposited in the beach access area (collected September 26, 2017; location  $24^{\circ}43'48.42''N$ ,  $81^{\circ}0'5.81''W$ ).
