# Post-2017 Hurricane Season Assessment of Civil Infrastructure Impacts on Beach and Near-Beach Environments

**ABSTRACT:** *This paper presents an overview of observations and preliminary measurements of coastal infrastructure in the aftermath of Hurricanes Harvey and Irma in 2017. Two teams mobilized by the Geotechnical Extreme Events Reconnaissance (GEER) Association were sent to document perishable data along the Texas coastline (Port Aransas, Holiday Beach, East Matagorda Peninsula, and Follets Island) and Florida Keys (Simonton Beach, Sombrero Beach, and Coco Plum Beach). Significant damage from sediment overwash and road undercutting was observed at beach access paths and roads that transect dune fields. It was also observed that beach access points weaken the line of coastal defense provided by dunes, vegetation, and structures. The lessons learned from these field reconnaissance missions indicate that longshore non-uniformity in the dune system should be well-documented. Measurements of the geometry of beach access pathways and dunes, including the height, width, length, and vegetation coverage, should be collected prior to recovery of the system post-storm.*

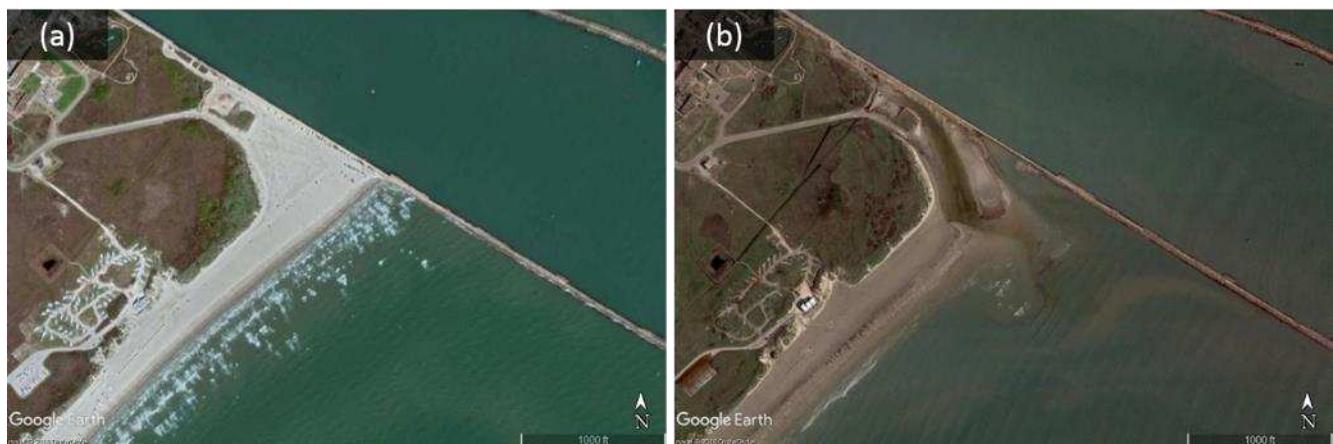
Southwest of the jetties that protect Port Aransas Pass, several paths transect the dune system to provide beach access to Port Aransas. The closest of these beach access points at the end of East Cotter Avenue experienced severe undercutting and paralleled a newly-formed eroded runnel that extended from the road, around a large dune, to the beach (Figure 3). This breach was observed to start at a small culvert under East Cotter Avenue, extend northwest toward the jetty, follow the jetty for approximately 120 m (394 ft), then turn southwest toward the GoM. At the beginning of the breach, a maximum undercut depth of 0.4 m (1.2 ft) was measured on the west side of East Cotter Avenue (Figure 4). The toe of the large dunes between the jetty and East Cotter Avenue and at the end of the beach access road were severely eroded (Figure 5). A scarp measuring approximately 0.9 m (3 ft) was observed and a thick wrack line of debris was deposited at the toe of the scarped dune. This location, along with several other beach access points in Port Aransas, provides evidence that these transects through the dune system provide a pathway for flow channelization, resulting in increased erosion.

Figure 3. (a) Pre-storm satellite imagery (imagery date February 22, 2017) and (b) post-storm satellite imagery (imagery date August 29, 2017) show the eroded runnel created during Hurricane Harvey near Port Aransas Pass (location  $27^{\circ}50'6.39''N$ ,  $97^{\circ}2'50.56''W$ ). Map data: Google Earth, Digital Globe.

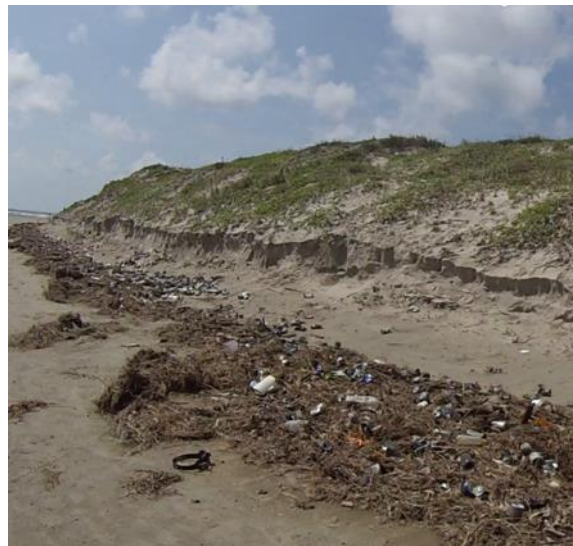
Figure 5. The dune near East Cotter Avenue was eroded and a thick wrack line of debris was deposited at the toe of the scarped dune (collected September 3, 2017; location  $27^{\circ}50'6.60''N$ ,  $97^{\circ}2'51.64''W$ ).

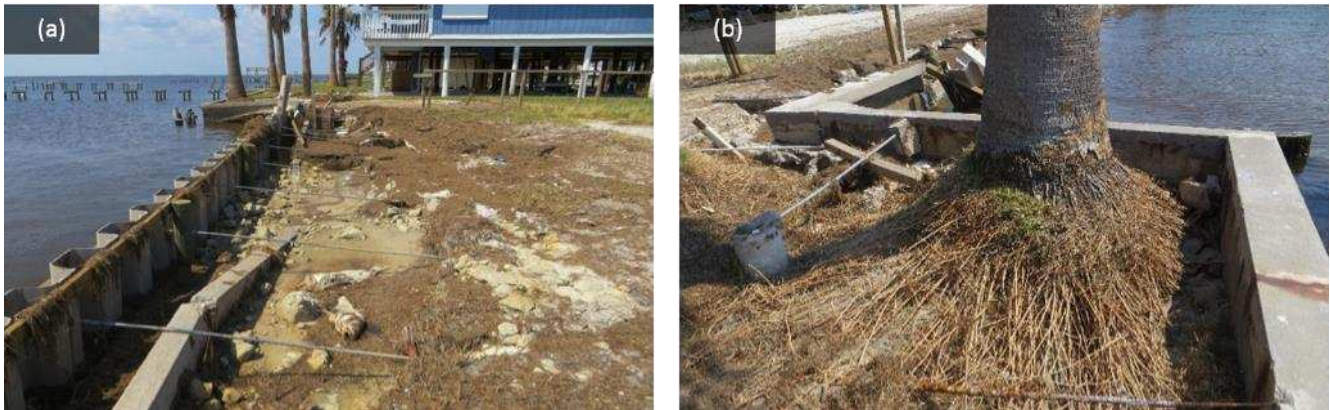
During the reconnaissance survey, houses in Holiday Beach were found heavily damaged by wind and bay surge, particularly those located on the bayfront street that parallels the canals. Anchored bulkhead retaining walls constructed along the bayfront property line were overtopped during Hurricane Harvey and severely eroded on their backsides, exposing supporting steel rods (Figure 6a). Scouring around trees and other fixed obstacles was also observed (Figure 6b). Although Holiday Beach is located on Copano Bay and is not subject to GoM wave action, the damage due to hydrodynamic forces in this region was extensive. Observations show the bulkhead was overtopped during Hurricane Harvey, leaving fish and other debris on land. As the water levels retreated, sediment appeared to be transported from the backside of the bulkhead and around the base of fixed objects, leaving these structures damaged and in need of repair. The condition of the bulkheads and service life

maintenance prior to Hurricane Harvey remain unknown, and it is unclear if it affected the damage observed during the survey.

Figure 6. (a) Supporting steel rods were exposed after storm surge retreat scoured the backside of a bulkhead, and (b) scour was also observed around other fixed objects (collected September 3, 2017; location  $28^{\circ}10'11.24''N$ ,  $97^{\circ}1'2.03''W$ ).

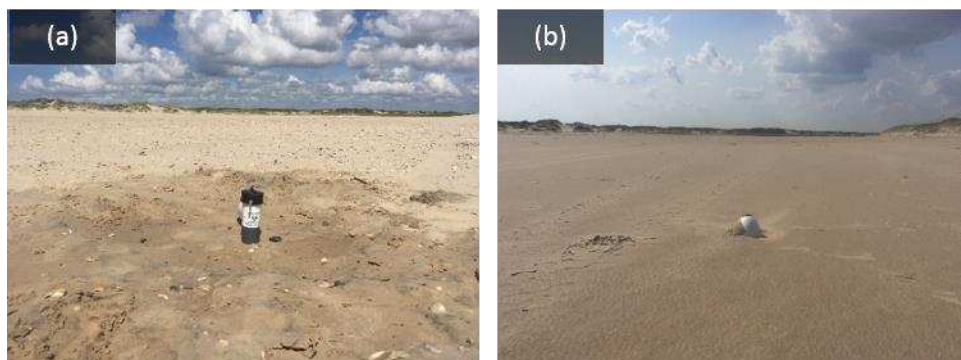
The infilled storm cut through East Matagorda Peninsula hydraulically connects GoM and bay surface waters only during elevated storm water levels. During Hurricane Harvey, the maximum water surface elevation at the backshore (GoM side of the cut) was 1.8 m above Mean Sea Level (MSL) and 1.0 m above MSL at the back-barrier location (bay side of the cut) as measured by rapid response field measurement units containing pressure transducers. The dunes at this site were not overtopped. Surface hydraulic connection through the cut lasted for approximately six hours. During this time, up to 0.50 m (1.6 ft) of GoM sediment was deposited in the backshore (back-barrier) region of the cut as a result of onshore-directed transport of sediment eroded from the shoreface by hurricane wave action. Figure 7 shows before and after photos of the backshore area on the GoM side of the cut, clearly indicating the accretion that occurred at this location. The cut serves as a roadway to access the back-barrier areas and is an example of what can happen to shore-perpendicular gaps in the dune line during hurricane impact.

Figure 7. (a) Pre-storm (collected August 23, 2017) and (b) post-storm observations (collected August 30, 2017) of the backshore area fronting the East Matagorda cut where 0.5 m of sediment accretion was observed (location  $28^{\circ}36'43.57''N$ ,  $95^{\circ}56'24.88''W$ ).

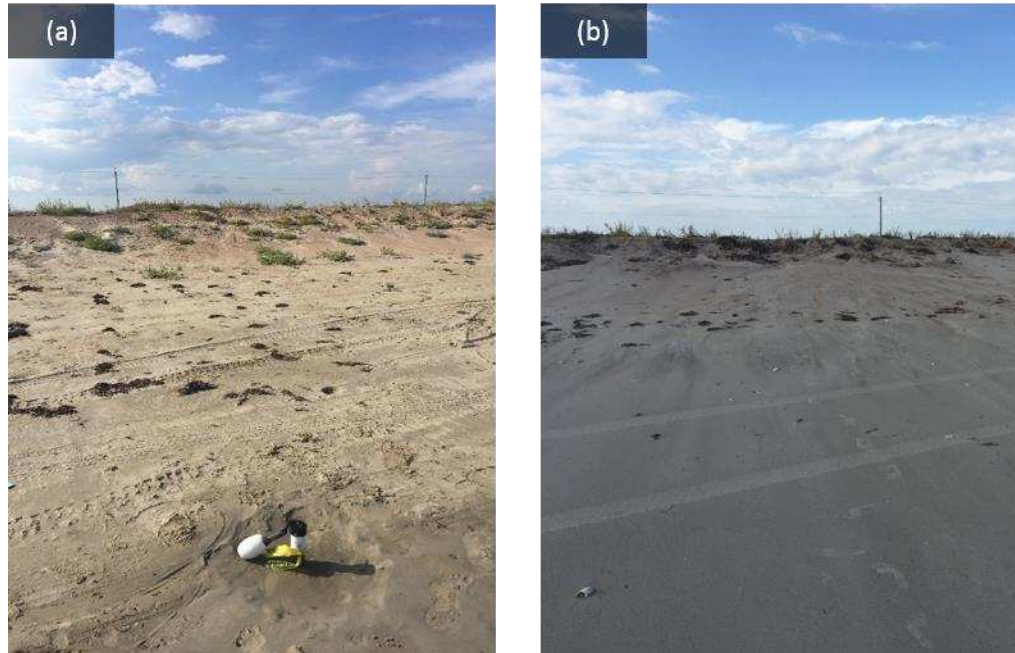
The recently nourished, relatively longshore uniform beach on Follets Island experienced dune collision and re-grading of the beach profile by storm surge and waves, but was not overtopped or severely overwashed as observed in other study locations discussed herein (Figure 8). Significant erosion of the dune line was observed due to heavy rainfall. A shore-parallel ridge-runnel system was observed in the foreshore (Figure 9a). At the beach access point from Bluewater Highway, sediment

Figure 8. (a) Pre-storm (collected August 24, 2017) and (b) post-storm observations (collected August 31, 2017) of the dune show regrading of the beach profile and washout from heavy rainfall on the dune peak (location  $29^{\circ}1'27.93''N$ ,  $95^{\circ}11'24.93''W$ ).

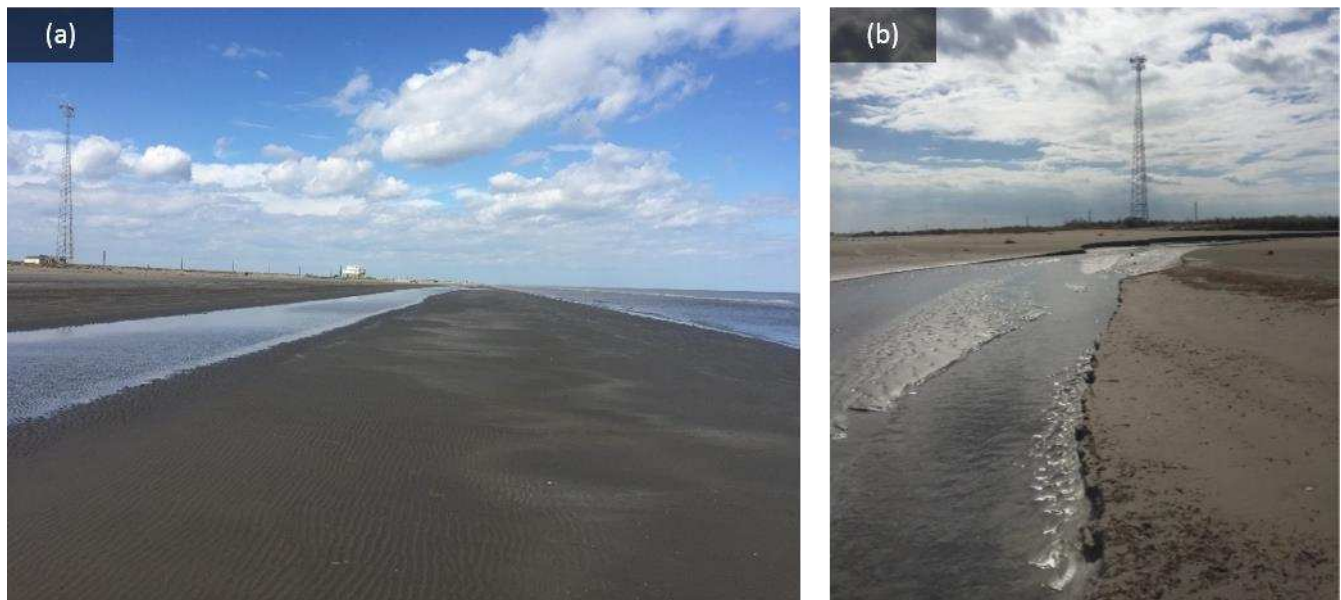
deposits were observed on the road (257R) and a channel was formed connecting the flooded backbarrier region to the beach along the eastern and western flanks of the dunes (Figure 9b). This study location on Follets Island shows the protection afforded by dunes against storm flooding, but it also demonstrates damaging erosion along the sides of roadways. It also highlights that beach access points can serve as a funnel as rainwater and storm surge retreat, allowing the channelization of sediment transport.

Figure 9. (a) A ridge-runnel system formed parallel to the shore, and (b) a channel was eroded from the beach access point to the GoM (location  $29^{\circ}1'27.93''N$ ,  $95^{\circ}11'24.93''W$ ).

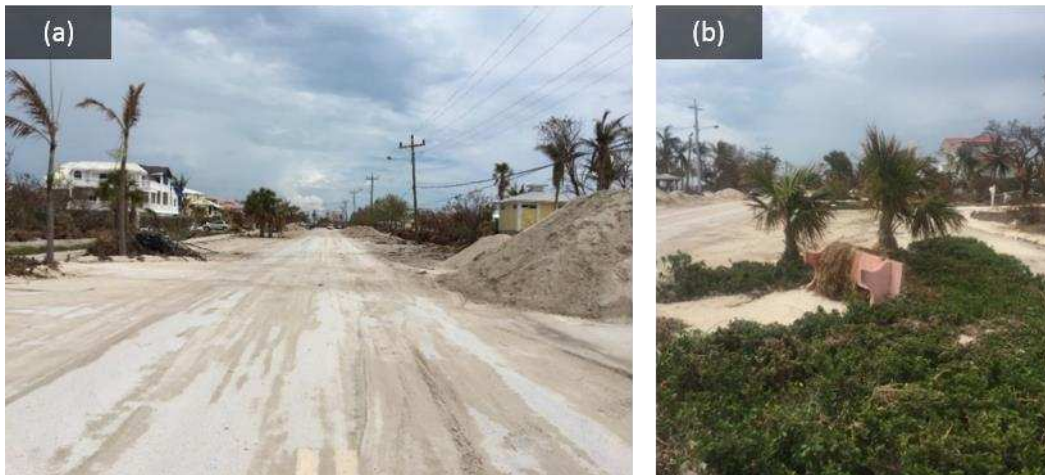
At the time of reconnaissance, sections of Sombrero Beach Road were still covered with sand deposits (Figure 12) that were transported from the small nourished beach in Sombrero Beach Park. Homeowners were removing sand from inside their houses (Figure 13), which were buried with up to about 1 m (3 ft) of sediment. Additional evidence of damage by storm surge and waves was observed as structural and flood damage to houses, including the collapse of a wall located in front of an oceanfront home (Figure 14). Undermining of another home was observed to expose the foundation, likely causing structural damage in the form of large cracks in the floor slab to the beach house (Figure 15).

Figure 12. (a) Large volumes of sediment were deposited on Sombrero Beach Road (facing east) and (b) a concrete bench was overturned, trapping debris on its side (collected September 26, 2017; location 24°41'33.01"N, 81°5'5.57"W).

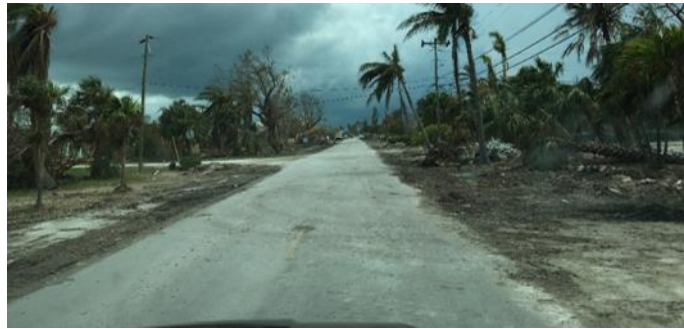
On Coco Plum Drive, evidence of wind and inundation by storm surge was observed from the debris deposited onto the roadway (Figure 17). At Coco Plum Beach Park, large volumes of sediment were transported from the beach, narrowing its

Figure 17. Sand and debris were deposited on Coco Plum Drive (collected September 26, 2017; location  $24^{\circ}43'34.52''N$ ,  $81^{\circ}0'36.53''W$ ).

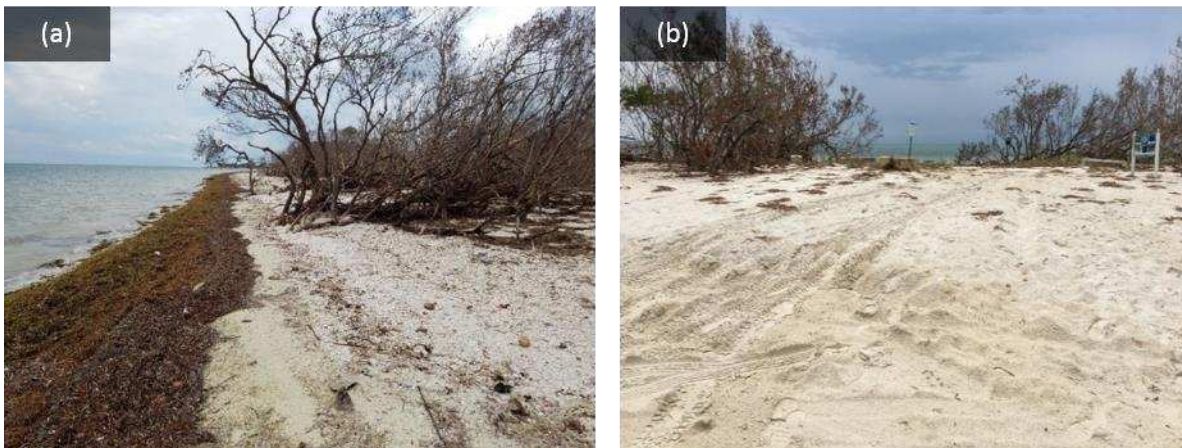
width, and deposited in the parking area (Figure 18). From the observations, the densely vegetated regions of the island trapped much of the sediment in a 20 m to 25 m zone, except at the beach access point where the transect in the vegetation served as a transport pathway through which sediment was channelized.

Figure 18. (a) The beach width was narrowed due to erosion and algae washed up on the beach, and (b) sediment approximately 0.3 m in depth was deposited in the beach access area (collected September 26, 2017; location  $24^{\circ}43'48.42''N$ ,  $81^{\circ}0'5.81''W$ ).
