Reconnaissance of the New Orleans Hurricane and Storm Damage Risk Reduction System after Hurricane Gustav

Reconnaissance of the New Orleans Hurricane and Storm Damage Risk Reduction System after Hurricane Gustav.

International Journal of Geoengineering Case Histories, Volume 5, Issue 4, pp. 129-154, doi: 10.4417/IJGCH-05-04-

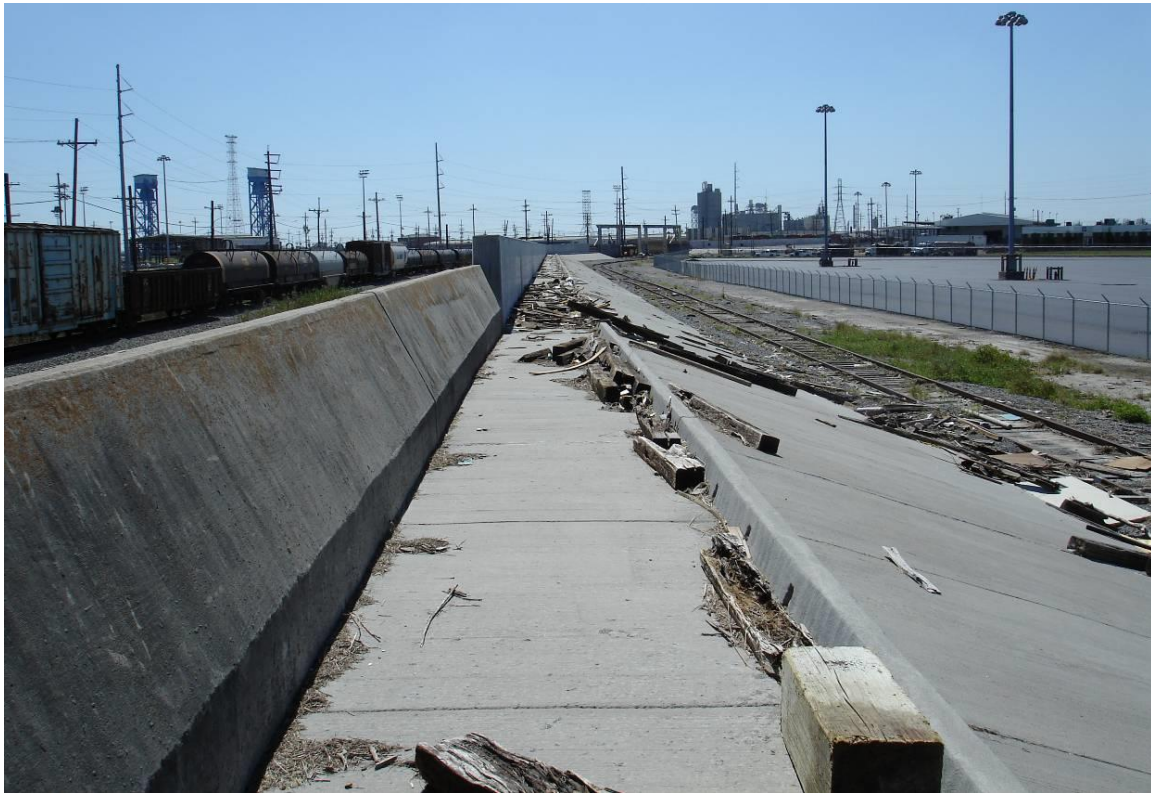
Figure 6. I-wall and splash apron, IHNC west along France Road; new L-wall and splash apron in background. (October 2, 2008, 90.0272° W, 90.0272° W)

At the transition between the new L-wall and the old I-wall (Figure 6), there was storm debris left on top of and behind the higher L-wall, while the top of the lower I-wall was left clean. It is possible that the water elevation or waves during the peak storm surge exceeded the top of the old I-wall on a more consistent basis (elevation of about 4.3 m [14 ft], NAVD88) at this location, sweeping wave debris from the wall top.

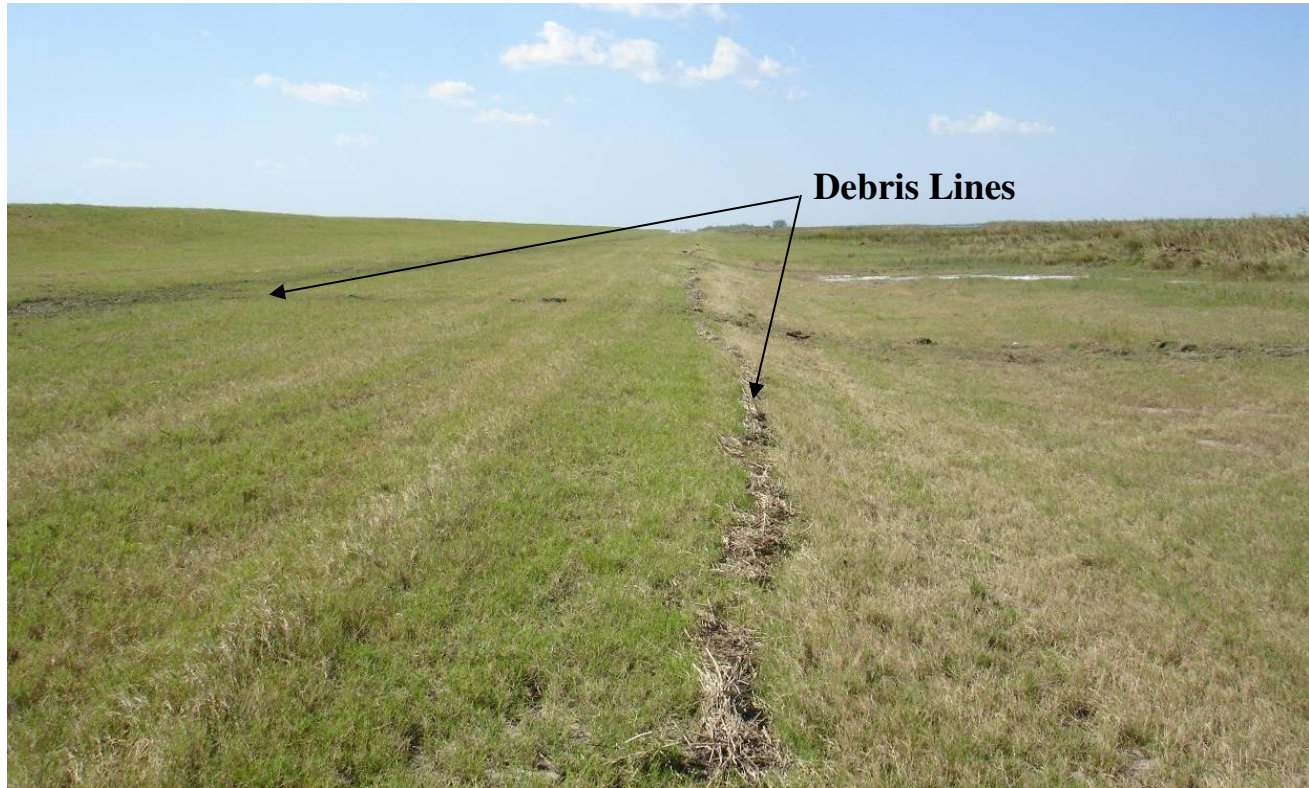
The team observed no signs of either erosion or overtopping during Gustav along the southeast sections of the MRGO frontage levee, which the team believes was representative of the MRGO frontage levees. Based on the limited debris lines along the levee, the high water levels during Gustav were well below the crest of these rebuilt and elevated earthen embankments. The wave and current actions of Gustav also appeared to have caused no erosion on the earth embankments. Figure 12 shows a typical view of the MRGO frontage levee embankment in October 2008.

Figure 12. MRGO frontage levee, flood side, looking northwest. Upper debris line, believed to be due to Gustav, was cleared prior to our visit, probably as part of the ongoing efforts to maintain the protective grass cover. The lower debris line may represent the high-water level during hurricane Ike, which followed Gustav in September 2008. (October 2, 2008, 29.8889°N, 89.7617°W)

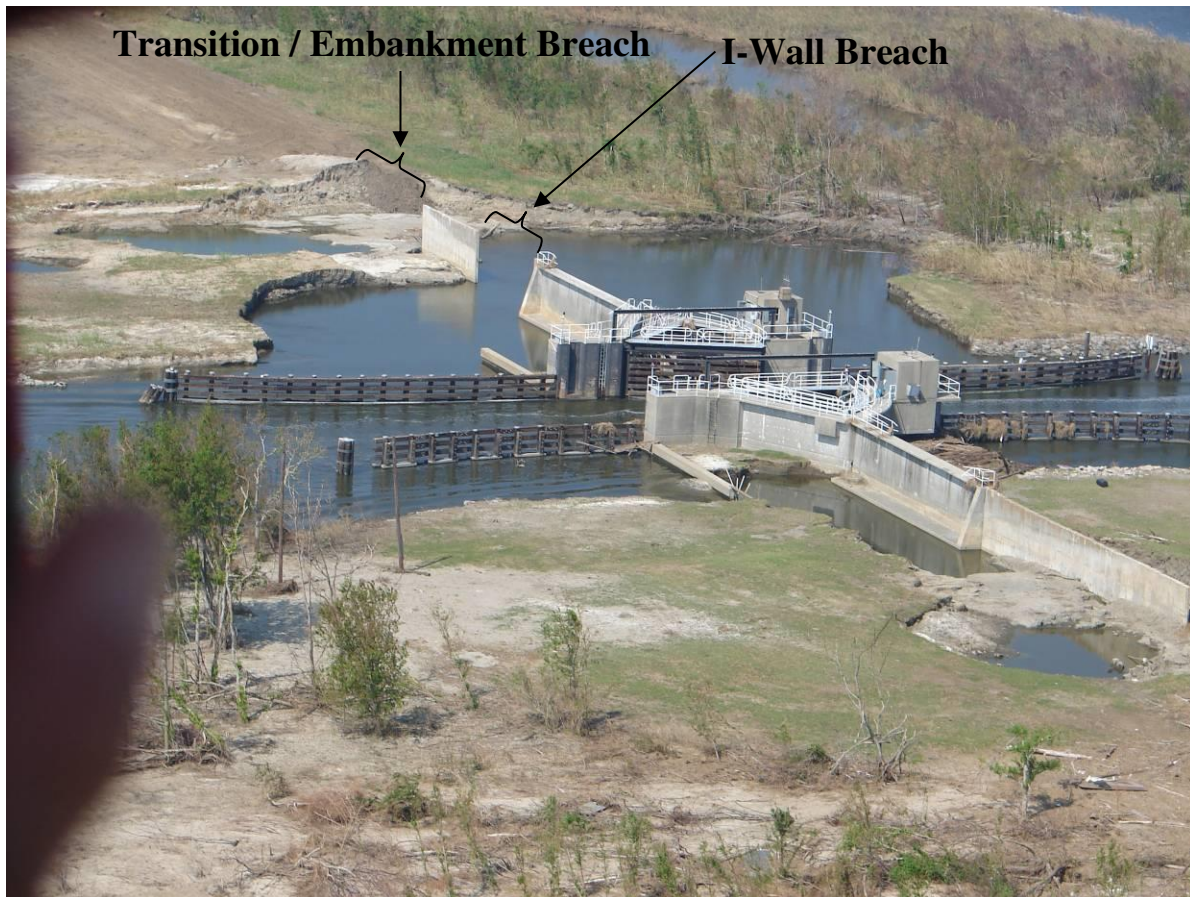
The Bayou Dupree gate structure on the MRGO suffered several severe breaches during Katrina, which overtopped the entire structure by 0.6 to 1.5 m (2 to 5 ft). Figure 13 is an October 2005 photo of the gate structure following Katrina, showing breaches at the I-wall section and at the transition from the I-wall to the embankment.

Figure 13. Post-Katrina Bayou Dupree gate. (October 14, 2005, 29.935° N, 89.837° W, L. Harder)

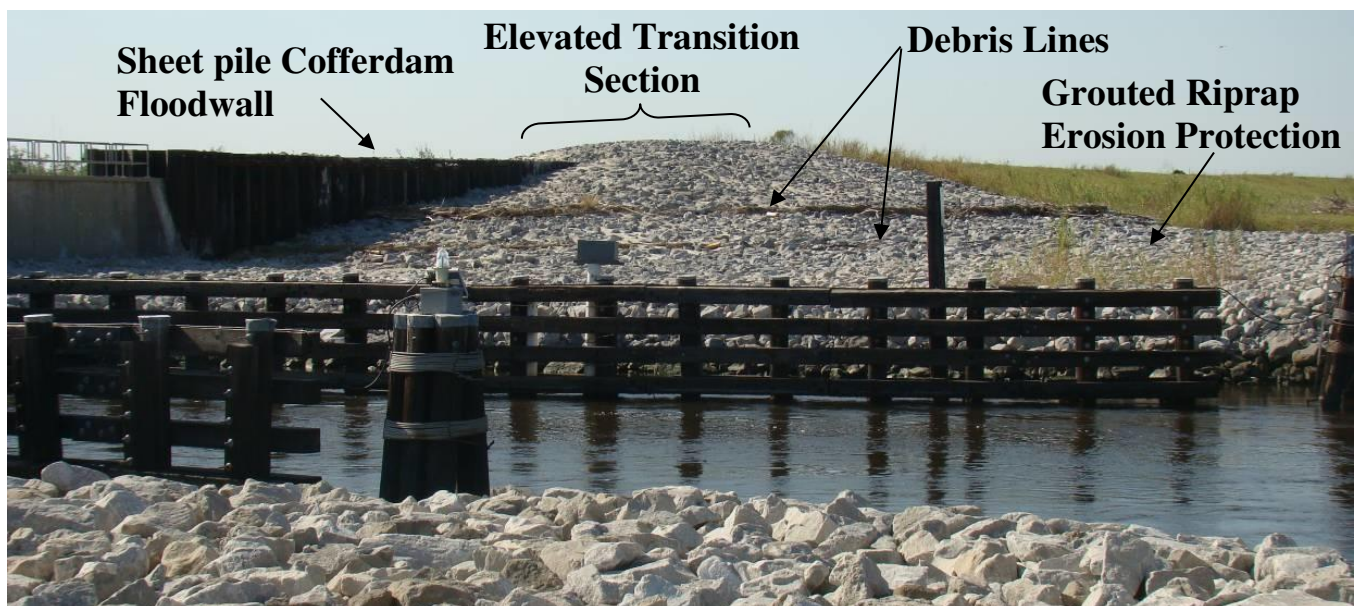
Figure 14 shows the improvements constructed by the USACE to the same Bayou Dupree gate structures. The concrete sheet pile I-wall was replaced with a steel sheet pile cofferdam section, and the transitions to the earthen levees on both sides of the gate were elevated and covered with grouted riprap. The use of grouted riprap to harden vulnerable areas around the gate was extensive, as illustrated in Figure 14. UngROUTED riprap was placed as erosion protection at the toe areas of grouted riprap. The team observed no signs of erosion or damage from Gustav's high water and waves at or near the gate. The limited debris line on the northwest flank appeared to indicate that the highest waters from Gustav were about 1 to 1.5 m (3 to 5 ft) below the crest of any of the gate structure elements (see Figure 14).

Figure 14. Bayou Dupree gate, northwest flank, MRGO side, looking east. The lower debris line may represent the high-water level during Hurricane Ike. (October 2, 2008, 29.9352° N, 89.8358° W)

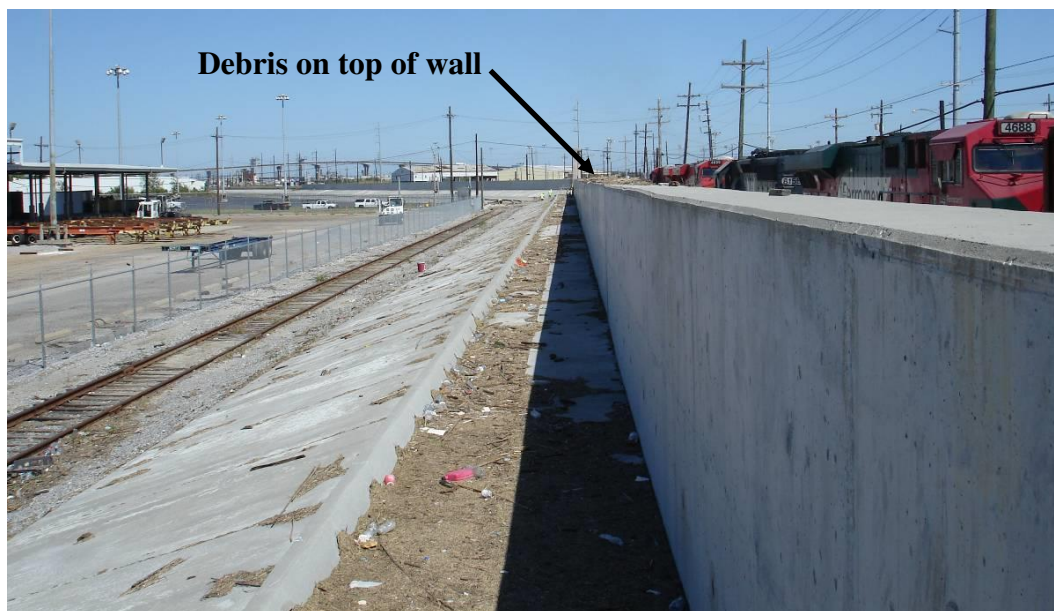
The repairs and improvements of these sections of the hurricane protection appeared to have performed well in light of clear evidence of wave overtopping. Figure 20 shows the debris left by overtopping waves on the protected side of one section of new L-wall along the IHNC West.

Figure 20. Protected side of new L-wall along IHNC West. Note debris left by overtopping on floodwall and slope protection. October 2008. (October 2, 2008, 29.9899° N, 90.0272° W)

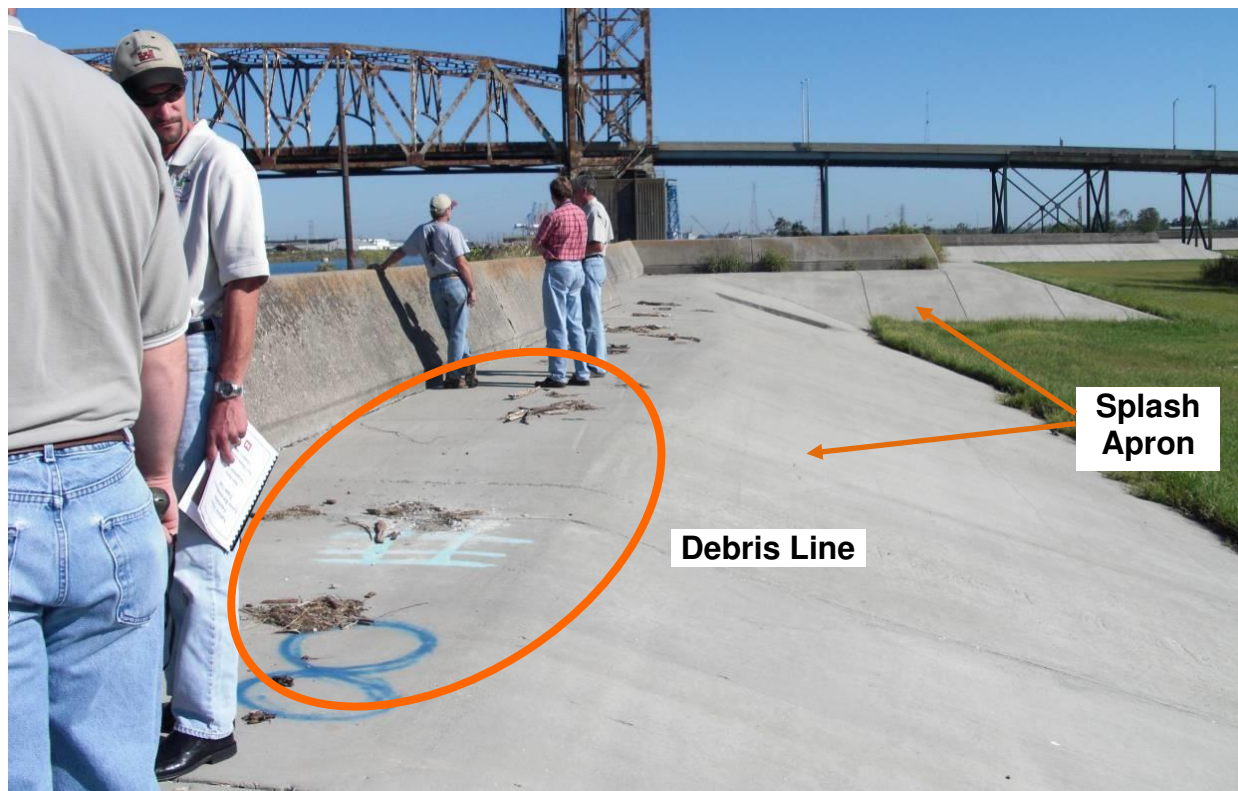
Figure 26. Hardened I-wall along east side of the IHNC south of Claiborne Avenue looking north (IHNC is to the left and Lower 9th Ward / Holy Cross to the right). (Oct. 2, 2008, 29.9682° N, 90.0250° W)

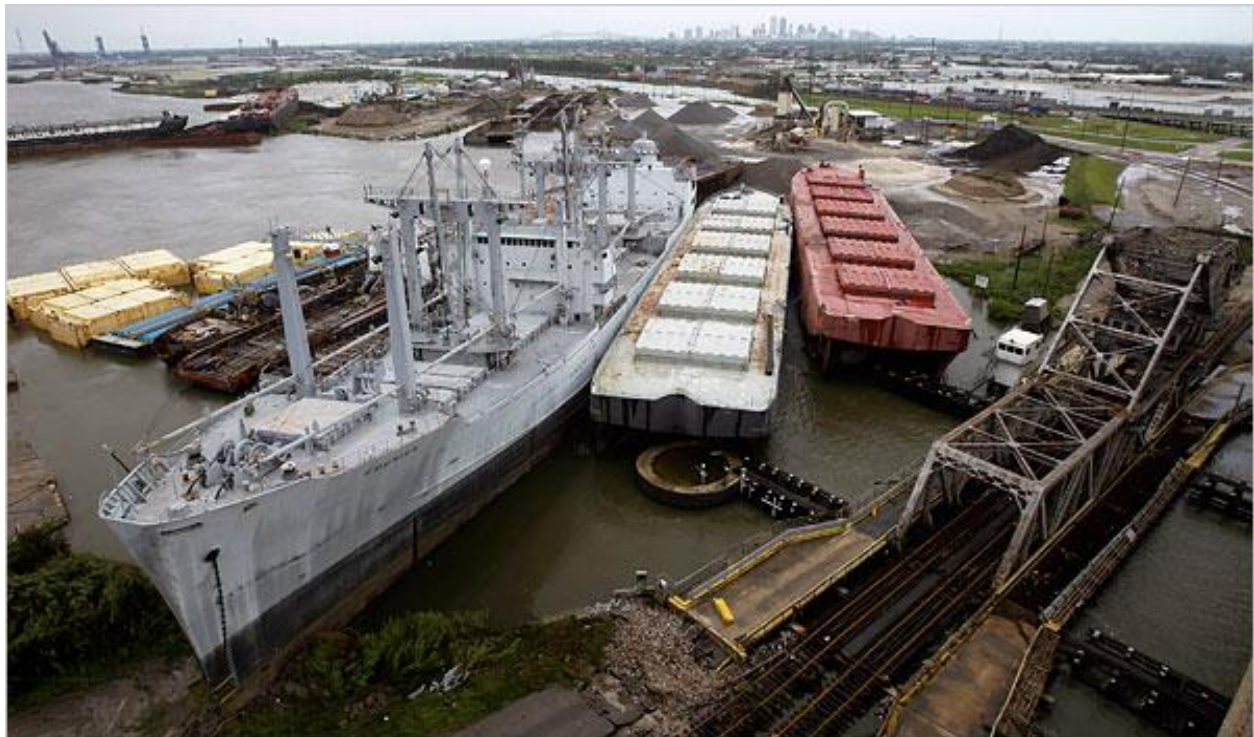
Figure 33 shows how ships and barges were pushed during Gustav against the dolphins protecting the northern railroad bridge that crosses the IHNC just south of the I-10 bridge. This railroad bridge was in the lowered position and thus remained underwater during periods of high water. The Florida Avenue Bridge to the south of these barges and ships was in a slightly raised position so as to be out of the water, but low enough to keep wind loads from having leverage on the support towers. In these positions, both bridges would have confined the ships and barges to the central part of the canal. In preparation for the subsequent hurricane, Ike, the USCG ordered all ships and barges removed from the IHNC.

Figure 33. Ships and barges pushed against a railroad bridge after Gustav. (September 1, 2008, 30.0050° N, 90.0251° W, Eric Gay, Associated Press)

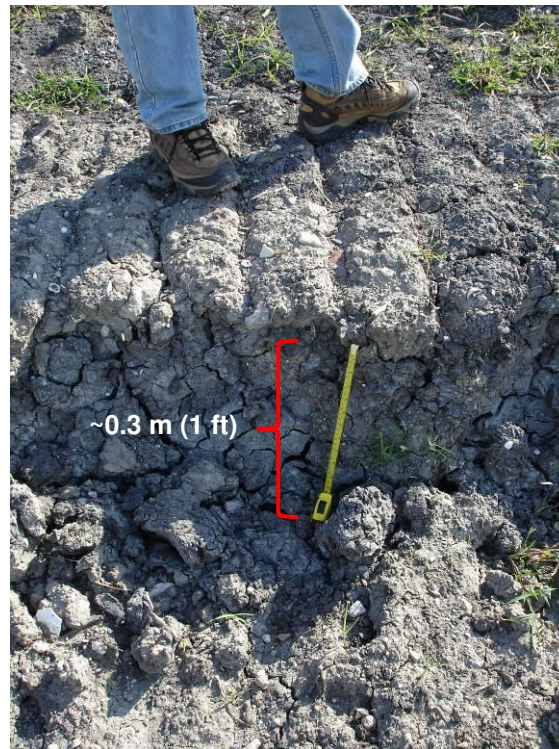
*Figure 36. Scarp above slide on Plaquemines back levee.
(October 3, 2008, 29.8506° N, 89.9085° W)*

The non-federal local back levee in Plaquemines Parish was overtopped by Gustav flood levels and was in danger of failure at the location of the slope slide. Desiccation cracks on the levee may have contributed to the slide by allowing overtopping water pressures into embankment zones critical to slope stability. The placement water content, compaction, and organic

- The erosion resistance of non-federal local levees in Plaquemines Parish (not part of the HSDRRS) during overtopping was noted during Katrina. The clay back levees in Plaquemines Parish resisted erosion during Gustav but may have demonstrated a potential vulnerability due to desiccation cracks. Improved control of placement water content and compaction, revised material requirements relative to plasticity and organic content, or landscaping measures such as the establishment of dense vegetation and use of irrigation may be required to prevent desiccation.
