## Reconnaissance of the New Orleans Hurricane and Storm Damage Risk Reduction System after Hurricane Gustav

**ABSTRACT:** On October 2 and 3, 2008, a group of civil engineers sponsored by the National Science Foundation (NSF) and organized by the Geoengineering Extreme Events Reconnaissance (GEER) Association, visited the New Orleans area to assess levee performance during hurricane Gustav. This paper summarizes the team's observations and understanding of the state of the New Orleans Hurricane and Storm Damage Risk Reduction System (HSDRRS) in the fall of 2008 and the performance of elements of the HSDRRS during Hurricane Gustav. The fundamental conclusion was that the HSDRRS performed well under the surge and wave stresses generated by Gustav. The team's observations led to lessons about dangers to floodwalls from boats and barges, the importance of timely preparation for hurricanes, erosion resistance of clay levees, and the need for continued emphasis on evacuation for life protection.

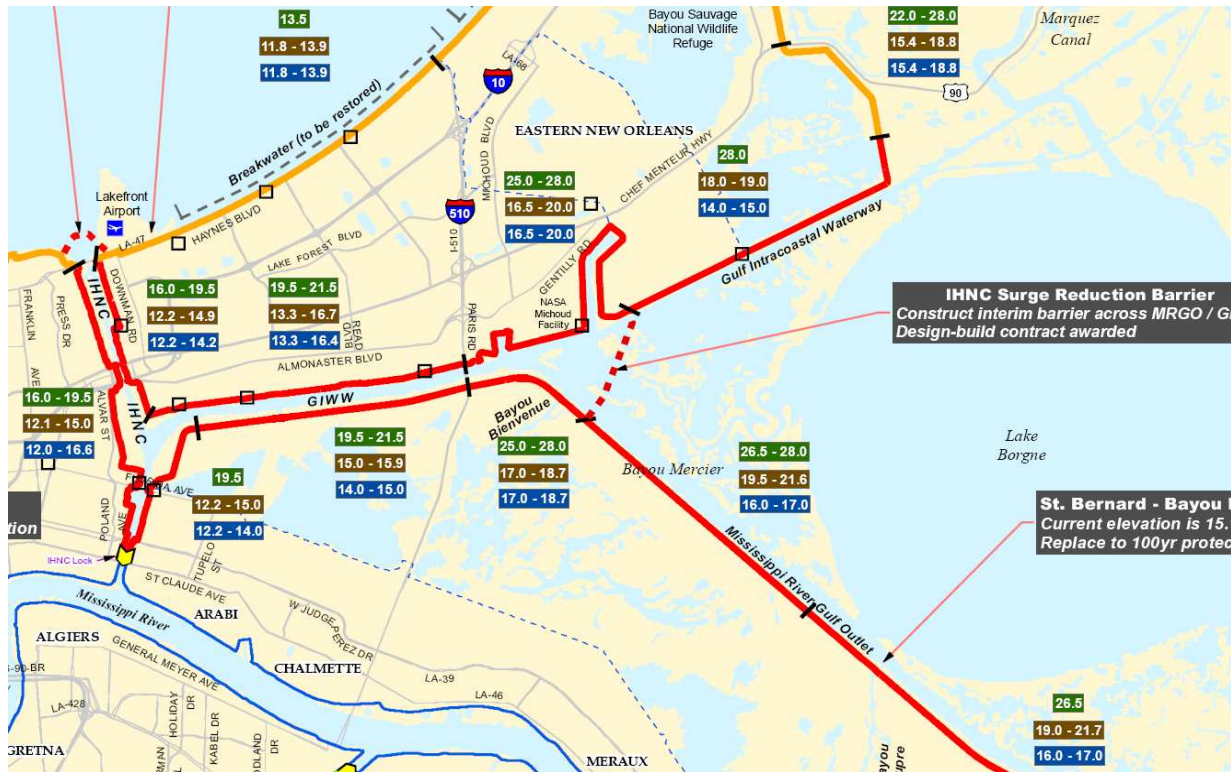
Earthen Levee Reconstruction – The USACE designed and constructed repairs and improvements to the HSDRRS earth levees with two main purposes: (1) to raise the level of protection so that the likelihood of overtopping would be lessened, and (2) to improve the capacity of levees to withstand erosion during overtopping by using clay instead of silty sand fill. Figure 2 shows the eastern part of the HSDRRS plan along the Mississippi River Gulf Outlet (MRGO), which is a typical example of the reconstructed earthen levees, noting the elevations of the pre-Katrina levee crests (blue boxes) and the June 2008 levee crests (brown boxes). Figure 3 is a photograph of the raised earth levee at the southeast corner of the HSDRRS along the MRGO, which is a typical example of the reconstructed earthen levees.

Figure 3. Southeast corner of the MRGO levee, flood side. (October 2, 2008, 29.8889°N, 89.7617°W)

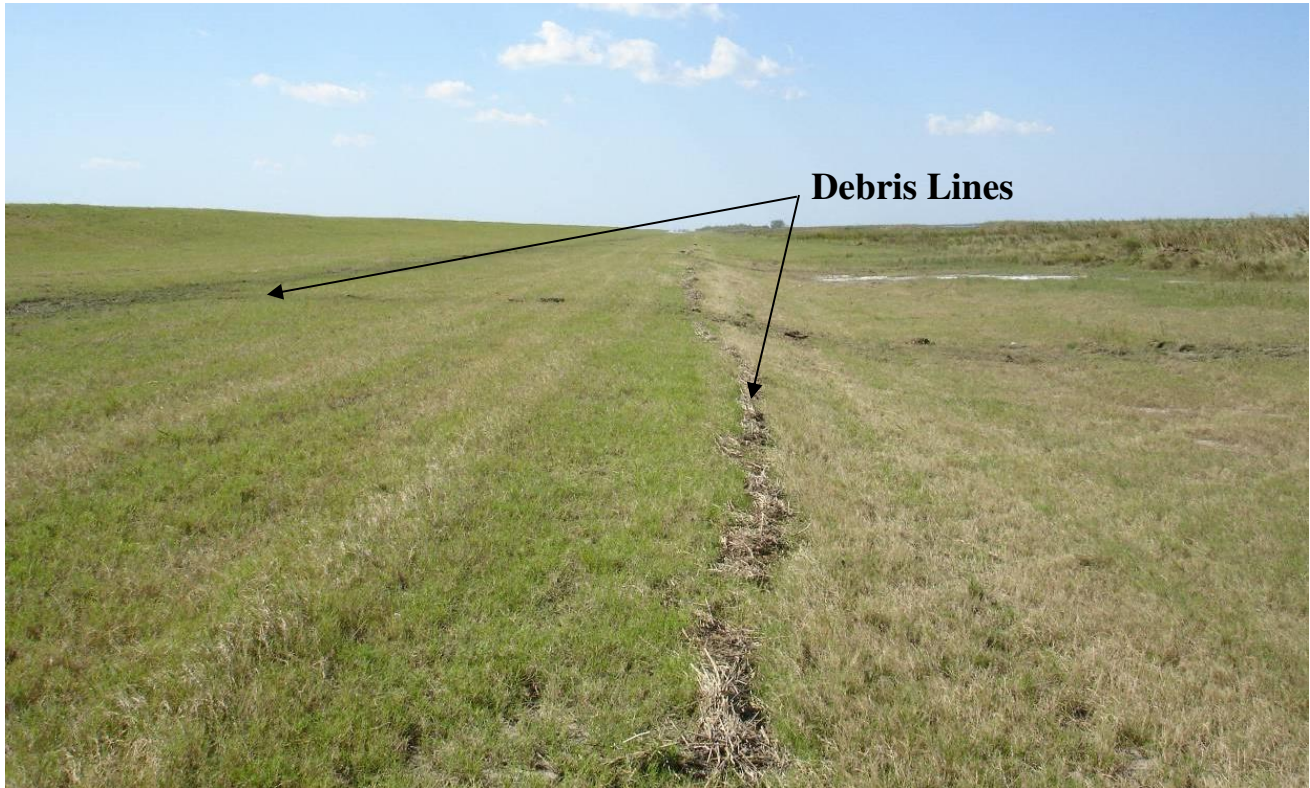
The team observed no signs of either erosion or overtopping during Gustav along the southeast sections of the MRGO frontage levee, which the team believes was representative of the MRGO frontage levees. Based on the limited debris lines along the levee, the high water levels during Gustav were well below the crest of these rebuilt and elevated earthen embankments. The wave and current actions of Gustav also appeared to have caused no erosion on the earth embankments. Figure 12 shows a typical view of the MRGO frontage levee embankment in October 2008.

*Figure 12. MRGO frontage levee, flood side, looking northwest. Upper debris line, believed to be due to Gustav, was cleared prior to our visit, probably as part of the ongoing efforts to maintain the protective grass cover. The lower debris line may represent the high-water level during hurricane Ike, which followed Gustav in September 2008. (October 2, 2008, 29.8889°N, 89.7617°W)*

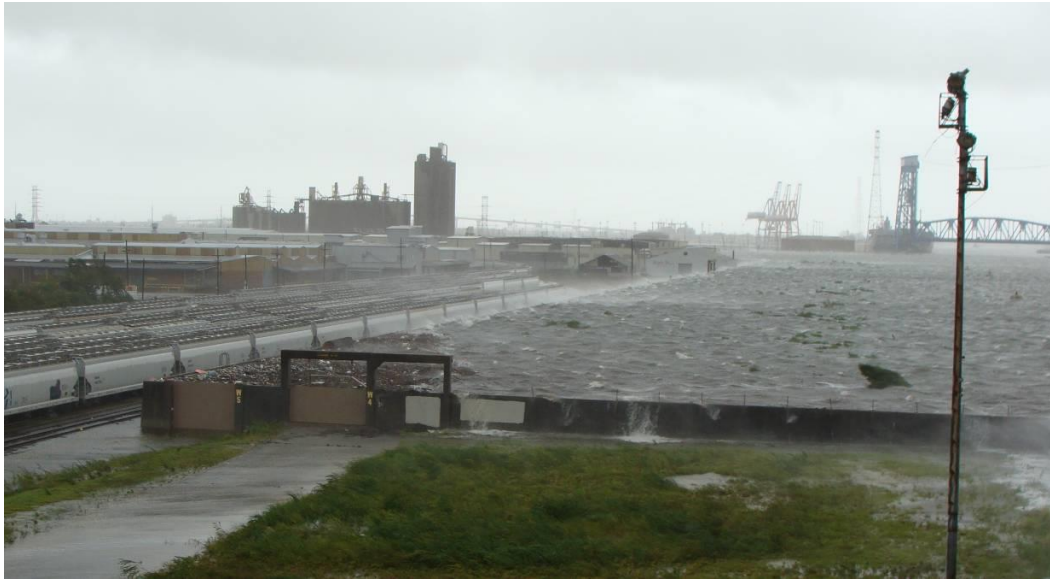
Clear photographic evidence showed wave overtopping during Hurricane Gustav along the T-wall located on the west side of the IHNC just north of Claiborne Avenue (see Figure 15 for location, and Figures 21 and 22 for photographs during hurricane). This T-wall had previously survived Hurricane Katrina. A concrete splash apron at the toe of the wall on the protected side was added after Katrina to protect from erosion. The wall performed well during Gustav. During the field reconnaissance, the team saw no noticeable sign of distress in the wall, including the joints between concrete panels and in the new concrete splash apron. There was evidence of minor erosion beyond the splash apron on the protected side as well as debris left by the overtopping (Figure 23).

*Figure 21. Photograph from September 1, 2008, of Gustav's storm surge. Photograph taken from Claiborne Ave. Bridge looking north. The waves are overtopping the T-wall. (September 1, 2008, 29.969° N, 90.027° W, USACE)*

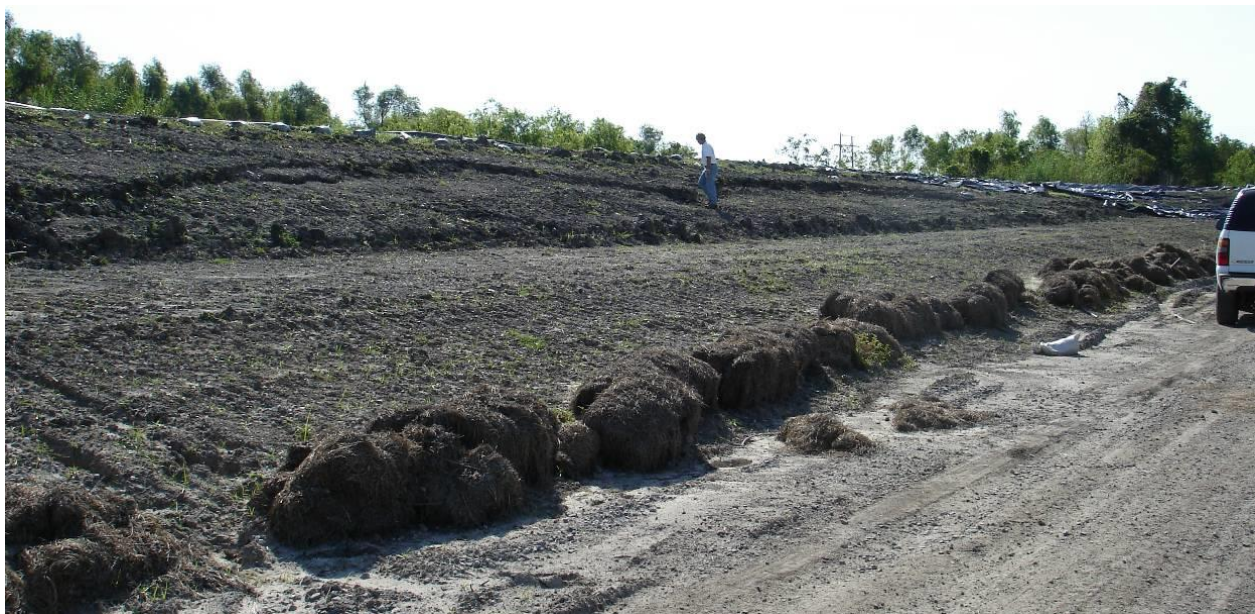
Along more southerly sections of the levee, the team observed signs of overtopping with less dramatic effects. Debris from overtopping and erosion gullies, often covered with sand bags, was prevalent along all sections of the levee.

Figure 35. Protected side slope of the Plaquemines Parish back levee and slide.  
(October 3, 2008, 29.8506° N, 89.9085° W)

The non-federal local back levee in Plaquemines Parish was overtopped by Gustav flood levels and was in danger of failure at the location of the slope slide. Desiccation cracks on the levee may have contributed to the slide by allowing overtopping water pressures into embankment zones critical to slope stability. The placement water content, compaction, and organic

- The erosion resistance of non-federal local levees in Plaquemines Parish (not part of the HSDRRS) during overtopping was noted during Katrina. The clay back levees in Plaquemines Parish resisted erosion during Gustav but may have demonstrated a potential vulnerability due to desiccation cracks. Improved control of placement water content and compaction, revised material requirements relative to plasticity and organic content, or landscaping measures such as the establishment of dense vegetation and use of irrigation may be required to prevent desiccation.
