# Reconnaissance of the New Orleans Hurricane and Storm Damage Risk Reduction System after Hurricane Gustav

**ABSTRACT:** On October 2 and 3, 2008, a group of civil engineers sponsored by the National Science Foundation (NSF) and organized by the Geoengineering Extreme Events Reconnaissance (GEER) Association, visited the New Orleans area to assess levee performance during hurricane Gustav. This paper summarizes the team's observations and understanding of the state of the New Orleans Hurricane and Storm Damage Risk Reduction System (HSDRRS) in the fall of 2008 and the performance of elements of the HSDRRS during Hurricane Gustav. The fundamental conclusion was that the HSDRRS performed well under the surge and wave stresses generated by Gustav. The team's observations led to lessons about dangers to floodwalls from boats and barges, the importance of timely preparation for hurricanes, erosion resistance of clay levees, and the need for continued emphasis on evacuation for life protection.

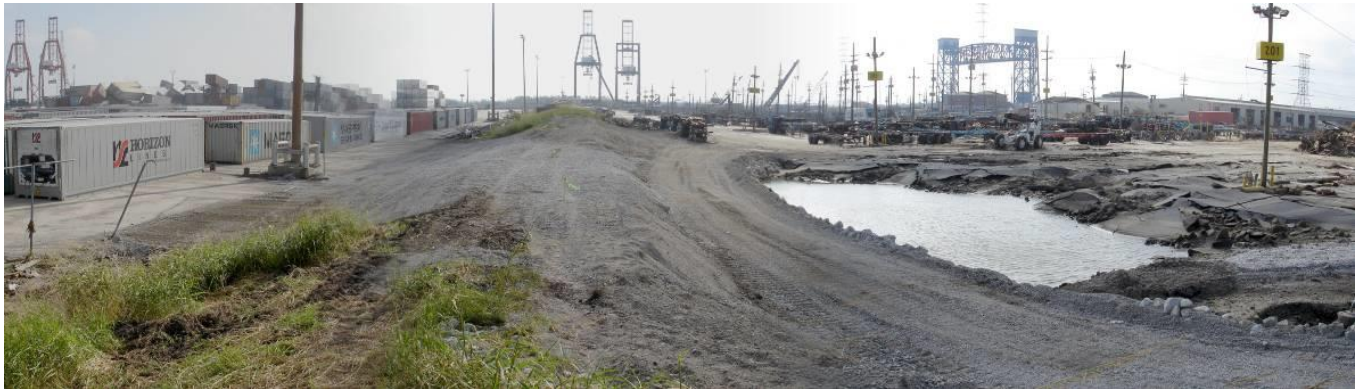
*Figure 16. Post-Katrina IHNC West levee breach site, October 2005 (The breach had been temporarily repaired; note scour hole). (October 4, 2005, 29.9880° N, 90.0263° W, L. Wooten)*

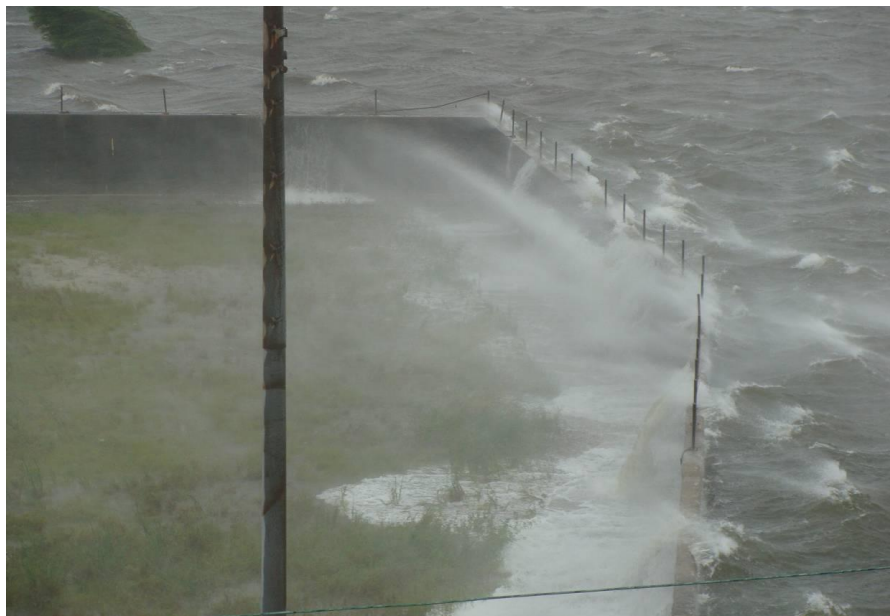
*Figure 22. Gustav's storm surge along IHNC East, taken from Claiborne Ave. Bridge looking north at T-wall southeast on September 1, 2008. (September 1, 2008, 29.969° N, 90.027° W, USACE)*

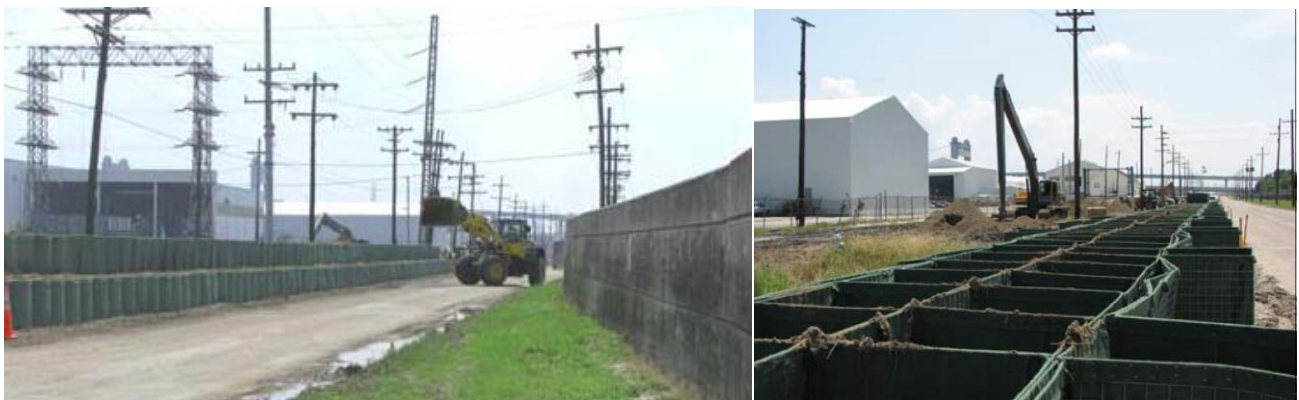
Immediately prior to Gustav, the USACE constructed a ~550-m- (~1800-ft-) long temporary bin wall using HESCO baskets to protect one length of the I-wall along the northwest side of the IHNC that did not meet required stability criteria. Figure 30 shows the temporary bin wall under construction by the USACE, and Figure 31 shows the bin wall immediately after Gustav.

Figure 30. Temporary bin wall under construction, IHNC West along France Road. (August 2008, 30.0157° N, 90.0324° W, [http://www.mvn.usace.army.mil/HPS/Status%20Report%20Newsletters/Sept\\_9\\_2008.pdf](http://www.mvn.usace.army.mil/HPS/Status%20Report%20Newsletters/Sept_9_2008.pdf))

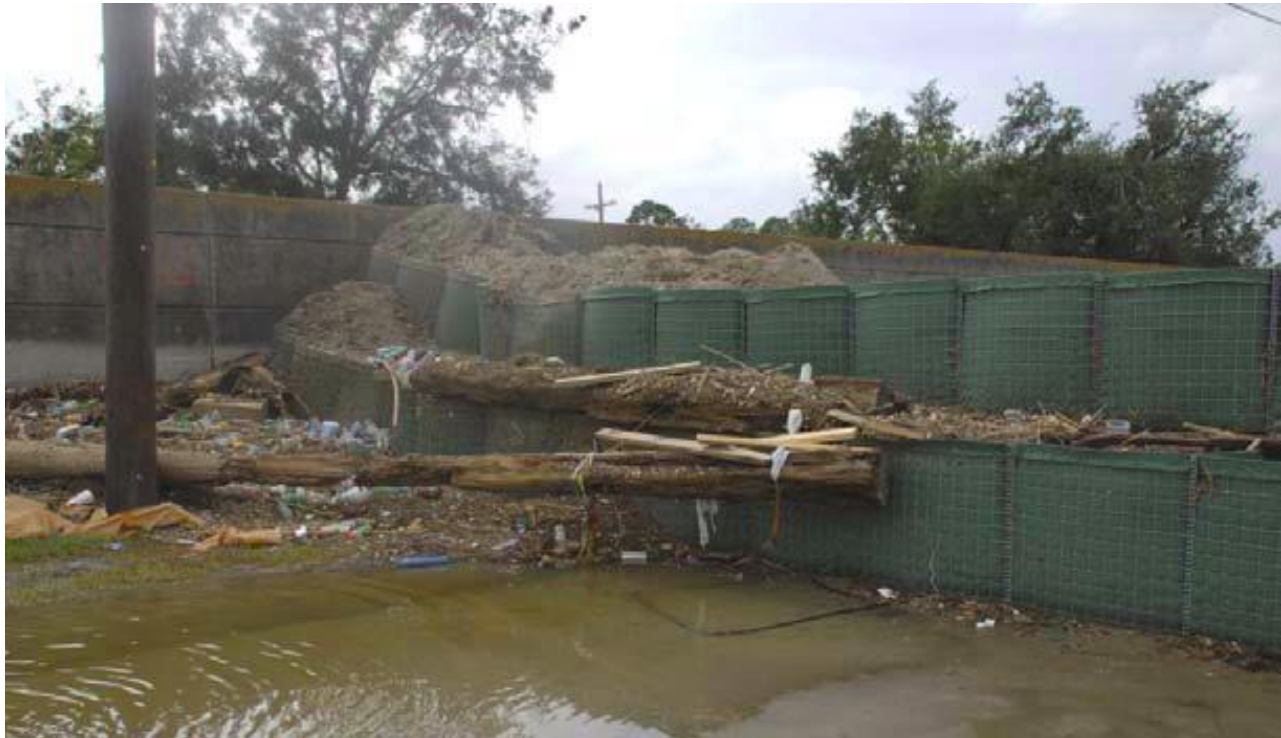
*Figure 31. End of temporary bin wall at tie-in to I-Wall, post-Gustav (September 2008, 30.0122° N, 90.0313° W, [http://www.mvn.usace.army.mil/HPS/Status%20Report%20Newsletters/Sept\\_9\\_2008.pdf](http://www.mvn.usace.army.mil/HPS/Status%20Report%20Newsletters/Sept_9_2008.pdf))*
