Reconnaissance of the New Orleans Hurricane and Storm Damage Risk Reduction System after Hurricane Gustav

ABSTRACT: On October 2 and 3, 2008, a group of civil engineers sponsored by the National Science Foundation (NSF) and organized by the Geoengineering Extreme Events Reconnaissance (GEER) Association, visited the New Orleans area to assess levee performance during hurricane Gustav. This paper summarizes the team's observations and understanding of the state of the New Orleans Hurricane and Storm Damage Risk Reduction System (HSDRRS) in the fall of 2008 and the performance of elements of the HSDRRS during Hurricane Gustav. The fundamental conclusion was that the HSDRRS performed well under the surge and wave stresses generated by Gustav. The team's observations led to lessons about dangers to floodwalls from boats and barges, the importance of timely preparation for hurricanes, erosion resistance of clay levees, and the need for continued emphasis on evacuation for life protection.

Reference: Wooten L., Gilbert R. B., Marcuson, III W. F., Harder, Jr. L. F., and Nicholson P. G. (2020).

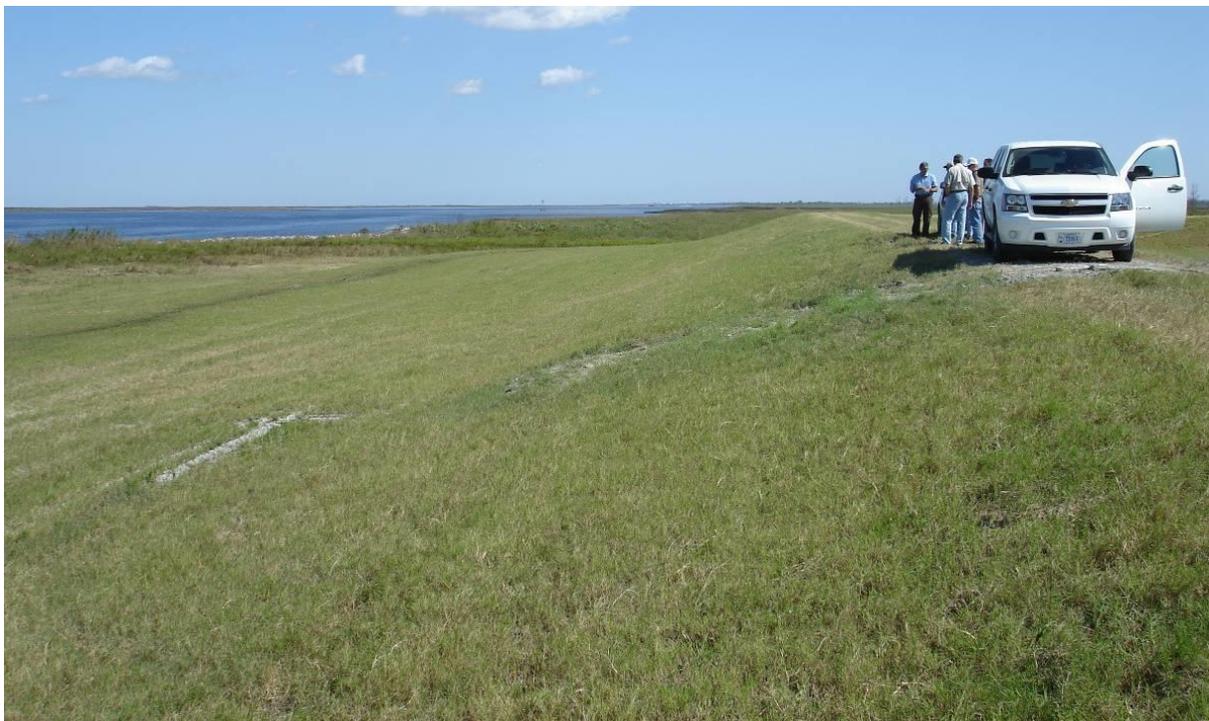
Figure 3. Southeast corner of the MRGO levee, flood side. (October 2, 2008, 29.8889°N, 89.7617°W)

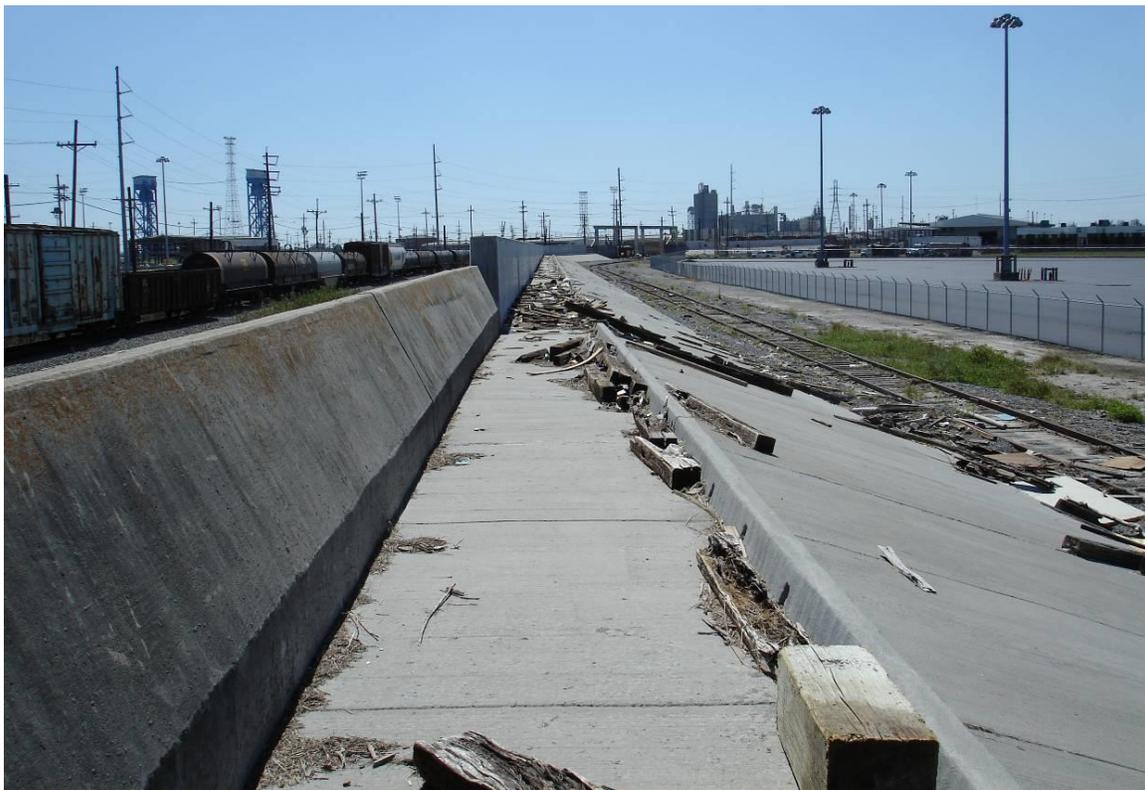
Figure 6. I-wall and splash apron, IHNC west along France Road; new L-wall and splash apron in background. (October 2, 2008, 90.0272° W, 90.0272° W)

At the transition between the new L-wall and the old I-wall (Figure 6), there was storm debris left on top of and behind the higher L-wall, while the top of the lower I-wall was left clean. It is possible that the water elevation or waves during the peak storm surge exceeded the top of the old I-wall on a more consistent basis (elevation of about 4.3 m [14 ft], NAVD88) at this location, sweeping wave debris from the wall top.

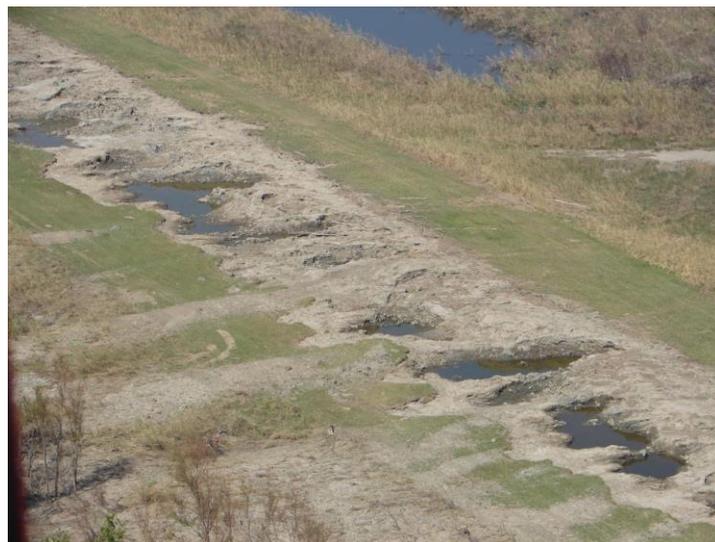
The frontage levees along the Mississippi River Gulf Outlet (MRGO) channel are the closest elements of the HSDRRS to the open waters of the Gulf. These earthen embankments experienced the earliest and highest water levels during both Gustav and Katrina. The high-water levels during Katrina overwhelmed the MRGO frontage levees, with overtopping along the entire stretch of the MRGO and eroded significant lengths of the levee. Figure 11 shows a section of the MRGO frontage levee and the typical extent of the erosion damage caused by the Katrina overtopping.

Figure 11. Post-Katrina MRGO frontage levee. (October 14, 2005, ~89.8° W, ~29.9° N, L. Harder)

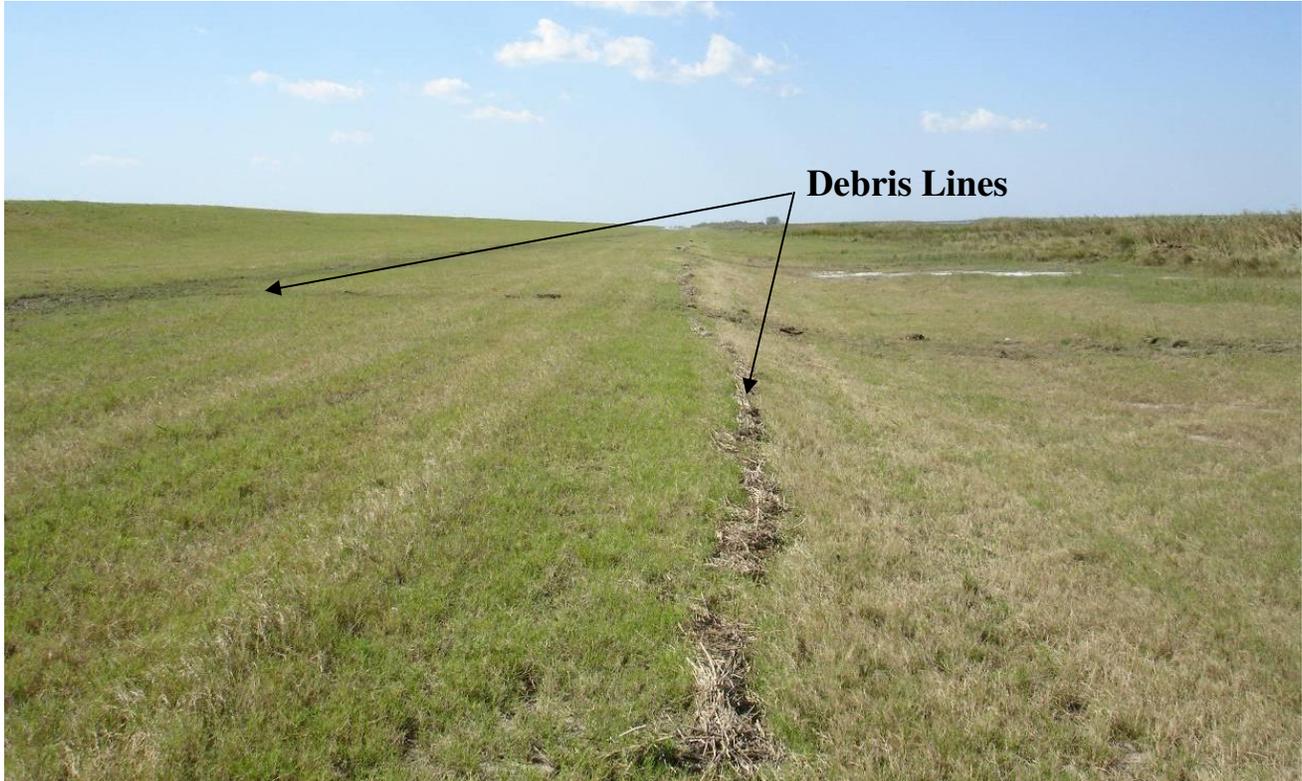
The team observed no signs of either erosion or overtopping during Gustav along the southeast sections of the MRGO frontage levee, which the team believes was representative of the MRGO frontage levees. Based on the limited debris lines along the levee, the high water levels during Gustav were well below the crest of these rebuilt and elevated earthen embankments. The wave and current actions of Gustav also appeared to have caused no erosion on the earth embankments. Figure 12 shows a typical view of the MRGO frontage levee embankment in October 2008.

Figure 12. MRGO frontage levee, flood side, looking northwest. Upper debris line, believed to be due to Gustav, was cleared prior to our visit, probably as part of the ongoing efforts to maintain the protective grass cover. The lower debris line may represent the high-water level during hurricane Ike, which followed Gustav in September 2008. (October 2, 2008, 29.8889°N, 89.7617°W)

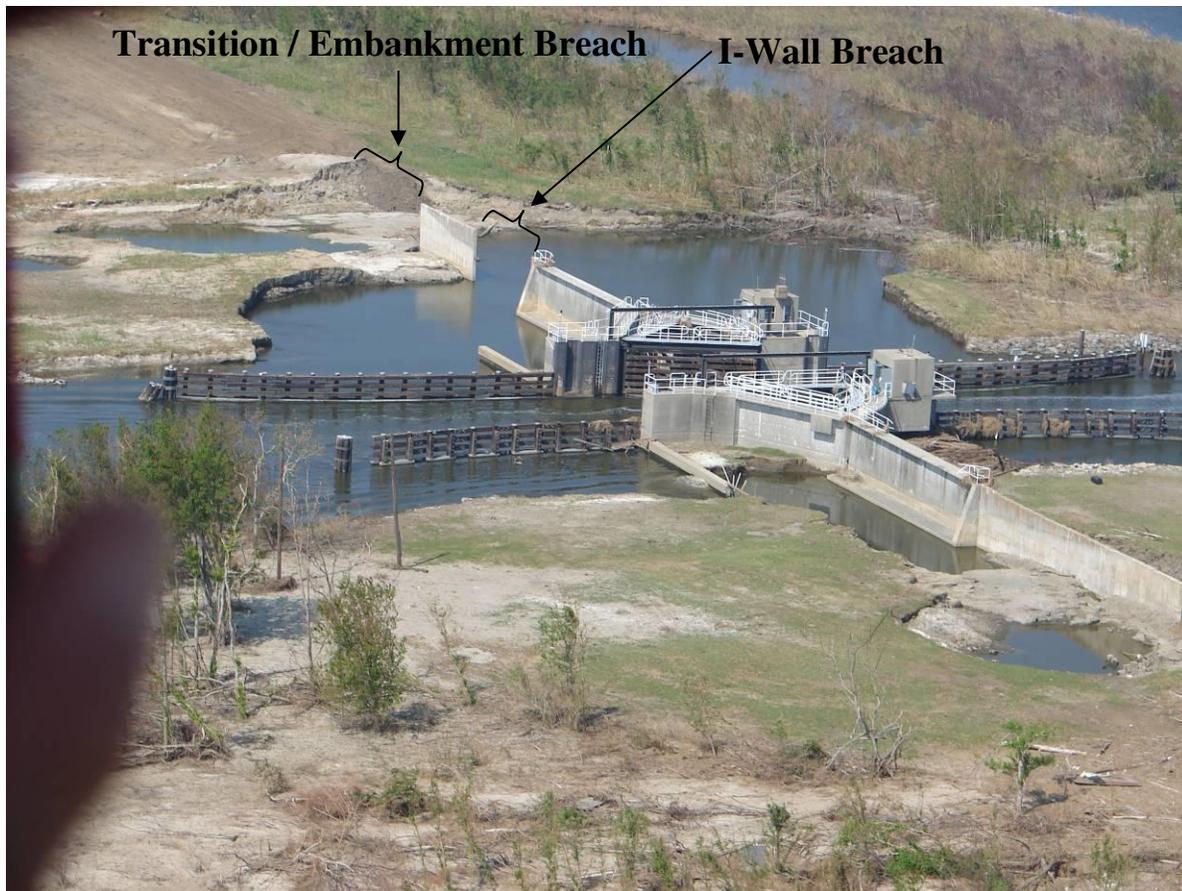
The Bayou Dupree gate structure on the MRGO suffered several severe breaches during Katrina, which overtopped the entire structure by 0.6 to 1.5 m (2 to 5 ft). Figure 13 is an October 2005 photo of the gate structure following Katrina, showing breaches at the I-wall section and at the transition from the I-wall to the embankment.

Figure 13. Post-Katrina Bayou Dupree gate. (October 14, 2005, 29.935° N, 89.837° W, L. Harder)

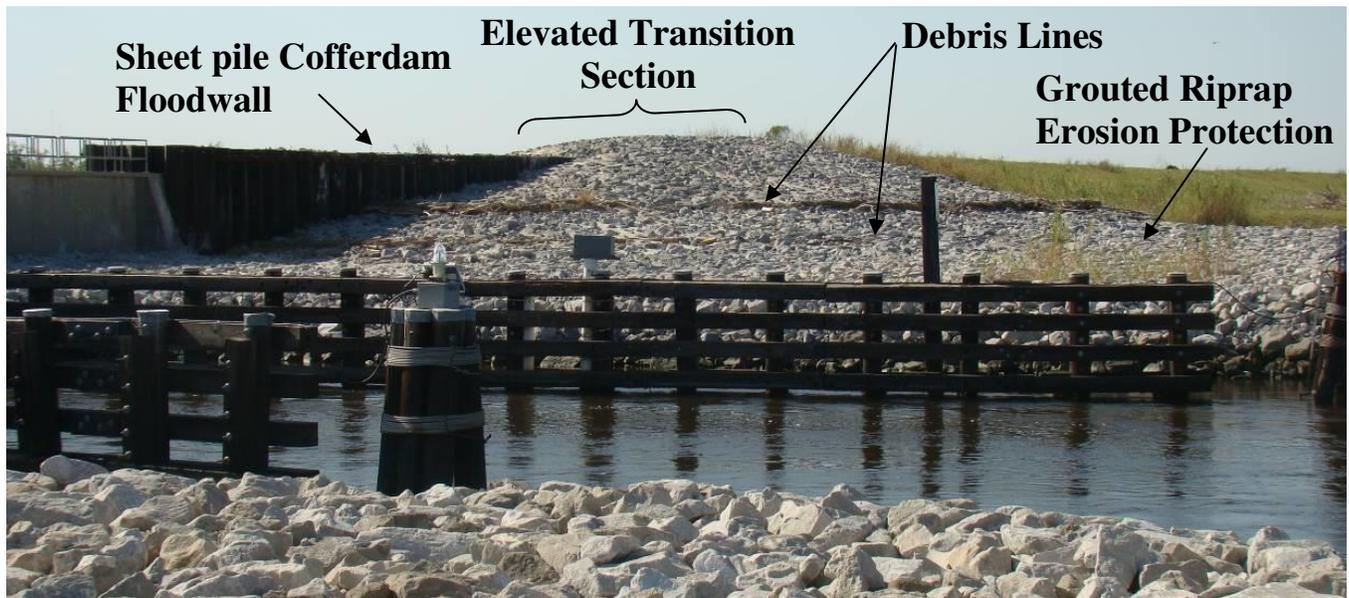
Figure 14. Bayou Dupree gate, northwest flank, MRGO side, looking east. The lower debris line may represent the high-water level during Hurricane Ike. (October 2, 2008, 29.9352° N, 89.8358° W)

Figure 14 shows the improvements constructed by the USACE to the same Bayou Dupree gate structures. The concrete sheet pile I-wall was replaced with a steel sheet pile cofferdam section, and the transitions to the earthen levees on both sides of the gate were elevated and covered with grouted riprap. The use of grouted riprap to harden vulnerable areas around the gate was extensive, as illustrated in Figure 14. UngROUTED riprap was placed as erosion protection at the toe areas of grouted riprap. The team observed no signs of erosion or damage from Gustav's high water and waves at or near the gate. The limited debris line on the northwest flank appeared to indicate that the highest waters from Gustav were about 1 to 1.5 m (3 to 5 ft) below the crest of any of the gate structure elements (see Figure 14).

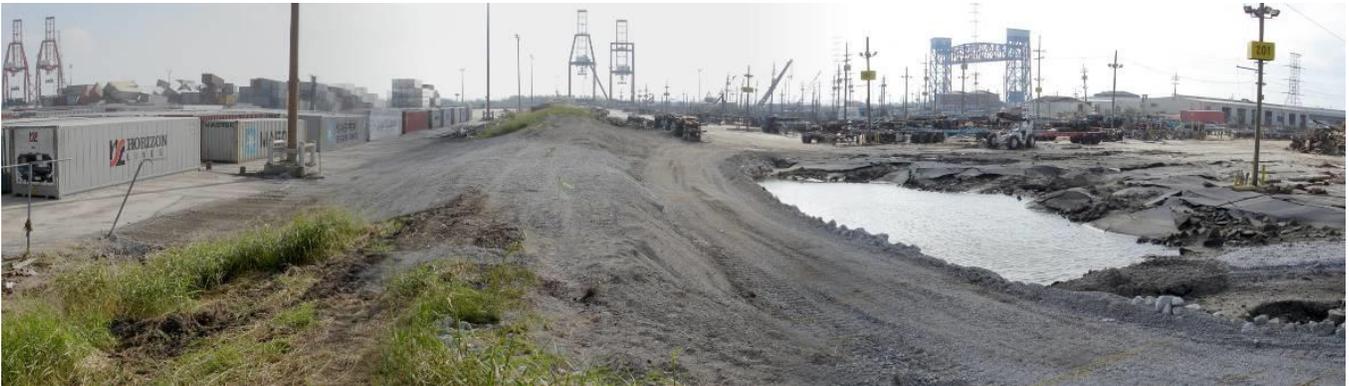
Figure 16. Post-Katrina IHNC West levee breach site, October 2005 (The breach had been temporarily repaired; note scour hole). (October 4, 2005, 29.9880° N, 90.0263° W, L. Wooten)

Post-Katrina repairs and improvements of these failed and distressed sections included raising and buttressing embankment sections, armoring of embankment-concrete floodwall transitions, replacement of I-walls with L-walls (T-walls were not used due to space constraints), and buttressing of pre-existing I-wall sections to reduce the stick-up height (the height of wall above finished grade). Figures 16-19 show the post-Katrina (October 2005) and post-Gustav (October 2008) conditions at the locations of the earth levee breach (Figures 16 and 17) and of the I-wall breach (Figures 18 and 19) that occurred during Katrina.

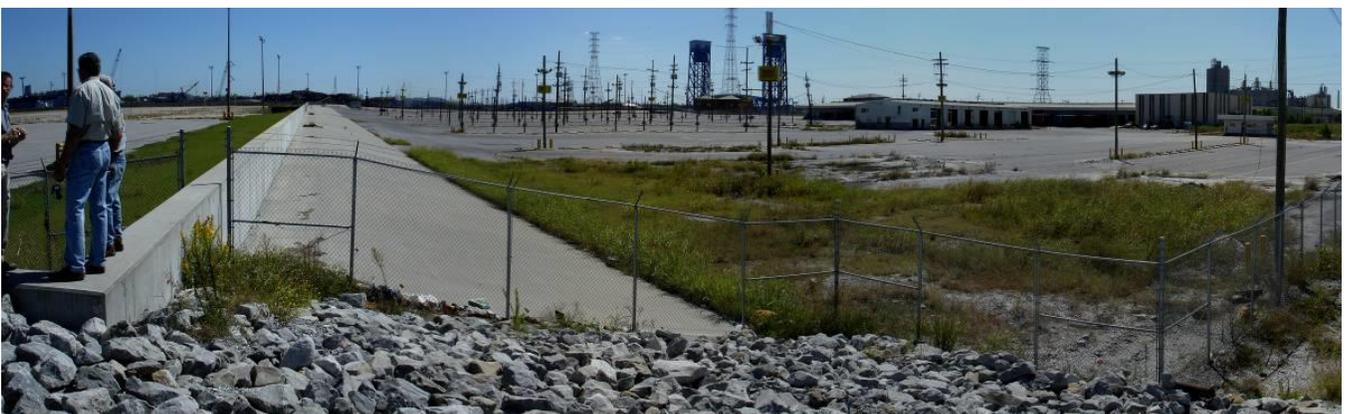
Figure 17. IHNC West new embankment and floodwall at location of breach, as was shown in Figure 14, in October 2008. (October 2, 2010, 29.9880° N, 90.0263° W)

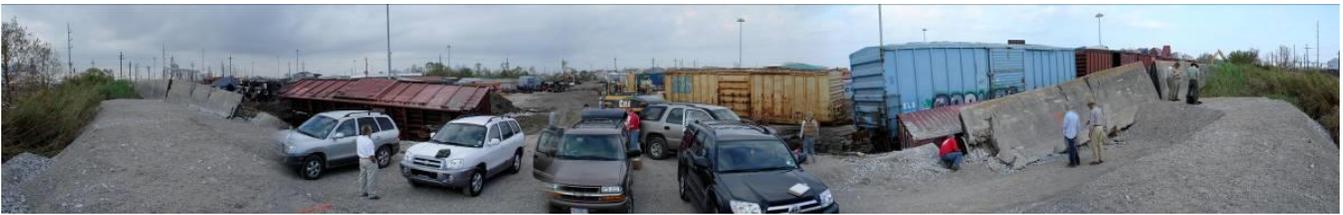
Figure 18. IHNC West I-wall Katrina breach site, October 2005. (October 4, 2005, 29.9899° N, 90.0272° W, L. Wooten)

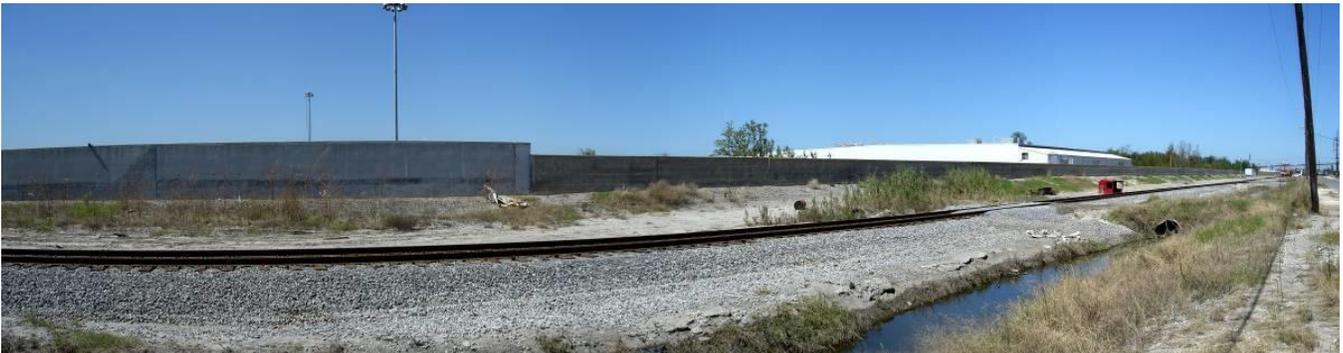
Figure 19. New L-wall and old I-wall transition near location of Katrina I-wall breach on IHNC West. (October 2, 2008, 29.9899° N, 90.0272° W)

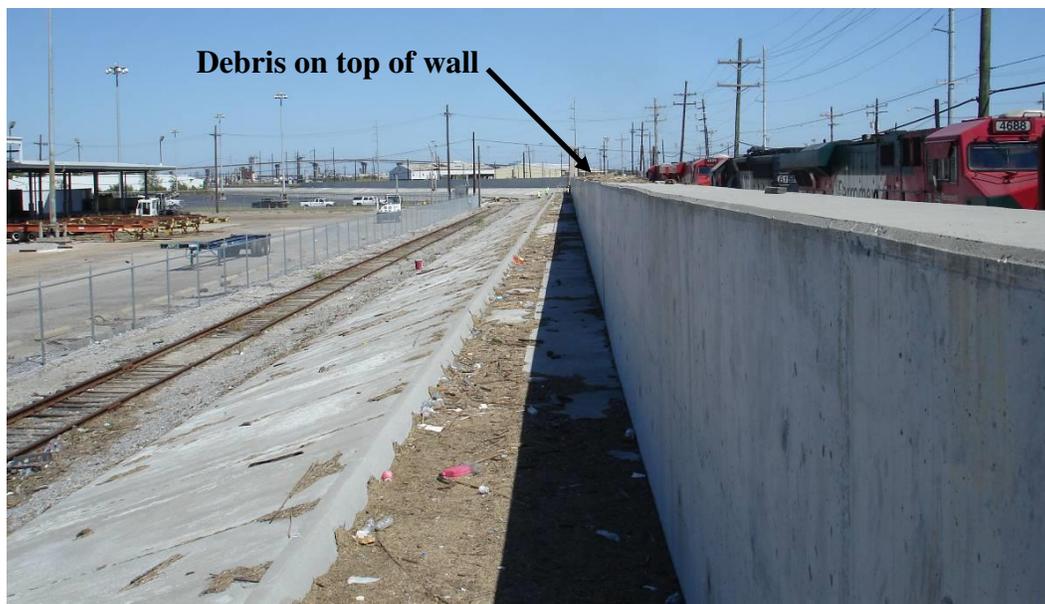
The repairs and improvements of these sections of the hurricane protection appeared to have performed well in light of clear evidence of wave overtopping. Figure 20 shows the debris left by overtopping waves on the protected side of one section of new L-wall along the IHNC West.

Figure 20. Protected side of new L-wall along IHNC West. Note debris left by overtopping on floodwall and slope protection. October 2008. (October 2, 2008, 29.9899° N, 90.0272° W)

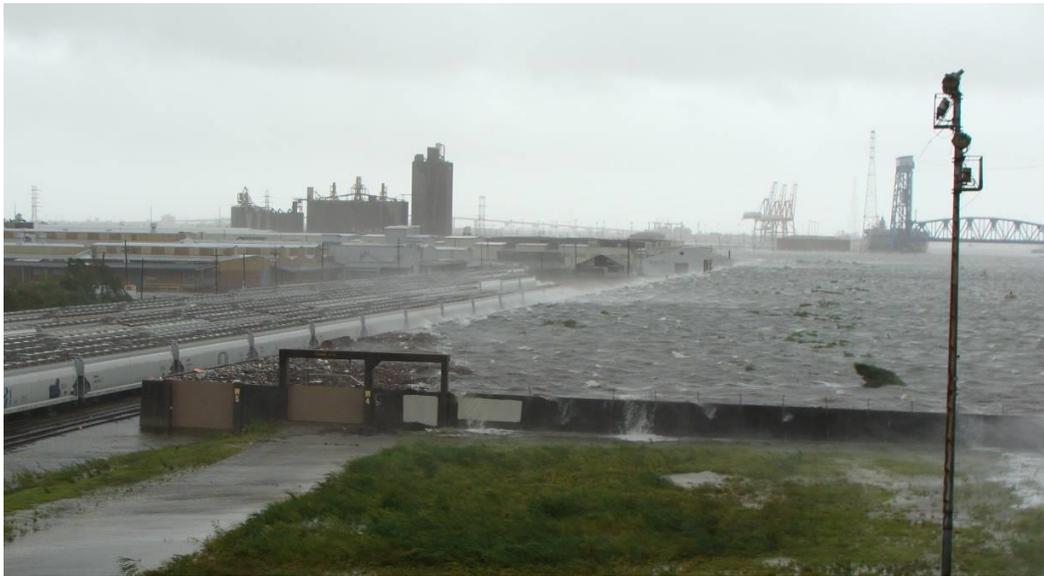
Clear photographic evidence showed wave overtopping during Hurricane Gustav along the T-wall located on the west side of the IHNC just north of Claiborne Avenue (see Figure 15 for location, and Figures 21 and 22 for photographs during hurricane). This T-wall had previously survived Hurricane Katrina. A concrete splash apron at the toe of the wall on the protected side was added after Katrina to protect from erosion. The wall performed well during Gustav. During the field reconnaissance, the team saw no noticeable sign of distress in the wall, including the joints between concrete panels and in the new concrete splash apron. There was evidence of minor erosion beyond the splash apron on the protected side as well as debris left by the overtopping (Figure 23).

Figure 21. Photograph from September 1, 2008, of Gustav's storm surge. Photograph taken from Claiborne Ave. Bridge looking north. The waves are overtopping the T-wall. (September 1, 2008, 29.969° N, 90.027° W, USACE)

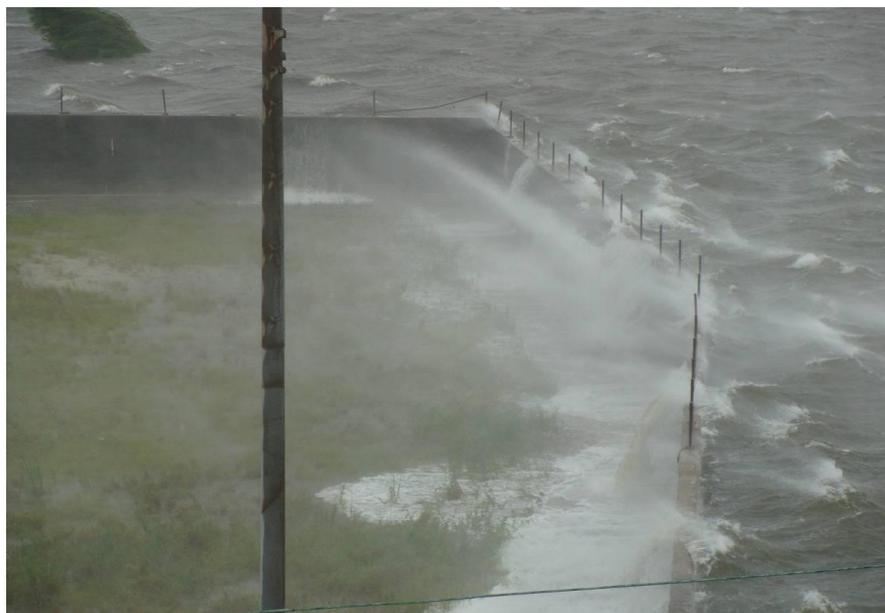
Figure 22. Gustav's storm surge along IHNC East, taken from Claiborne Ave. Bridge looking north at T-wall southeast on September 1, 2008. (September 1, 2008, 29.969° N, 90.027° W, USACE)

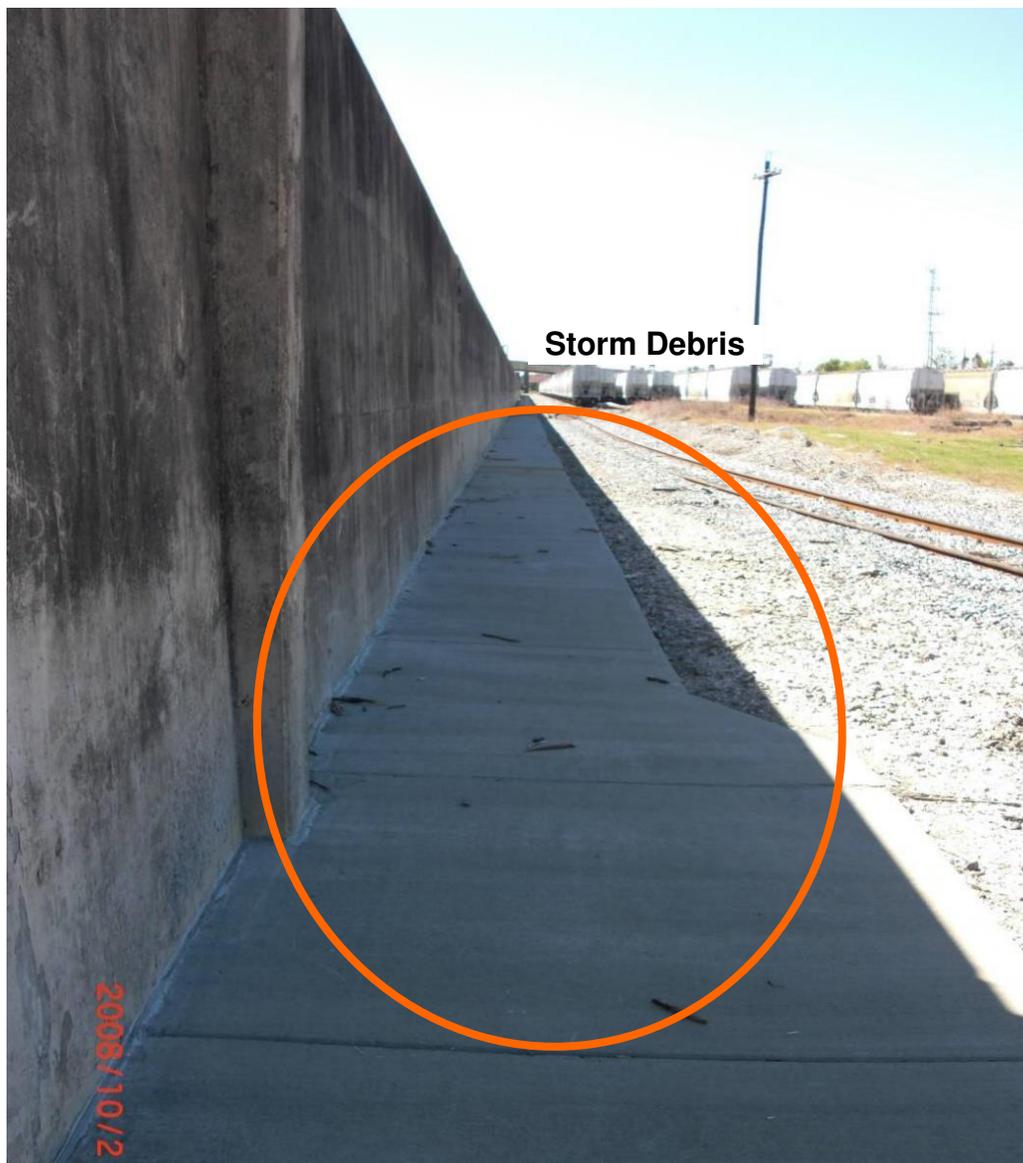
Figure 23. Photograph from October 2, 2008, of IHNC West T-wall (same section as shown during Gustav in Figures 20 and 21). (October 2, 2008, 29.970° N, 90.026° W)

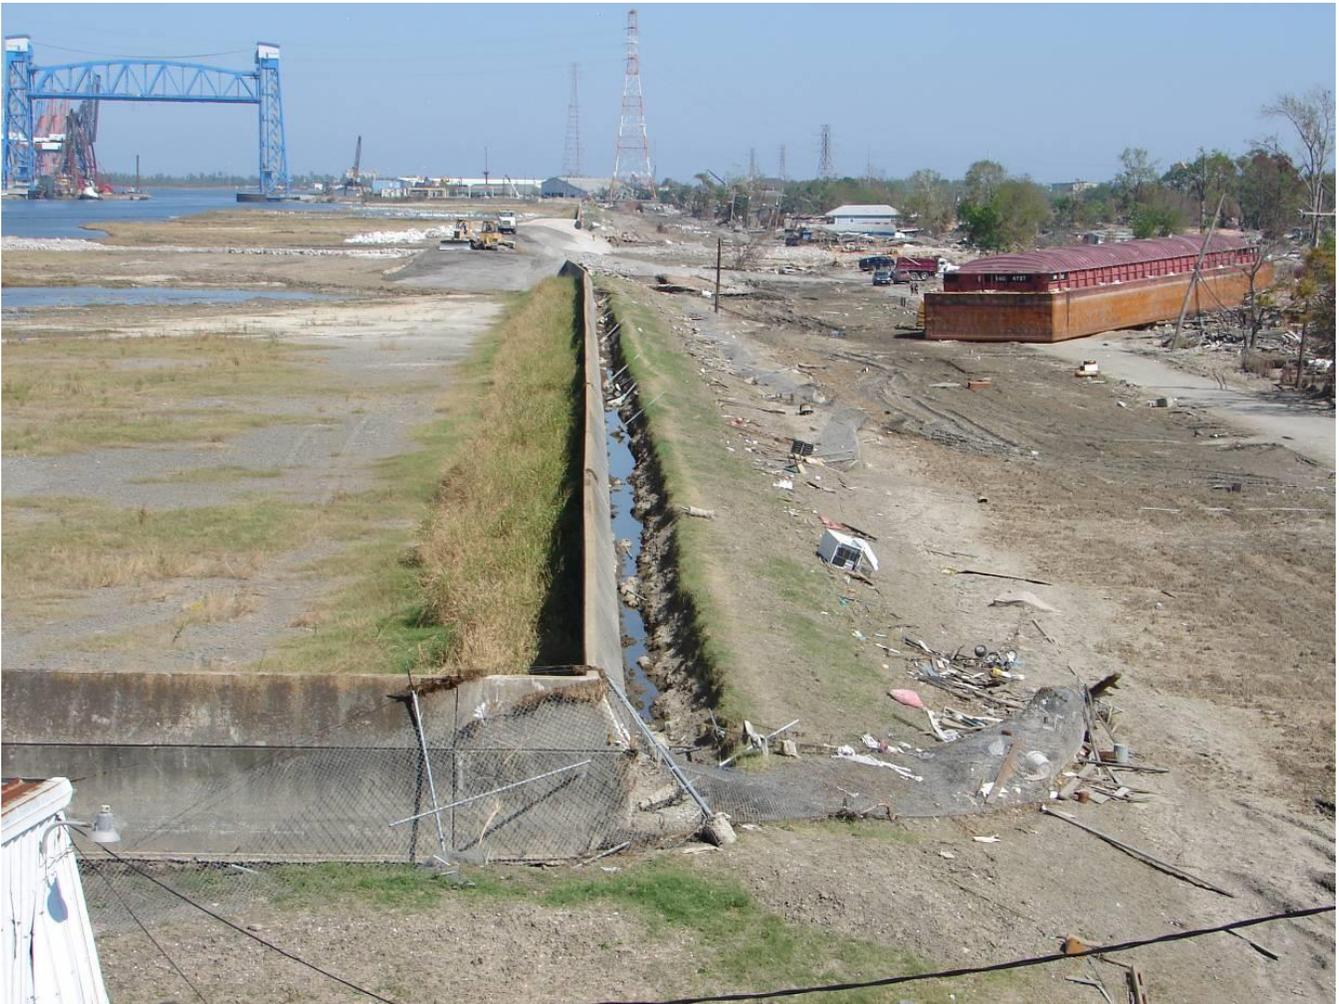
Two breaches occurred during Hurricane Katrina on a stretch of I-wall between Claiborne and Florida Avenues on the east side of the IHNC. Water flow through these breaches flooded the Lower 9th Ward. The suspected cause of the southern-most breach was loss of soil support due to overtopping erosion on the protected side of the I-wall (Figure 24), while the suspected cause of the northern-most breach was a stability failure before the surge level reached the top of the wall.

Figure 24. Post-Katrina IHNC East floodwall with southern-most breach and the scour, looking north, from the Claiborne Avenue Bridge. (October 11, 2005, 29.9685° N, 90.0238° W, L. Harder)

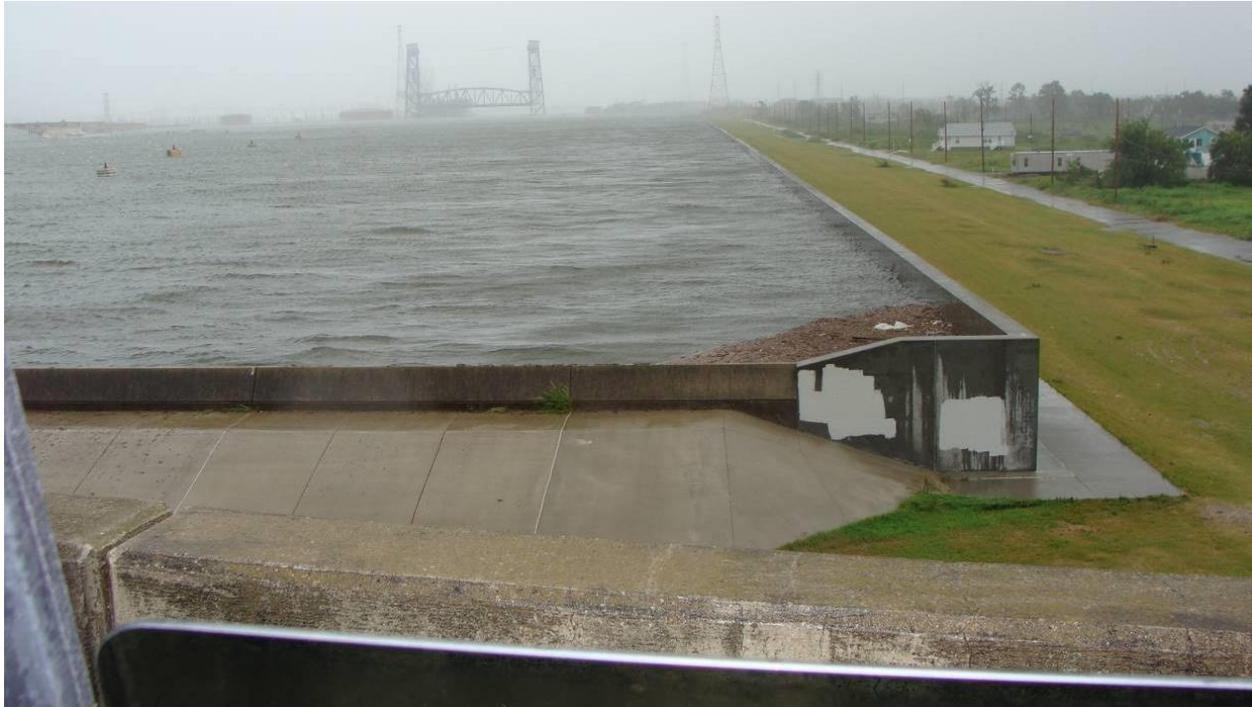
Figure 25. Gustav storm surge at IHNC East floodwall, taken from the Claiborne Avenue Bridge, looking north toward Florida Avenue Bridge (seen in background) from a perspective similar to that in Figure 18. (September 1, 2008, 29.9686° N, 90.0241° W, USACE)

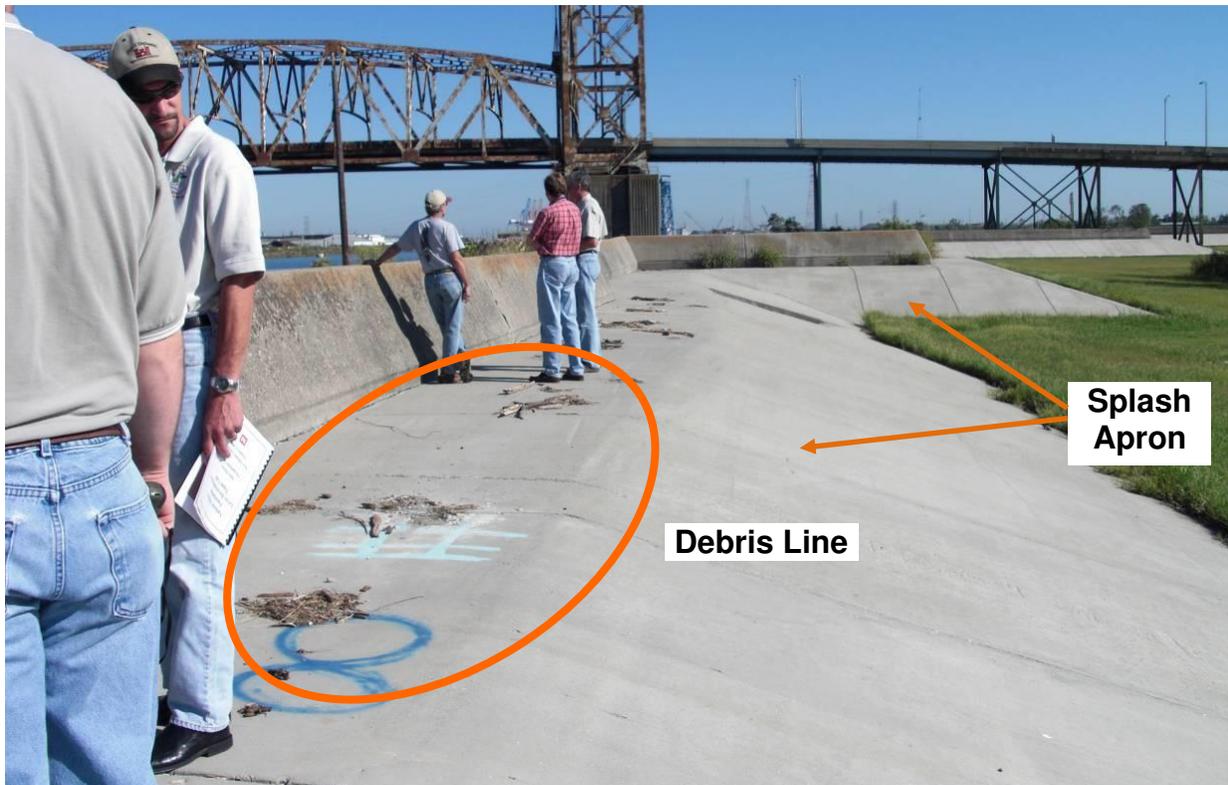
Along the east side of the IHNC south of Claiborne Avenue, the peak still water level was near the top of the old I-wall, and waves apparently overtopped the wall. The top of this wall was at about an elevation of 4.0 m (13 ft), NAVD88. After Gustav, the wall showed no noticeable signs of distress such as movement of the wall due to the surge load or erosion at the toe due to waves overtopping the wall (Figure 26). Also, there was no visible evidence of underseepage on the protected side.

Figure 26. Hardened I-wall along east side of the IHNC south of Claiborne Avenue looking north (IHNC is to the left and Lower 9th Ward / Holy Cross to the right). (Oct. 2, 2008, 29.9682° N, 90.0250° W)

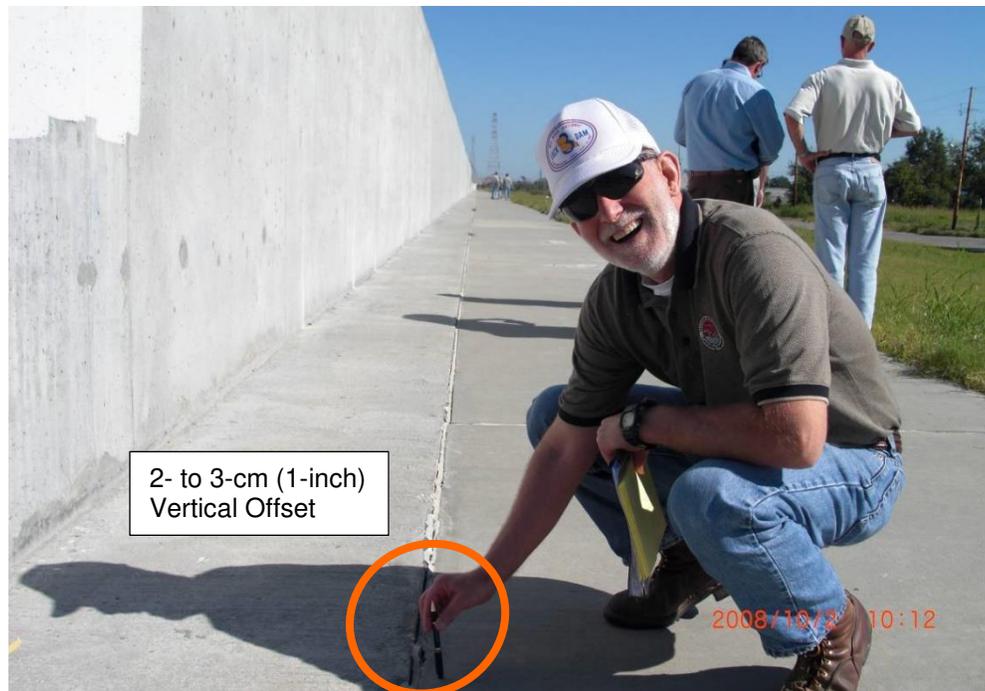
The team noted a 2- to 3-cm-deep (~1-inch-deep) vertical offset between the pile-supported base of the T-wall and the slab-on-grade concrete splash apron (Figure 27). This offset, if the splash apron was cast to be flush with the base of the wall in the summer of 2006, may indicate a differential settlement of the apron relative to the pile-supported T-wall occurring at a rate of about 1 cm per year (0.5 inch per year) in the upper 21 m (70 ft) of the soil profile.

Figure 27. New T-wall section along the east side of the IHNC between Claiborne and Florida Avenues (shown in Figure 23 during Gustav). (October 2, 2008, 29.9691° N, 90.0236° W)

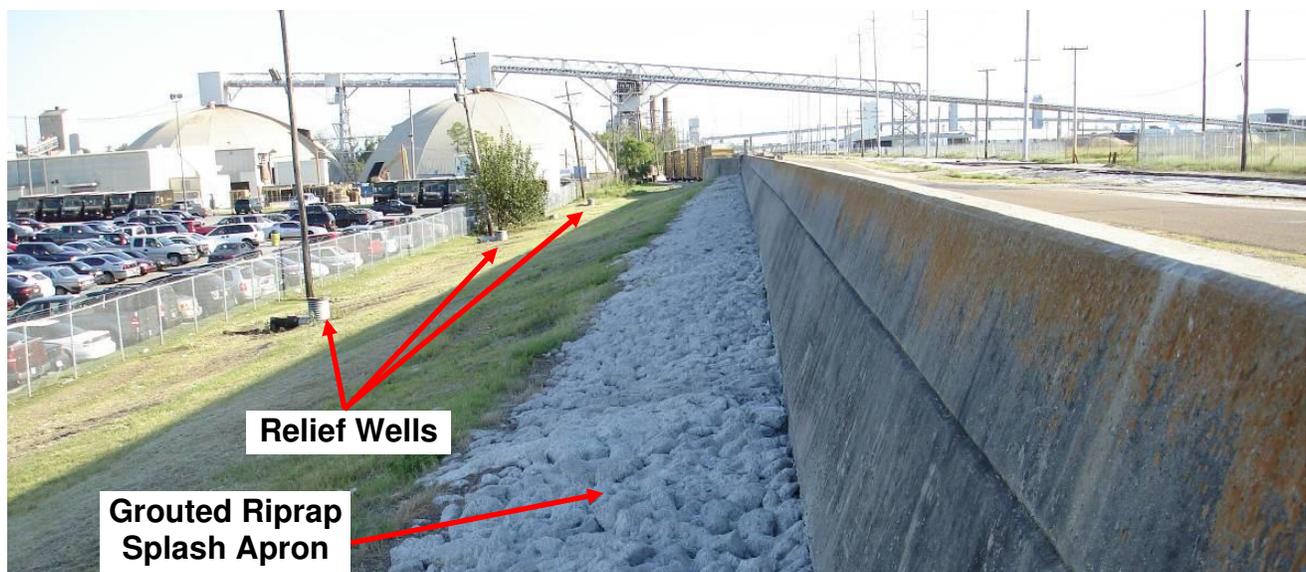
Figure 28. IHNC floodwall near East Morrison Road. Note splash apron (center) and relief wells (left). (October 2, 2008, 30.0248° N, 90.0295° W)

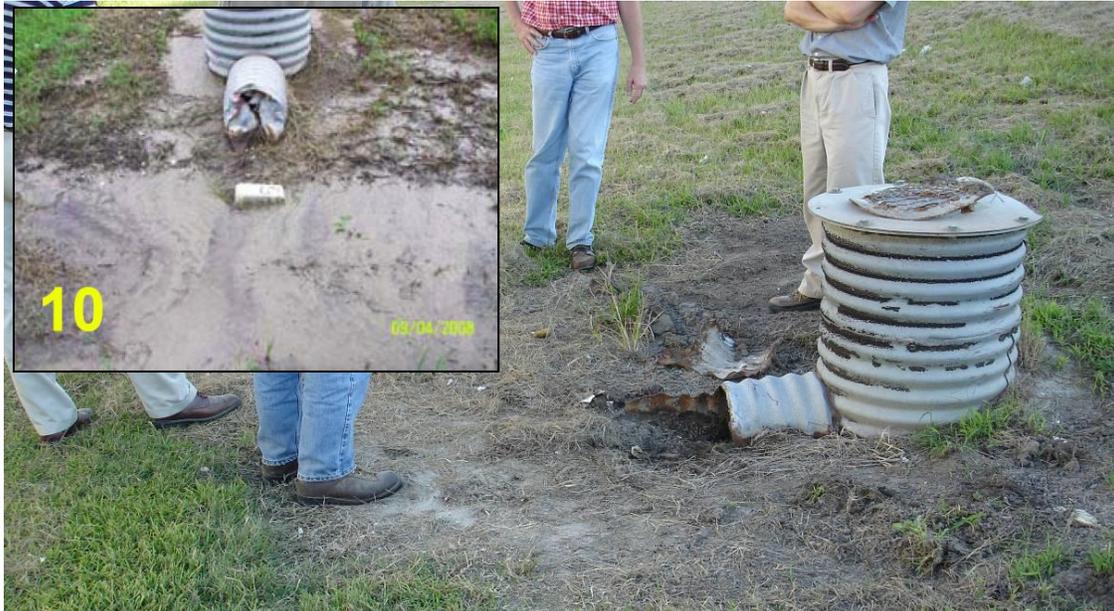
The team observed no signs of damage to the HSDRRS near East Morrison Road due to Hurricane Gustav. The corrugated metal protective casings over the relief well outlets were in various states of deterioration. The team also did not see evidence of extensive sand migration out of the wells, although our observations were made more than a month after Gustav had swept through the region, and the team did not inspect all wells. The inset photo in Figure 28 was taken from the USACE Situation Report dated September 5, 2008, which shows a damaged outlet casing and sand that appears to have discharged from the well.

Figure 29. Relief well cover, as of October 2008, with inset taken from the USACE Hurricane Gustav Damage Assessment Team SITREP on September 5, 2008. (October 2, 2008, 30.0249° N, 90.0294° W)

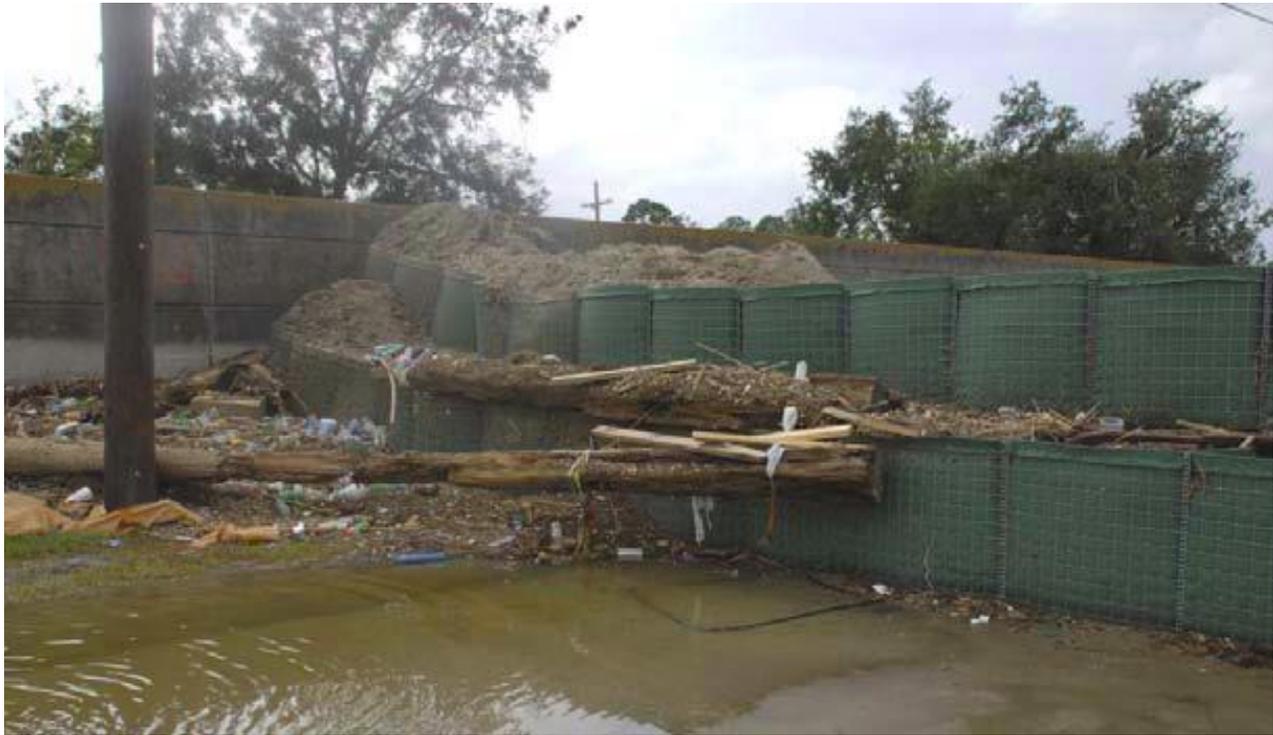
Figure 31. End of temporary bin wall at tie-in to I-Wall, post-Gustav (September 2008, 30.0122° N, 90.0313° W, http://www.mvn.usace.army.mil/HPS/Status%20Report%20Newsletters/Sept_9_2008.pdf)

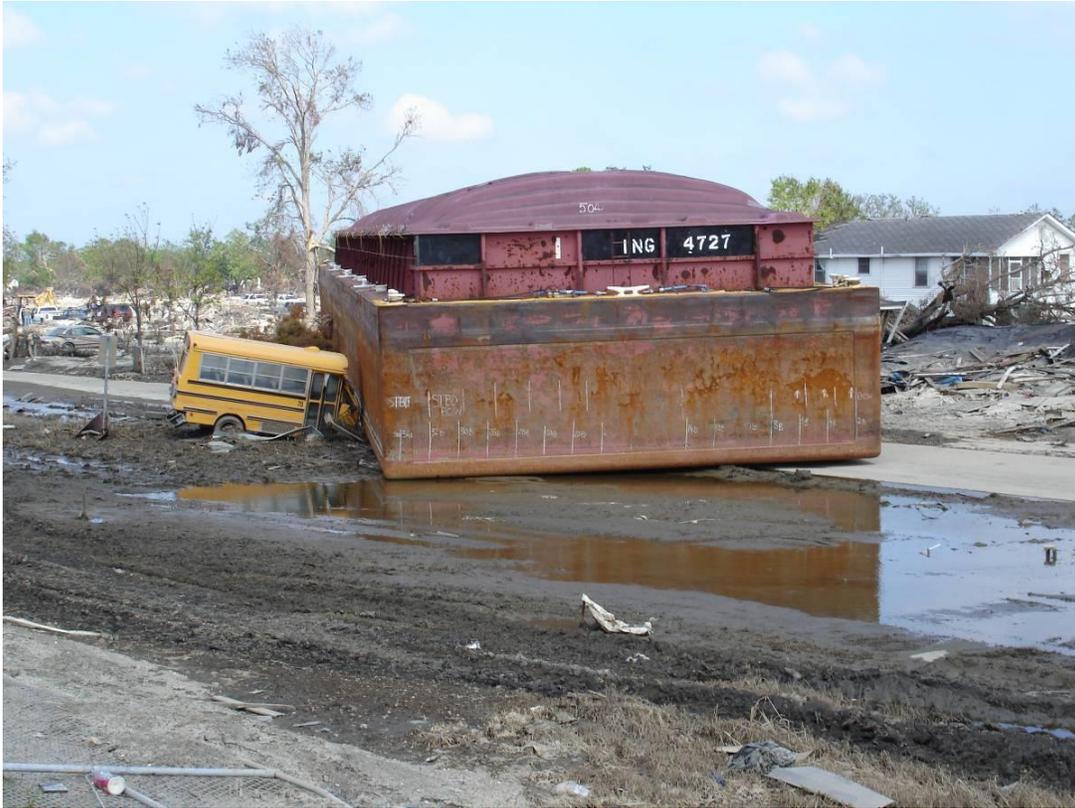
The empty barge that floated into the Lower 9th Ward following Katrina and Rita has been well-documented (see Figures 24 and 32). There has been speculation that this barge or another barge could have contributed to the failure of the Lower 9th Ward I-wall. The high winds of a hurricane can easily push an empty vessel with enough force to break mooring lines and force the vessel into structures along the IHNC. Such was the case during Hurricane Gustav. The U.S. Coast Guard (USCG) has jurisdiction over the ships and barges in the IHNC.

Figure 32. Barge in the Lower 9th Ward after Katrina. (October 4, 2005, 29.9703° N, 90.0230° W, L. Wooten)

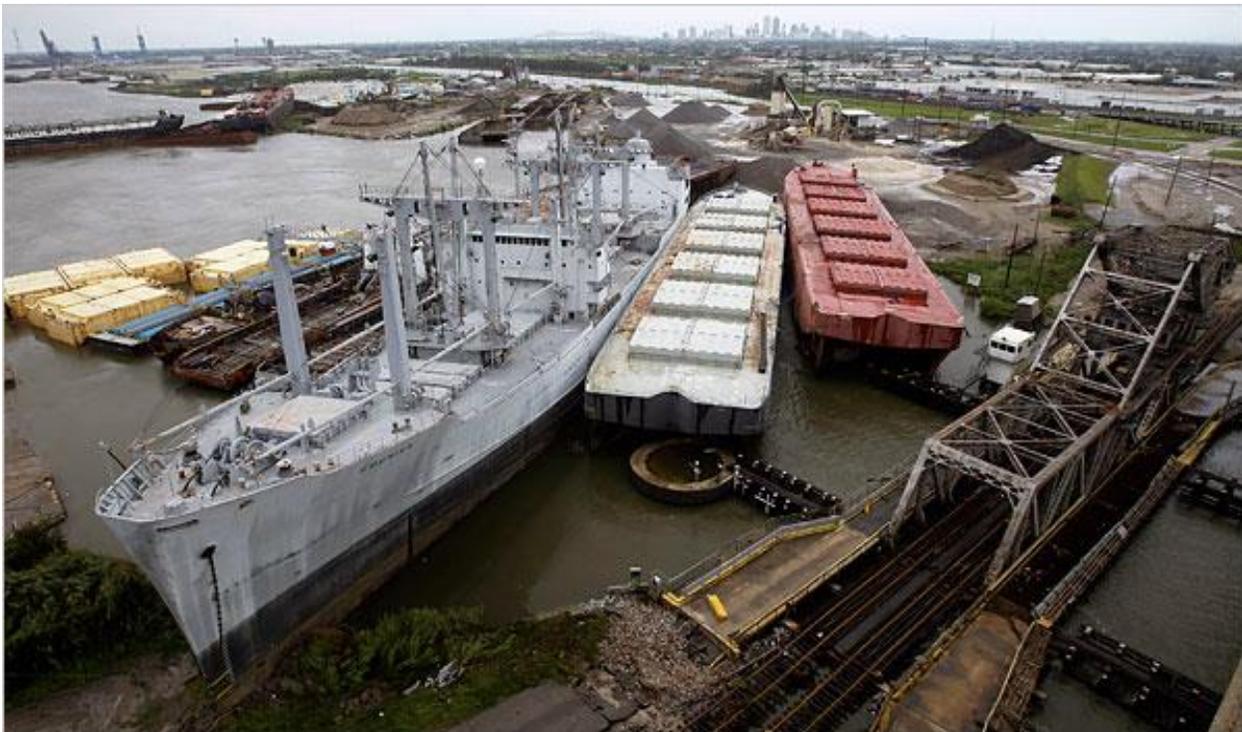
Figure 33 shows how ships and barges were pushed during Gustav against the dolphins protecting the northern railroad bridge that crosses the IHNC just south of the I-10 bridge. This railroad bridge was in the lowered position and thus remained underwater during periods of high water. The Florida Avenue Bridge to the south of these barges and ships was in a slightly raised position so as to be out of the water, but low enough to keep wind loads from having leverage on the support towers. In these positions, both bridges would have confined the ships and barges to the central part of the canal. In preparation for the subsequent hurricane, Ike, the USCG ordered all ships and barges removed from the IHNC.

Figure 33. Ships and barges pushed against a railroad bridge after Gustav. (September 1, 2008, 30.0050° N, 90.0251° W, Eric Gay, Associated Press)

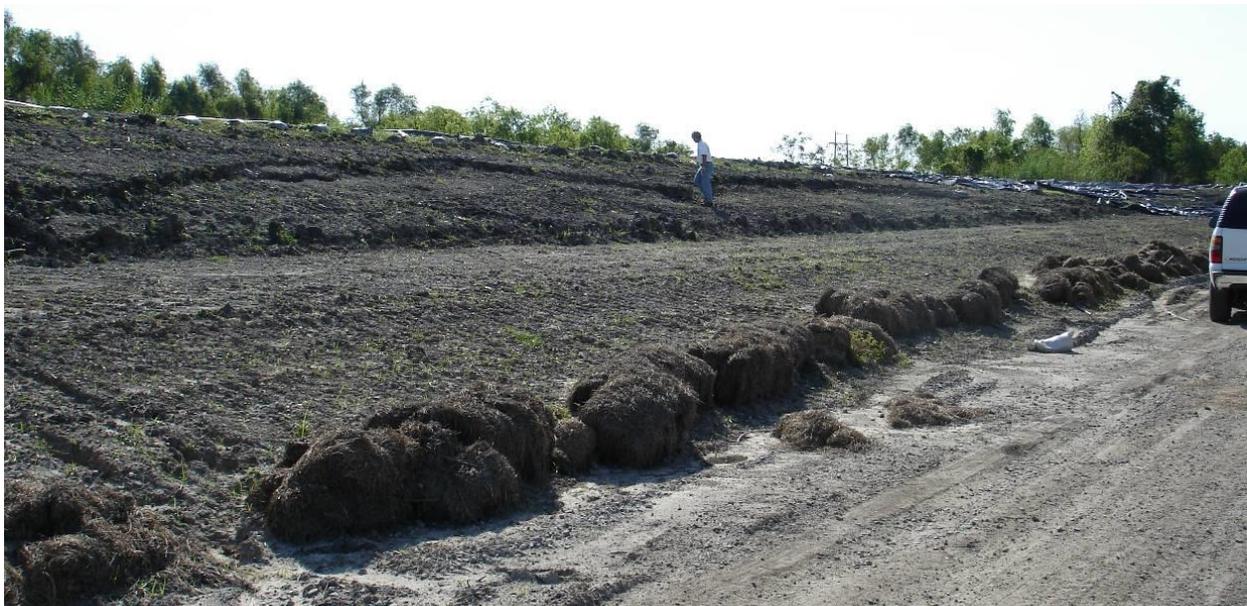
Figure 35. Protected side slope of the Plaquemines Parish back levee and slide.
(October 3, 2008, 29.8506° N, 89.9085° W)

The non-federal local back levee in Plaquemines Parish was overtopped by Gustav flood levels and was in danger of failure at the location of the slope slide. Desiccation cracks on the levee may have contributed to the slide by allowing overtopping water pressures into embankment zones critical to slope stability. The placement water content, compaction, and organic

- The erosion resistance of non-federal local levees in Plaquemines Parish (not part of the HSDRRS) during overtopping was noted during Katrina. The clay back levees in Plaquemines Parish resisted erosion during Gustav but may have demonstrated a potential vulnerability due to desiccation cracks. Improved control of placement water content and compaction, revised material requirements relative to plasticity and organic content, or landscaping measures such as the establishment of dense vegetation and use of irrigation may be required to prevent desiccation.

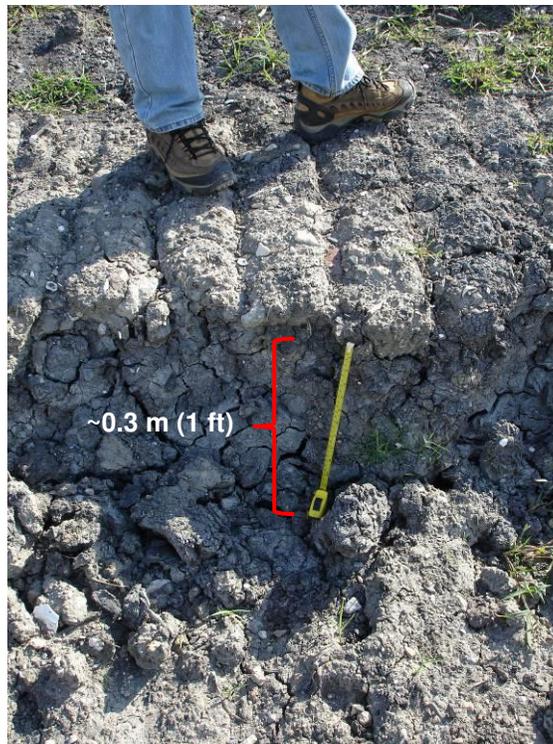
*Figure 36. Scarp above slide on Plaquemines back levee.
(October 3, 2008, 29.8506° N, 89.9085° W)*
