Bridge Abutment Remediation – A Case Study

International Journal of Geoengineering Case Histories, Volume 7, Issue 4, pp. 1-7,

doi: 10.4417/IJGCH-07-04-01

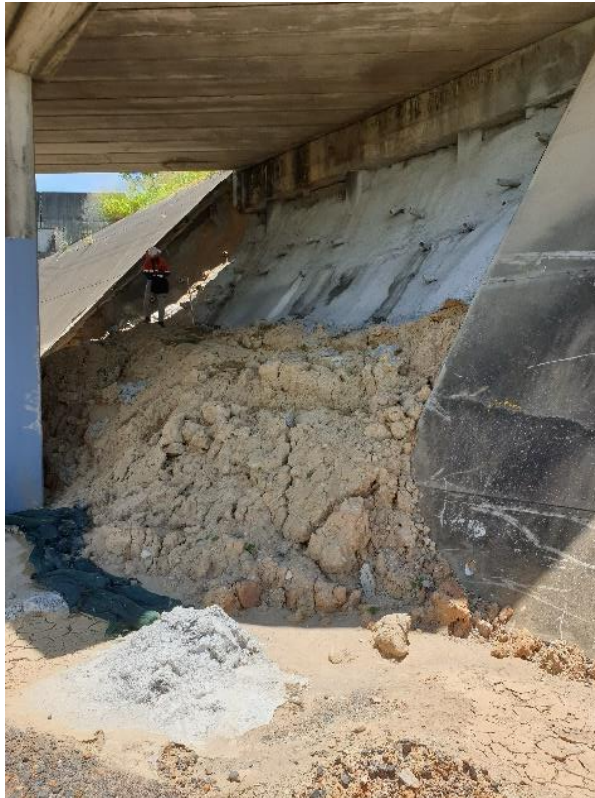
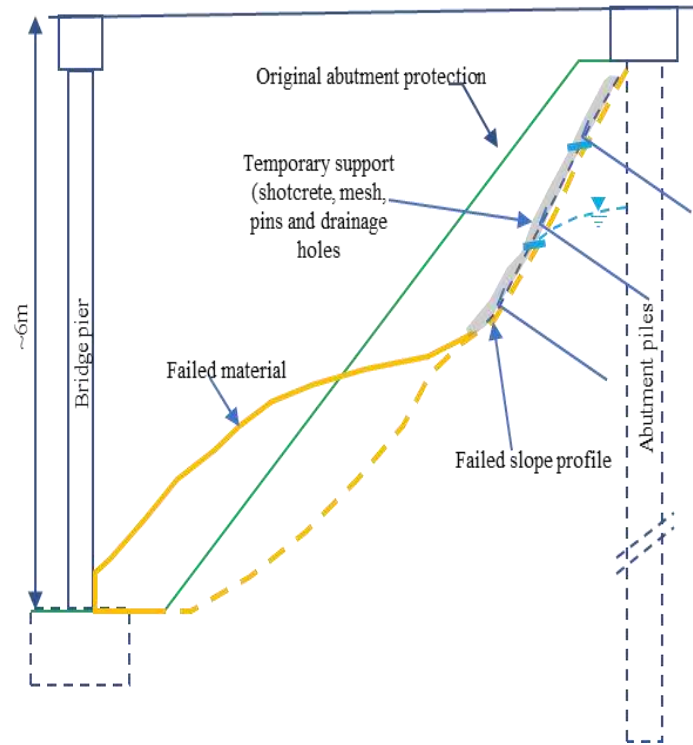
Figure 3. Temporary remediation (shotcrete with mesh, drainage holes, and driven pins) installed within 24 hours of the failure. The sketch illustrates the slope profile and temporary remediation installed. Seepage continued to occur two meters below the headstock at a reducing rate.

Due to a forecast of further rainfall in the days following the failure, there was an urgent requirement to making the abutment safe and prevent further slips from the exposed surface. The following immediate and urgent mitigation measures were implemented within 24 hours (Figure 3):

- Removal of failed material from batter face and abutting against slope toe to provide passive support.
- Installation of two rows of 1-m long drainage pipes.
- Installation of three rows of 2-meter long, 20-millimeters diameter coggled steel reinforcement bars (driven) at 1-meter spacing.
- Application of 160 millimeters (average) thick shotcrete with SL82 mesh.
- Closure of one lane on the road below with temporary traffic lights with contra flow.
- Risk management advice included daily inspections of the site (to later be reduced to weekly, granted there were no further movements) and checks after rainfall events.

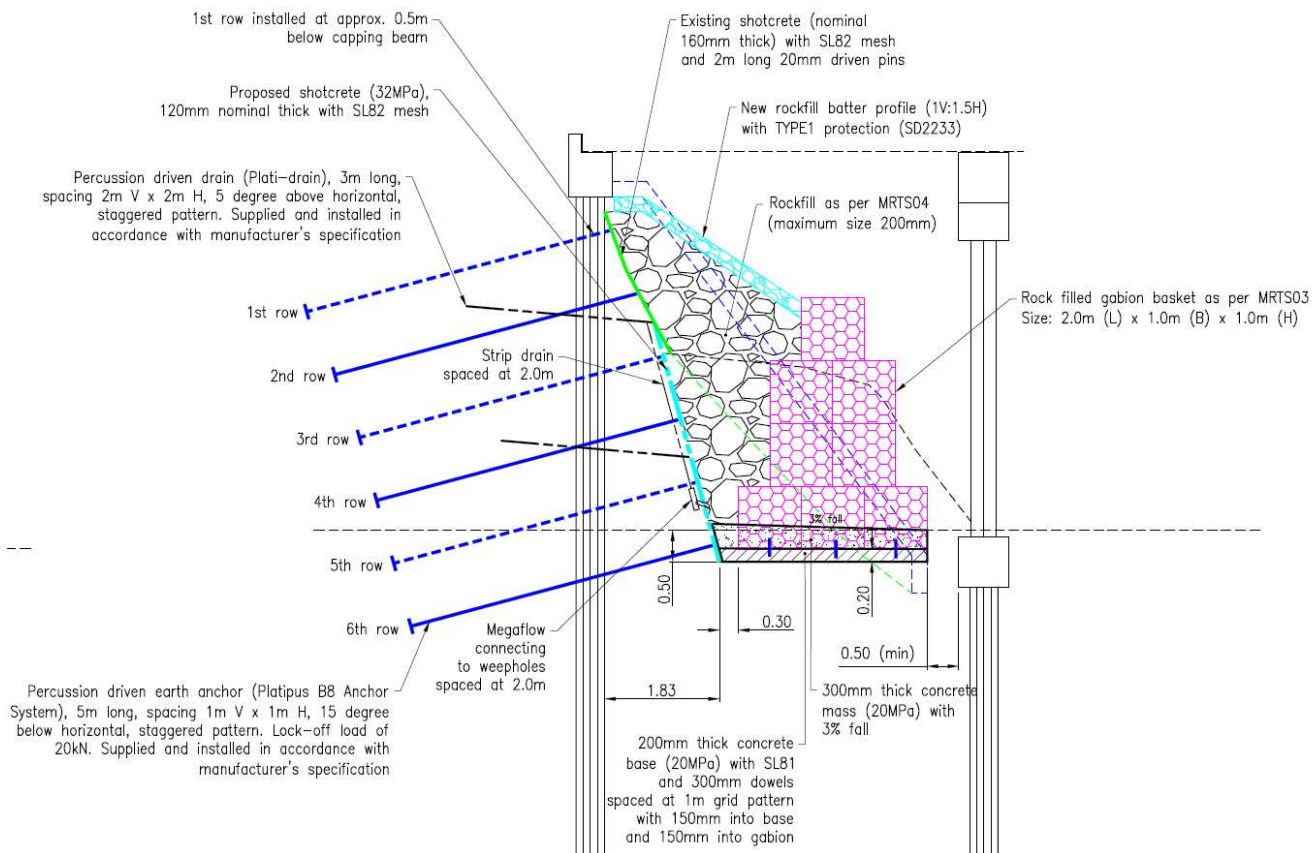
Figure 4. Permanent remediation of the bridge abutment.

- Installation of percussion anchors (300 millimeters wide head, 20 kilo Newton lock-off load) via slots cut into existing shotcrete (urgent works) at 1 meter vertical and horizontal spacing in a staggered pattern.
- Staged excavation at 1.2 meters lifts, followed by installation of percussion anchors, mesh and shotcrete, a row at a time until the toe of excavation was reached for formation of foundation for gabion.
- Installation of percussion drainage (three meters long by two rows at two meters staggered spacing).

It is worth noting that percussion anchors were chosen as they are quick to install, do not need specialized equipment, suit the application in a small space, and can be loaded soon after installation. Figure 4 shows the final design adopted to remediate the bridge abutment.
