## Bridge Abutment Remediation – A Case Study

Reference: Sundaram, M., Sugawara, J. and Sivakumar, S. (2022). Bridge Abutment Remediation – A Case Study.

International Journal of Geoengineering Case Histories, Volume 7, Issue 4, pp. 1-7,

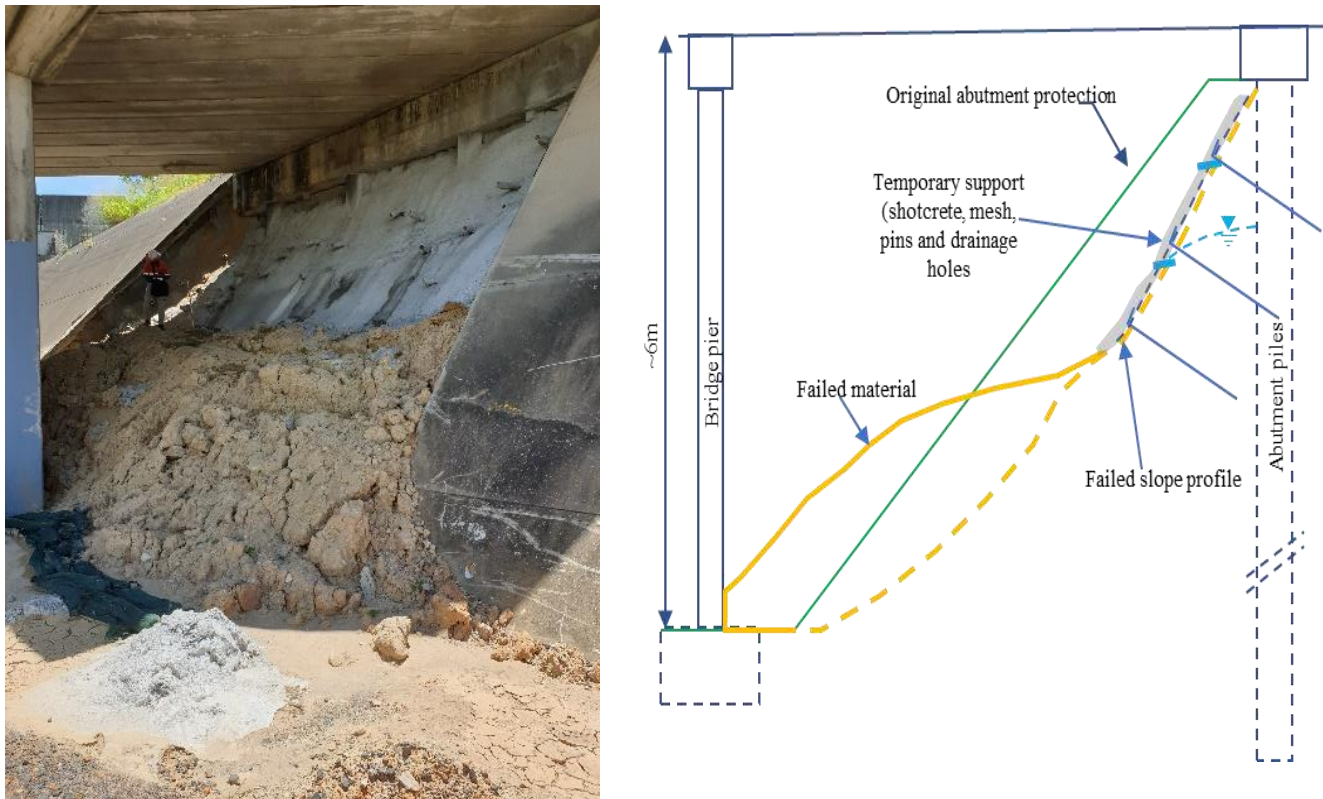
Figure 3. Temporary remediation (shotcrete with mesh, drainage holes, and driven pins) installed within 24 hours of the failure. The sketch illustrates the slope profile and temporary remediation installed. Seepage continued to occur two meters below the headstock at a reducing rate.

Due to a forecast of further rainfall in the days following the failure, there was an urgent requirement to making the abutment safe and prevent further slips from the exposed surface. The following immediate and urgent mitigation measures were implemented within 24 hours (Figure 3):

- Removal of failed material from batter face and abutting against slope toe to provide passive support.
- Installation of two rows of 1-m long drainage pipes.
- Installation of three rows of 2-meter long, 20-millimeters diameter coggled steel reinforcement bars (driven) at 1-meter spacing.
- Application of 160 millimeters (average) thick shotcrete with SL82 mesh.
- Closure of one lane on the road below with temporary traffic lights with contra flow.
- Risk management advice included daily inspections of the site (to later be reduced to weekly, granted there were no further movements) and checks after rainfall events.
