## Bridge Abutment Remediation – A Case Study

Reference: Sundaram, M., Sugawara, J. and Sivakumar, S. (2022). Bridge Abutment Remediation – A Case Study.

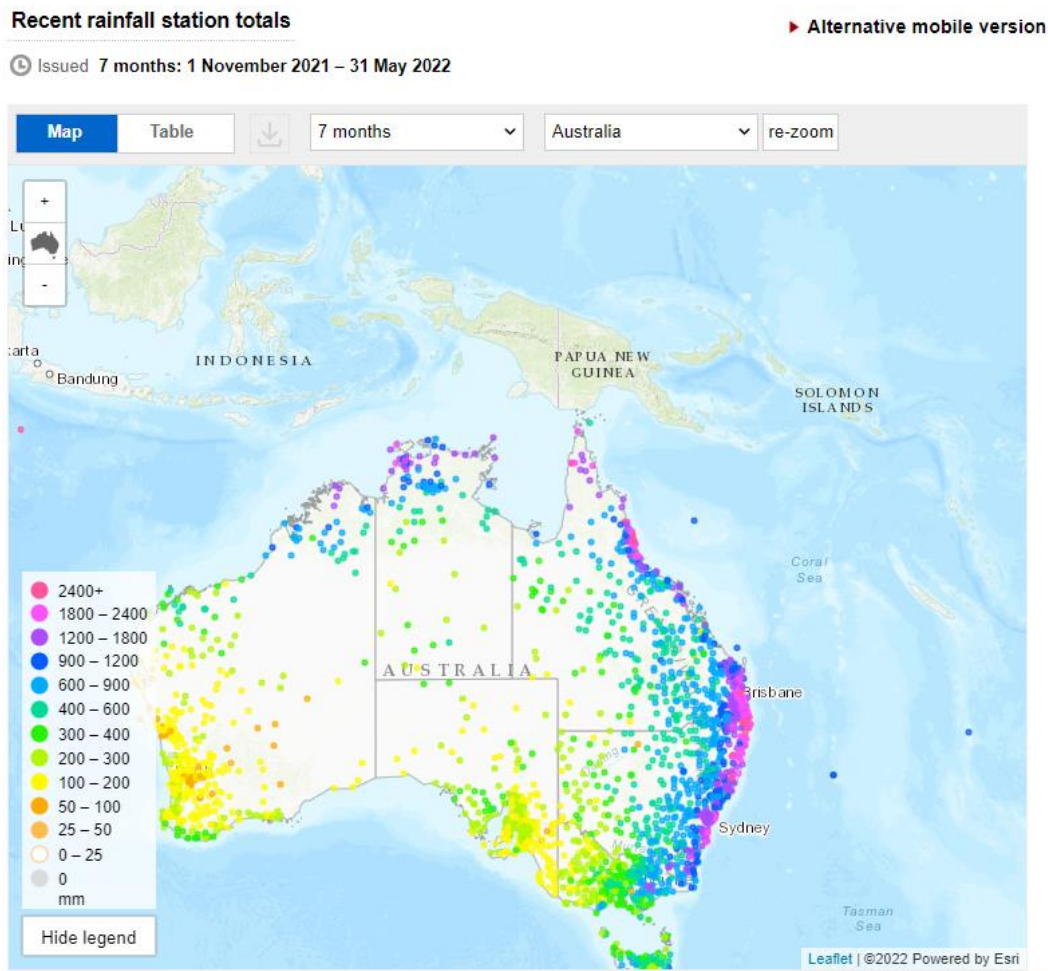
From November 2021 to May 2022, four weather events affected the east coast of Australia. During this period, Southeast Queensland experienced a cumulative rainfall of >1,800 millimeters (Figure 1).

Figure 1. Cumulative rainfall between Nov. 2021 and May 2022 in east coast of Queensland and Australia wide ([Australian rainfall update \(bom.gov.au\)](http://Australian.rainfall.update(bom.gov.au))).

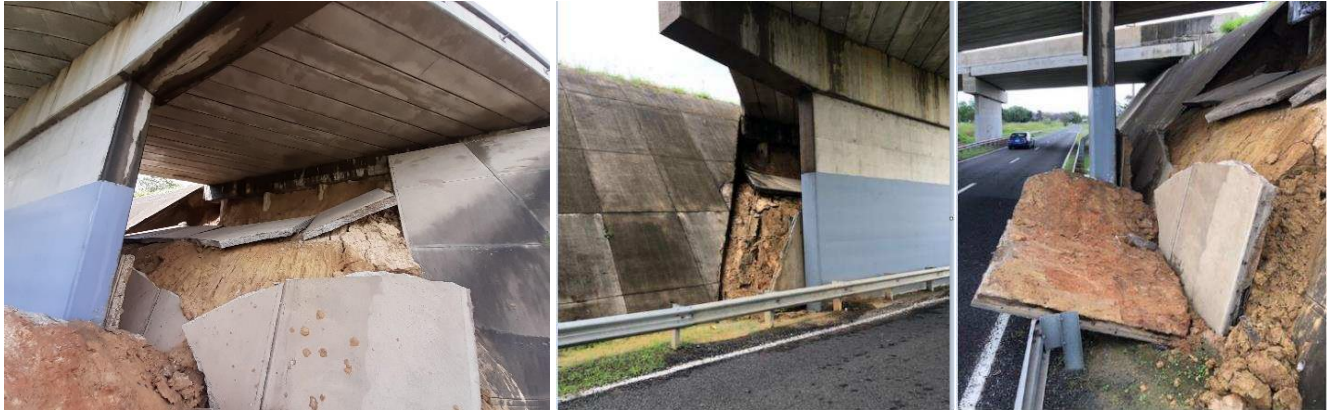
In November 2021, after a downpour, fill material from the crest of the abutment started to move, causing the concrete panels to slip and buckle, and to eventually topple onto the pier below and the guard rails. About 50 cubic meters of material failed from the abutment (Figure 2). However, the bridge pier prevented further movement of the fill material, containing it within the toe of the slope.

A total of 112 millimeters of rainfall was experienced in the month prior to the failure, which was almost double the mean annual rainfall. An additional 30 millimeters fell on the day of failure. The failed material was saturated and fluidized near

the surface. A seepage line was identified two meters below the headstock and was visible to about six meters from edge of the abutment. It is likely that water infiltration from pavement edges may have saturated the abutment fill behind the panels. Therefore, the main cause of the failure is thought to be excessive pore water pressure buildup behind the panels, perched water within the embankment, blockage of weepholes, and softening of the fill material from infiltrated stormwater.

*Figure 2. Abutment condition after failure.*

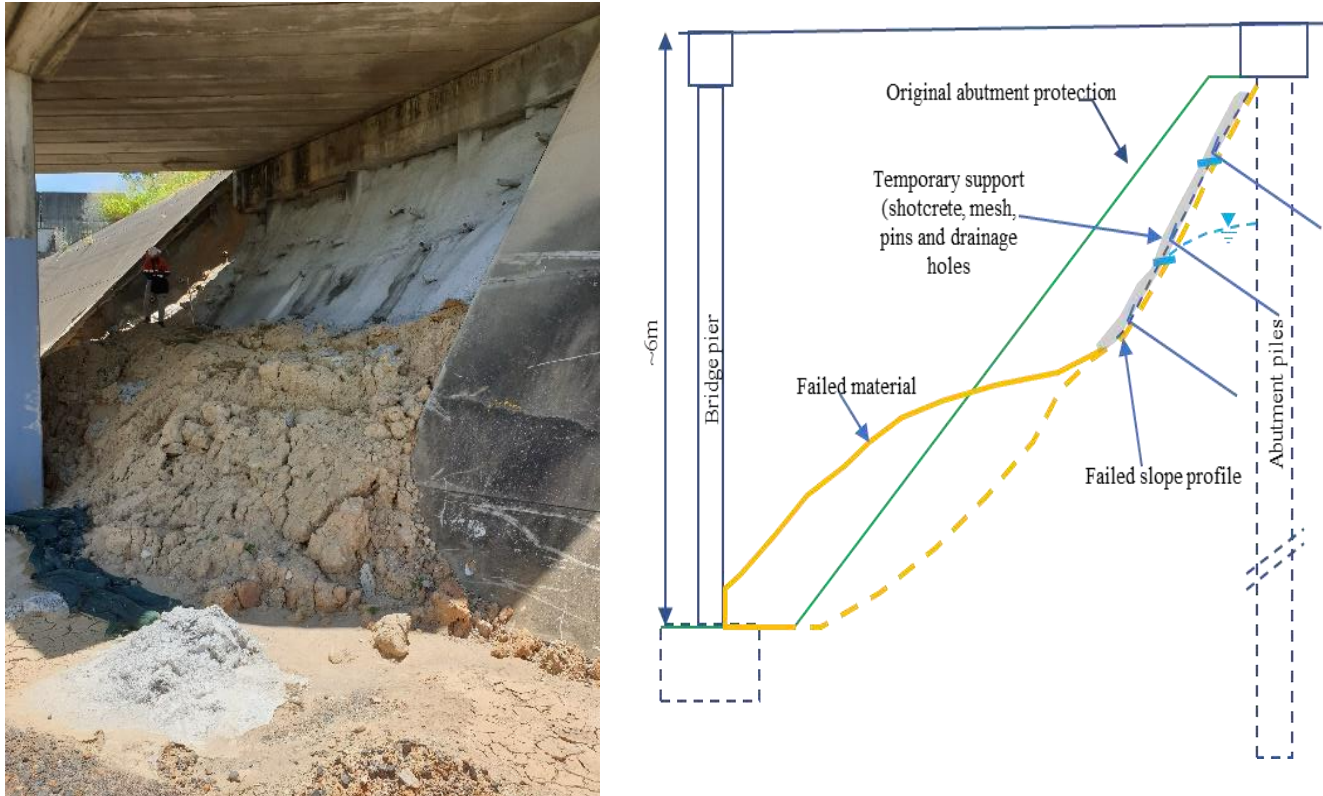
Figure 3. Temporary remediation (shotcrete with mesh, drainage holes, and driven pins) installed within 24 hours of the failure. The sketch illustrates the slope profile and temporary remediation installed. Seepage continued to occur two meters below the headstock at a reducing rate.

Due to a forecast of further rainfall in the days following the failure, there was an urgent requirement to making the abutment safe and prevent further slips from the exposed surface. The following immediate and urgent mitigation measures were implemented within 24 hours (Figure 3):

- Removal of failed material from batter face and abutting against slope toe to provide passive support.
- Installation of two rows of 1-m long drainage pipes.
- Installation of three rows of 2-meter long, 20-millimeters diameter coggled steel reinforcement bars (driven) at 1-meter spacing.
- Application of 160 millimeters (average) thick shotcrete with SL82 mesh.
- Closure of one lane on the road below with temporary traffic lights with contra flow.
- Risk management advice included daily inspections of the site (to later be reduced to weekly, granted there were no further movements) and checks after rainfall events.

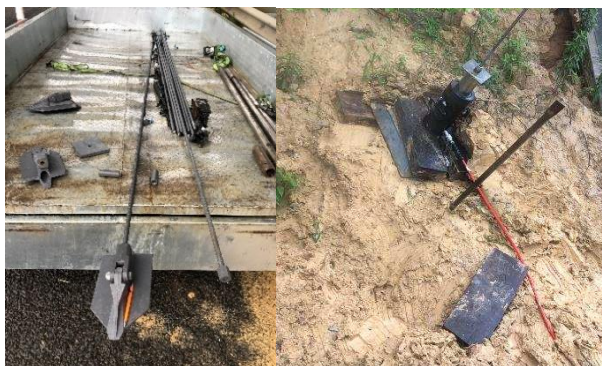
Figure 5. Percussion anchor (180-millimeter head) and load testing.

The construction of the remediation works commenced in May 2022. The appointed contractor proposed an alternative anchor head size to the size proposed in the design. This was mainly to accommodate a smaller machine to drive the percussion anchors. The proposal was accepted provided that the working load of 80 kilo Newton could be achieved. Three test anchors (180 millimeters head size) were tested prior to the commencement of production anchors. Two of the anchors achieved >25 kilo Newton and the test had to be terminated due to soft material around the collar (Figure 5). One anchor was tested to 100 kilo Newton (at 850 millimeters extension) and the test was terminated as the load reached 80 per cent of ultimate breaking load of the steel tendon, 120 kilo Newton. On that basis, the proposed 180 millimeters anchor head was accepted as the minimum size that could be used. However, during construction, a mixture of 180-millimeter and 300-millimeter head sizes were used since there was a supply issue with the smaller heads. No issues were encountered during installation of the anchors.

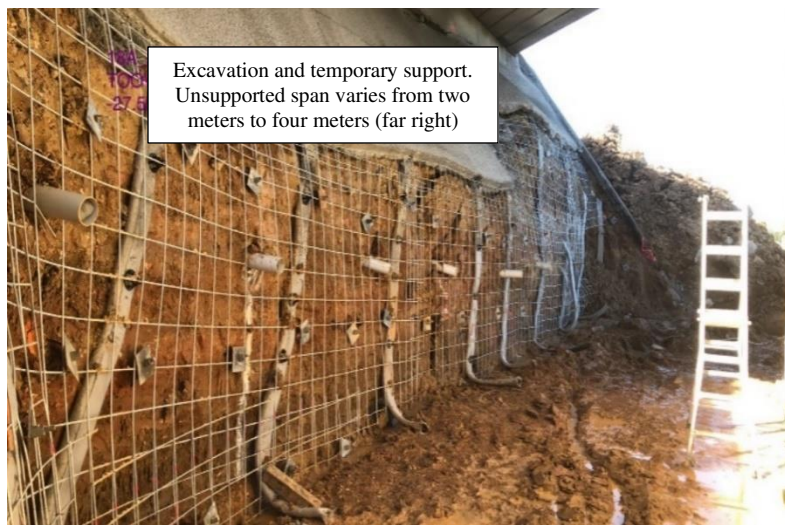
The excavation, anchor installation, and shotcrete application progressed well for the first three rows of anchors, after which, the contractor inadvertently excavated to full depth not following the support sequences specified in the design drawings. This resulted in the exposure of the slope face between 2-4 meters high without full protection. Consequently, approximately, 0.5 meter thick soil movement occurred behind the highest exposed face (Figure 6) with displacement of 250 millimeters in shotcrete below the headstock. On the same day, 13 millimeters of rainfall exacerbated the movement. Additional rows of anchors and steel mesh were installed to stabilize the movement. As a precautionary measure, the highway speed was also reduced to 60 kilometers per hour to minimize any vibration-induced movements. Surveillance was also increased to ensure safety was not compromised. The rate of the movement reduced after the installation of additional support measures and ceased two days after shotcrete application was completed (Figure 7).

Figure 6. Excavation completed to formation level. The abutment is supported with percussion anchors and reinforced shotcrete. Note larger unsupported span on the far right.

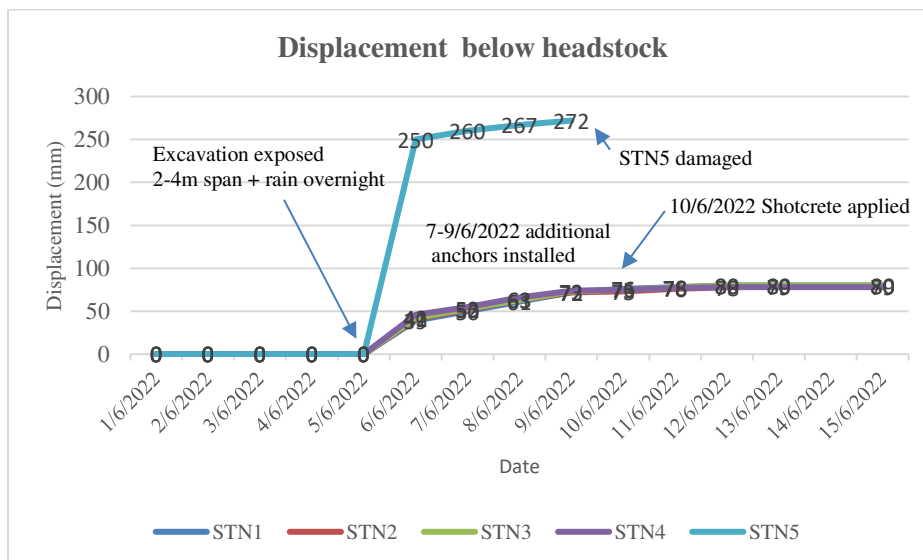
Figure 7. Displacement (mm) in shotcrete below headstock. Station 5 (STN5) located on far right. Displacement ceased two days after shotcrete application.
