## Bridge Abutment Remediation – A Case Study

Reference: Sundaram, M., Sugawara, J. and Sivakumar, S. (2022). Bridge Abutment Remediation – A Case Study.

International Journal of Geoengineering Case Histories, Volume 7, Issue 4, pp. 1-7,

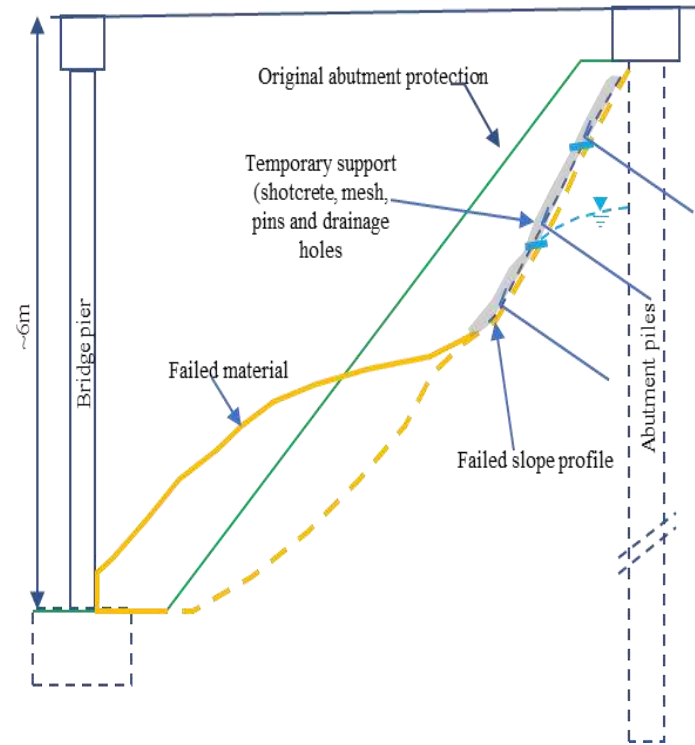
The above measures appeared to have worked well, with no further movement observed on the abutment slope which withstood subsequent rainfall events.

Figure 3. Temporary remediation (shotcrete with mesh, drainage holes, and driven pins) installed within 24 hours of the failure. The sketch illustrates the slope profile and temporary remediation installed. Seepage continued to occur two meters below the headstock at a reducing rate.

- Removal of failed material from batter face and abutting against slope toe to provide passive support.
- Installation of two rows of 1-m long drainage pipes.
- Installation of three rows of 2-meter long, 20-millimeters diameter coggled steel reinforcement bars (driven) at 1-meter spacing.
- Application of 160 millimeters (average) thick shotcrete with SL82 mesh.
- Closure of one lane on the road below with temporary traffic lights with contra flow.
- Risk management advice included daily inspections of the site (to later be reduced to weekly, granted there were no further movements) and checks after rainfall events.
