Bridge Abutment Remediation – A Case Study

Reference: Sundaram, M., Sugawara, J. and Sivakumar, S. (2022). Bridge Abutment Remediation – A Case Study.

International Journal of Geoengineering Case Histories, Volume 7, Issue 4, pp. 1-7,

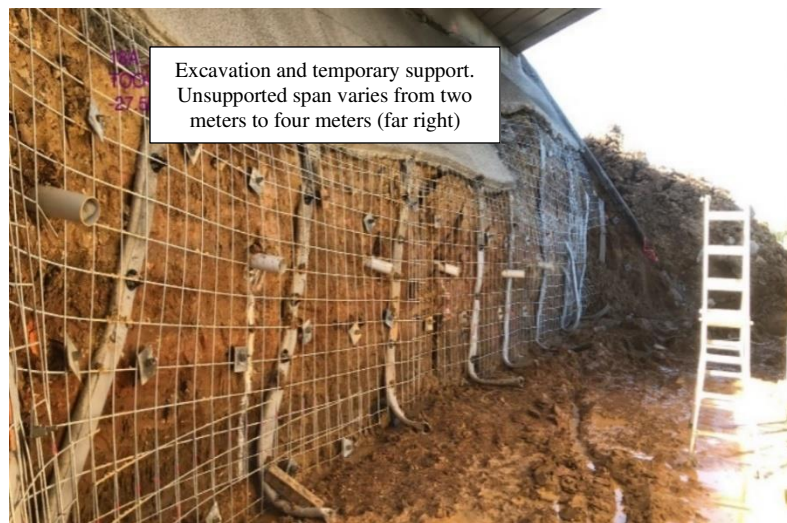
The excavation, anchor installation, and shotcrete application progressed well for the first three rows of anchors, after which, the contractor inadvertently excavated to full depth not following the support sequences specified in the design drawings. This resulted in the exposure of the slope face between 2-4 meters high without full protection. Consequently, approximately, 0.5 meter thick soil movement occurred behind the highest exposed face (Figure 6) with displacement of 250 millimeters in shotcrete below the headstock. On the same day, 13 millimeters of rainfall exacerbated the movement. Additional rows of anchors and steel mesh were installed to stabilize the movement. As a precautionary measure, the highway speed was also reduced to 60 kilometers per hour to minimize any vibration-induced movements. Surveillance was also increased to ensure safety was not compromised. The rate of the movement reduced after the installation of additional support measures and ceased two days after shotcrete application was completed (Figure 7).

Figure 6. Excavation completed to formation level. The abutment is supported with percussion anchors and reinforced shotcrete. Note larger unsupported span on the far right.
