Bridge Abutment Remediation – A Case Study

Reference: Sundaram, M., Sugawara, J. and Sivakumar, S. (2022). Bridge Abutment Remediation – A Case Study. International Journal of Geoengineering Case Histories, Volume 7, Issue 4, pp. 1-7, doi: 10.4417/IJGCH-07-04-01

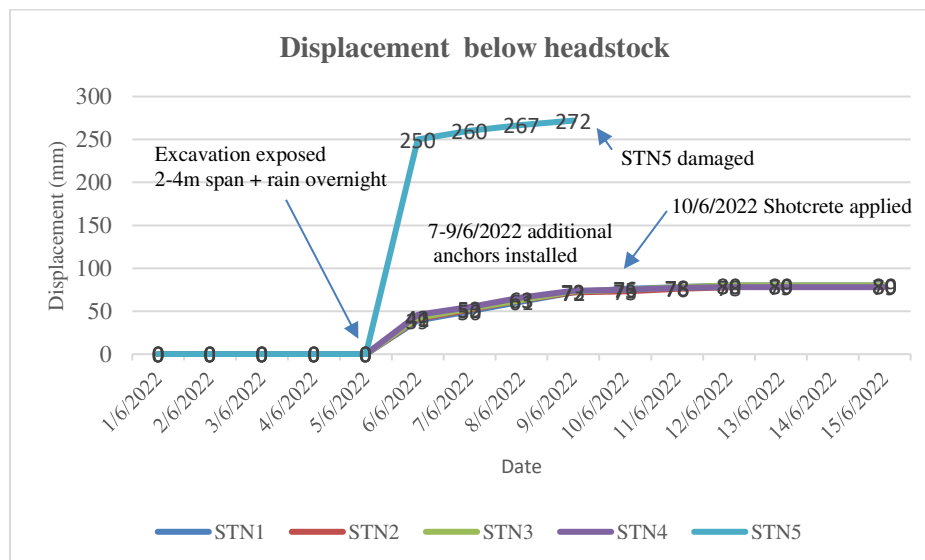
Figure 7. Displacement (mm) in shotcrete below headstock. Station 5 (STN5) located on far right. Displacement ceased two days after shotcrete application.
