# Images Collected from the Internet Reveal the Failing Mechanism of the Tailing Dam Breach at Kolontar, Hungary

**Reference:** Garai J., and Kovács I. (2025). *Images Collected from the Internet Reveal the Failing Mechanism of the Tailing Dam Breach at Kolontar, Hungary*. International Journal of Geoengineering Case Histories, Vol.8, Issue 1, p.64-81. doi: 10.4417/IJGCH-08-01-04

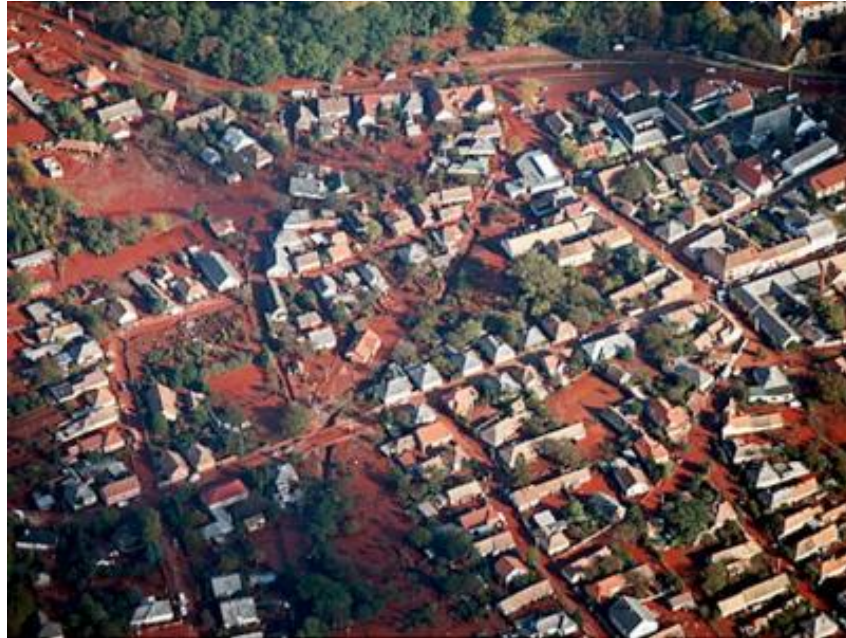
*Figure 1. The scale of the disaster: the highly toxic sludge flooded the neighboring villages in the valley of Torna. (Source: <http://www.nydailynews.com/news/world/bodies-found-hungary-toxic-red-sludge-seeped-danube-river-article-1.188733>.)*

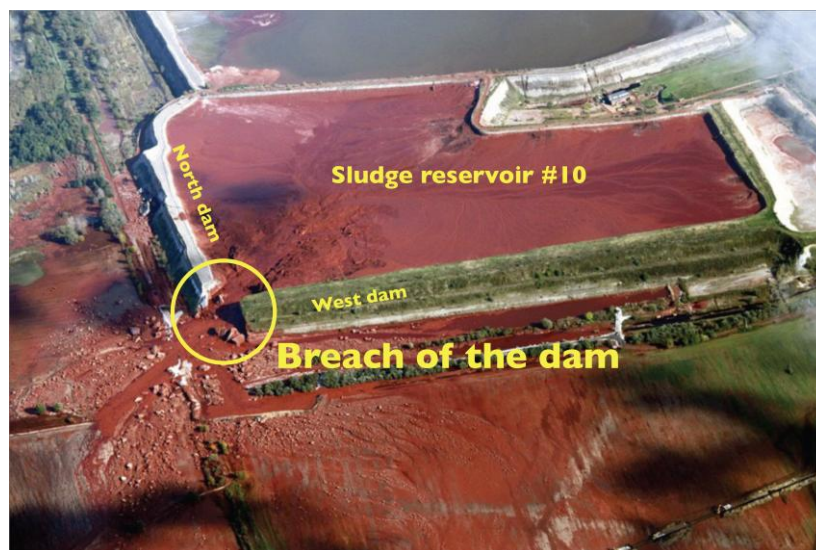
*Figure 2. Aerial photo of the breach of the tailing dam. (Source: <https://www.ndtv.com/world-news/hungarys-toxic-sludge-spill-as-big-as-gulf-oil-leak-435094>.)*

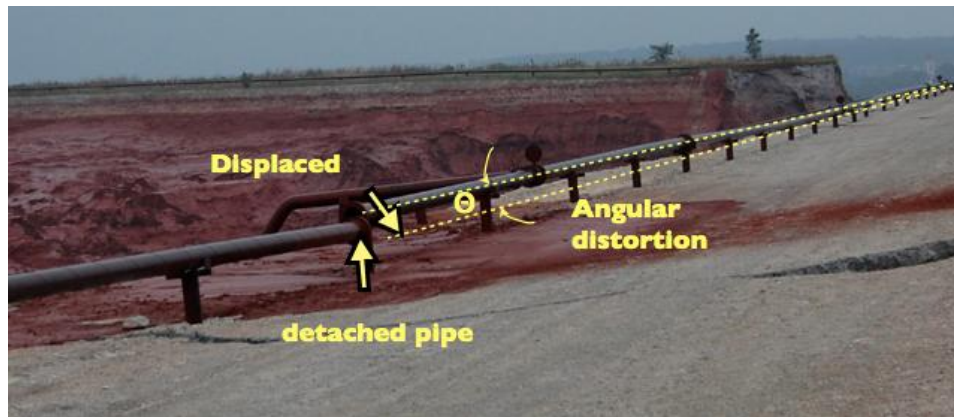
**Figure 10.** The angular distortion of the failed section of the dam can be seen from the position of the displaced broken pipe. On the failed part of the dam the pipe moved towards the reservoir despite the outward movement of the failed dam section. This indicates that the displacement resulting from angular distortion exceeded the outward displacement of the dam. (Source:

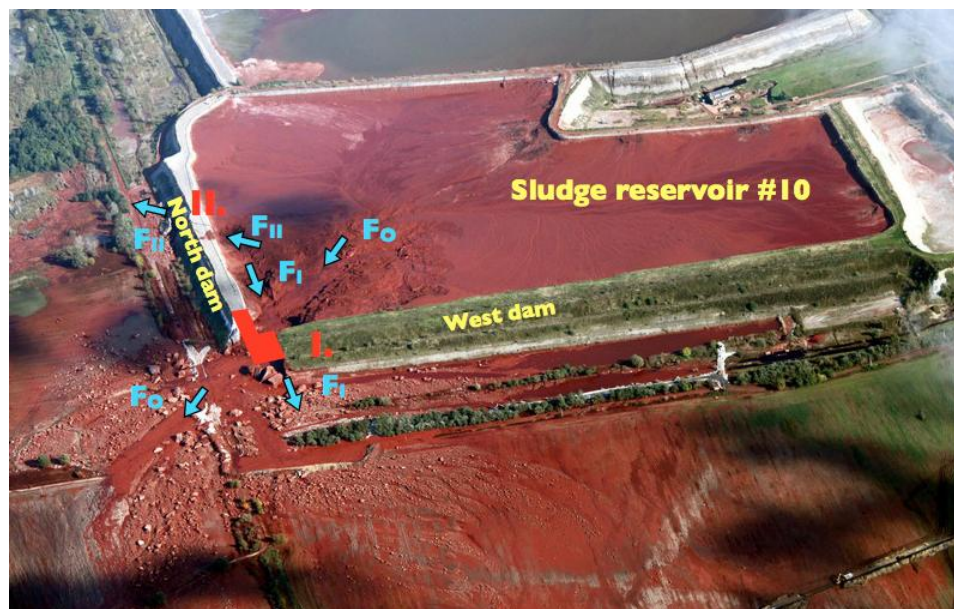
**Figure 11.** Based on the created flow channels in the red sludge, the flow directions were reconstructed. The initial flows  $F_1$  and  $F_2$  occurred at Locations I and II, pointing toward the direction of the existing fractures. The direction of flow  $F_1$  changed to  $F_0$  when the western part of the North dam had been washed away, creating a big opening. (Source: <https://www.ndtv.com/world-news/hungarys-toxic-sludge-spill-as-big-as-gulf-oil-leak-435094>.)

The flow directions pointing towards Location I ( $F_I$ ) and Location II ( $F_{II}$ ) are narrow, indicating that these were the initial flows which were active right after the breach of the dam. These channels,  $F_I$  and  $F_{II}$ , are also deeper than the third one,  $F_O$ . The bigger depth of these channels indicates that these are the initial flows, when the initial hydraulic gradient was the highest. The flow directions further confirm that the fractures developed at Locations I and II initiated the breach of the dam. The third identified flow direction ( $F_O$ ) is shallower and wider, pointing toward the direction of the biggest opening. It is concluded that the flow  $F_I$  changed its direction to  $F_O$  when part of the North dam had been washed away.

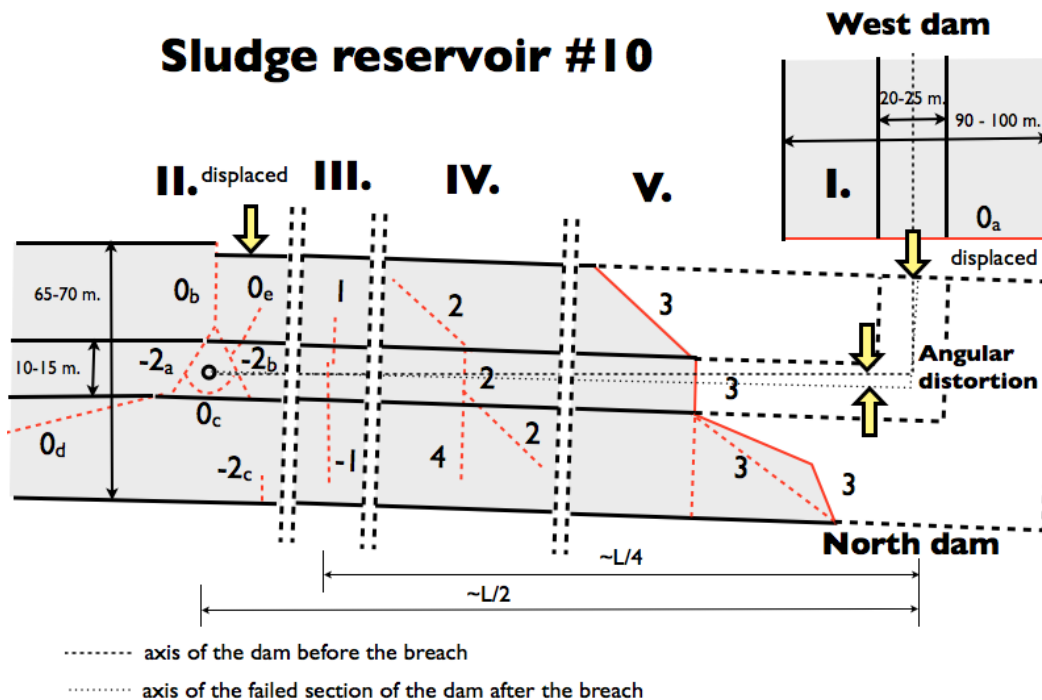
The five locations of the fractures can be seen in Figures 7 and 8. The individual fractures are numbered in the sequence of their occurrence. Minus and plus signs are used to indicate if the fractures occurred before or after the breach respectively. Number zero has been assigned to the fractures that occurred at the breach of the dam. The schematic patterns of the identified fractures and the assigned numbers are shown in Figure 12.

**Figure 12.** The sketch of the identified fractures is shown. The fractures are numbered in the sequence of their occurrence. Minus and plus signs are used to indicate if the fracture occurred before or after the breach respectively. Number zero has been assigned to the fractures that occurred at the breach of the dam.

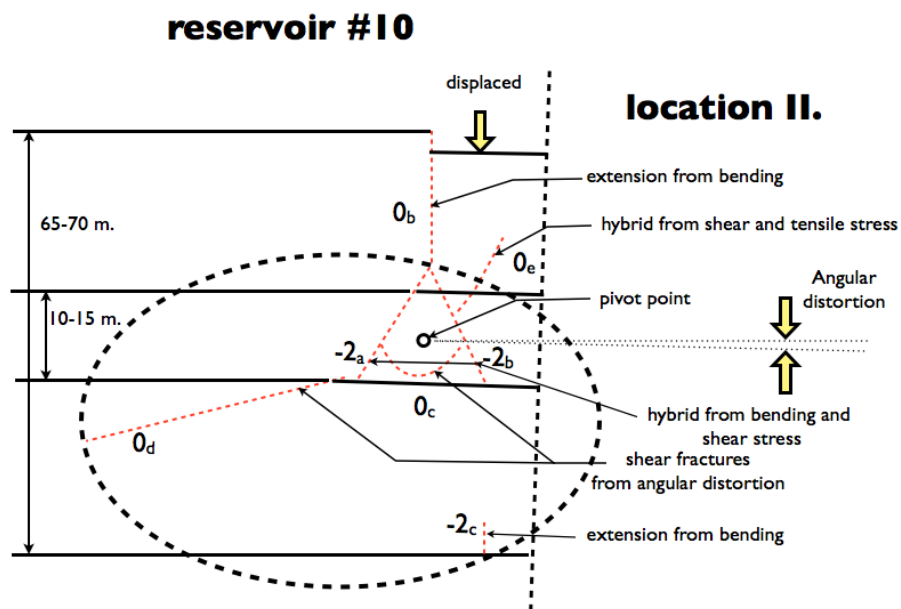
Location II is in the middle of the North dam. The fracture pattern is quite complex. Based on the fracture pattern, it can be identified that the fractures  $-2_a$  and  $-2_b$  relate to bending (Figure 6). The tension side of the bending was the outer side of the reservoir. However, on this side (outward from the reservoir), shear fractures  $0_c$  and  $0_d$  are also present, indicating compression stress on the same side (Figures 4 and 5).

**Figure 13.** The identified fractures at Location II are shown. Dashed circles mark fractures, formed from compression and tension in the same location. The coexistence of the extension and shear fractures in the same location can only be possible if the stress conditions changed in time.

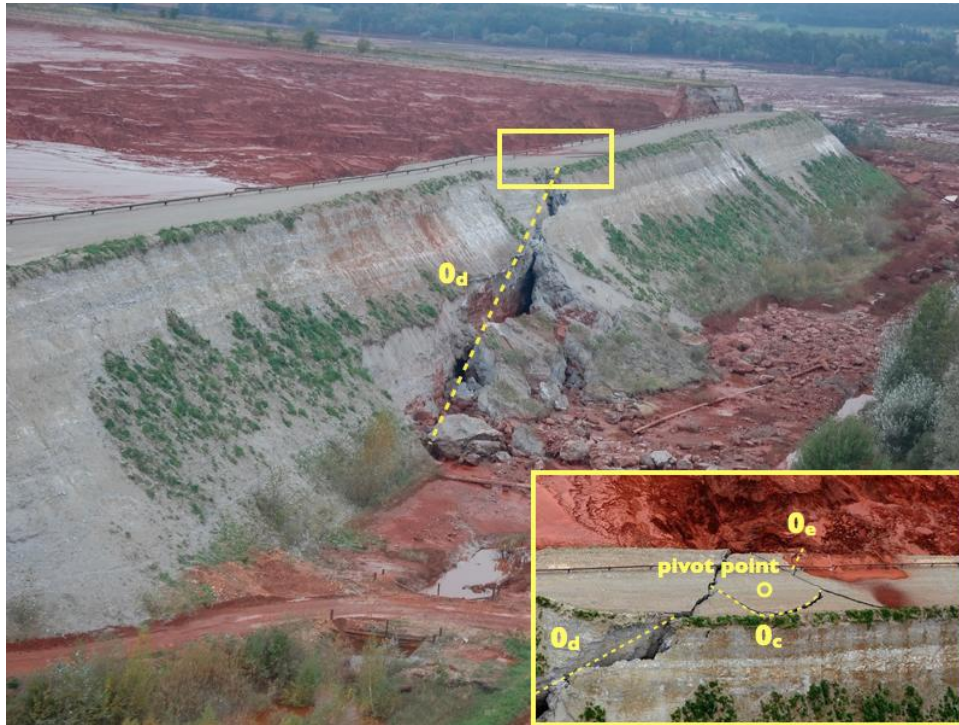
The last straw leading to the breach of the entire dam section was when the tensional resistance of the West dam was exhausted. The dam, whose sliding resistance had already been exhausted, had been detached at fracture 0<sub>a</sub> and the dam moved outward from the reservoir, activating the preexisting bending fractures at Location II. The displacement also induced an angular distortion which generated tensile and shear stresses on the reservoir side, resulting in fractures 0<sub>b</sub> and 0<sub>c</sub> respectively. The angular distortion of the dam produced compression stress at the outward site of the reservoir, which resulted in the development of shear fractures 0<sub>c</sub> and 0<sub>d</sub> on the outward side of the dam (Figure 15). The detachment occurred along the extension fracture (0<sub>b</sub>) (Figure 9), and the preexisting fracture -2<sub>a</sub> (Figure 14). Fracture 0<sub>c</sub> (Figure 9) is a hybrid fracture caused by extension (angular distortion) and shear stresses (displacement).

**Figure 15.** Shear fractures ( $0_c$  and  $0_d$ ) caused by compressional stress at Location II are shown. These fractures were formed at the breach, resulting from the angular distortion of the failed dam section. On the opposite (reservoir) side, at the same time, extension fracture  $0_b$  occurred (Figure 9), extending the existing fracture of  $-2_b$ . (Sources: <https://www.nbcnews.com/slideshow/toxic-red-sludge-floods-towns-near-budapest-39514793>; <http://www.hungarianambiance.com/2011/09/possibility-of-act-of-terrorism-cant-be.html>).

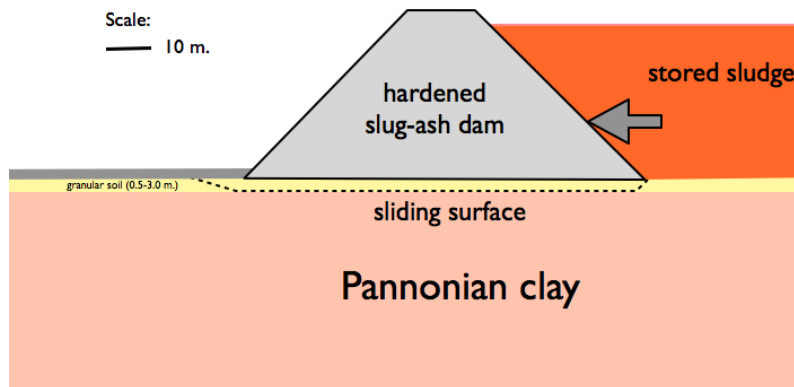
The granular soil (sandy gravel) under the dams, with its weight and its bearing capacity at the toe of the dam, increased the resistance against sliding. Thus, the failure of the dam occurred where the thickness of the granular soil is the smallest (Ndagijimana, 2019). This conclusion is consistent with the failed section of the dam, where the granular layer was the

thinnest (0,5 m) under the dam (Farkas et al., 2013). The dams with a bigger cross section had additional weights, which prevented the sliding failure, even though the resistance against sliding was nearly exhausted.

**Figure 18.** Schematic cross section of the soil profile and sliding surface of the failing is shown. The high pH and the cation exchange weakened the internal friction of the clay on the surface of the layer. The increasing horizontal pressure of the sludge on the dam led to the sliding failure of the dam along this weak resistant layer. The weight of the granular layer and its bearing capacity at the toe of the dam increased the resistance against sliding. Thus, failure of the dam occurred where the thickness of the granular layer was the thinnest.
