Images Collected from the Internet Reveal the Failing Mechanism of the Tailing Dam Breach at Kolontar, Hungary

ABSTRACT: *The failure of the red sludge tailing dam at Kolontar in 2010 was the most severe environmental disaster in the history of Hungary. The official investigations are confidential because the legal case has not been closed. The publicly accessible information from the breach of the dam are the photographs taken by the media and news agencies. Collecting these images and analyzing the recorded fractures and displacements of the dam reveal the failing mechanism. The breach of the dam resulted from failing to sliding, which had been developed in three stages. This conclusion is consistent with the observed movements of the dam deduced from a persistent scattered radar interferometry deformation analysis conducted between 2003 and 2010.*

Reference: Garai J., and Kovács I. (2025). *Images Collected from the Internet Reveal the Failing Mechanism of the Tailing Dam Breach at Kolontar, Hungary*. International Journal of Geoengineering Case Histories, Vol.8, Issue 1, p.64-81. doi: 10.4417/IJGCH-08-01-04

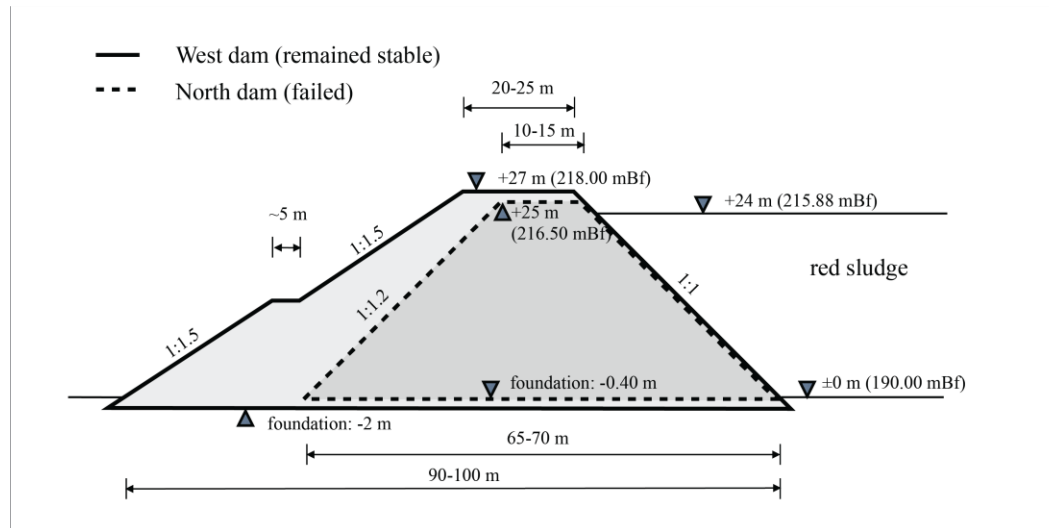
Figure 3. The cross sections of the North and West dams (Farkas et al., 2013). The Northern dam primarily was designed to separate two reservoirs. The cross section of the dam therefore is significantly smaller in comparison to the West dam, which was designed to support the sludge pressure of the reservoir.
