Images Collected from the Internet Reveal the Failing Mechanism of the Tailing Dam Breach at Kolontar, Hungary

ABSTRACT: *The failure of the red sludge tailing dam at Kolontar in 2010 was the most severe environmental disaster in the history of Hungary. The official investigations are confidential because the legal case has not been closed. The publicly accessible information from the breach of the dam are the photographs taken by the media and news agencies. Collecting these images and analyzing the recorded fractures and displacements of the dam reveal the failing mechanism. The breach of the dam resulted from failing to sliding, which had been developed in three stages. This conclusion is consistent with the observed movements of the dam deduced from a persistent scattered radar interferometry deformation analysis conducted between 2003 and 2010.*

Reference: Garai J., and Kovács I. (2025). *Images Collected from the Internet Reveal the Failing Mechanism of the Tailing Dam Breach at Kolontar, Hungary*. International Journal of Geoengineering Case Histories, Vol.8, Issue 1, p.64-81. doi: 10.4417/IJGCH-08-01-04

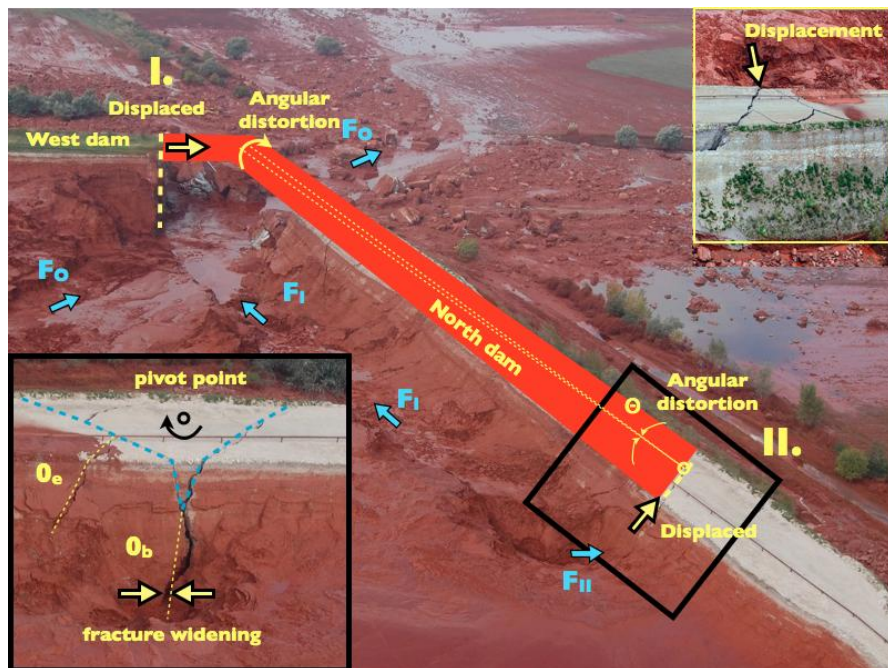
Displacements outward from the reservoir at Locations I and II of the western part of the North dam had been identified (Figure 9). The dam remained intact between these two locations; it is reasonable to assume that the entire dam section between them had been displaced. The displacements at the two ends of the failed dam section are different, which induced an angular distortion on the failed section. This distortion can be identified from the widening of the fracture at Location II (see Figure 9) and from the position of the detached pipe at Location II (see Figure 10). Thus, the failed section of the dam between Locations I and II has been displaced, and an angular distortion has been induced (Figure 9).

Figure 9. The failed section of the North dam is shown in red. This entire section had been displaced outward from the reservoir. Angular distortion also occurred from the bigger displacement at Location I. The widening of fracture 0_b supports the angular distortion. The channels created by the outflow are visible on the surface of the red sludge. The identified flow directions (F) are shown. (Sources: <http://www.hungarianambiance.com/2011/09/possibility-of-act-of-terrorism-cant-be.html> and <https://phys.org/news/2011-04-wildlife-largely-absent-red-sludge.html#nRlv>.)
