# Images Collected from the Internet Reveal the Failing Mechanism of the Tailing Dam Breach at Kolontar, Hungary

**ABSTRACT:** The failure of the red sludge tailing dam at Kolontar in 2010 was the most severe environmental disaster in the history of Hungary. The official investigations are confidential because the legal case has not been closed. The publicly accessible information from the breach of the dam are the photographs taken by the media and news agencies. Collecting these images and analyzing the recorded fractures and displacements of the dam reveal the failing mechanism. The breach of the dam resulted from failing to sliding, which had been developed in three stages. This conclusion is consistent with the observed movements of the dam deduced from a persistent scattered radar interferometry deformation analysis conducted between 2003 and 2010.

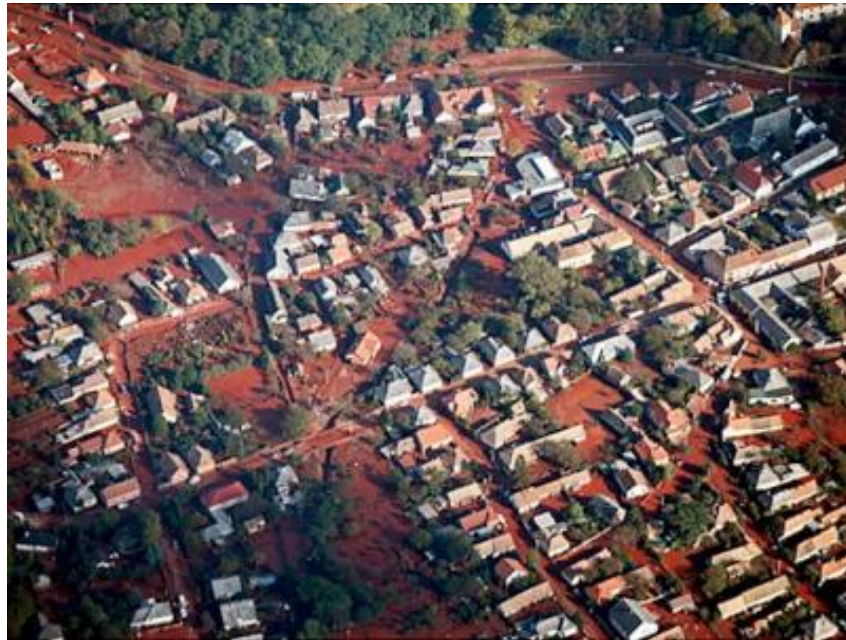
The failure of the dam occurred on October 4th around noon. The dam broke over a 50 m length, resulting in the release of 1 million  $\text{m}^3$  of highly basic sludge (Figures 1, 2). The flood of sludge killed 10 people and another 286 were injured (Banvolgyi, Gy., 2010).

**Figure 1.** The scale of the disaster: the highly toxic sludge flooded the neighboring villages in the valley of Torna. (Source: <http://www.nydailynews.com/news/world/bodies-found-hungary-toxic-red-sludge-seeped-danube-river-article-1.188733>.)

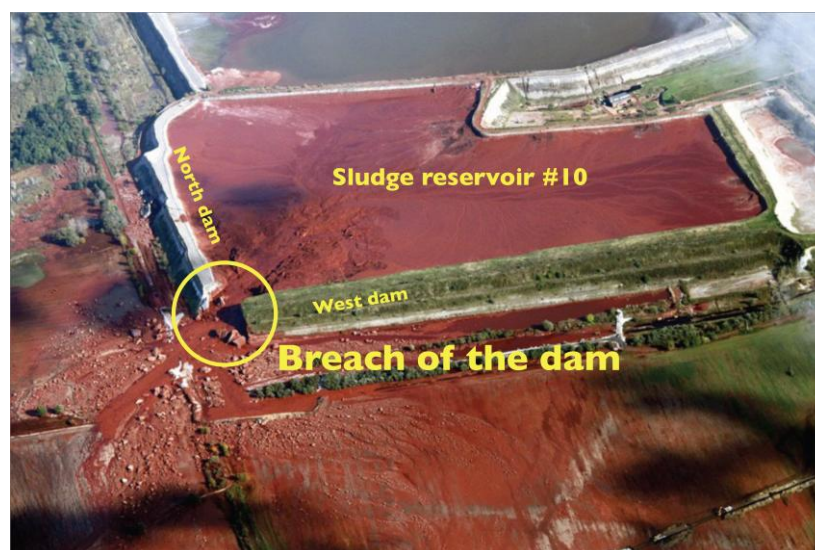
**Figure 2.** Aerial photo of the breach of the tailing dam.  
(Source: <https://www.ndtv.com/world-news/hungarys-toxic-sludge-spill-as-big-as-gulf-oil-leak-435094>.)

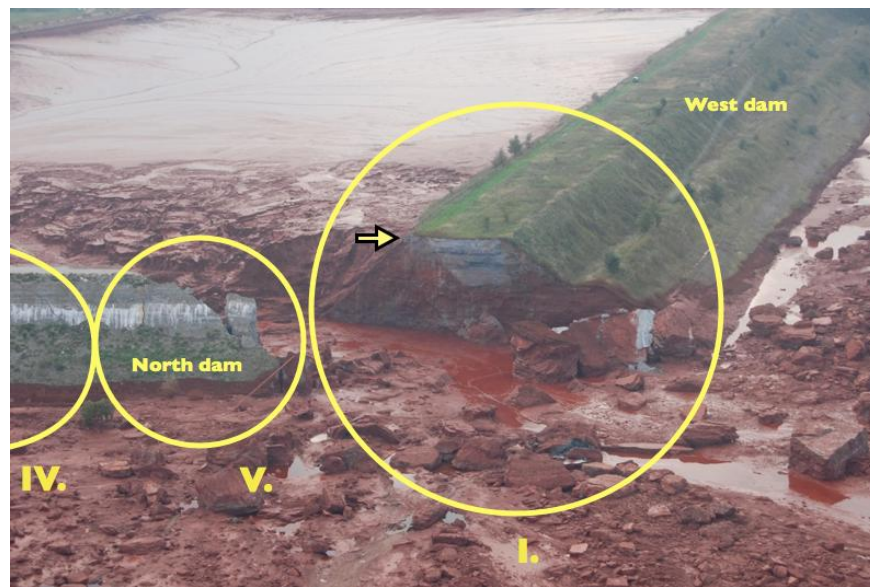
**Figure 7.** Photo showing the fracture Locations I, IV, and V. The red mark of the sludge on the open surface of the fracture at Location I is the same as the original sludge level. Thus, this fracture occurred right at the breach of the dam before the sludge level decreased in the reservoir. (Source: [https://www.aljazeera.com/photo\\_galleries/europe/20101072047436735](https://www.aljazeera.com/photo_galleries/europe/20101072047436735); <http://www.kormany.hu/en/photo-galleries/negy-eve-tortent-a-vorosizsap-katasztrof>.)

This location has one characteristic fracture ( $0_a$ ), which has been exposed at the breach (Figure 7). The fracture occurred at the corner of the North and West dams and its surface is perpendicular to the West dam. This fracture is clearly the result of tensional stress acting in the direction of the axis of the West dam. The fracture occurred at the breach because the marks of the red sludge on the exposed surface are at the same elevation as the original level in the reservoir (Figure 7). The North

dam has been detached following the development of this fracture and displaced from the West dam, creating an opening. This opening was one of the initiators of the breach. The direction of the flow channel  $F_1$  is consistent with this conclusion.

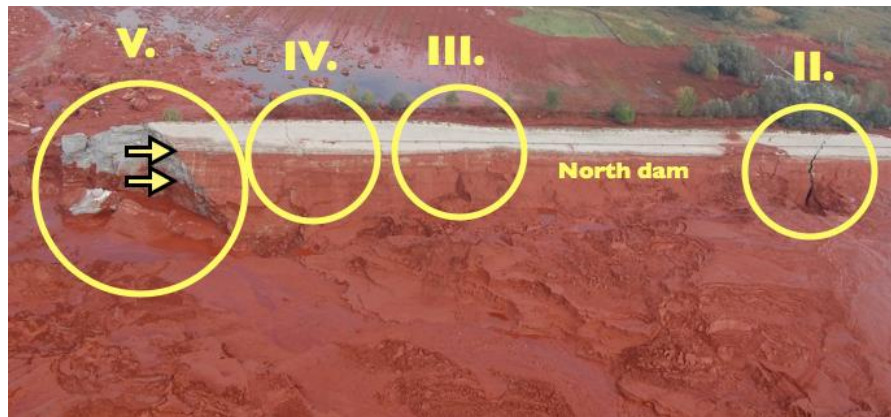
At Location V, the mark of the red sludge on the fracture (Figure 8) is lower than the original one, which indicates that this fracture occurred after the breach, when the sludge level in the reservoir was already lowered.

**Figure 8.** Photo showing fracture Locations II-V. The red mark of the sludge on the open surface of the fracture at Location V is shown. This mark is much lower than the original level in the reservoir, indicating that this fracture was formed after the breach, when the sludge level was significantly lower. (Source: <http://toleducation.org/achievements/red-legacy/>.)

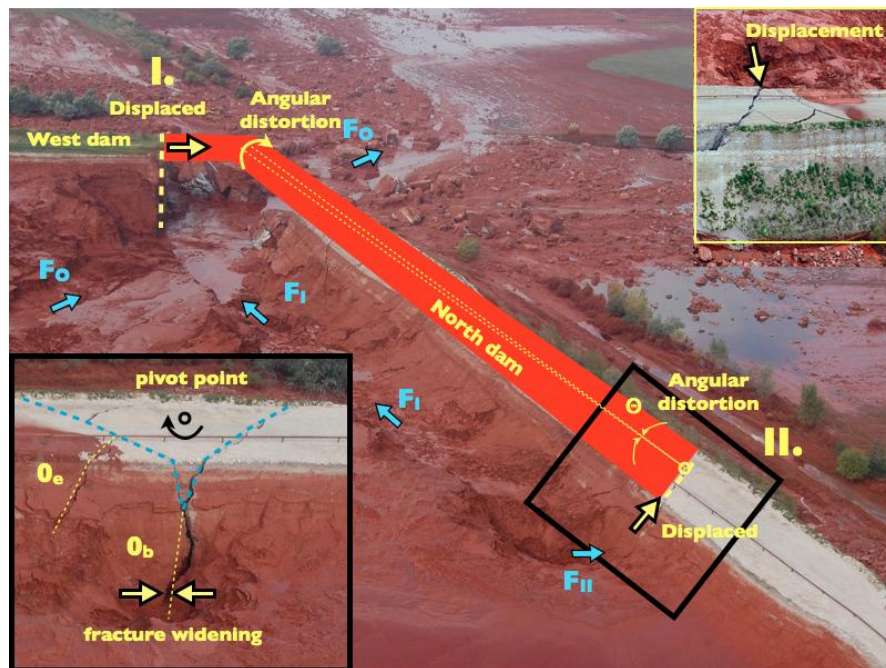
Displacements outward from the reservoir at Locations I and II of the western part of the North dam had been identified (Figure 9). The dam remained intact between these two locations; it is reasonable to assume that the entire dam section between them had been displaced. The displacements at the two ends of the failed dam section are different, which induced an angular distortion on the failed section. This distortion can be identified from the widening of the fracture at Location II (see Figure 9) and from the position of the detached pipe at Location II (see Figure 10). Thus, the failed section of the dam between Locations I and II has been displaced, and an angular distortion has been induced (Figure 9).

**Figure 9.** The failed section of the North dam is shown in red. This entire section had been displaced outward from the reservoir. Angular distortion also occurred from the bigger displacement at Location I. The widening of fracture  $0_b$  supports the angular distortion. The channels created by the outflow are visible on the surface of the red sludge. The identified flow directions ( $F$ ) are shown. (Sources: <http://www.hungarianambiance.com/2011/09/possibility-of-act-of-terrorism-cant-be.html> and <https://phys.org/news/2011-04-wildlife-largely-absent-red-sludge.html#nRlv>.)

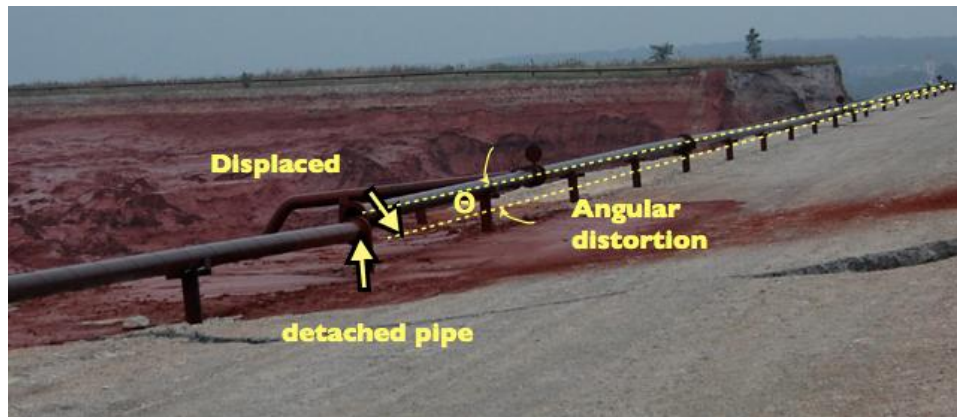
**Figure 10.** The angular distortion of the failed section of the dam can be seen from the position of the displaced broken pipe. On the failed part of the dam the pipe moved towards the reservoir despite the outward movement of the failed dam section. This indicates that the displacement resulting from angular distortion exceeded the outward displacement of the dam. (Source:

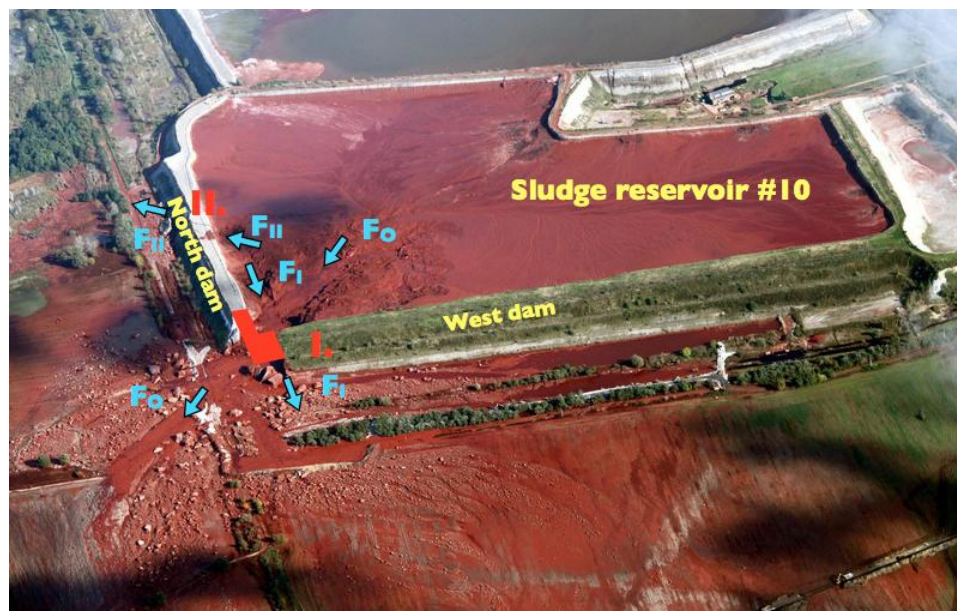
**Figure 11.** Based on the created flow channels in the red sludge, the flow directions were reconstructed. The initial flows  $F_1$  and  $F_2$  occurred at Locations I and II, pointing toward the direction of the existing fractures. The direction of flow  $F_1$  changed to  $F_0$  when the western part of the North dam had been washed away, creating a big opening. (Source: <https://www.ndtv.com/world-news/hungarys-toxic-sludge-spill-as-big-as-gulf-oil-leak-435094>.)

The flow directions pointing towards Location I ( $F_I$ ) and Location II ( $F_{II}$ ) are narrow, indicating that these were the initial flows which were active right after the breach of the dam. These channels,  $F_I$  and  $F_{II}$ , are also deeper than the third one,  $F_O$ . The bigger depth of these channels indicates that these are the initial flows, when the initial hydraulic gradient was the highest. The flow directions further confirm that the fractures developed at Locations I and II initiated the breach of the dam. The third identified flow direction ( $F_O$ ) is shallower and wider, pointing toward the direction of the biggest opening. It is concluded that the flow  $F_I$  changed its direction to  $F_O$  when part of the North dam had been washed away.

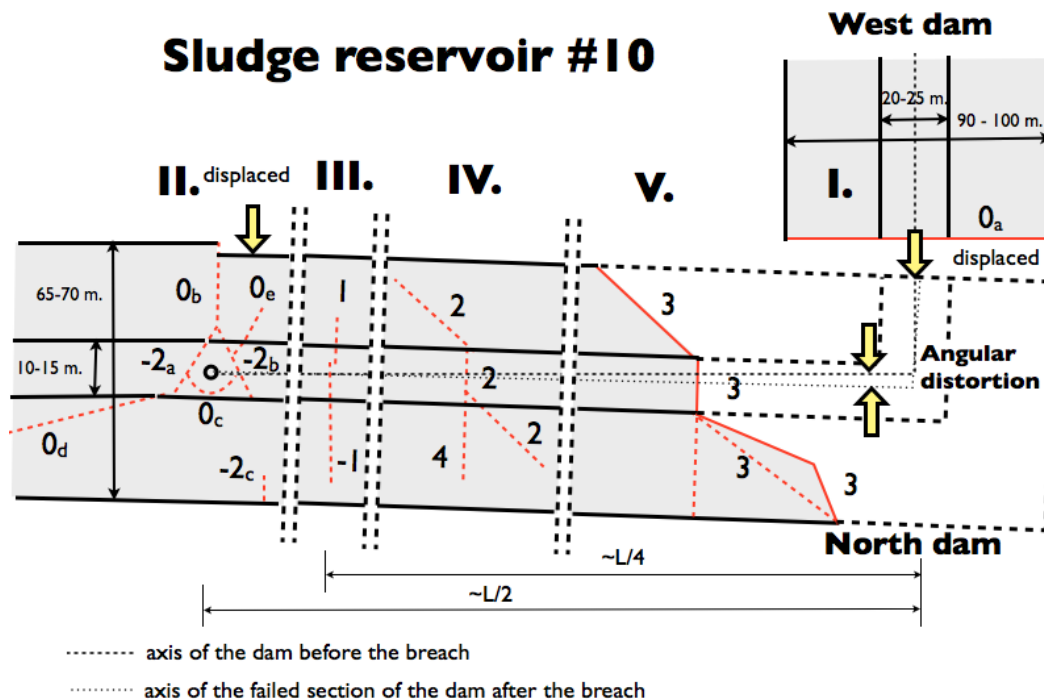
The five locations of the fractures can be seen in Figures 7 and 8. The individual fractures are numbered in the sequence of their occurrence. Minus and plus signs are used to indicate if the fractures occurred before or after the breach respectively. Number zero has been assigned to the fractures that occurred at the breach of the dam. The schematic patterns of the identified fractures and the assigned numbers are shown in Figure 12.

**Figure 12.** The sketch of the identified fractures is shown. The fractures are numbered in the sequence of their occurrence. Minus and plus signs are used to indicate if the fracture occurred before or after the breach respectively. Number zero has been assigned to the fractures that occurred at the breach of the dam.

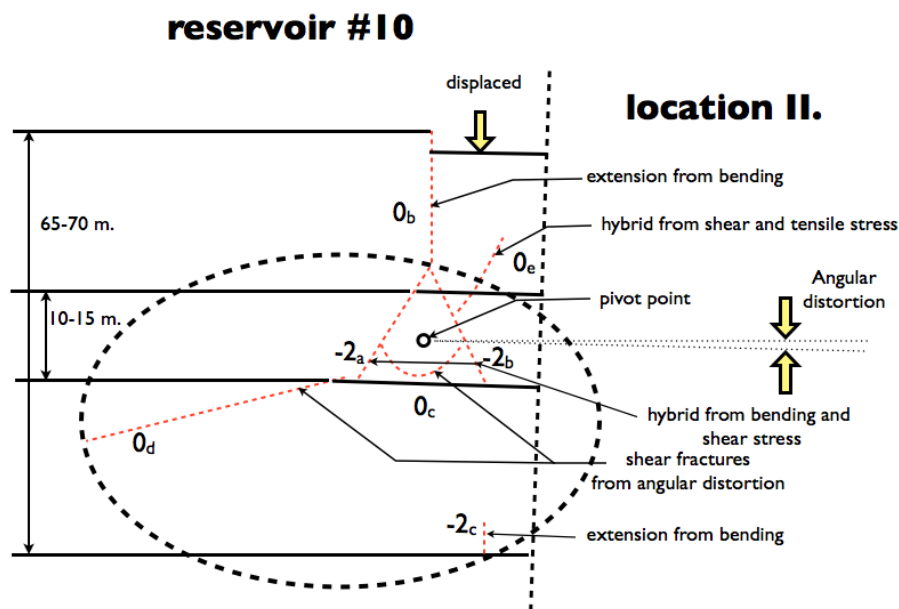
Location II is in the middle of the North dam. The fracture pattern is quite complex. Based on the fracture pattern, it can be identified that the fractures  $-2_a$  and  $-2_b$  relate to bending (Figure 6). The tension side of the bending was the outer side of the reservoir. However, on this side (outward from the reservoir), shear fractures  $0_c$  and  $0_d$  are also present, indicating compression stress on the same side (Figures 4 and 5).

**Figure 13.** The identified fractures at Location II are shown. Dashed circles mark fractures, formed from compression and tension in the same location. The coexistence of the extension and shear fractures in the same location can only be possible if the stress conditions changed in time.

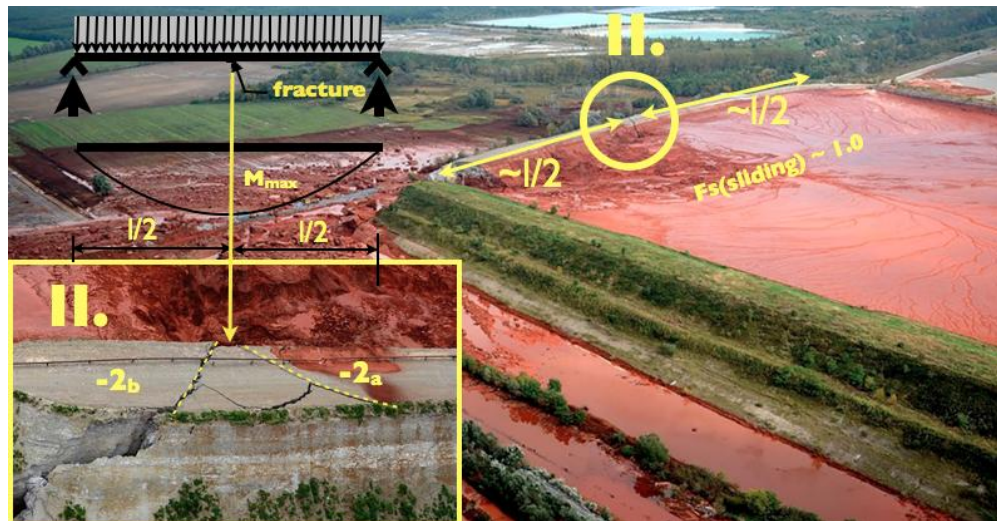
The coexistence of compressional and tensional stresses at the same side of the dam is possible only if the stress conditions changed in time. At the breach, displacement and angular distortion occurred. These movements should develop compression stress on the outward and tensile stress in the inward side and shear stress. The bending related fractures  $-2_a$  and  $-2_b$  are not consistent with the stress condition at breaching, which indicates that these fractures  $-2_a$  and  $-2_b$  were already present when the breach occurred. The fracture pattern  $-2_a$  and  $-2_b$  is an indicative of failing from bending (Figure 6), which developed from the pressure of the red sludge acting from the reservoir site on the dam. The bending related fracture pattern is further supported by the location of the fractures, which is in the middle of the North dam, where the maximum bending moment should occur in a beam subject to uniform load (Figure 14).

**Figure 14.** Location II is at the middle of the North dam, where the bending moment has its maximum under uniformly distributed load. The fracture pattern (Figure 6) and the location suggest that these fractures (-2a, and -2b) occurred from the bending. These fractures were formed before the breach of the dam. (Sources: <http://toleducation.org/achievements/red-legacy/>; <http://www.hungarianambiance.com/2011/09/possibility-of-act-of-terrorism-cant-be.html>.)

The allowable angular distortion in buildings is  $1/300$  (Skempton and MacDonald, 1956). In masonry or concrete structures, fractures start to develop when the angular distortion exceeds this value, which might be too conservative for the dam because its material is not as rigid as these building materials. Using this conservative value on the approximately 500 m long dam, many decimeters of displacement in the middle of the dam were required to develop these fractures. Thus, the dam suffered a very significant deformation before the breach. The displacement occurred in the horizontal direction, indicating that, at the time of the fracture formation, the resistance against sliding was already exhausted. The developed fractures (-2<sub>a</sub> and -2<sub>b</sub>) reduced the bending moment at Location II close to zero, and the dam did not fail.

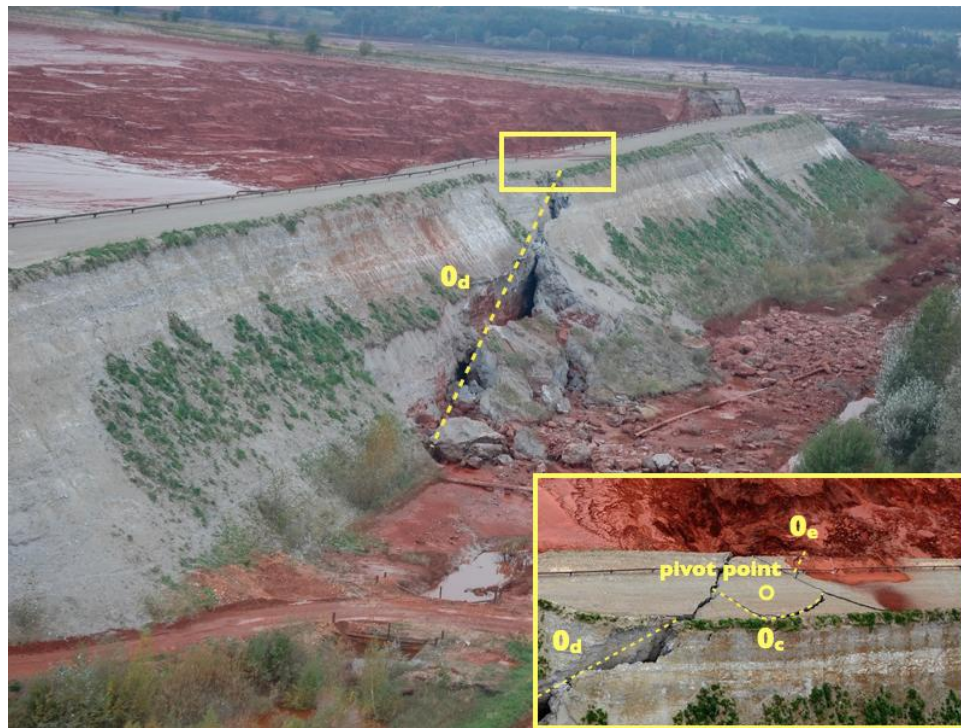
The last straw leading to the breach of the entire dam section was when the tensional resistance of the West dam was exhausted. The dam, whose sliding resistance had already been exhausted, had been detached at fracture 0<sub>a</sub> and the dam moved outward from the reservoir, activating the preexisting bending fractures at Location II. The displacement also induced an angular distortion which generated tensile and shear stresses on the reservoir side, resulting in fractures 0<sub>b</sub> and 0<sub>c</sub> respectively. The angular distortion of the dam produced compression stress at the outward site of the reservoir, which resulted in the development of shear fractures 0<sub>c</sub> and 0<sub>d</sub> on the outward side of the dam (Figure 15). The detachment occurred along the extension fracture (0<sub>b</sub>) (Figure 9), and the preexisting fracture -2<sub>a</sub> (Figure 14). Fracture 0<sub>c</sub> (Figure 9) is a hybrid fracture caused by extension (angular distortion) and shear stresses (displacement).

**Figure 15.** Shear fractures ( $0_c$  and  $0_d$ ) caused by compressional stress at Location II are shown. These fractures were formed at the breach, resulting from the angular distortion of the failed dam section. On the opposite (reservoir) side, at the same time, extension fracture  $0_b$  occurred (Figure 9), extending the existing fracture of  $-2_b$ . (Sources: <https://www.nbcnews.com/slideshow/toxic-red-sludge-floods-towns-near-budapest-39514793>; <http://www.hungarianambiance.com/2011/09/possibility-of-act-of-terrorism-cant-be.html>).

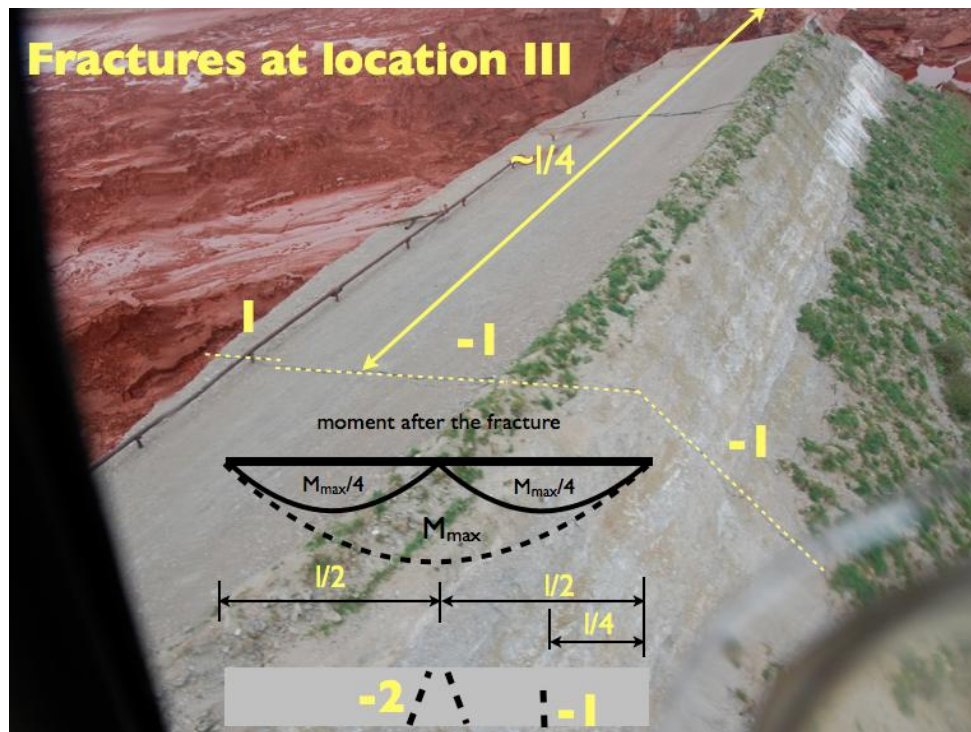
There are two independent fractures (1 and -1) perpendicular to the axis of the North dam. Based on the fracture direction, it is concluded that these fractures are the result of tensile stress acting in the direction of the axis of the dam (Figure 4). Both of these fractures resulted from bending, but there is a time gap between their occurrences. Following the development of fractures  $-2_{a,b}$  at Location II, the maximum bending moment shifted from the middle of the dam to 1/4 of the length of the dam, which is where Location III is (Figure 16). The tensile strength relating to the bending moment of sludge pressure caused fracture -1 at the outward side of the dam. This failure occurred before the breach of the dam. At this weakened cross section, the angular distortion occurring at the breach and the additional flow pressures after the breach led to the development fracture 1 on the opposite side.

Figure 16. The location and the shape of fracture -1 is shown. Both the location and the shape of the rupture indicate that the failing was caused by bending. Following the formation of fractures -2 at Location II, the maximum moment was formed at Location III, resulting in the fracture of -1. (Source: <http://www.hungarianambiance.com/2011/09/possibility-of-act-of-terrorism-cant-be.html>.)

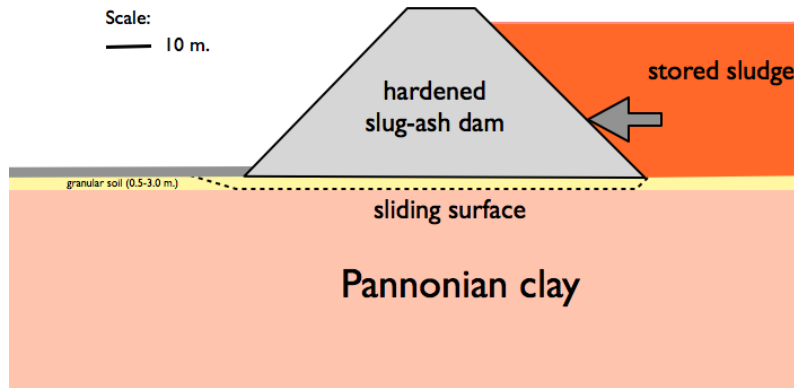
The granular soil (sandy gravel) under the dams, with its weight and its bearing capacity at the toe of the dam, increased the resistance against sliding. Thus, the failure of the dam occurred where the thickness of the granular soil is the smallest (Ndagijimana, 2019). This conclusion is consistent with the failed section of the dam, where the granular layer was the

thinnest (0,5 m) under the dam (Farkas et al., 2013). The dams with a bigger cross section had additional weights, which prevented the sliding failure, even though the resistance against sliding was nearly exhausted.

**Figure 18.** Schematic cross section of the soil profile and sliding surface of the failing is shown. The high pH and the cation exchange weakened the internal friction of the clay on the surface of the layer. The increasing horizontal pressure of the sludge on the dam led to the sliding failure of the dam along this weak resistant layer. The weight of the granular layer and its bearing capacity at the toe of the dam increased the resistance against sliding. Thus, failure of the dam occurred where the thickness of the granular layer was the thinnest.
