# Images Collected from the Internet Reveal the Failing Mechanism of the Tailing Dam Breach at Kolontar, Hungary

**ABSTRACT:** *The failure of the red sludge tailing dam at Kolontar in 2010 was the most severe environmental disaster in the history of Hungary. The official investigations are confidential because the legal case has not been closed. The publicly accessible information from the breach of the dam are the photographs taken by the media and news agencies. Collecting these images and analyzing the recorded fractures and displacements of the dam reveal the failing mechanism. The breach of the dam resulted from failing to sliding, which had been developed in three stages. This conclusion is consistent with the observed movements of the dam deduced from a persistent scattered radar interferometry deformation analysis conducted between 2003 and 2010.*

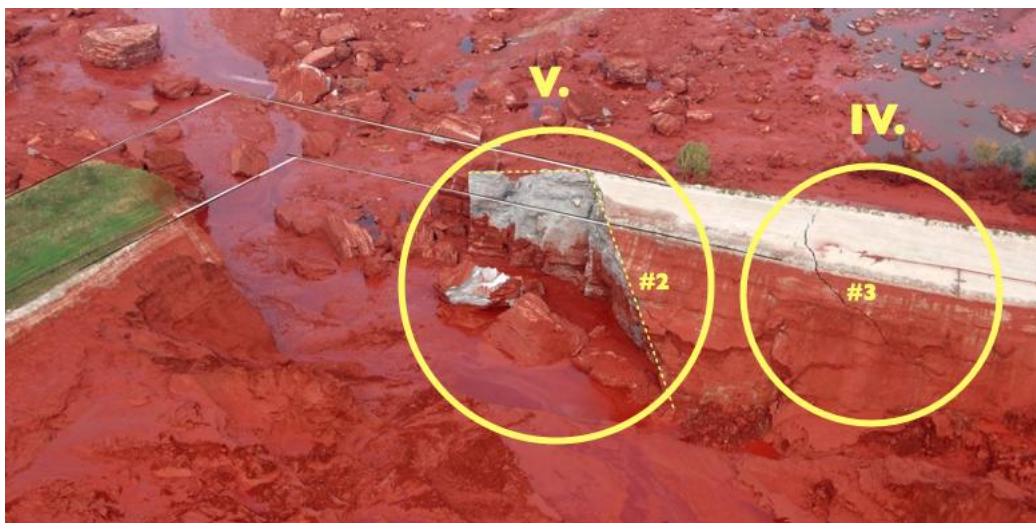
The fracture pattern of these sites shows hybrid failure (Figure 17).

Figure 17. The fractures at Locations IV and V are hybrid fractures caused by the outflowing pressure of the red sludge and the additional settlement. These fractures occurred after the breach of the dam and they have no relevance to the failing of the dam. (Source: [https://commons.wikimedia.org/wiki/File:Ajka\\_accident\\_d7df9fea08\\_b.jpg](https://commons.wikimedia.org/wiki/File:Ajka_accident_d7df9fea08_b.jpg).)

If the fractures at Locations IV and V existed before the breach, then the transformation of the force and the torque would be very limited beyond these locations. Elimination of the torque would not allow the development of the angular distortion beyond Location IV or V. Thus, these fractures at Locations IV and V were formed after the breach. The mark of the red sludge on the surface of fracture 2 also shows that this failing occurred after the breach when the level of the red sludge was reduced from its original elevation (Figure 8). The widening of fracture 3 towards the top of the dam indicates that additional angular distortion in the vertical direction occurred, most likely resulting from the outflow of the sludge, which washed out the soil below the dam section at the opening. The settlement of the dam section led to the development of the extension fracture 4. All fractures at Locations IV and V had been developing after the breach of the dam; therefore, these fractures have no relevance to the breach. The list of all the fractures, as well as the type and the cause of the respective failure, is given in Table 1.
