Lack of Maintenance Compromises Tunnel Structural Safety

ABSTRACT: *The Chekka tunnels represent a critical section of the Northern Lebanon Highway. The approximately 350-m long twin tunnels are the most important tunnels in the country. They are used by regular and freight traffic and are a vital link to the capital, Beirut. The tunnels were completed in the early 1970s on the eve of the Lebanon civil war. Given the state of affairs in the country for about two decades of strife, the tunnels were not maintained nor did they undergo any regular inspection. This unique condition of near-abandonment continued up until recently, when the first signs of distress were documented. These consisted of severe and extensive cracking, particularly in the portal approach of the southbound tunnel, along with significant deterioration of the tunnel lining and radial section joints. The danger to traffic and, potentially, to the structure itself was evident. In this paper, the results of an extensive site inspection and evaluation program are presented. The underlying causes of the observed damage are analyzed and discussed using a modeling approach of the progressive loading conditions. Remedia

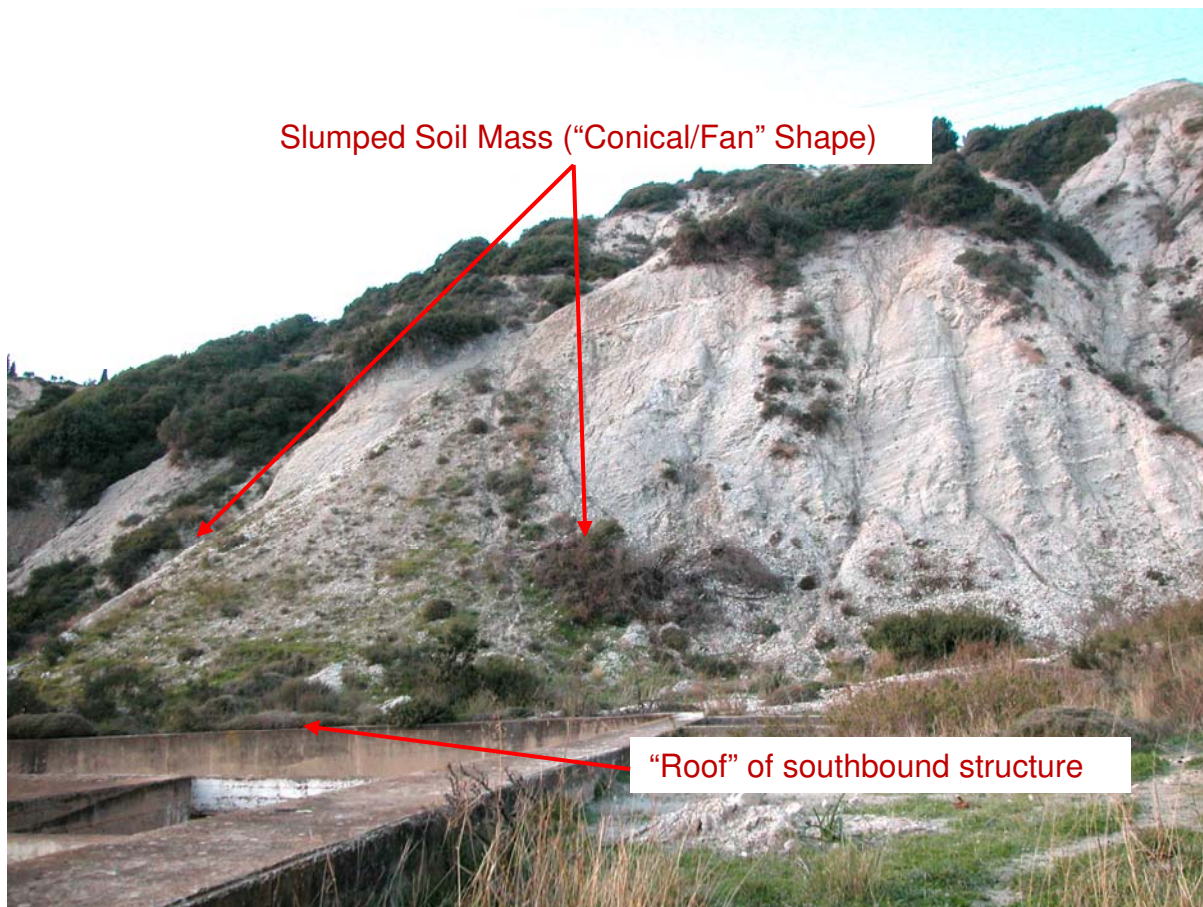
Figure 3. Slumped Soil Mass Loading the Top of the Southbound Tunnel Exit Structure.

1. “Soil 1”, is characteristic of the slumped mass above the southbound tunnel cross-section (Fig. 3). This soil type is characterized by relatively low values of the Menard modulus, dry density and unconfined compressive strength.
2. “Soil 2” is typical of the soft marlstone layers. This material is typical of materials in a band 4 to 6 m thick as evidenced in boreholes BH-1, BH-2, and BH-5.
3. Finally, the third type is the intact marly-limestone rock of the Chekka Formation.

1. Controlling surface water flow and improving drainage around structure area.
2. Removal of the slumped mass on top of the southbound tunnel exit structure and the provision of long-term stability and erosion control measures to eliminate the possibility of recurrence. These provisions included the installation of rock bolts/nails with a high strength steel wire mesh facing (Fig. 13 and Fig. 14). A program for regular inspection and maintenance of the structures was also developed.

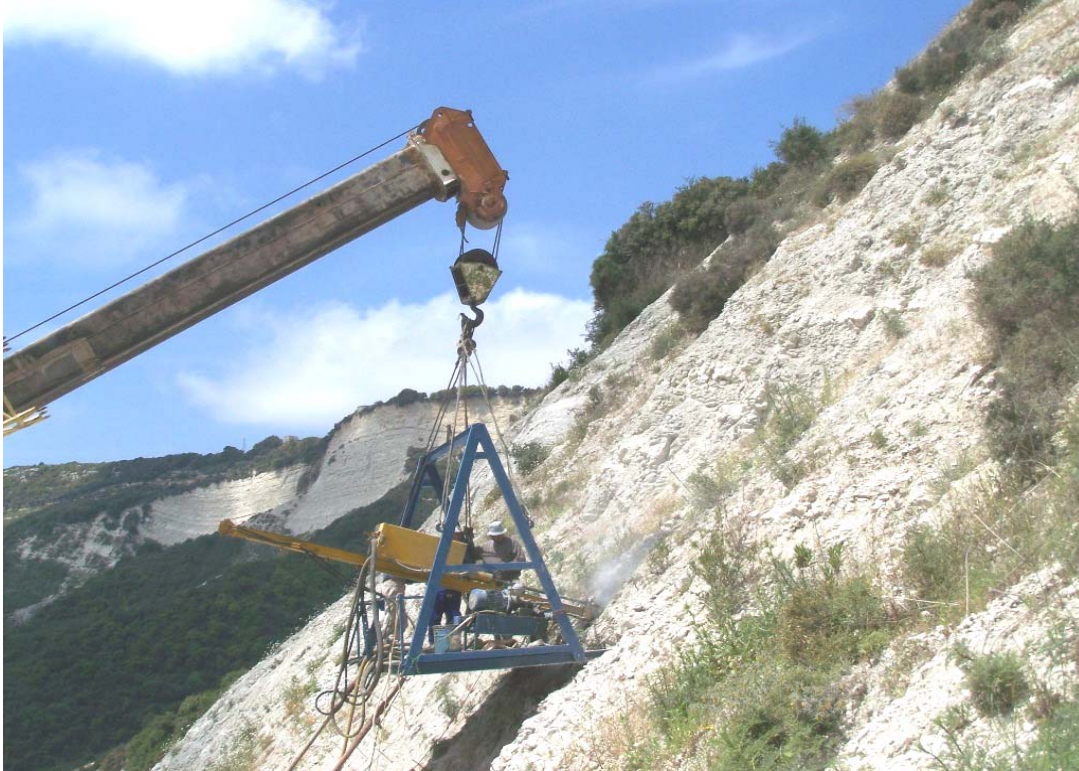
Figure- 13. Installation of the Nails/bolts Along the Western Slopes.

3. Repair and rehabilitation of the distressed structural elements including jacketing and repair of the eastern outer wall and the provision of passive nails/rock bolts on the western wall, tying into the parent intact rock, thus reducing pressures on the wall and lateral deformations.

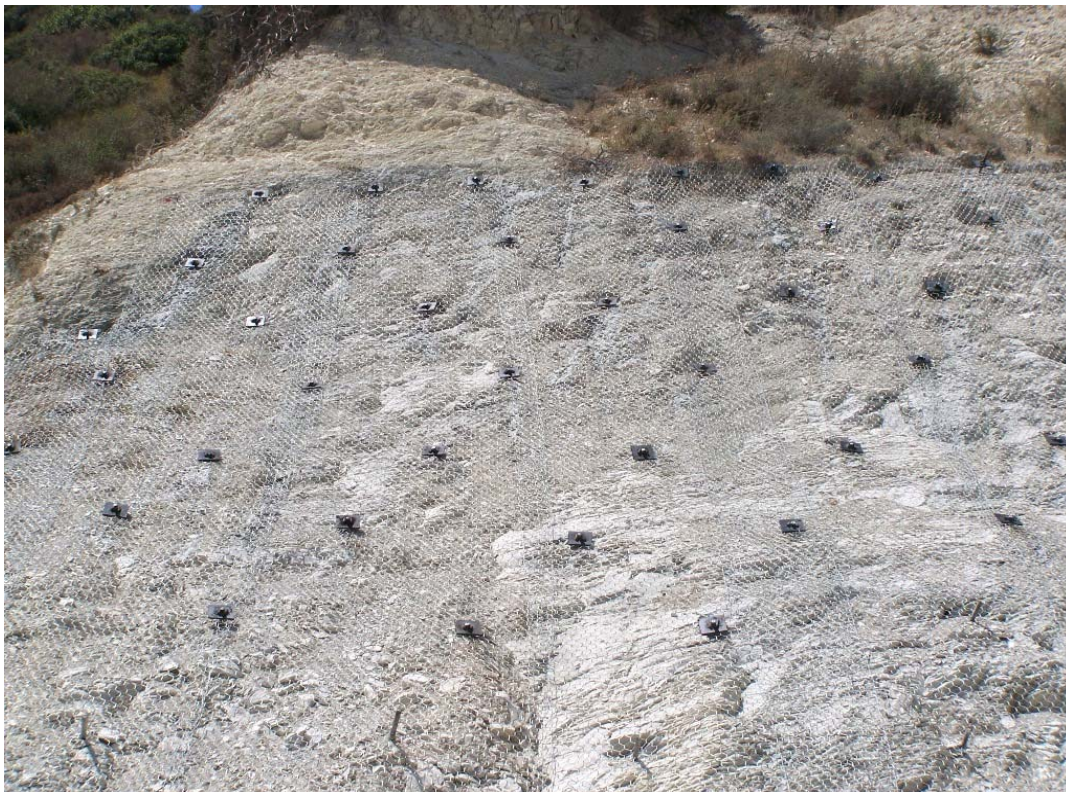
Figure 14. Completed Rock Bolts/nails and Wire Mesh Installation Along the Western Slope.
