## The July 10 2000 Payatas Landfill Slope Failure

**ABSTRACT:** *This paper presents an investigation of the slope failure in the Payatas landfill in Quezon City, Philippines. This failure, which killed at least 330 persons, occurred July 10<sup>th</sup> 2000 after two weeks of heavy rain from two typhoons. Slope stability analyses indicate that the raised leachate level, existence of landfill gas created by natural aerobic and anaerobic degradation, and a significantly over-steepened slope contributed to the slope failure. The Hydrologic Evaluation of Landfill Performance (HELP) model was used to predict the location of the leachate level in the waste at the time of the slope failure for analysis purposes. This paper presents a description of the geological and environmental conditions, identification of the critical failure surface, and slope stability analyses to better understand the failure and present recommendations for other landfills in tropical areas. In addition, this case history is used to evaluate uncertainty in parameters used in back-analysis of a landfill slope failure.*

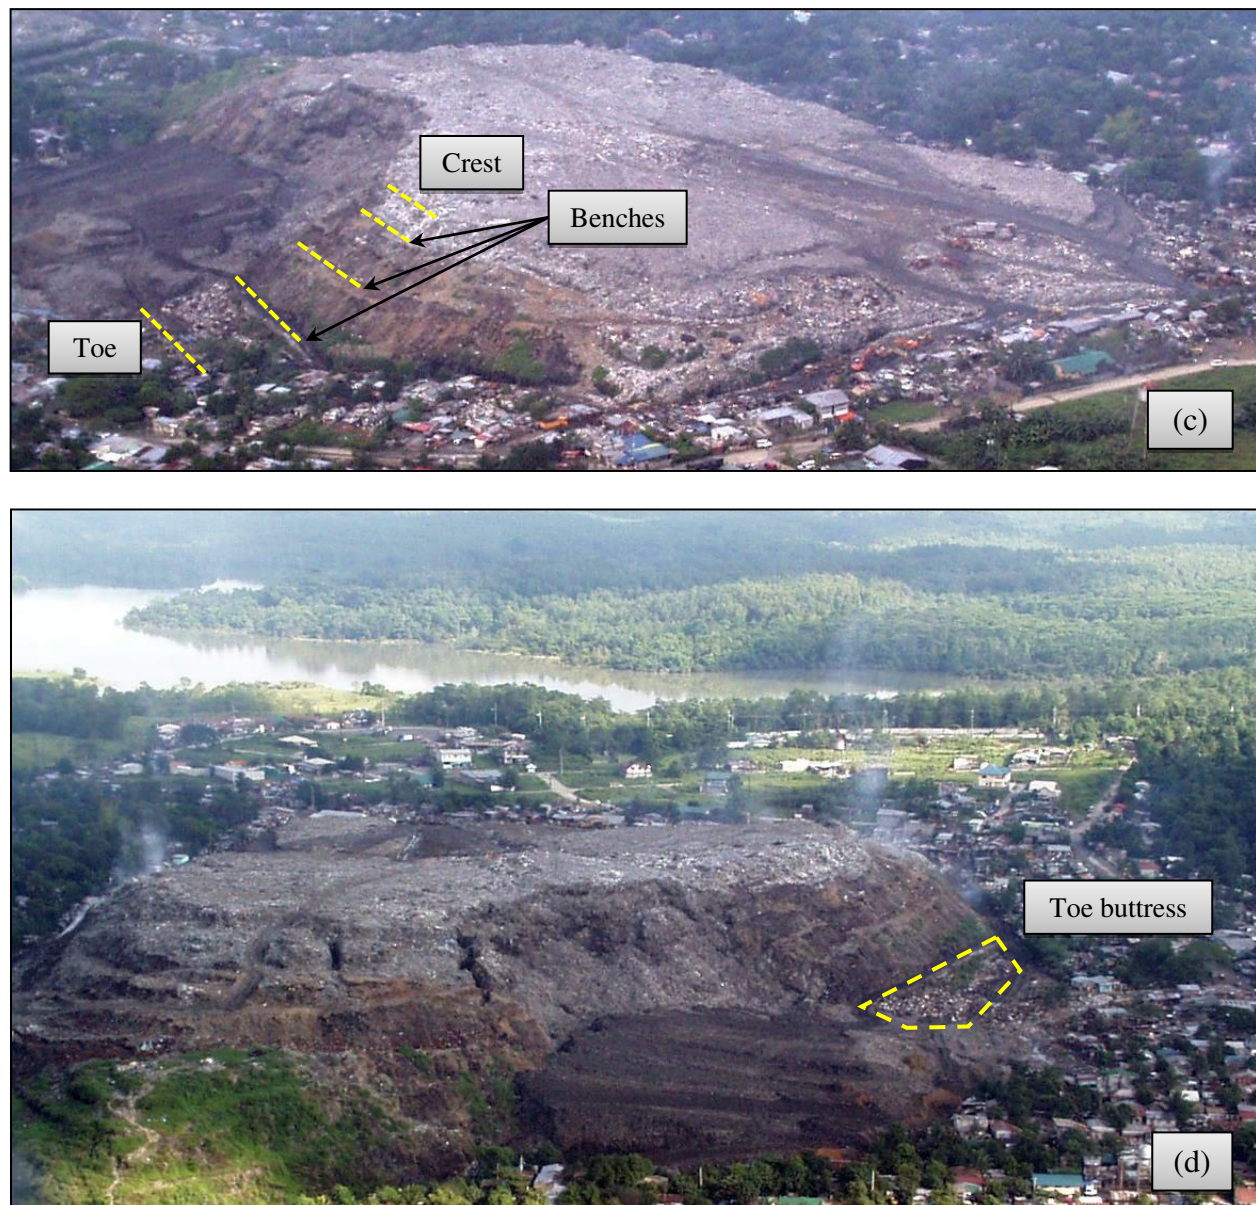
Figure 6 shows a series of aerial views of the waste slide area that were used to understand the failure surface for use in the stability analyses. Figures 6(a) and 6(b) provide side views from the southeast and northwest direction, respectively, of the waste slide. Figure 6(c) highlights benches in the landfill slope, and Figure 6(d) delineates a mildly sloped toe buttress. Digital measurements from these photographs were used to create the cross-section shown in Figure 7. These measurements indicate toe buttress slope angles in the slide area of 1.4H:1V ( $\sim 35^\circ$ ) to 0.84H:1V ( $\sim 50^\circ$ ) and steeper side slopes above the buttress that range from  $60^\circ$  to  $70^\circ$  (Bautista, 2007; UNFCCC, 2007). Additionally, site reconnaissance and pictures both indicate that leachate was seeping from this toe buttress.

Figure 6. Slope geometry and failure surface after failure (a) evidence of seeping leachate, (b) representative slope inclination, (c) location of slope benches, (d) toe buttress (photos by S.M. Merry).

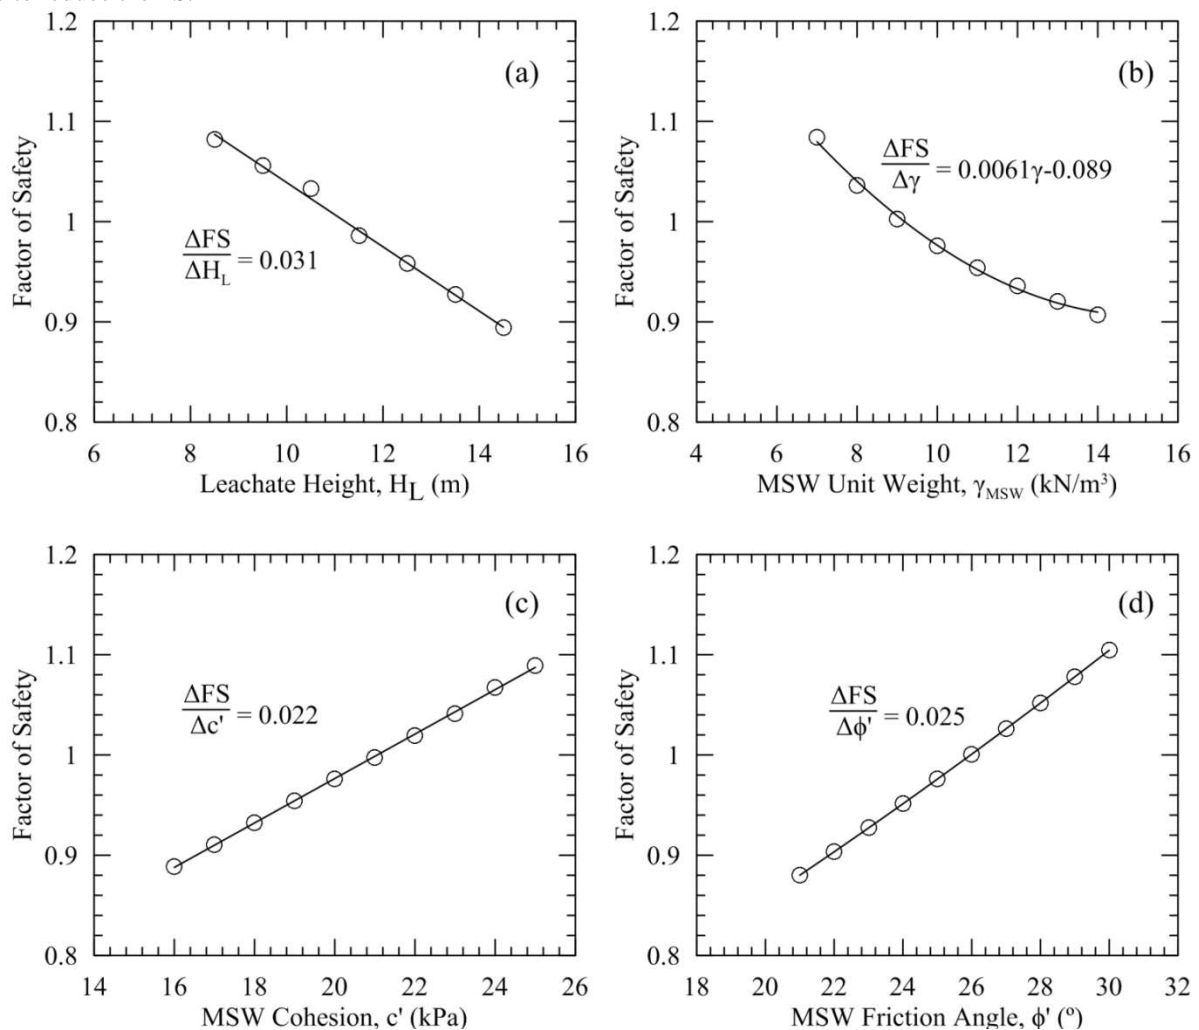
Using site reconnaissance information, pictures, and reports of the wasteslide, an inverse analysis was conducted to estimate the piezometric level at the time of failure. Figures 14(a), 14(b), 14(c), and 14(d) show the sensitivity of the factor of safety for a range of MSW shear strength parameters, MSW unit weight, and leachate level. For each sensitivity parameter, the factor of safety was computed using the circular failure surface in Figure 11(a). In Figure 14, the trend line slope is used to capture the sensitivity of FS to each parameter. For example, Figure 14(a) shows that FS decreases by 0.031 for a 1 m increase in leachate level. Using the trend line slopes for each parameter, the contributing factors leading to failure can be compared. MSW unit weight can increase when rain infiltrates into the waste mass and increases moisture content. The sensitivity of MSW unit weight is a nonlinear relationship shown in Figure 14(b). Figures 14(c) and 14(d) indicate that reducing MSW cohesion and friction, i.e., slopes equal to 0.022 and 0.025, respectively, contributes less to failure than increasing the leachate height (slope=0.031). Thus, Figure 14 suggests that leachate height has the greatest influence to reduce the FS.

Figure 14. Sensitivity of Inverse analysis to MSW input parameters for FS of unity.
