# A Large Scale Landslide in a Coal Mine in Marly Formations: Evaluation, Analysis and Rehabilitation

**ABSTRACT:** *This paper describes a large scale landslide in a coal mine in Servia area in Kozani, Greece, which occurred in February 2011. The landslide, of ~250m width and ~350m length, took place in marly lacustrine sediments. The main factors for the manifestation of the landslide were a temporary interruption of works, the existence of a specific weak surface, the clayey nature and the sensitivity of marl to environmental agents, the action of water and the large slope height. Due to the magnitude and the position of the failure, a geotechnical solution was proposed that involved rearrangement of ground masses. The proposed solution led to successful rehabilitation and unimpeded continuation of the exploitation process.*

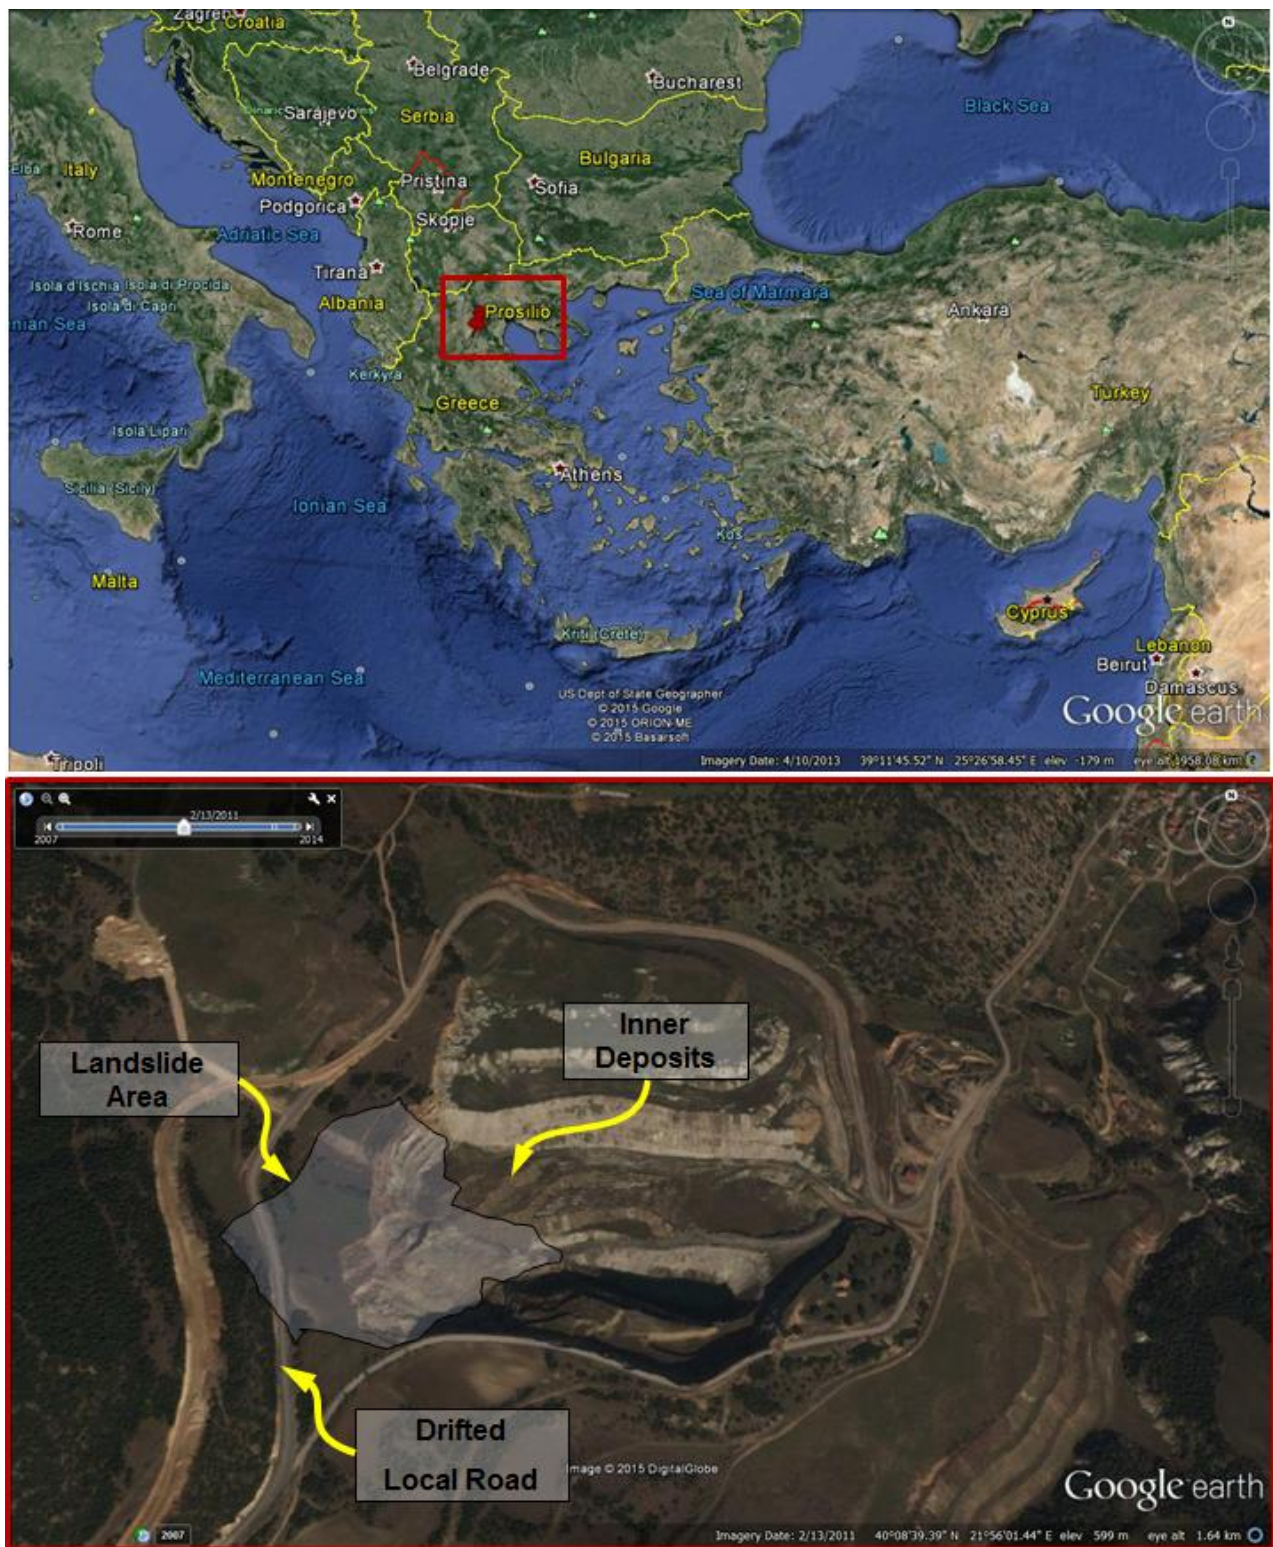
Figure 1 includes a demarcation of the position of the landslide, together with an aerial photo of the coal mine, only few days before the landslide. The landslide area, the local road affected by the landslide and the initially placed deposits for lateral retaining action to the mine slope are indicated on the satellite photo.

Figure 1. Position of landslide (up – red pin inside the red rectangle) and aerial photograph of the coal mine 2 weeks before the landslide (down). The area that was later occupied by the landslide is indicated with the transparent shape.

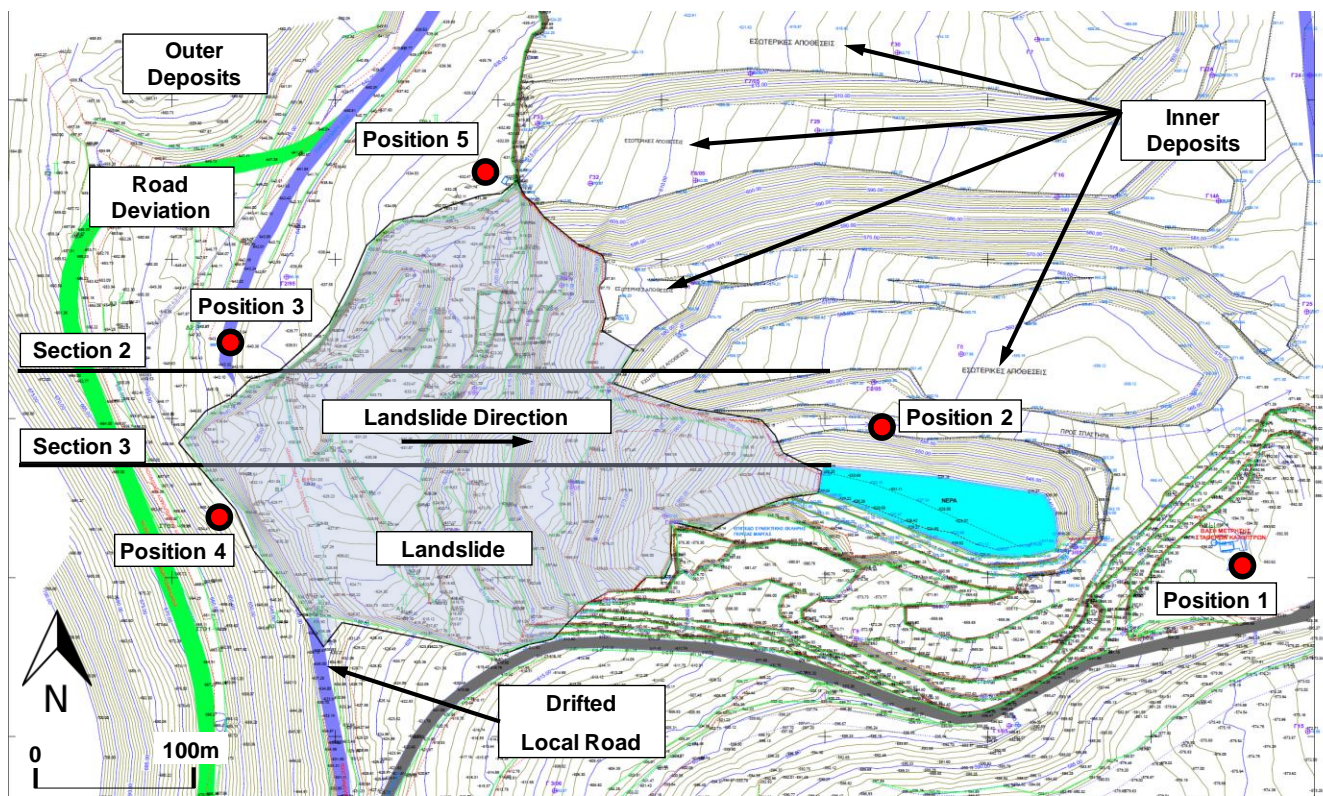
Figure 2 shows a plan view of the landslide area, with demarkation of the main features of the incident, as mentioned or referred to in the present paper. After examination of historical, geometrical and geotechnical data provided by the exploitation contractor, in-situ inspections and evaluation of the available information, it was concluded that the factors that played an important role in the initiation and triggering of sliding movement and the evolution of the landslide were:

Figure 2. Topographic mapping (plan view) of the coal mine after the landslide with demarkation of some key features

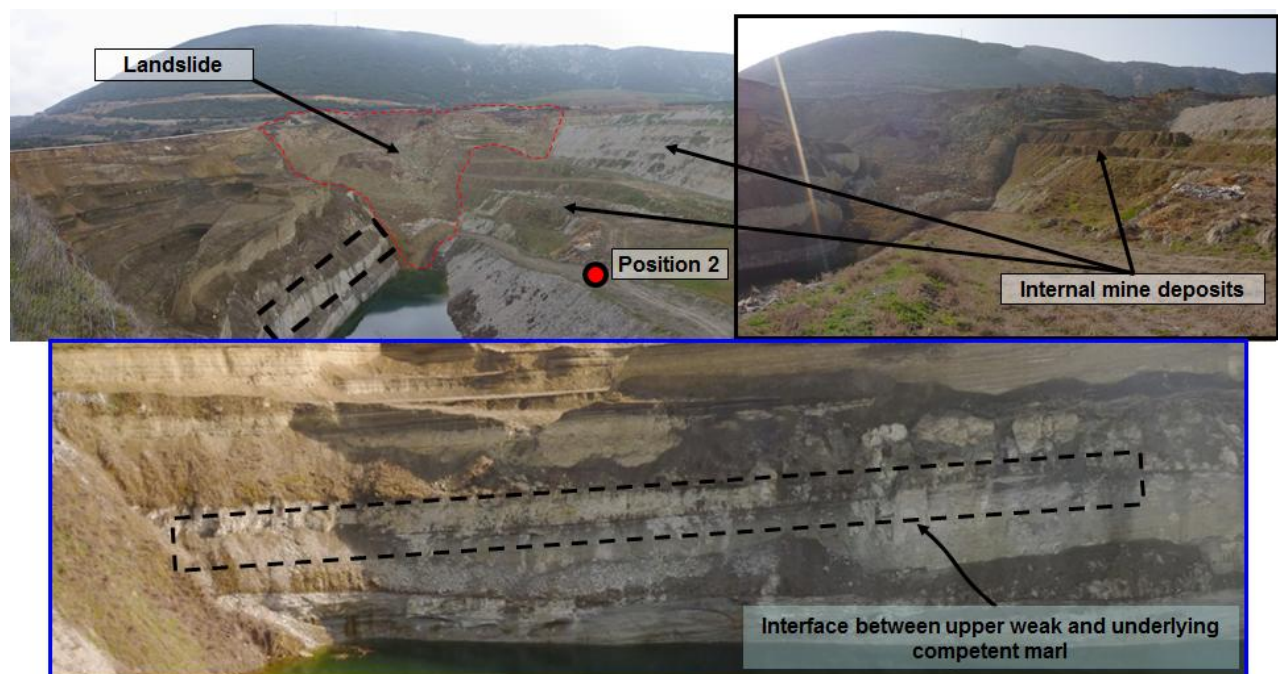
Figure 3 illustrates a general aspect of the landslide from its E and NE side (Positions 1 and 2 in Figure 2) and a view of the contact surface between the weak and the competent marl, which played a major role in the landslide manifestation. Figure 4 illustrates various aspects of the landslide and its main features.

Figure 3. Aspect of the coalmine and the landslide from Position 1 (upper left), the landslide from Position 2 (upper right) and the contact surface between the weak and the competent marl (bottom)

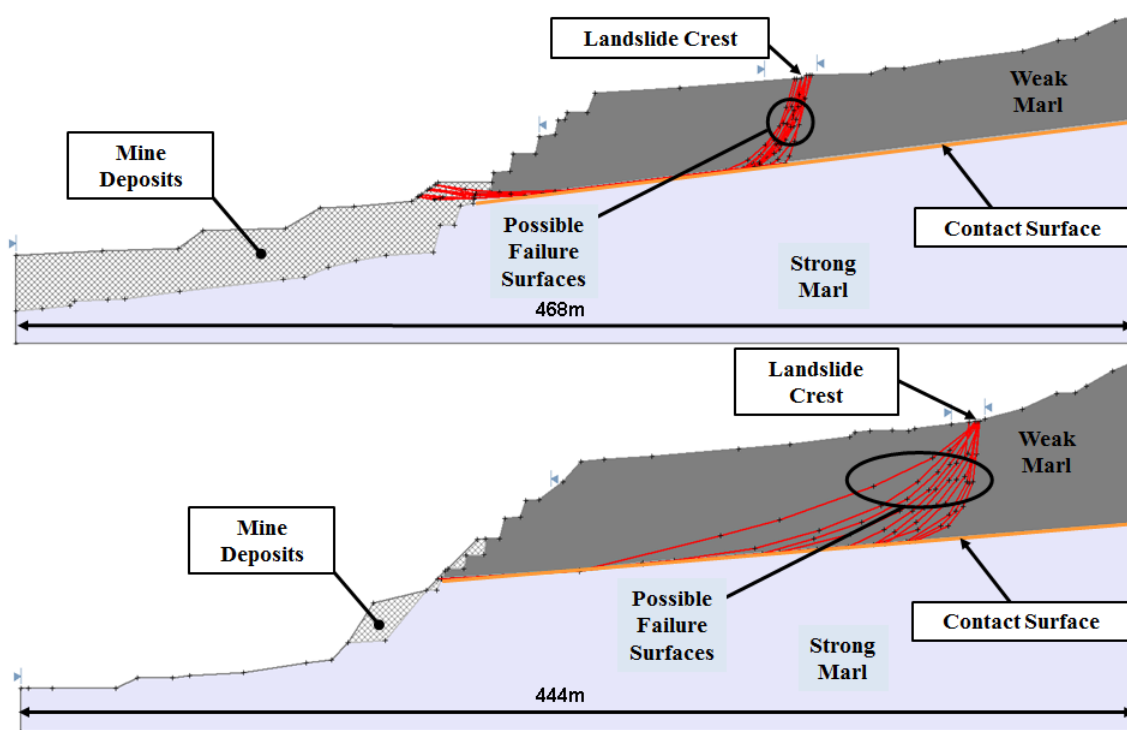
1. After in-situ inspection and study of available surveying mapping, conclusions were reached concerning the general shape of the failure surface along Section 2 (subvertical near the crest) and Section 3 (with more gentle slope near the crest). Based on these conclusions, a set of possible failure surfaces was considered for each Section, with varying inclination and part of the surface passing through the weak marl formation and along the contact surface between the weak and the competent marl.

Figure 5. Analysis Section 2 (up) and 3 (down). Slide software model.

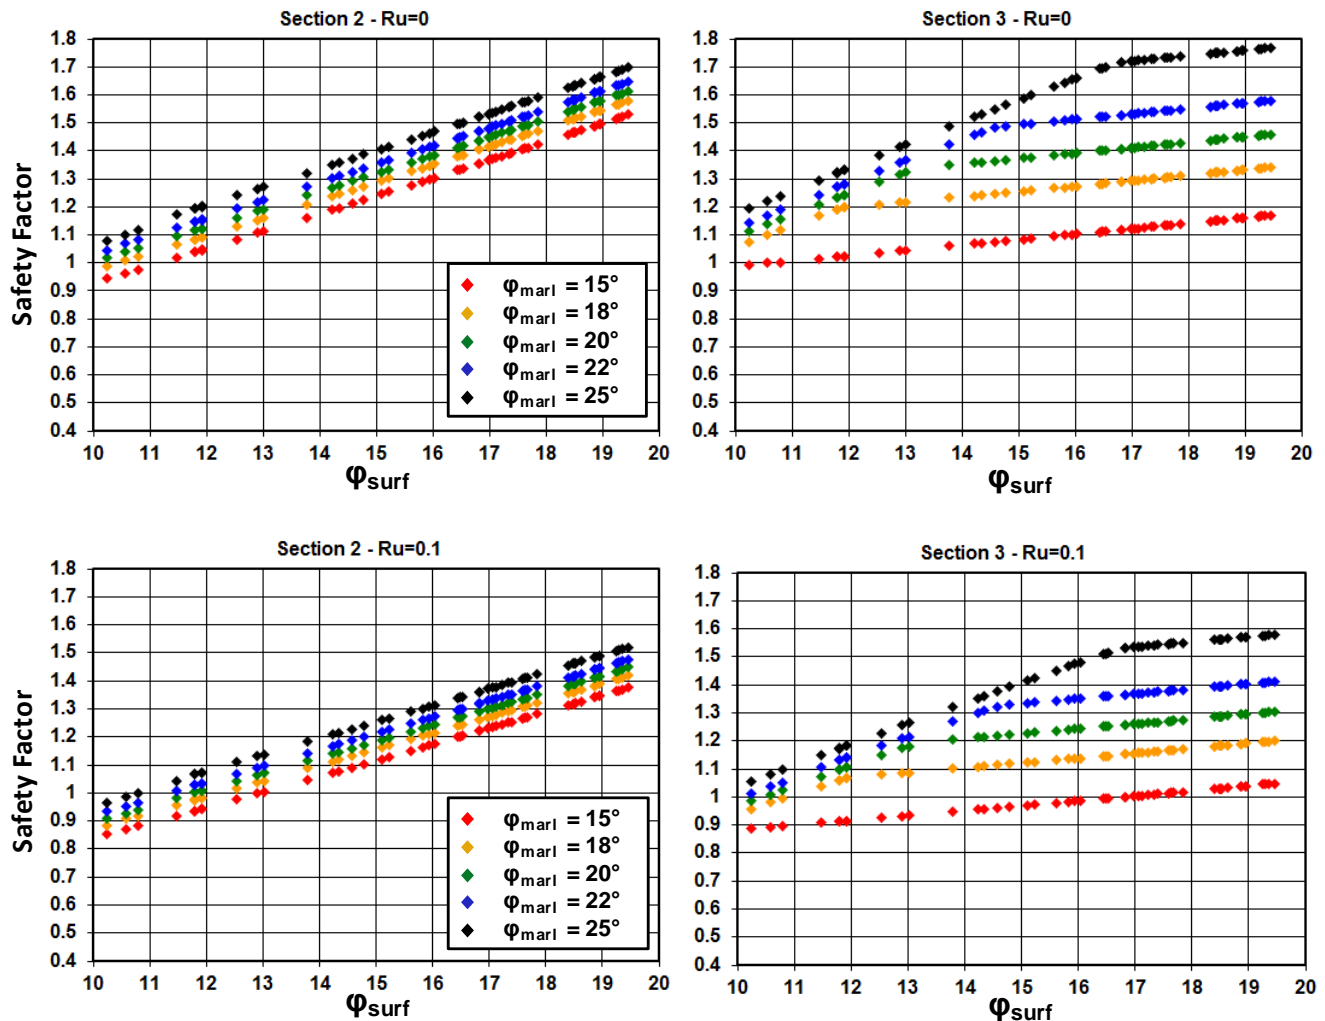
2. Values of the safety factor for values of pore pressure ratio  $R_u=0-0.1$  generally lie above unity for both Sections analyzed (see Figure 6), especially for  $\phi_{surf} > 13^\circ$  and were therefore excluded. This result was actually anticipated, since water seemed to have had a major role in the landslide triggering.

Figure 6. Variation of safety factor for different values of  $\phi_{marl}$  and  $\phi_{surf}$  for  $R_u=0.0$  (up) and  $R_u=0.1$  (down), as computed for Section 2 (left) and Section 3 (right)

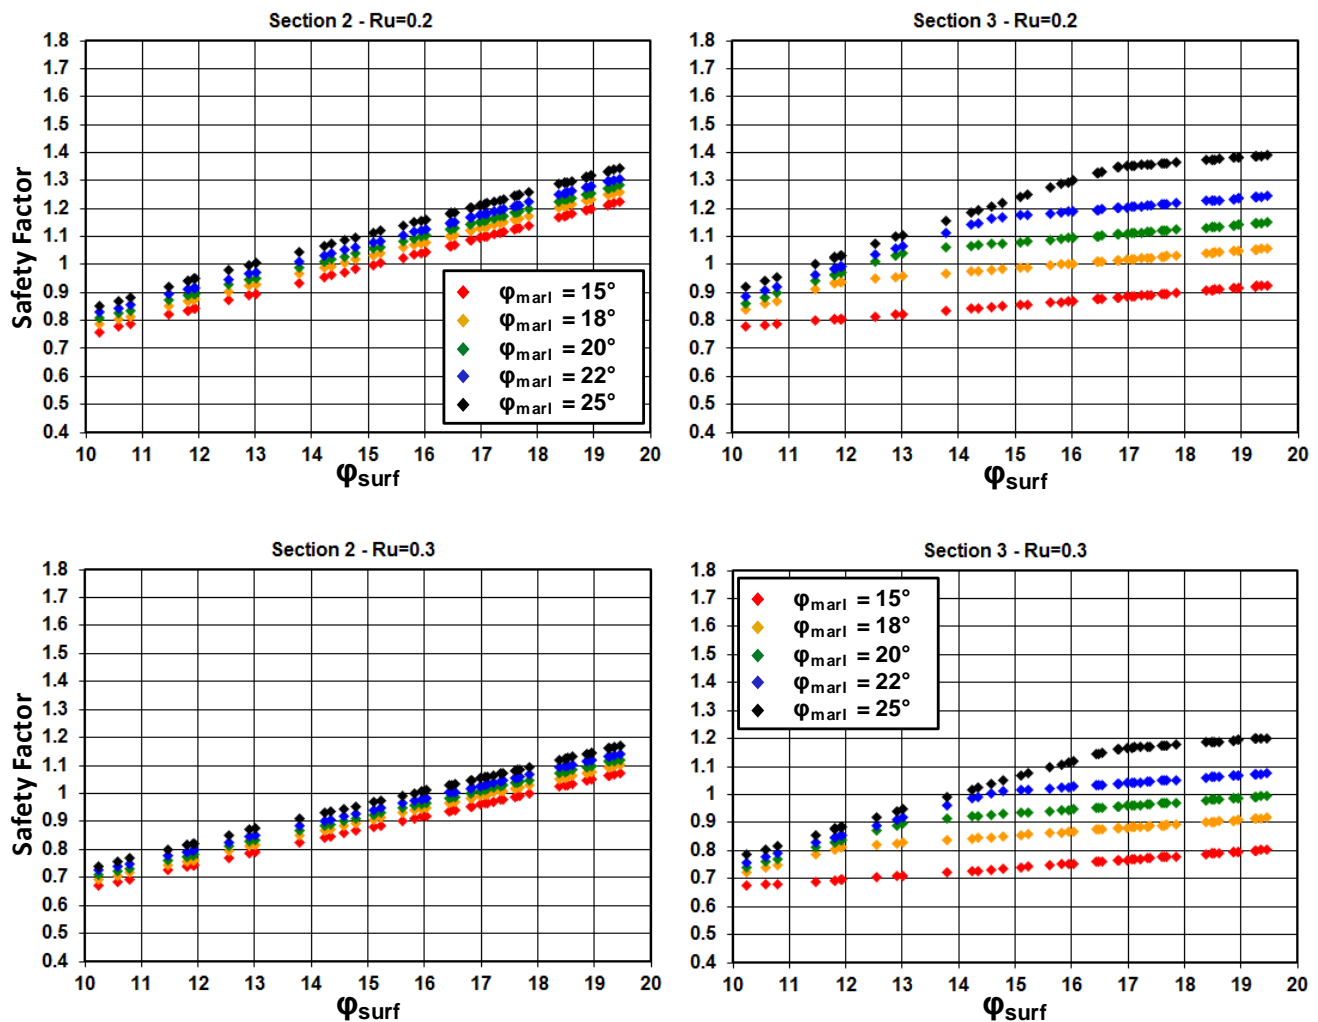
Figure 7. Variation of safety factor for different values of  $\phi_{marl}$  and  $\phi_{surf}$  for  $R_u=0.2$  (up) and  $R_u=0.3$  (down), as computed for Section 2 (left) and Section 3 (right)

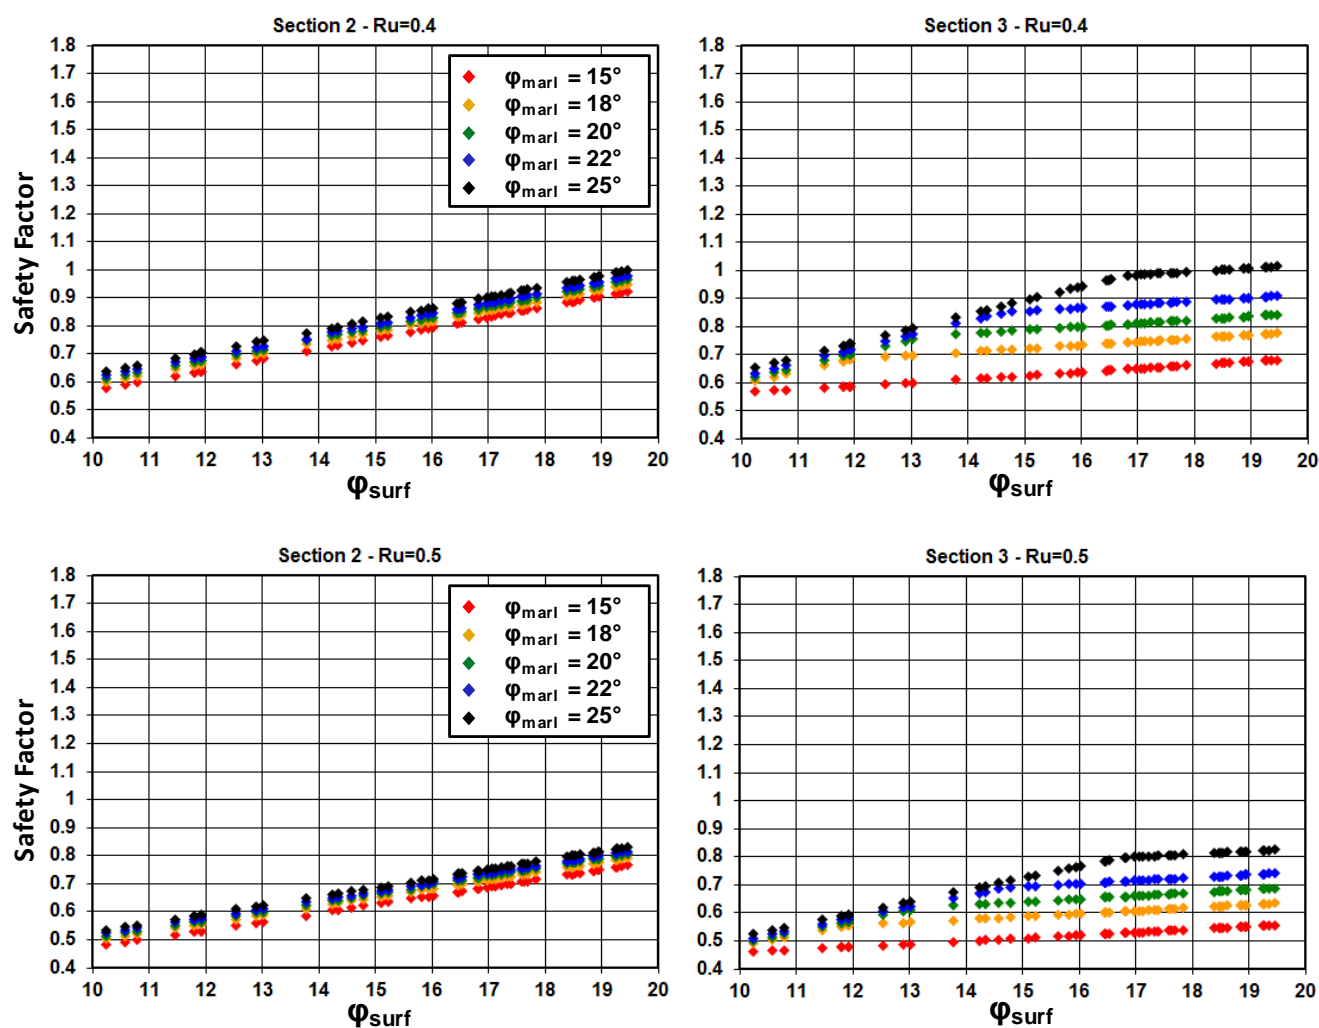
3. Values of the safety factor for values of the pore pressure ratio  $R_u=0.4-0.5$  were generally well below unity for both analysis Sections (see Figure 8), especially for  $\phi_{surf} < 17^\circ-18^\circ$  and were not considered likely. Values of the safety factor for  $\phi_{surf} > 18^\circ$ , given the nature of the specific surface and the fact that are assumed to refer to residual strength, were not considered reasonable.

Figure 8. Variation of safety factor for different values of  $\varphi_{marl}$  and  $\varphi_{surf}$  for  $R_u=0.4$  (up) and  $R_u=0.5$  (down), as computed for Section 2 (left) and Section 3 (right)

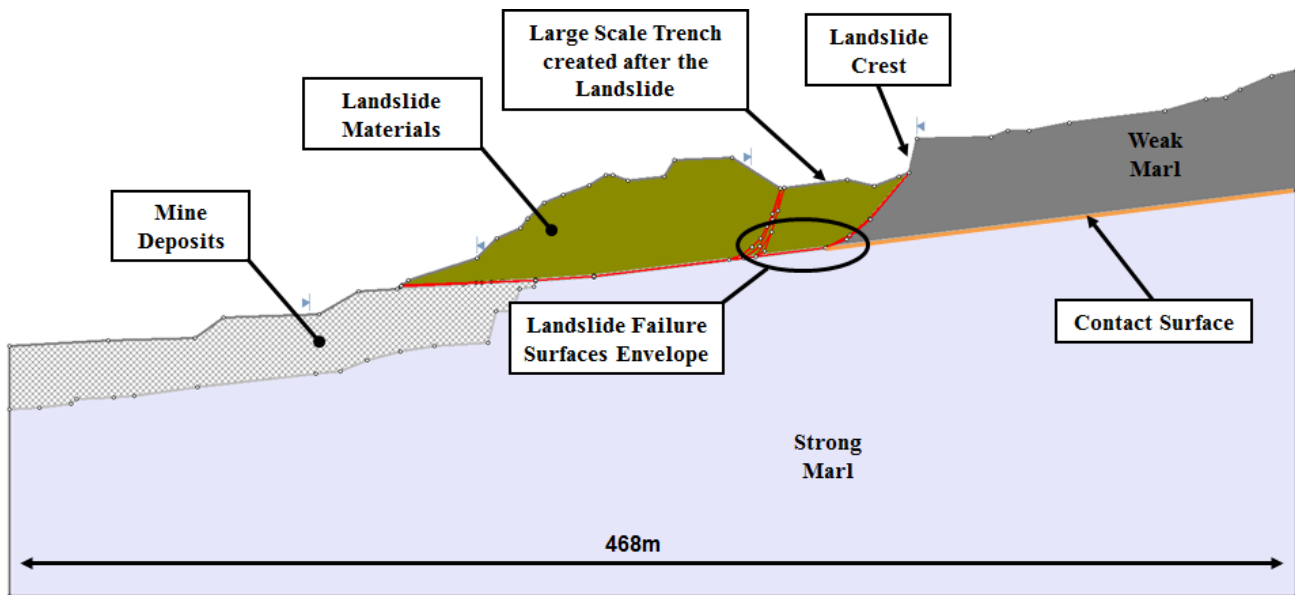
Figure 9. Analysis Section 2 after the landslide

The relevant analyses yielded results of the safety factor between 1.06 and 1.11, which were considered marginal, given the possible further deterioration of the shear strength of the materials involved in the slides, due to ongoing movements, especially during the rainy season in the area. Specifically, analyses of Section 2 resulted in a minimum value of the safety factor equal to 1.11, whereas the corresponding minimum value from Section 3 was 1.06. Analyses with free selection of surfaces by the software were not performed, as these would yield unrealistically low values of the safety factor (considerably  $<1$ ), under the assumption that the total mass included in the landslide envelope had been downgraded to its residual strength (zero cohesion and low friction), which was not the case due to monolithic, undisturbed blocks existing within the slid mass. The fact that the resulting safety factor values were rational, i.e. marginally larger than unity, indicating a temporarily stable situation after a main landslide event, enhanced our confidence in the assumptions that were made.

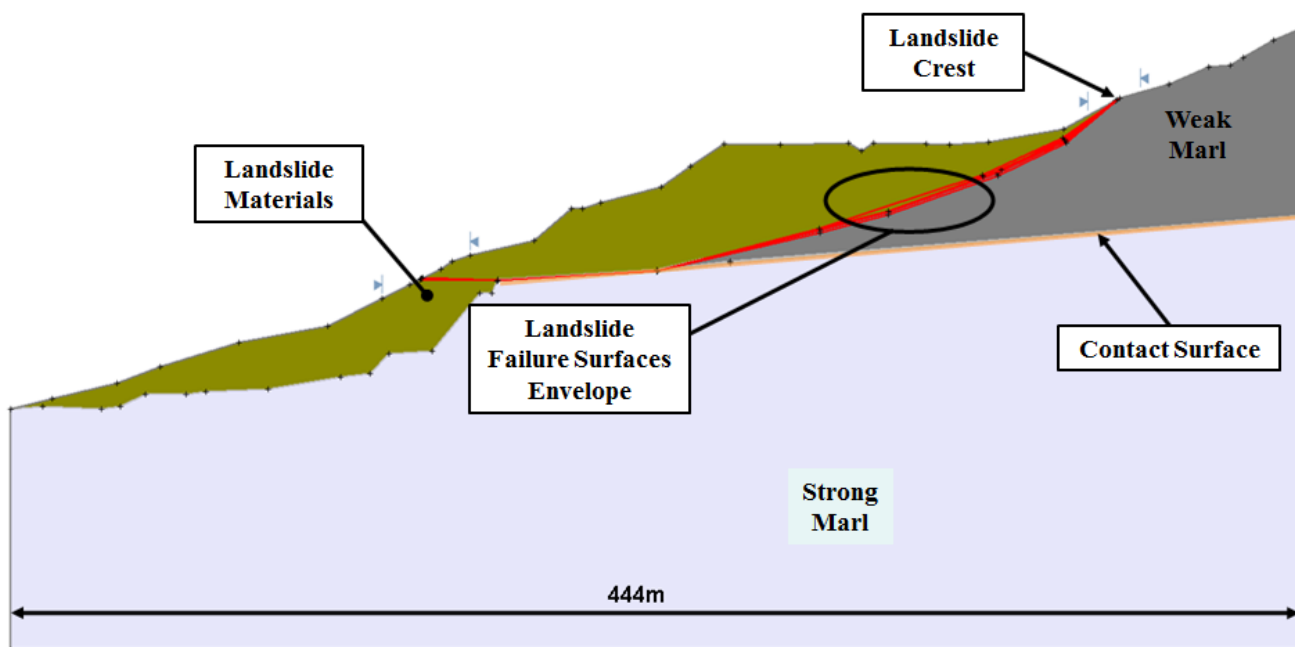
Figure 10. Analysis Section 3 after the landslide

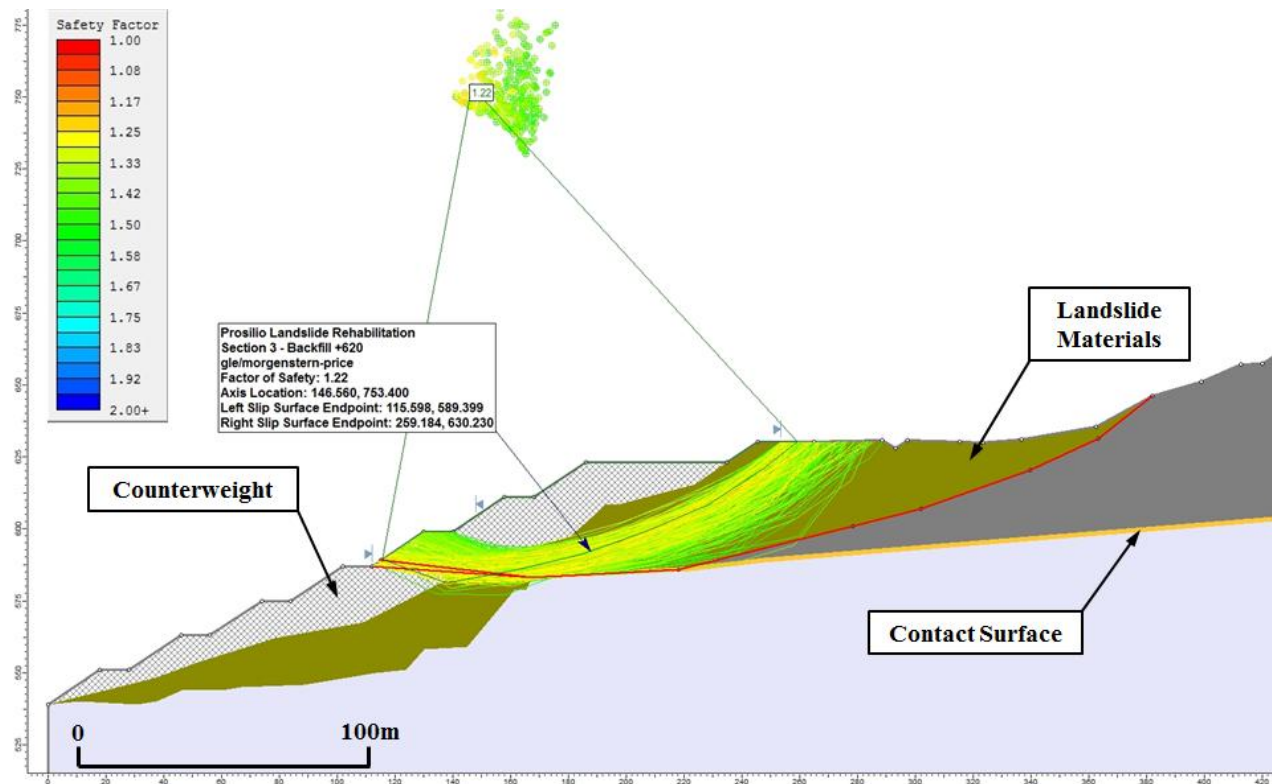
Figure 12. Analysis Results for Section 3 with backfill at the toe up to elevation +620 (  $F.S. = 1.22$  )

2. Placement of non commercial deposits at the toe of the landslide up to an elevation approximately 35 m above the contact surface between the upper weak and the underlying competent marl ( $\sim +620$  m absolute elevation), did not significantly differentiate the safety factor. Specifically, considering the envelope of the landslide or surfaces along obvious large scale movements within the total landslide mass as potential failure surfaces, the computed values of the safety factor ranged between 1.56 and 1.70. Assuming that any failure surface within the total landslide envelope was possible, the safety factor ranged between 1.22 and 1.57. Therefore, it was shown that the additional placement up to the specific level was only to facilitate the landslide removal and exploitation procedures and was not necessary for the stabilization of the landslide. In fact, locally, due to the existing geometry and morphology of the landslide, this additional placement could somehow reduce the available safety factor, as part of the deposits would actually increase the sliding moment for certain potential failure surfaces (pose additional loading to the landslide - see Figure 12 above).

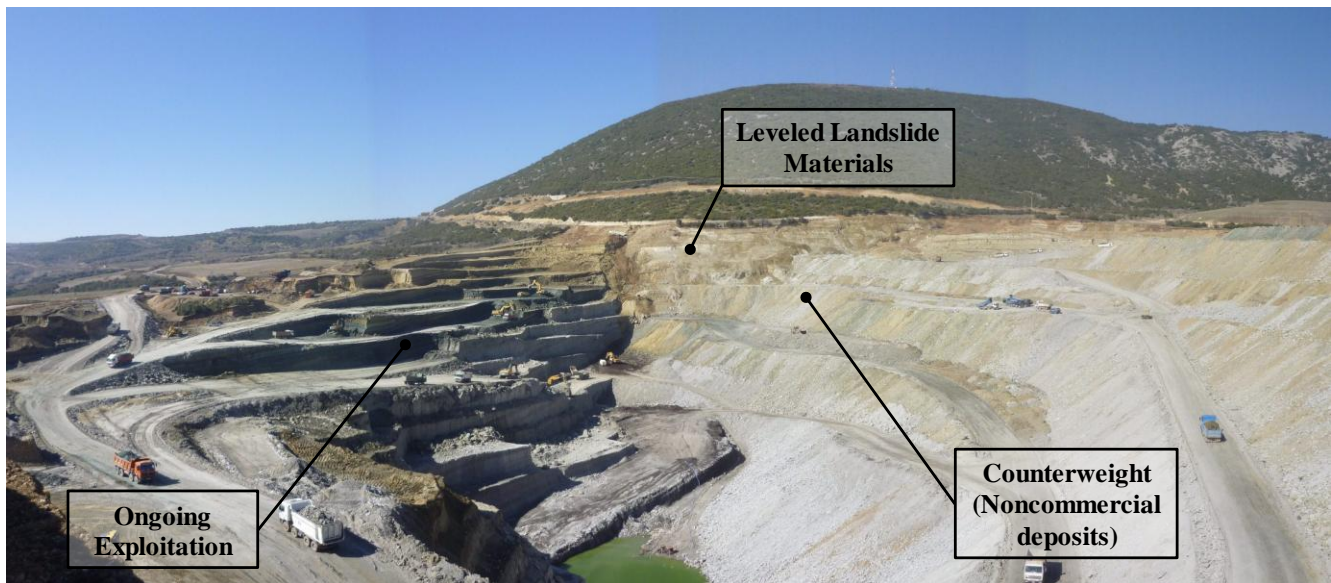
Figure 13. Aspect of the coal mine area after completion of counterweight construction and leveling works (March 2012).

The proposed rehabilitation scheme was successfully applied in order to stabilize the landslide before any intervention to its mass. The operation of the coal mine has continued without significant instability incidents ever since. The following figures show an aerial photo of the coal mine area and an aspect of the same from within the mine area, after completion of landslide counterweight construction and leveling of the landslide materials.

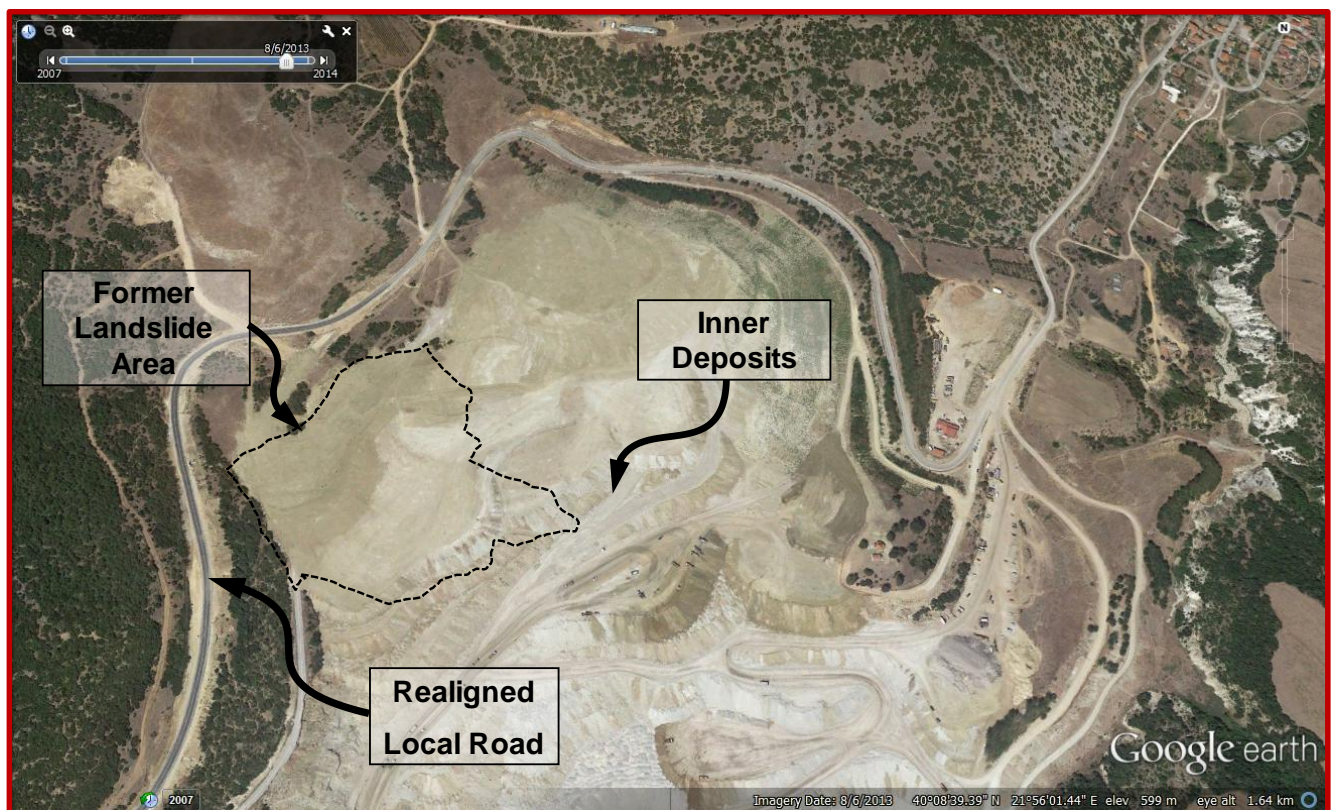
Figure 14. Aerial photo of the coal mine area after completion of counterweight construction and leveling works.
