A Large Scale Landslide in a Coal Mine in Marly Formations: Evaluation, Analysis and Rehabilitation

ABSTRACT: *This paper describes a large scale landslide in a coal mine in Servia area in Kozani, Greece, which occurred in February 2011. The landslide, of ~250m width and ~350m length, took place in marly lacustrine sediments. The main factors for the manifestation of the landslide were a temporary interruption of works, the existence of a specific weak surface, the clayey nature and the sensitivity of marl to environmental agents, the action of water and the large slope height. Due to the magnitude and the position of the failure, a geotechnical solution was proposed that involved rearrangement of ground masses. The proposed solution led to successful rehabilitation and unimpeded continuation of the exploitation process.*

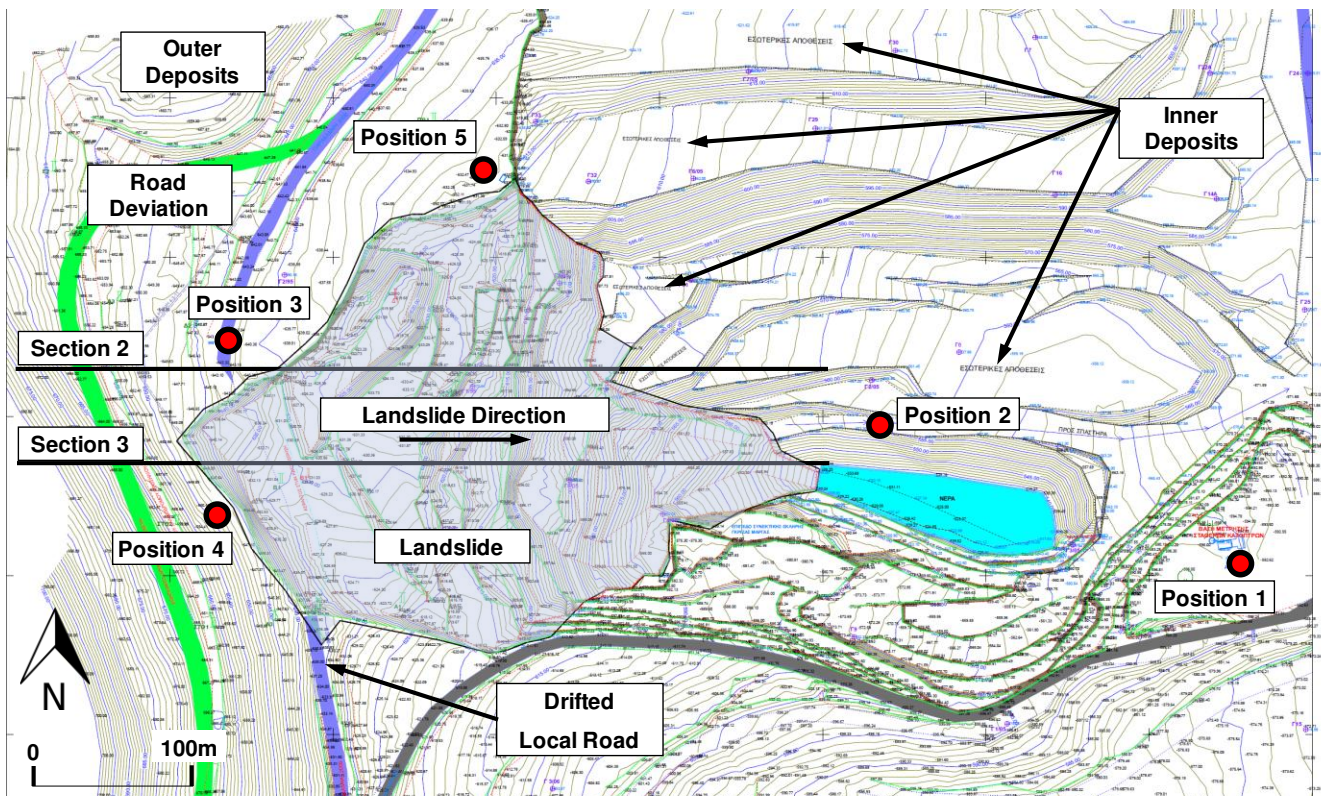
Figure 2. Topographic mapping (plan view) of the coal mine after the landslide with demarkation of some key features

Figure 2 shows a plan view of the landslide area, with demarkation of the main features of the incident, as mentioned or referred to in the present paper. After examination of historical, geometrical and geotechnical data provided by the exploitation contractor, in-situ inspections and evaluation of the available information, it was concluded that the factors that played an important role in the initiation and triggering of sliding movement and the evolution of the landslide were:

1. The period of stoppage of works, which enhanced instability phenomena, allowing the action of environmental agents, in combination with the initial small scale displacements and cracking that are inevitable in earthworks of such dimensions within soft rocks, due to stress relief.

2. The systematic and constant action of rain water. In addition to causing deterioration of upper marl quality, water also contributed by a gradual increase of pore pressure along various preceding sliding surfaces, after infiltrating in the generally impermeable formation through open and constantly widening cracks.

3. The existence of a distinct weak contact surface between the weathered and the underlying compact marl. This specific interface has been often shown to contribute to failures as a common sliding surface, not only from similar incidents in the area (Prountzopoulos et al., 2010) but also from statements of the on-site engineers of the specific project who attested that this surface had caused small scale failure incidents in the same coal mine before the specific landslide.

4. The clayey, weak nature of marl, especially in shallow depth, as well as its sensitivity to the action of environmental agents. The progressive transition of marly formations to residual strength conditions, due to combination of the action of water and small scale displacements, has been repeatedly reported in the Greek territory and has been related to landslide phenomena (Cavounidis & Sotiropoulos 1980, Dounias 1988, Prountzopoulos et al. 2014).

5. The important height of the mine slope cuts (>60 m), which was not timely retained through deposition of non-commercial excavation materials, due to the stoppage of works with adjudication.

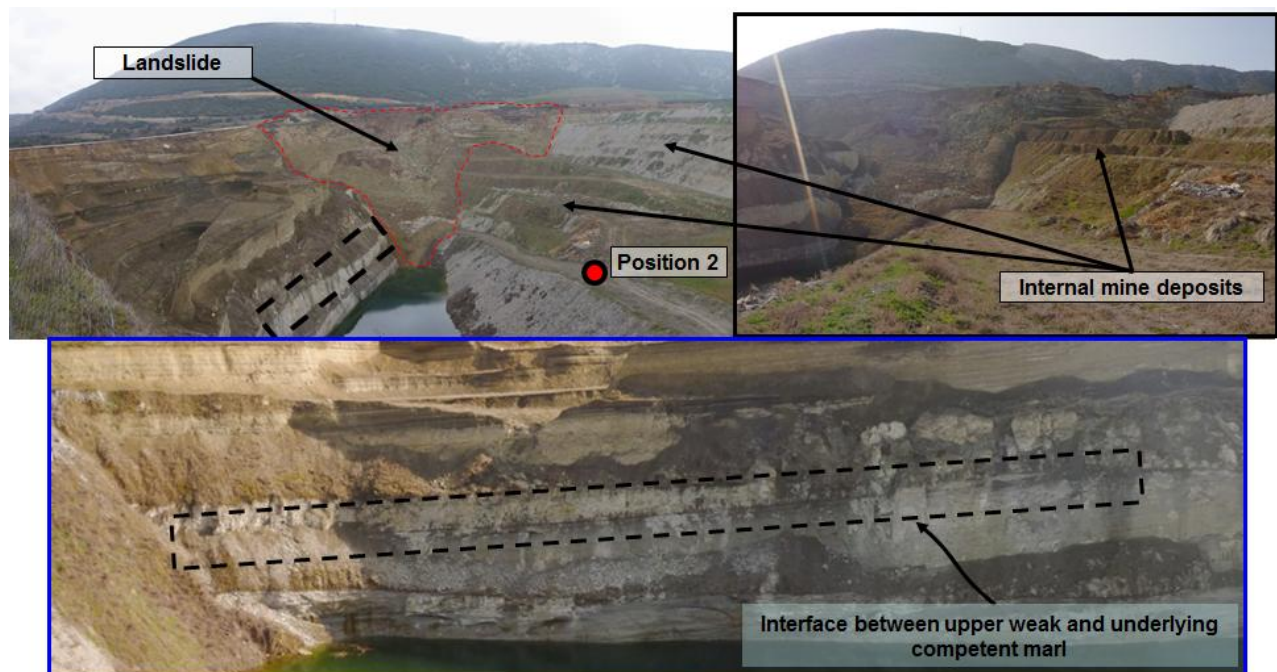
Figure 3 illustrates a general aspect of the landslide from its E and NE side (Positions 1 and 2 in Figure 2) and a view of the contact surface between the weak and the competent marl, which played a major role in the landslide manifestation. Figure 4 illustrates various aspects of the landslide and its main features.

Figure 3. Aspect of the coalmine and the landslide from Position 1 (upper left), the landslide from Position 2 (upper right) and the contact surface between the weak and the competent marl (bottom)

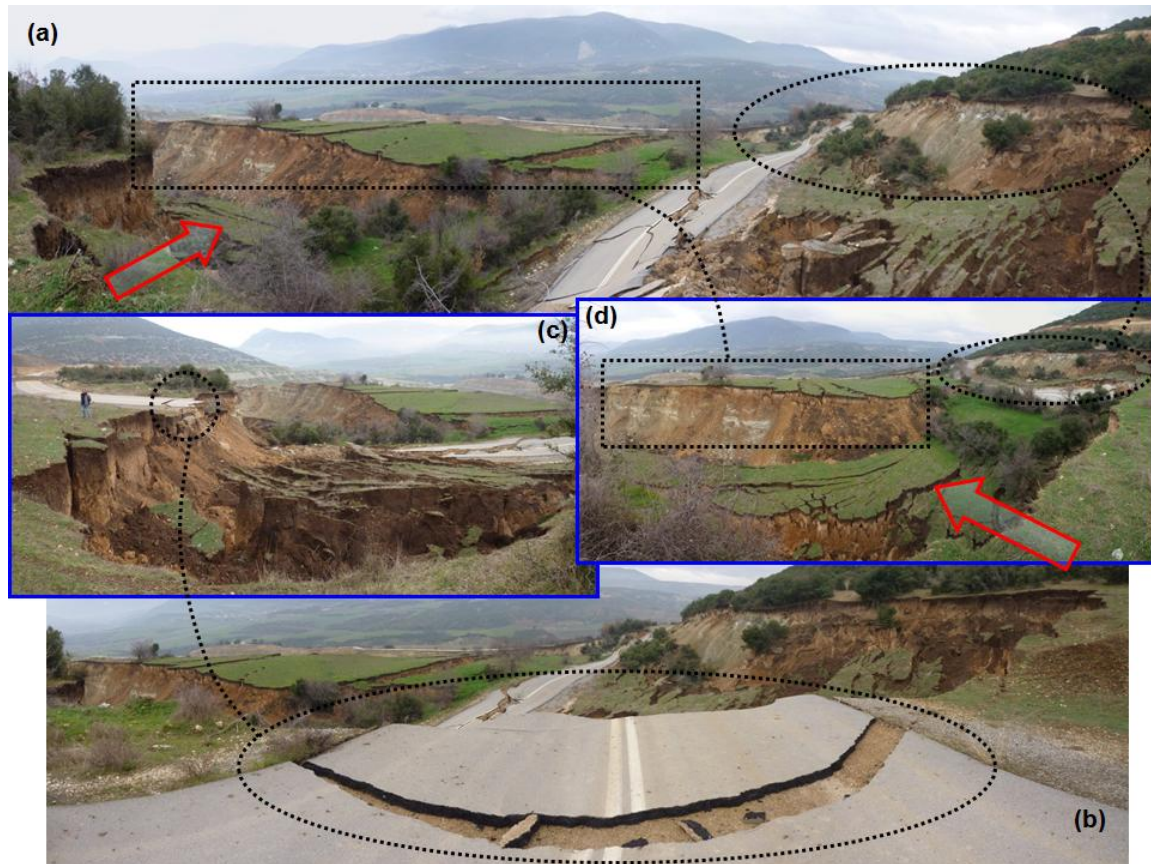
The landslide had a clearly three dimensional character, due to the lateral “constraints” posed by the non-commercial deposits of the mine at its north part and the exploitation limit at its south part. The failure surface at the landslide crest at its NW boundary had a considerable (subvertical) inclination and was steeply dipping towards the weak contact surface between the weathered and the underlying compact marl (Figure 4a left and 4c). On the contrary, at the west boundary of the landslide crest, the failure surface had a milder inclination (Figure 4a and 4b right) and seemed to have travelled a considerable length within the shallower weak marl formation. Within the landslide, large blocks of the marly formation were almost monolithically displaced (see Figure 4a and 4d) with limited cracking and detachments within their mass, giving the impression of a combination of rock slide and typical rotational landslide to the incident.

Figure 4. Aspect of the landslide from Position 3 (a & b), Position 4 (c) and Position 5 (d), the landslide crest (oval shape in a & d), the block that moved almost monolithically downstream (rectangle in a & d) and the mass that sank behind the block (arrow in a & d).

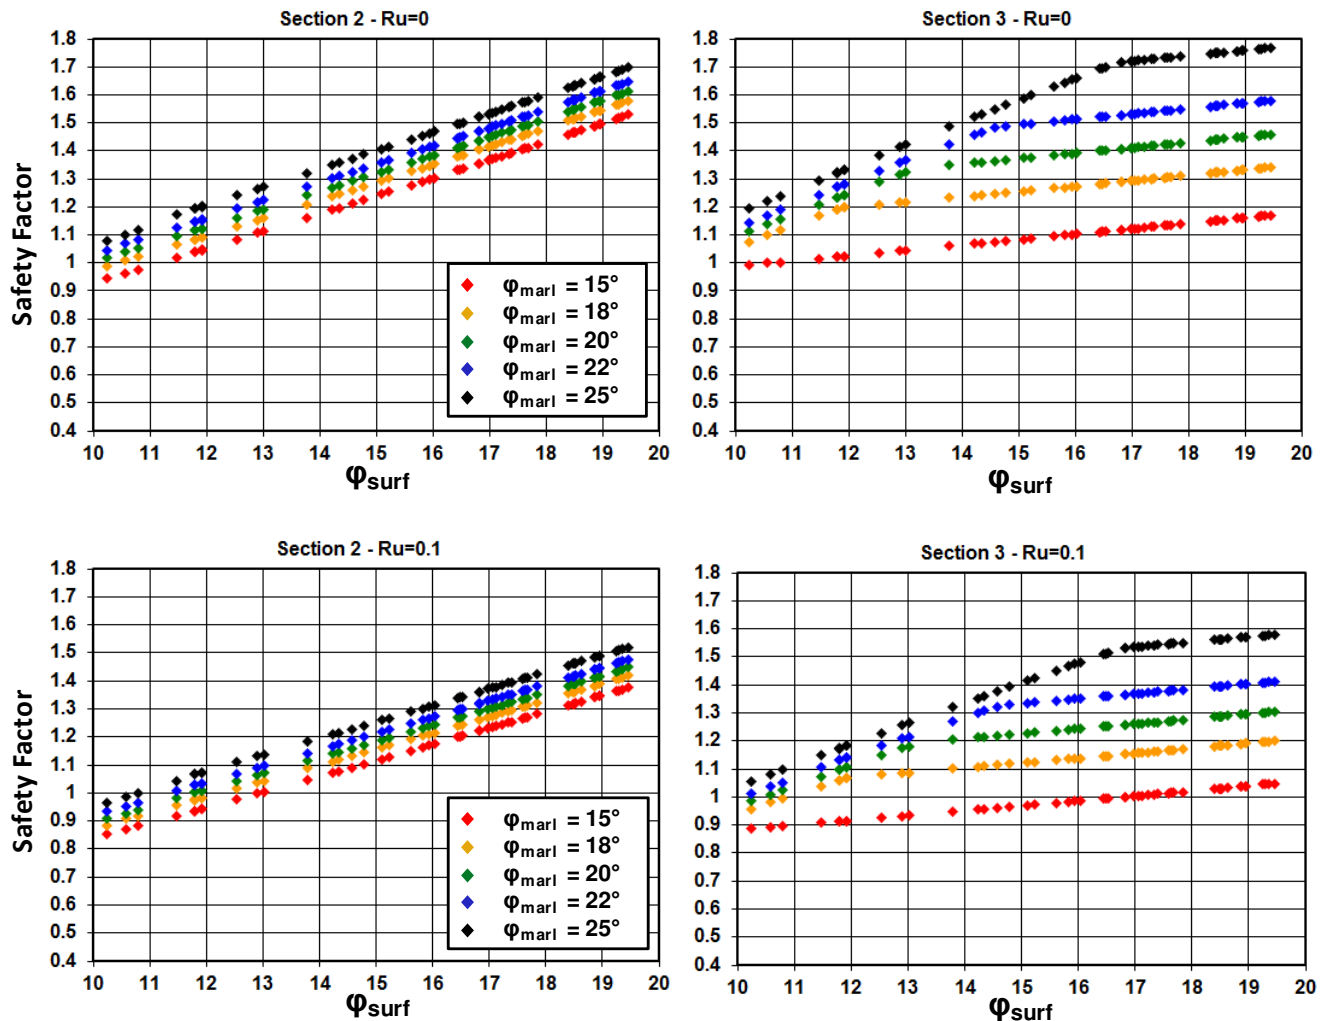
2. Values of the safety factor for values of pore pressure ratio $R_u=0-0.1$ generally lie above unity for both Sections analyzed (see Figure 6), especially for $\phi_{surf} > 13^\circ$ and were therefore excluded. This result was actually anticipated, since water seemed to have had a major role in the landslide triggering.

Figure 6. Variation of safety factor for different values of ϕ_{marl} and ϕ_{surf} for $R_u=0.0$ (up) and $R_u=0.1$ (down), as computed for Section 2 (left) and Section 3 (right)

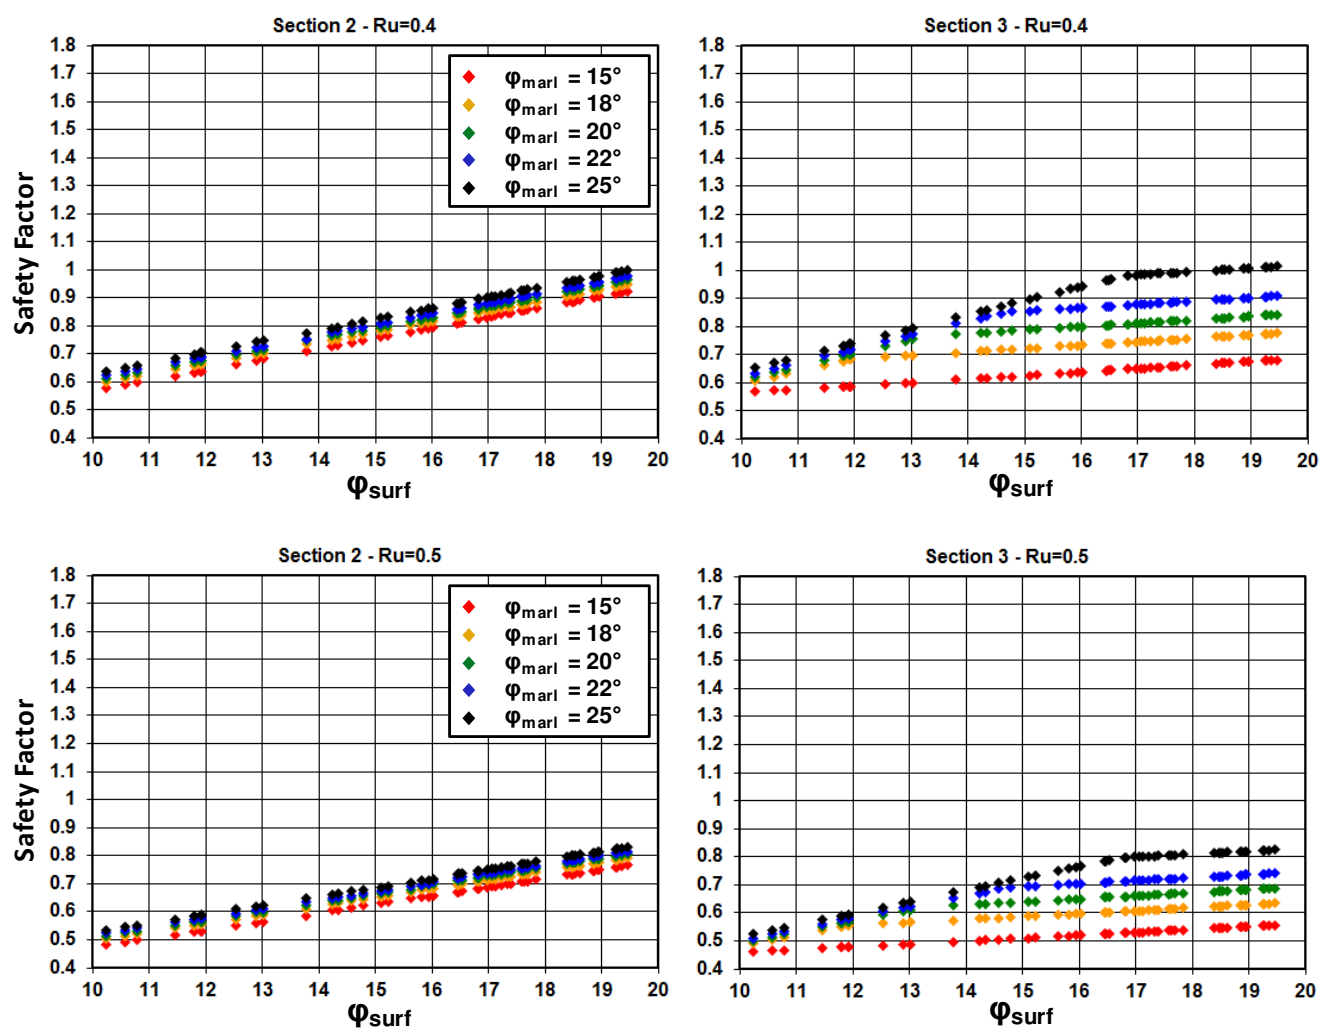
3. Values of the safety factor for values of the pore pressure ratio $R_u=0.4-0.5$ were generally well below unity for both analysis Sections (see Figure 8), especially for $\phi_{surf} < 17^\circ-18^\circ$ and were not considered likely. Values of the safety factor for $\phi_{surf} > 18^\circ$, given the nature of the specific surface and the fact that are assumed to refer to residual strength, were not considered reasonable.

Figure 8. Variation of safety factor for different values of φ_{marl} and φ_{surf} for $R_u=0.4$ (up) and $R_u=0.5$ (down), as computed for Section 2 (left) and Section 3 (right)

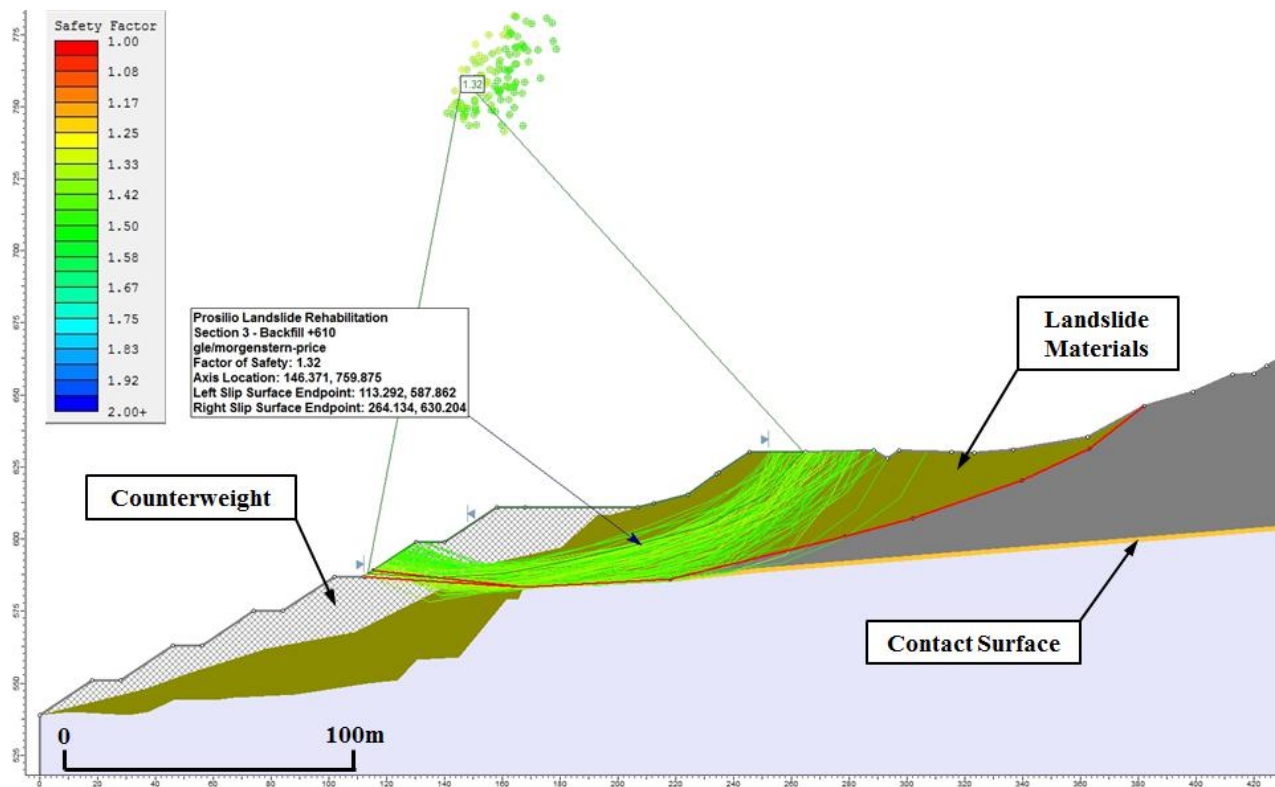
Figure 11. Analysis Results for Section 3 with backfill at the toe up to elevation +610 (F.S. = 1.32)

1. Placement of non commercial deposits at the toe of the landslide up to an elevation approximately 25 m above the contact surface between the upper weak and the undelying competent marl (~+610 m absolute evelation), significantly increased the safety factor. Specifically, considering the envelope of the landslide or surfaces along obvious large scale movements within the total landslide mass as potential failure surfaces, the computed values of the safety factor ranged between 1.52 and 1.63. Assuming that any failure surface within the total landslide envelope was possible (a quite conservative approach, since residual shear strength parameters were assigned in the analysis model) the safety factor ranged between 1.32 and 1.56. These values, even with the second, conservative approach, were considered adequate.

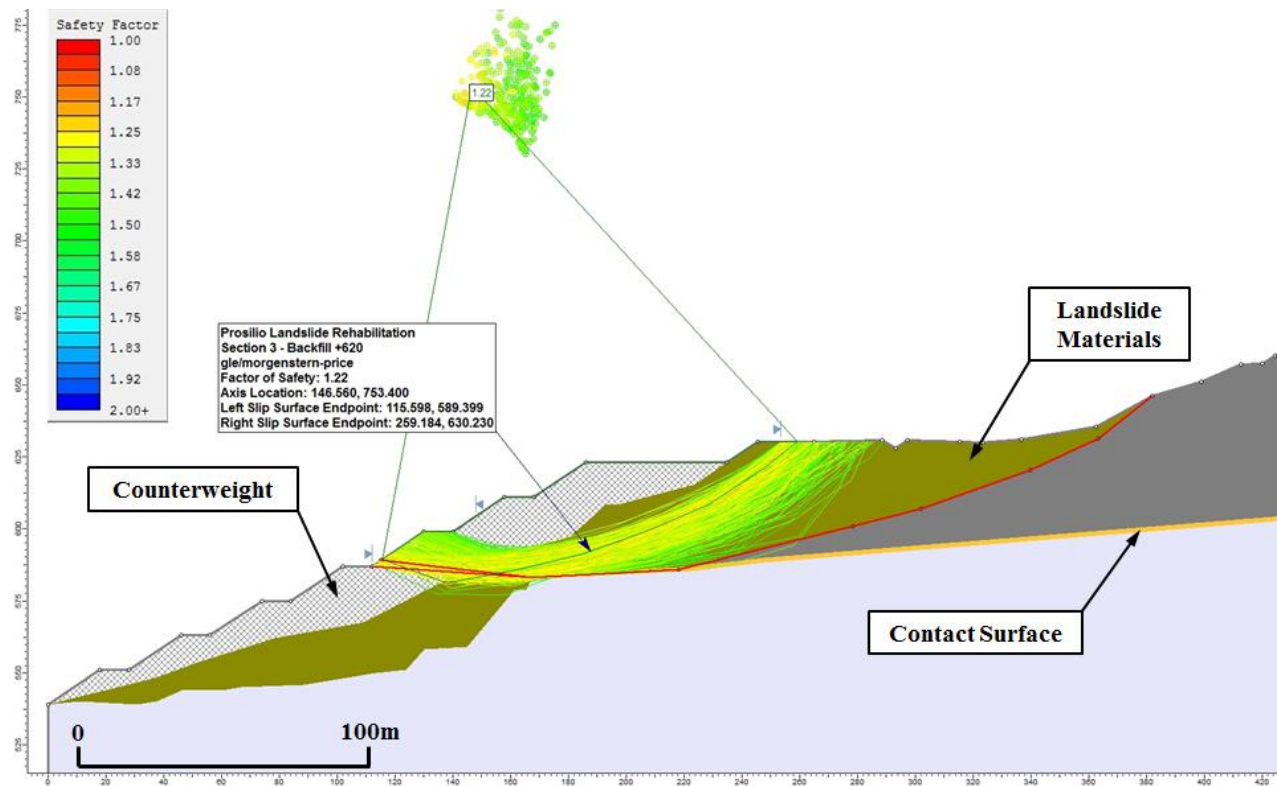
Figure 12. Analysis Results for Section 3 with backfill at the toe up to elevation +620 (F.S. = 1.22)

2. Placement of non commercial deposits at the toe of the landslide up to an elevation approximately 35 m above the contact surface between the upper weak and the undelying competent marl (~+620 m absolute evelation), did not significantly differentiate the safety factor. Specifically, considering the envelope of the landslide or surfaces along obvious large scale movements within the total landslide mass as potential failure surfaces, the computed values of the safety factor ranged between 1.56 and 1.70. Assuming that any failure surface within the total landslide envelope was possible, the safety factor ranged between 1.22 and 1.57. Therefore, it was shown that the additional placement up to the specific level was only to facilitate the landslide removal and exploitation procedures and was not necessary for the stabilization of the landslide. In fact, locally, due to the existing geometry and morphology of the landslide, this additional placement could somehow reduce the available safety factor, as part of the deposits would actually increase the sliding moment for certain potential failure surfaces (pose additional loading to the landslide - see Figure 12 above).

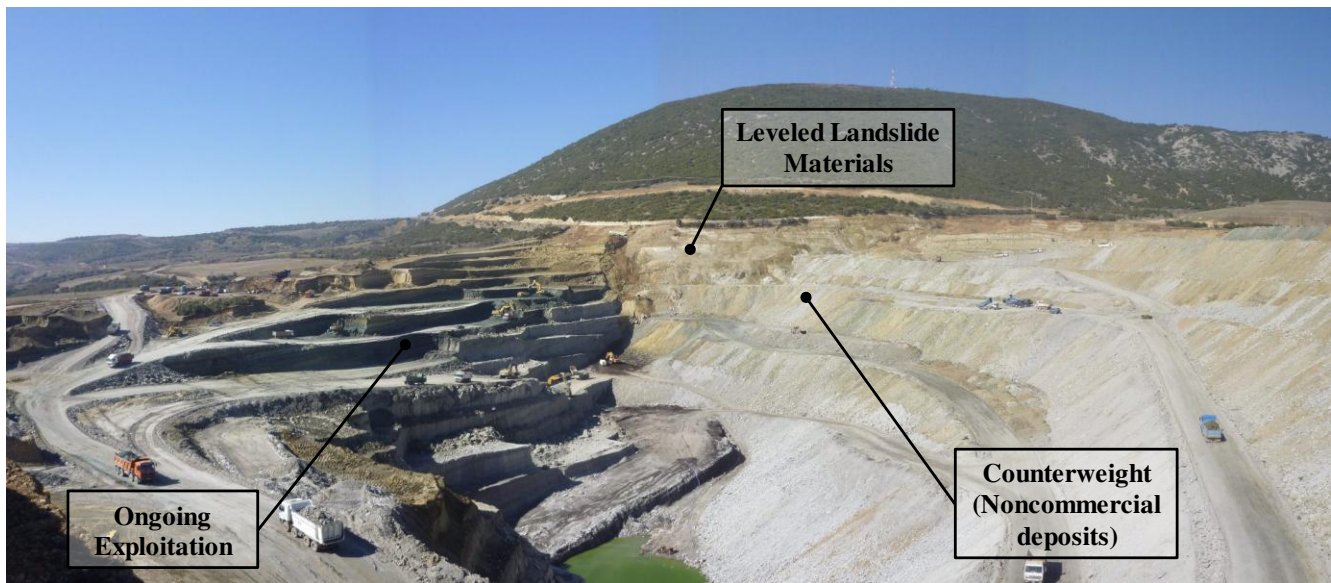
Figure 13. Aspect of the coal mine area after completion of counterweight construction and leveling works (March 2012).

The proposed rehabilitation scheme was succesfully applied in order to stabilize the landslide before any intervention to its mass. The operation of the coal mine has continued without significant instability incidents ever since. The following figures show an aerial photo of the coal mine area and an aspect of the same from within the mine area, after completion of landslide counterweight construction and leveling of the landslide materials.

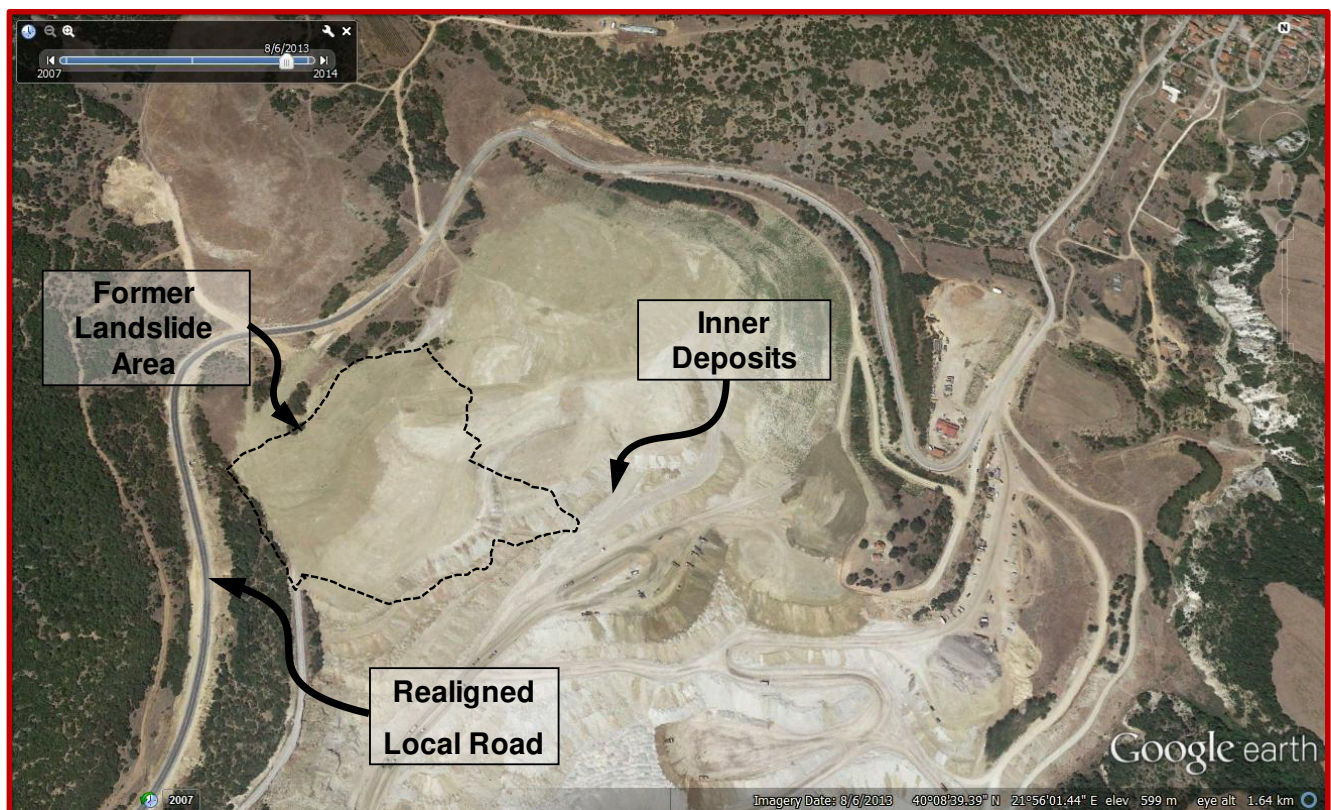
Figure 14. Aerial photo of the coal mine area after completion of counterweight construction and leveling works.
