A High Rock Cut Stabilization in Muscat City, Oman

Reference: Hayat, T.M., Bhatti, T.J. and Goldsmith, R. (2017). *A High Rock Cut Stabilization in Muscat City, Oman*.

International Journal of Geoengineering Case histories, <http://casehistories.geoengineer.org>, Vol.4, Issue 2, p.96-112.

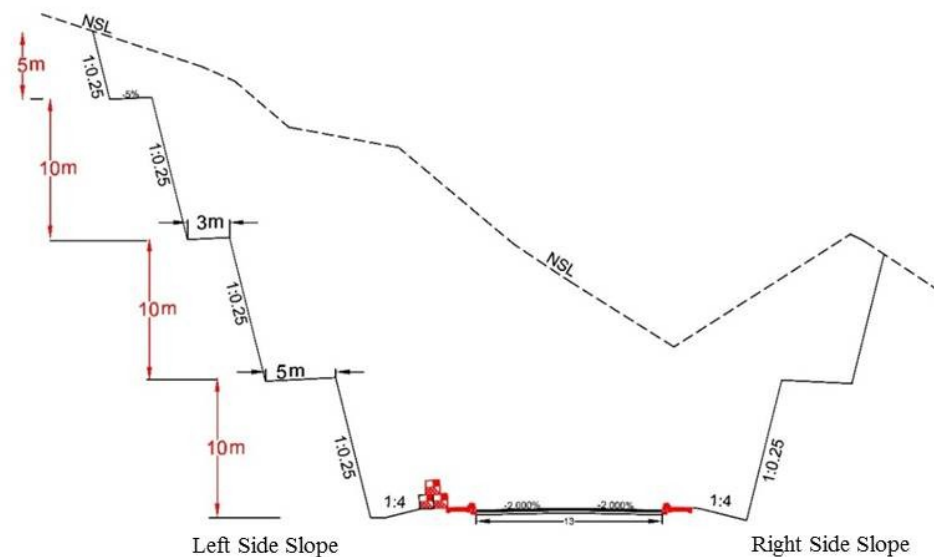
The maximum height of the rock slope in these cuts reaches 50 m with a cut slope of 1V:0.25H (76°) and 3 m wide benches at every 10 m height interval. A typical section of box cut at RD 0+420 m is shown in Figure 2. The initial design included slope protection measures such as short length rock bolts and reinforced shotcrete.

Figure 2. Slope and roadway configuration at station RD 0+420 m in Box Cut#1.

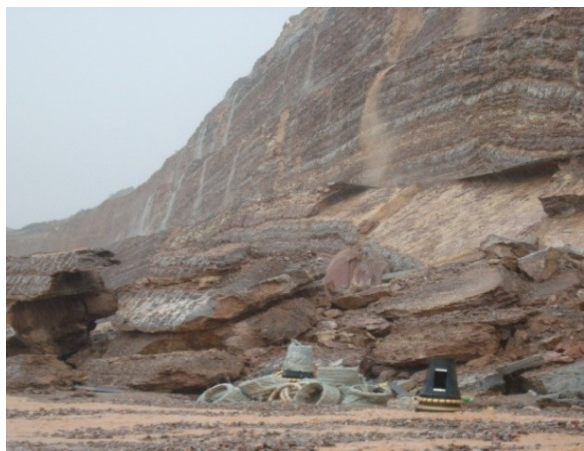
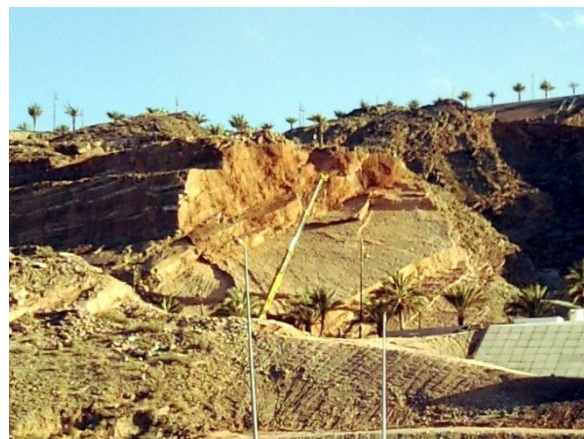
This rainfall caused a rock slide on the left side of the Box Cut # 1, from RD 0+380 m to 0+480 m. This section constituted the farthest edge of the cutting. On this side of Box Cut #1, a small wadi (valley) is located behind the slope. This was used as a channel for diverting the storm water from the catchment areas behind the slope. This wadi has steep gradient and was unlined at the time of slope failure.

Photographs taken just after the rain storm showed that the failure had occurred initially as a single event. Failure occurred along a 40° dipping bed in the lowest slope, which extended to the inner edge of the first berm and a near vertical joint forming the release plane. The photographs taken at that time also showed a large amount of water transported debris coming out from the above mentioned wadi adjacent to the failed area. Water was also noticed cascading over the crest of the main rock cut.

With the passage of time, the extent of the initial failure grew in size as more and more rock mass adjacent to the initial failure area failed progressively. Within a couple of weeks of the initial event, the failure grew to the top of the 35 m high cut, extending about 20 m along the crest and reaching as far as a steep joint with a strike of about 260° (N100 deg W), and dip of more than 70°. The total volume of failure was estimated at 800 m³ (Figure 4).

From site observations, it was concluded that the failure initiated along a laminated bed of argillaceous rock layers, which had the least shearing resistance of all the rock mass at the site. The failure undermined the slopes above it and caused their failure, which progressed in the weeks ahead of the initial event.

The main triggering factor was the increase in water pressure associated with the rainfall event. The Box Cut # 1 slope at the farthest end was exposed to weather on three sides; the front cut face, the edge face and behind in the wadi (valley). It is likely that the water in the wadi overflowed and infiltrated the loose jointed and bedded rock mass. It is also likely that the small solution channels formed conduits for water that entered the formation, contributing to the failure. Although the rock mass appeared visibly stable in the area after a few weeks, there were other bedding / joints in the area that could cause further instability in the future, especially under wet conditions.

Figure 4. Top photo provides an overall view of the slope face prior to sliding and the extent of two episodes of sliding on June 4th and October 11th 2010. The lower frames, except the lower right corner view, show sliding during Cyclone Phet, while the lower right corner view shows the resulting slope face after the final collapse on October 11th 2010. The sliding along the bedding and a vertical joint, a free release plane along the overspilled wadi, is an obvious reason of sliding during cyclone Phet.

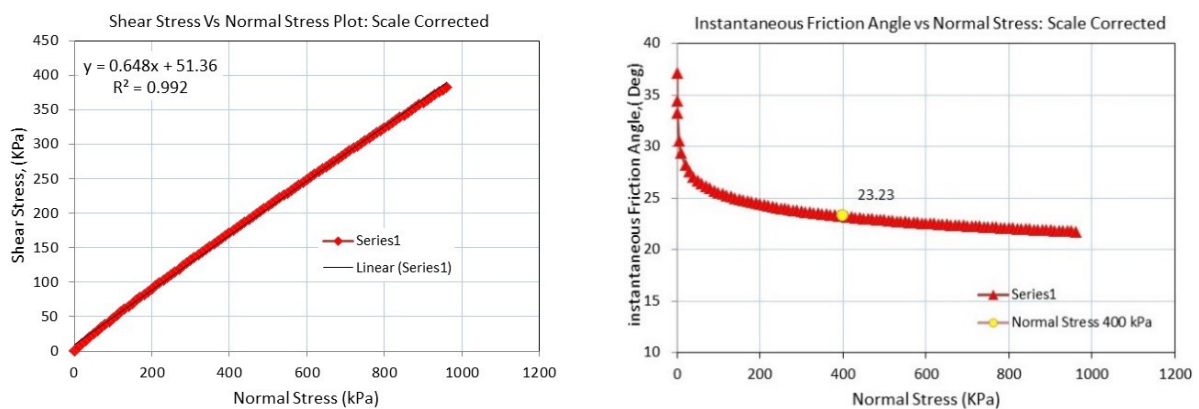
Figure 7. Friction angle at various stress levels for a deep seated sliding plane.

The average normal stress range was found to be about 400 kPa. Considering this, the corresponding friction angle (ϕ_L) was selected as 23.2° from Figure 7. In addition, based on site observations of intact rock bridges and test results, a cohesion value of 80 kPa was selected for analysis in deep seated failures. Similarly, for small scale failure, the ϕ_L value was calculated as 28° and zero cohesion was assumed in this case.

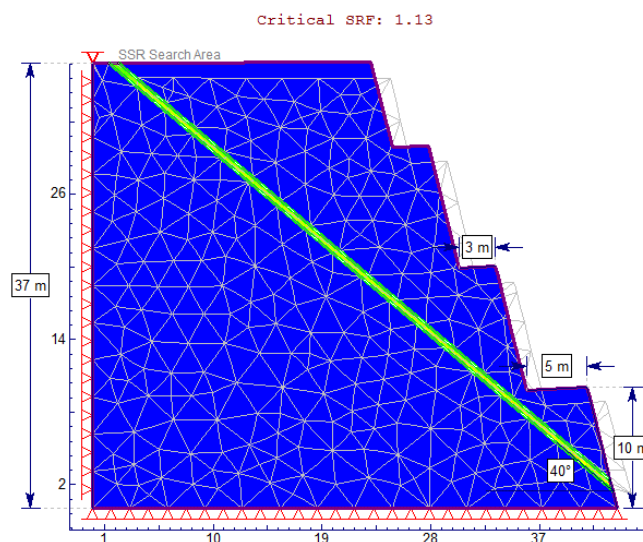
From the table above, it is can be observed that the Factors of Safety from the three approaches used are in general agreement. Figure 10 below shows the exaggerated deformed FE mesh of the upper sliding block for the $SRF = 1.2$ (In Dry Condition) for which no FEA convergence occurred.

Figure 10. Deformed mesh for the $SRF = 1.2$ (in dry conditions) for which no FEA convergence occurs. The maximum SRF for which the FEA satisfies the state of equilibrium is 1.13.

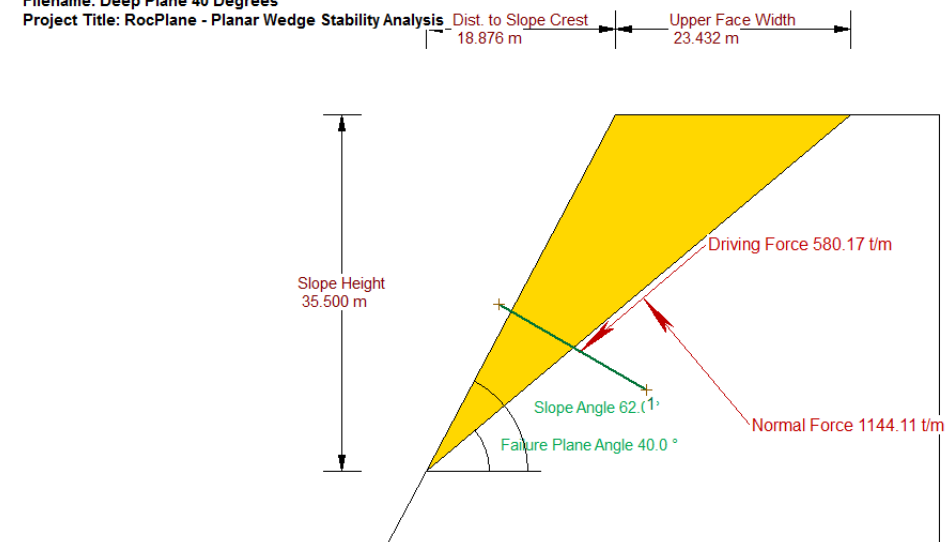
Figure 11. Factor of Safety (FOS) in dry condition with 3360 KN/m external force applied through designed cable anchors.

After several trials using different applied normal stresses on the failure plane, seven strand anchors of 1200 KN working load at 2.5 x 2.5 m grid (3400 KN/m) for a 35 m high slope were selected. The results of factor of safety using the 1200 KN anchors on the deep sliding planes are presented in Figures 11 to 14 and are summarized in Table 3.

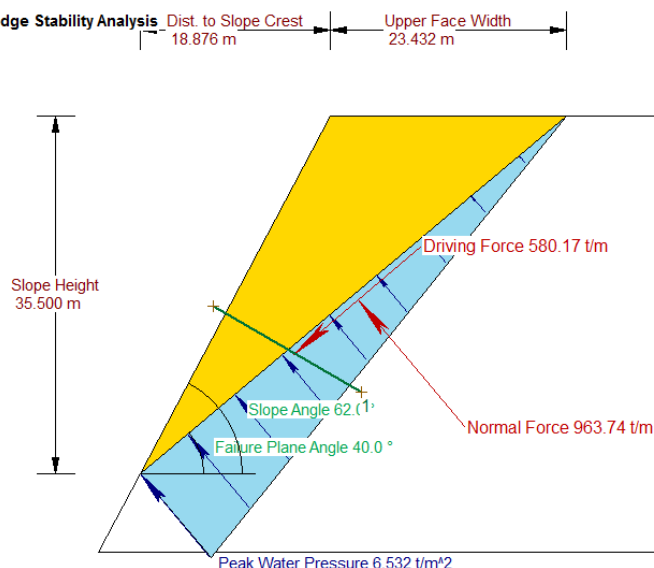
Factor of Safety	1.48
Driving Force	580.17t/m
Resisting Force	856.88t/m
Wedge Weight	1081.37t/m
Wedge Volume	415.91m³/m
Shear Strength	856.88t/m²
Normal Force	963.74t/m
Plane Waviness	0.0°
Active Bolt Force	336.00t
Active Bolt Angle	330.0°
Passive Bolt Force	0.00t
Passive Bolt Angle	0.0°
Water Force on Failure Plane	180.38t/m

Figure 12. Factor of Safety (FOS) in wet condition under 15 m water head and 3360 KN/m external force applied through designed cable anchors.

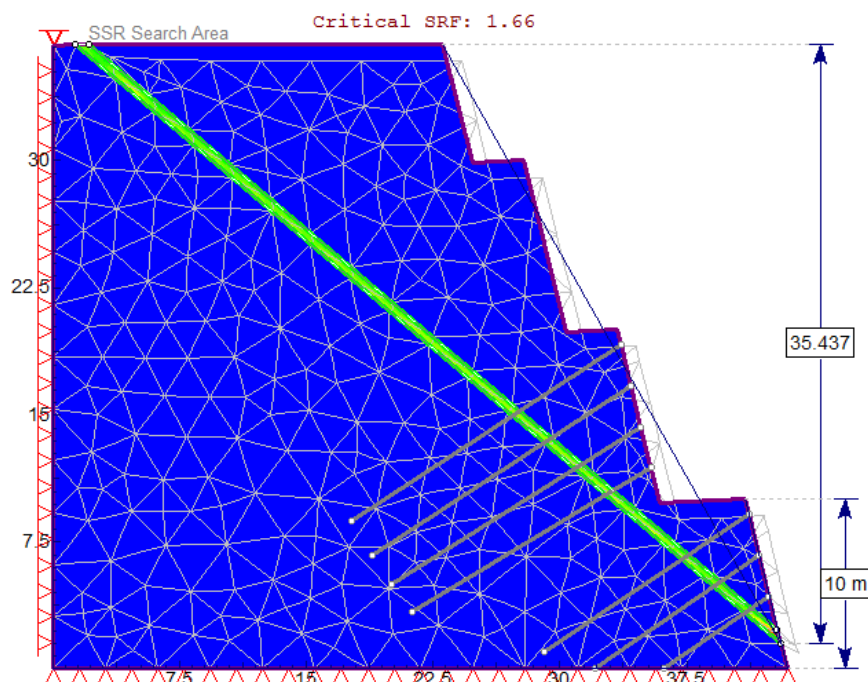
Figure 13. Deformed Mesh for the SRF =1.72 (in dry conditions) for which no FEA convergence occurred. The critical SRF for which the FEA satisfied the condition of equilibrium with 7 strand anchors of 1200 KN (2.5 x 2.5 m grid) is 1.66 as shown.

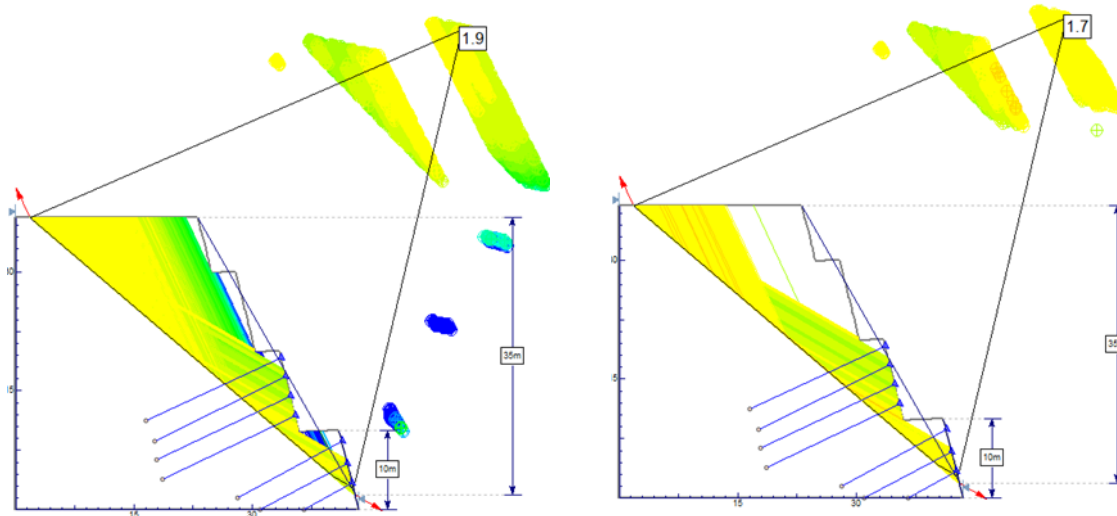
Figure 14. FOS with 7 x 1200 KN anchors in dry condition using Bishop (left) and Morgenstern-Price (right) methods.

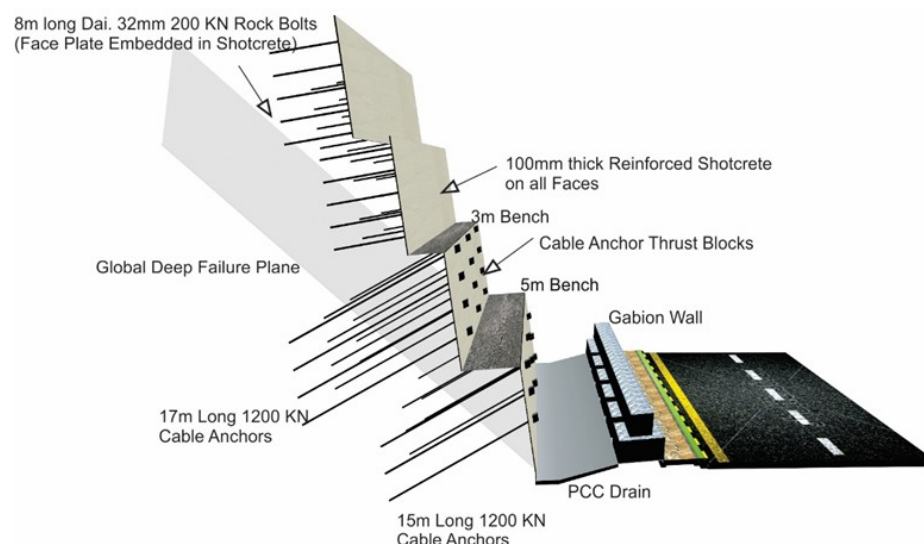
It was therefore concluded that the ends of box cut #1 were most vulnerable as at these locations large and deep seated failures were kinematically possible, whereas in the middle of these slopes, only shallower failures would be possible, the unstable wedges being confined at both ends. It was therefore decided to reinforce only the terminus of the 500 m long vulnerable slope with 1200 KN cable anchors. Other intermediate and cut faces above the cable anchored slopes were, however, reinforced with 200 KN rock bolts to control the comparatively smaller scale failures. The rock bolt heads were tensioned on steel plates resting on epoxy cement base. For long term durability, the steel plates were embedded in the shotcrete. The anchor heads of high capacity cable anchors were installed on specially constructed reinforced concrete anchor blocks. A typical arrangement of the reinforcement pattern at cut slope ends is shown in Figure 15.

Figure 15. 3D Conceptual arrangement of reinforcing elements at both the 20 m terminus of 500 m long left slope of Box Cut #1.

The arrangement of stabilization measures shown in Fig. 15 were implemented and are performing satisfactorily for the last six years.
