## Bridge Abutment Remediation – A Case Study

Reference: Sundaram, M., Sugawara, J. and Sivakumar, S. (2022). Bridge Abutment Remediation – A Case Study.

International Journal of Geoengineering Case Histories, Volume 7, Issue 4, pp. 1-7,

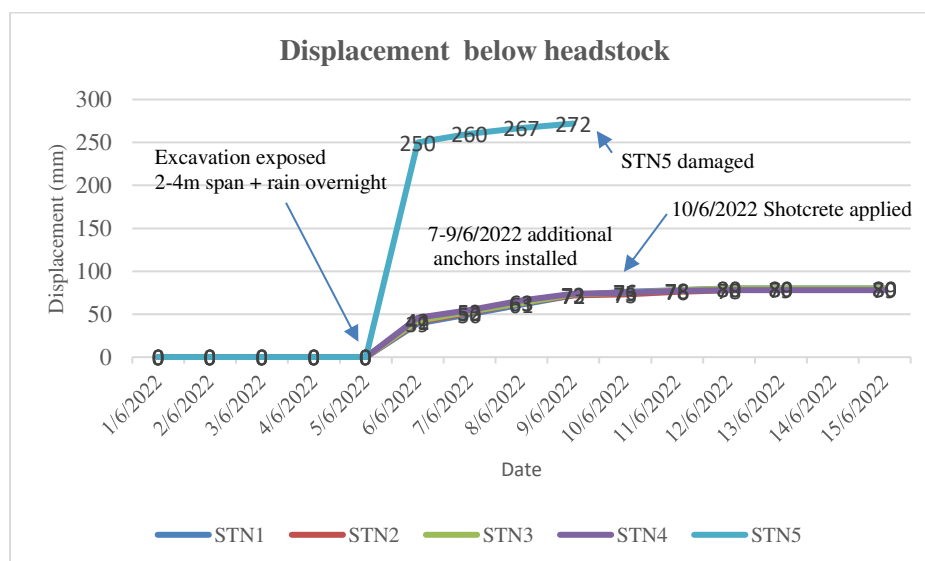
The excavation, anchor installation, and shotcrete application progressed well for the first three rows of anchors, after which, the contractor inadvertently excavated to full depth not following the support sequences specified in the design drawings. This resulted in the exposure of the slope face between 2-4 meters high without full protection. Consequently, approximately, 0.5 meter thick soil movement occurred behind the highest exposed face (Figure 6) with displacement of 250 millimeters in shotcrete below the headstock. On the same day, 13 millimeters of rainfall exacerbated the movement. Additional rows of anchors and steel mesh were installed to stabilize the movement. As a precautionary measure, the highway speed was also reduced to 60 kilometers per hour to minimize any vibration-induced movements. Surveillance was also increased to ensure safety was not compromised. The rate of the movement reduced after the installation of additional support measures and ceased two days after shotcrete application was completed (Figure 7).

Figure 7. Displacement (mm) in shotcrete below headstock. Station 5 (STN5) located on far right. Displacement ceased two days after shotcrete application.
