Geotechnical Effects of Hurricane Harvey in the Houston, Beaumont, and Port Arthur Areas

- Chadi El Mohtar**, Ph.D., Associate Professor, Civil, Architectural and Environmental Engineering, The University of Texas at Austin, Austin, Texas, USA; elmohtar@mail.utexas.edu

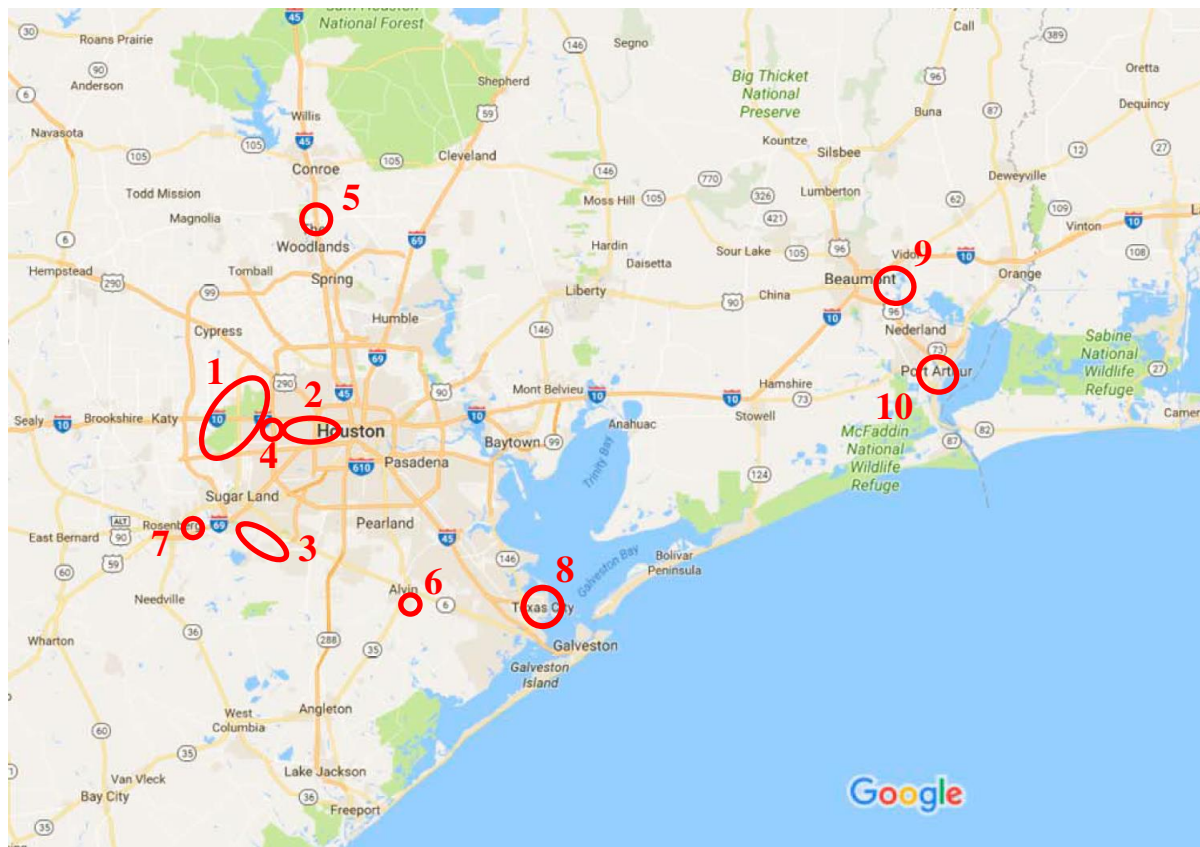
Figure 1. Observation Areas by GEER Hurricane Harvey Houston Team (see following list for site names). 1 – USACE Houston Flood Risk Management Dams – Barker and Addicks Dams, 2 – Buffalo Bayou, 3 – Brazos River Levees, 4 – Beltway 8 Underpass Slab, 5 – San Jacinto River Bridges, 6 – Mustang Bayou Bridge, 7 – FM 762 Road Culvert, 8 – Texas City Levees, 9 – Beaumont, 10 – Port Arthur

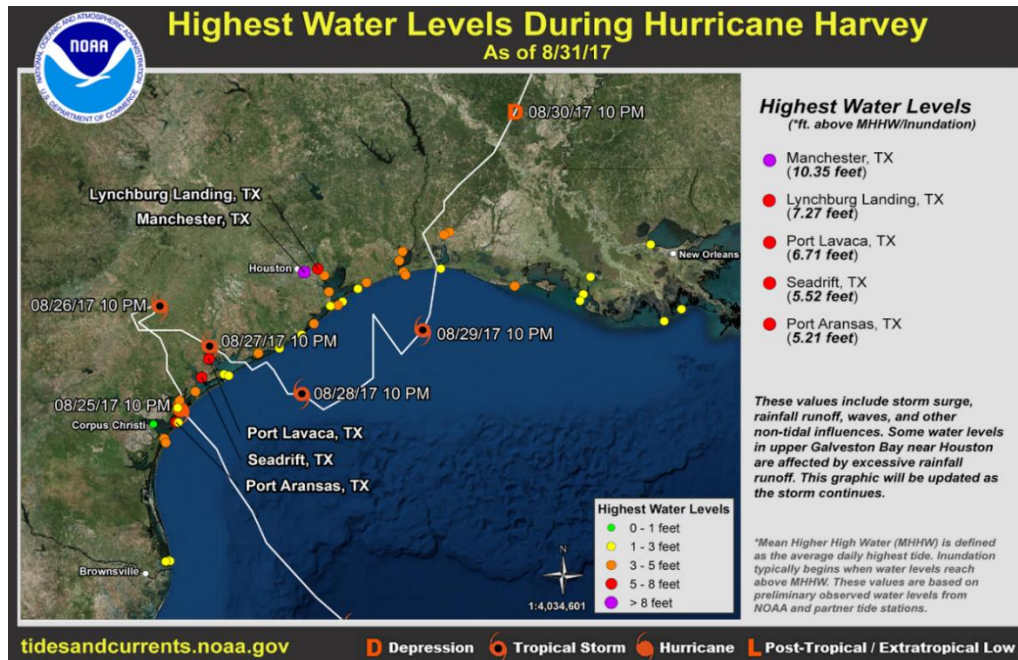
Figure 2. Harvey's path with the highest flood levels (NOAA, 2017).

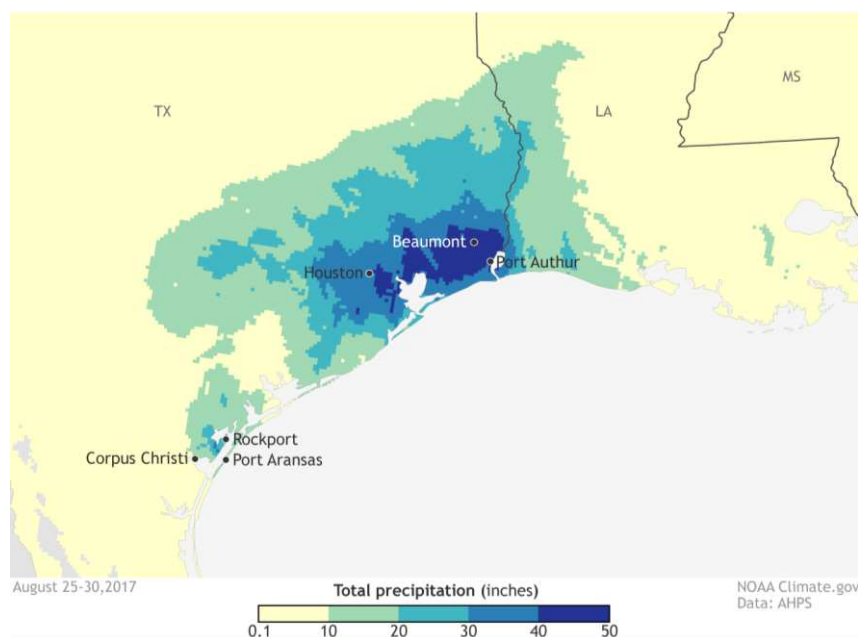
Figure 3. Rainfall totals in Texas from Hurricane Harvey, sourced from the National Weather Service. (<https://www.climate.gov/news-features/event-tracker/reviewing-hurricane-harveys-catastrophic-rain-and-flooding>)

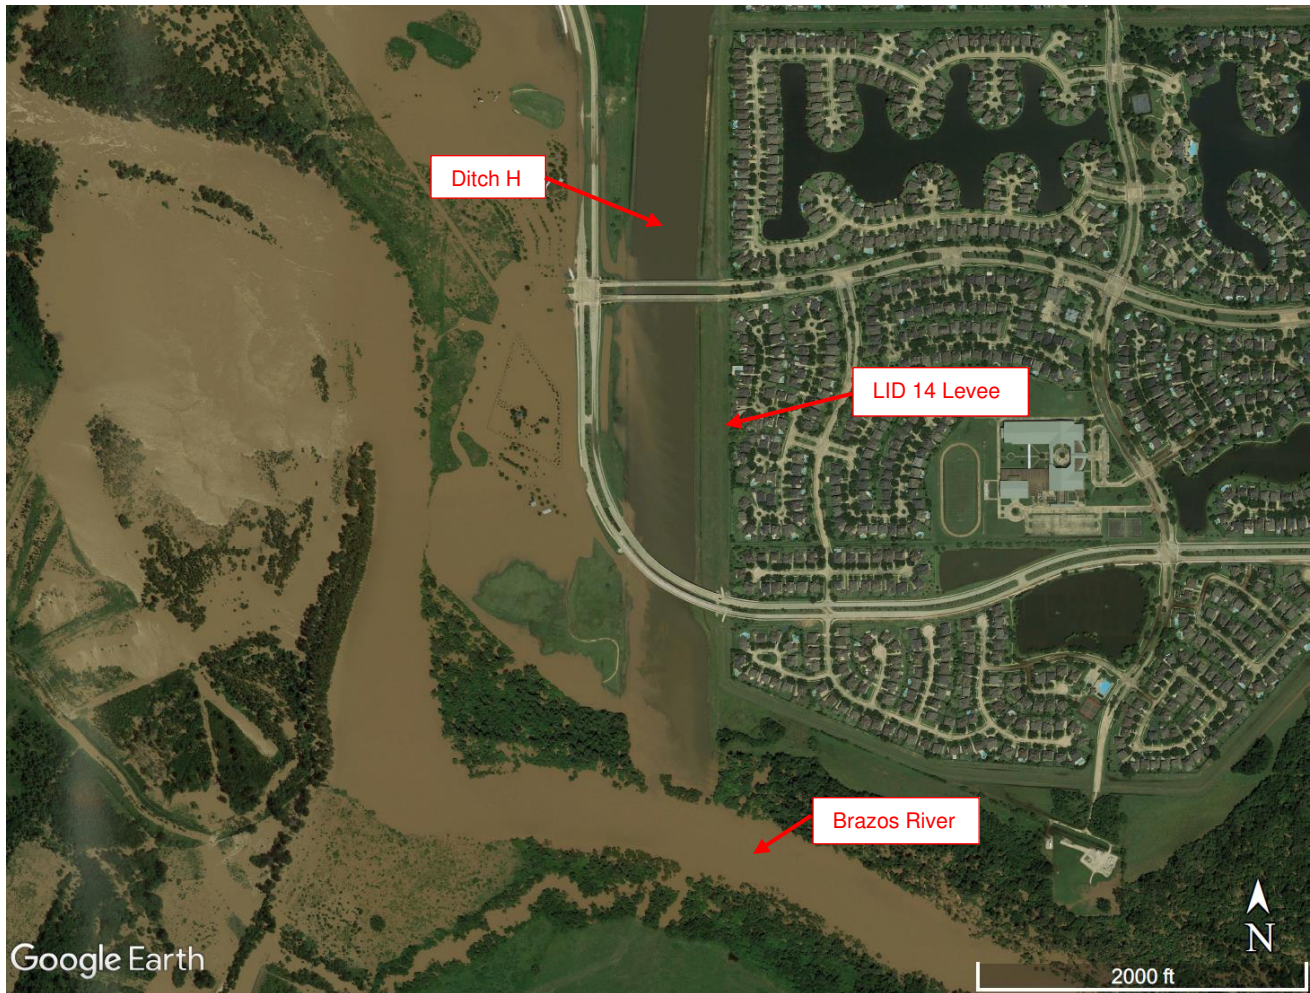
Figure 17. A Google Earth image of LID # 14 and Ditch H and its connection to the Brazos River (August 30, 2017).

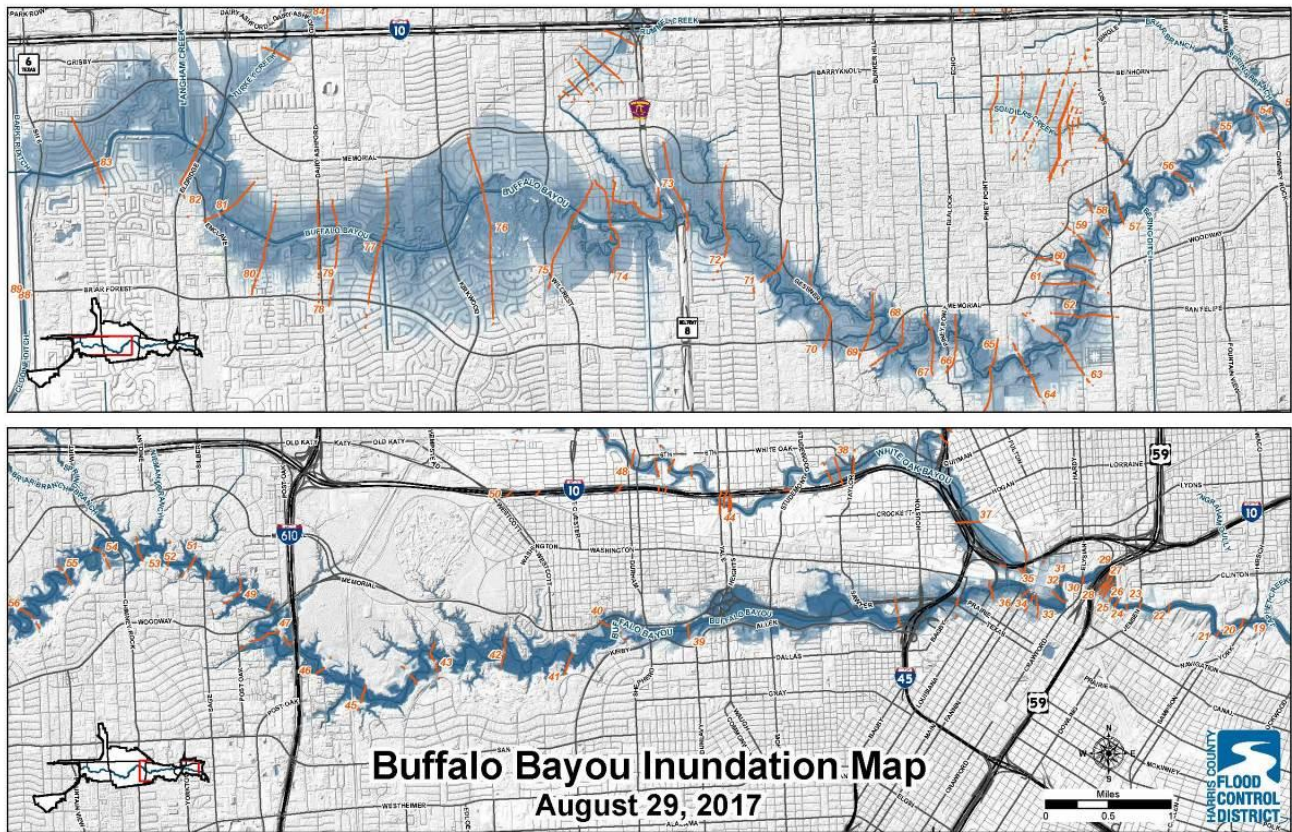
Figure 23. Buffalo Bayou inundation map (courtesy of Harris County Flood District).

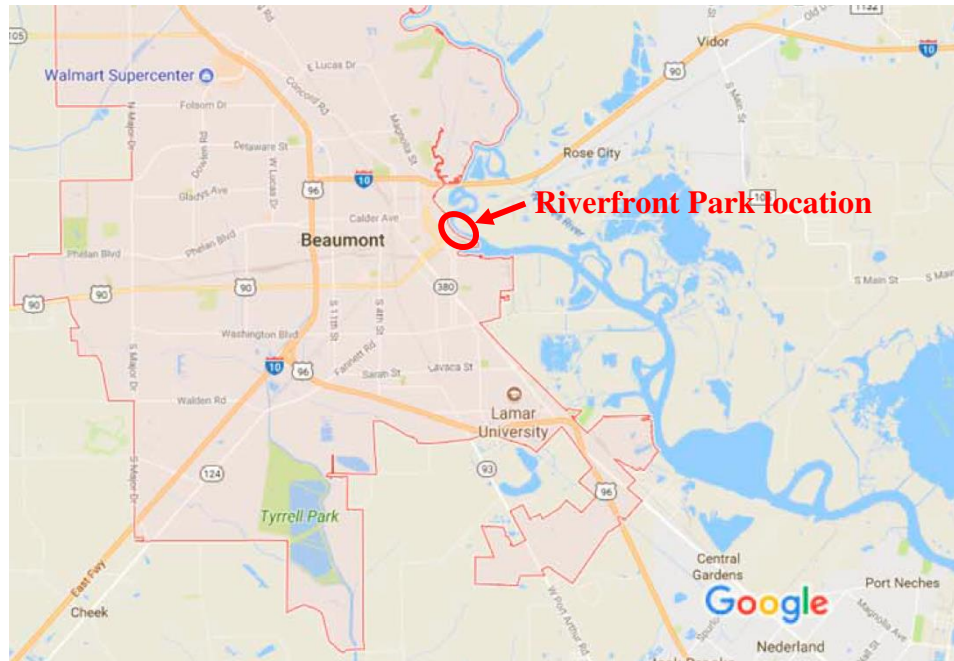
Figure 27. Riverfront Park location (Google Maps for source map).

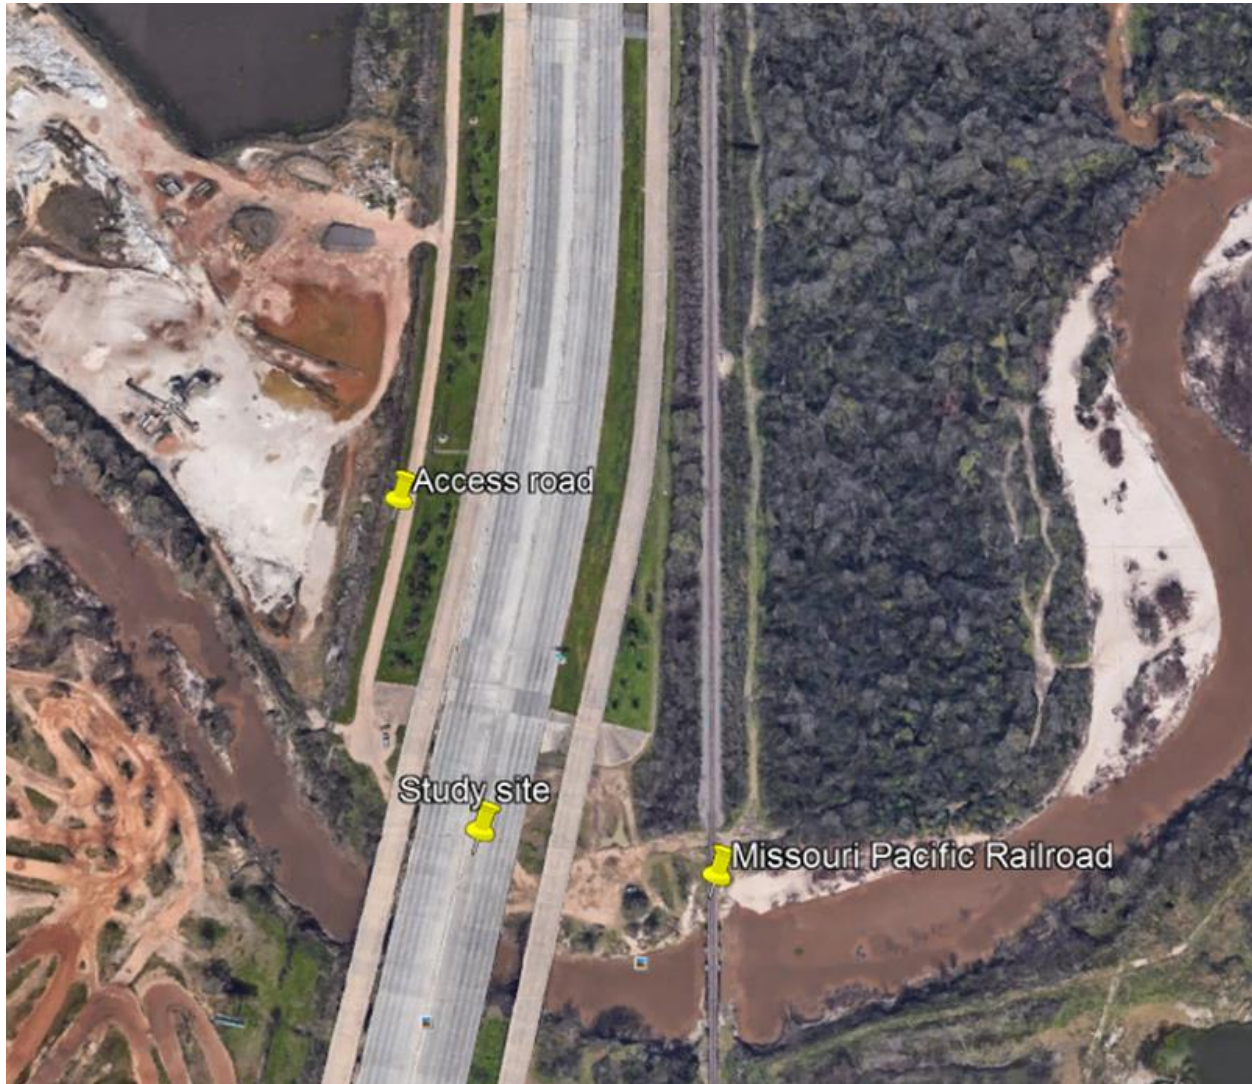
Figure 34. San Jacinto River Area observation locations (Google Earth image for April 2017, 30.24599° N, 95.45722° W).

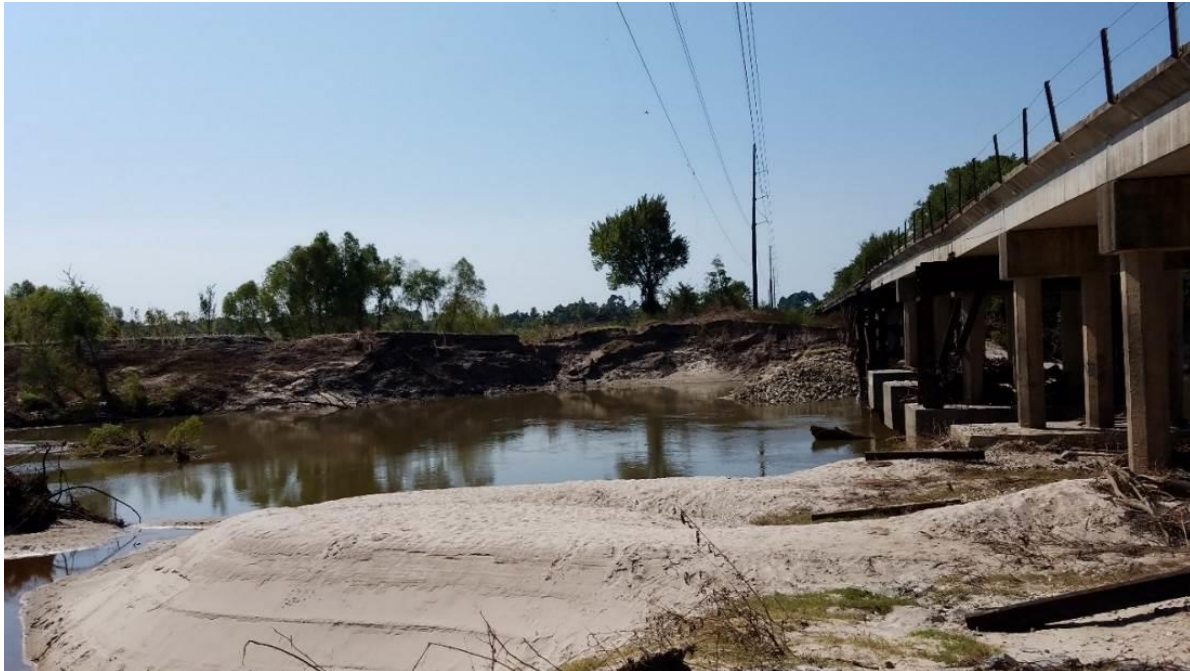
Figure 41. Bank erosion on the San Jacinto River downstream of I-45 and a railroad bridge parallel to the highway (September 11, 2017, Time 11:05 CDT, 30.24688° N, 95.45796° W).

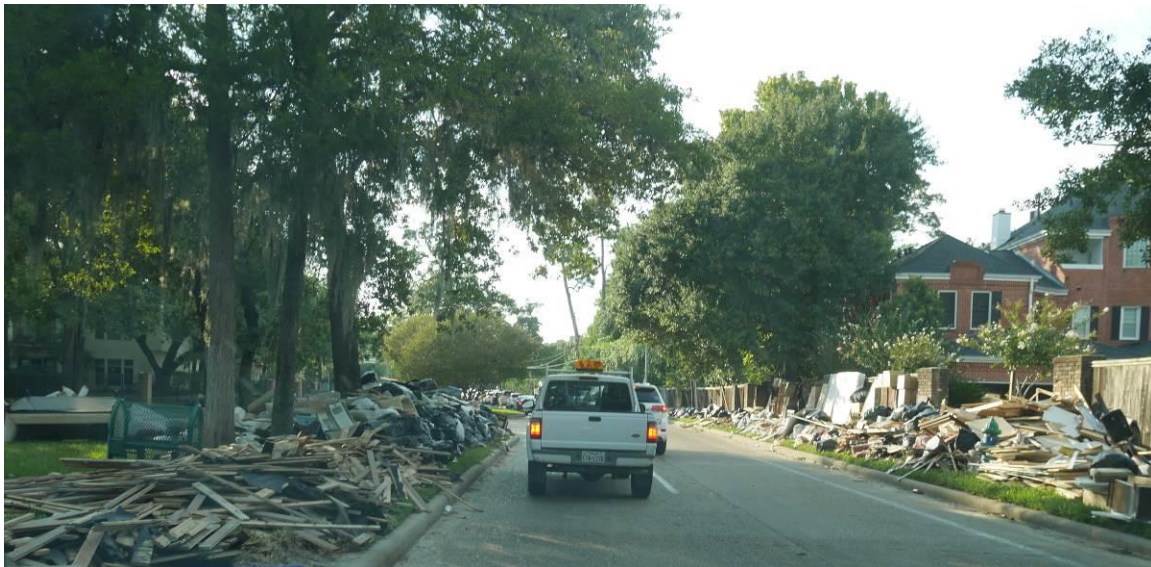
Figure 45. Residential flood damage debris, Houston.
