Geotechnical Effects of Hurricane Harvey in the Houston, Beaumont, and Port Arthur Areas

- Chadi El Mohtar**, Ph.D., Associate Professor, Civil, Architectural and Environmental Engineering, The University of Texas at Austin, Austin, Texas, USA; elmohtar@mail.utexas.edu

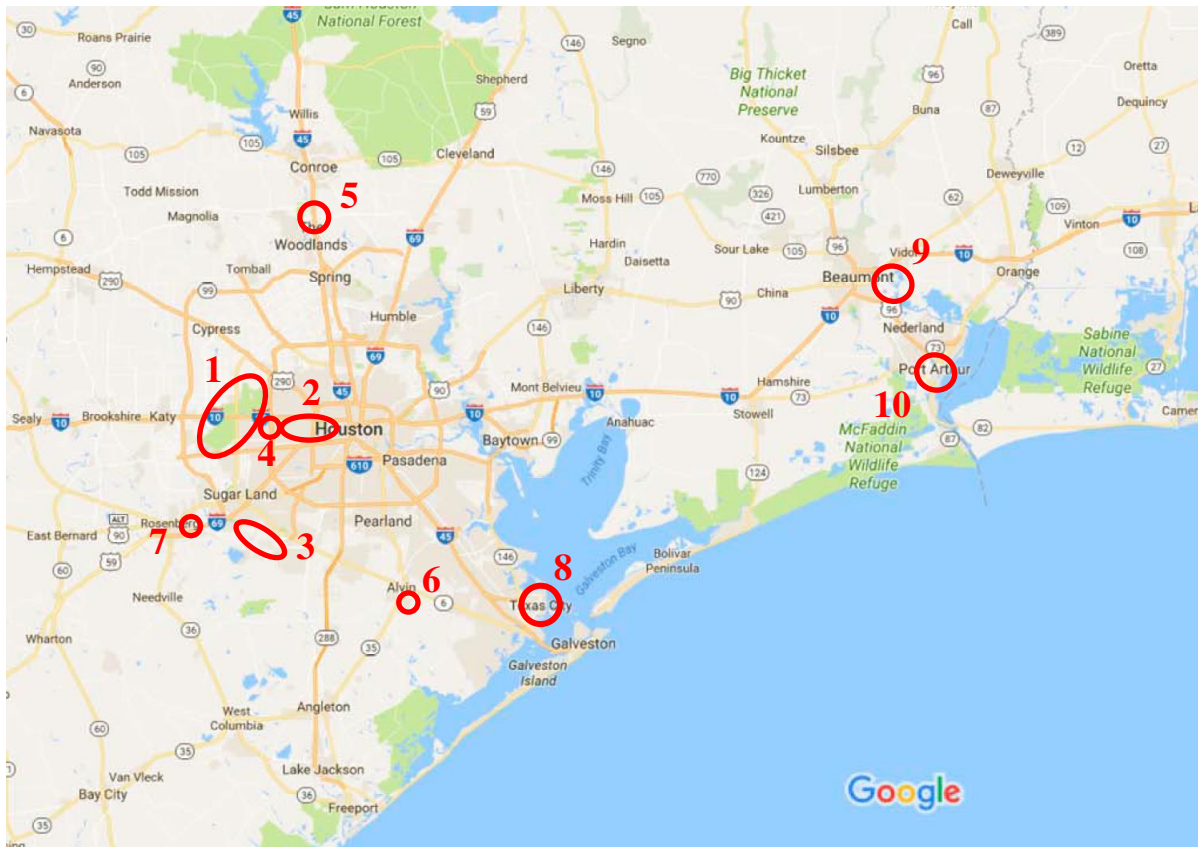
Figure 1. Observation Areas by GEER Hurricane Harvey Houston Team (see following list for site names). 1 – USACE Houston Flood Risk Management Dams – Barker and Addicks Dams, 2 – Buffalo Bayou, 3 – Brazos River Levees, 4 – Beltway 8 Underpass Slab, 5 – San Jacinto River Bridges, 6 – Mustang Bayou Bridge, 7 – FM 762 Road Culvert, 8 – Texas City Levees, 9 – Beaumont, 10 – Port Arthur

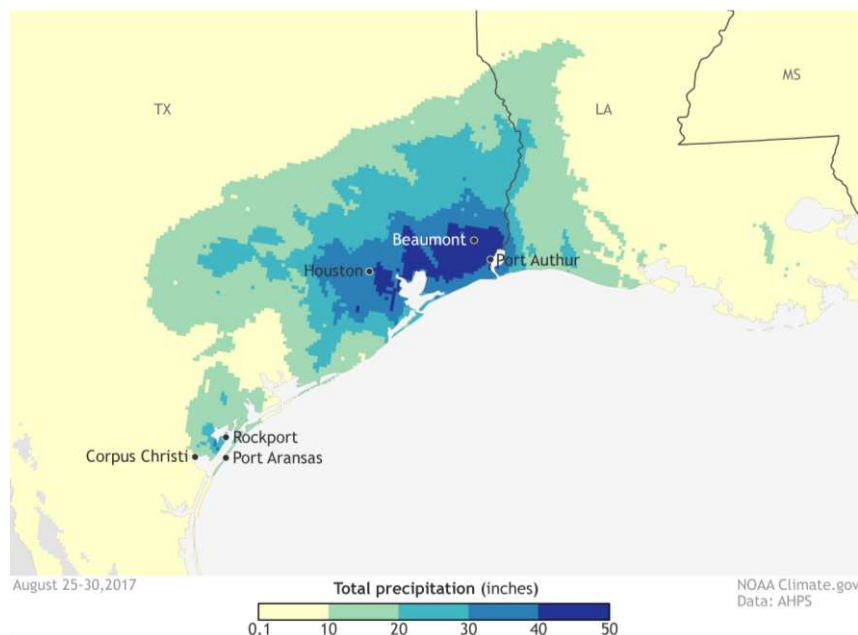
Figure 3. Rainfall totals in Texas from Hurricane Harvey, sourced from the National Weather Service. (<https://www.climate.gov/news-features/event-tracker/reviewing-hurricane-harveys-catastrophic-rain-and-flooding>)

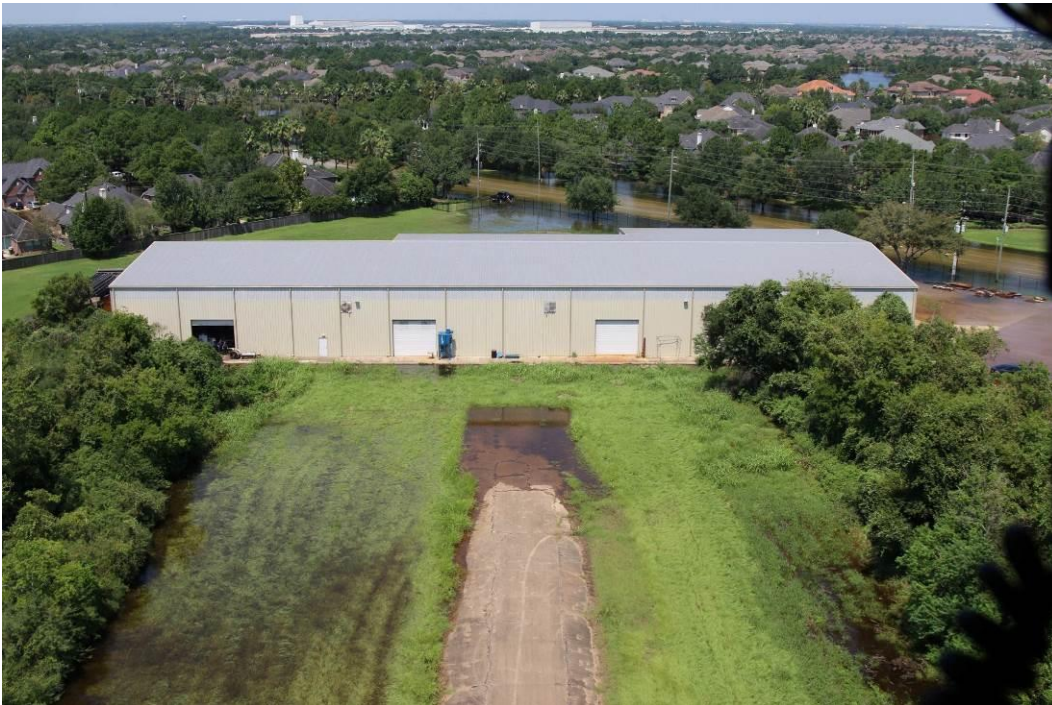
Figure 8. North end of Addicks auxiliary spillway (September 3, 2017, 29.84977° N, 95.58904° W, photo by USACE).

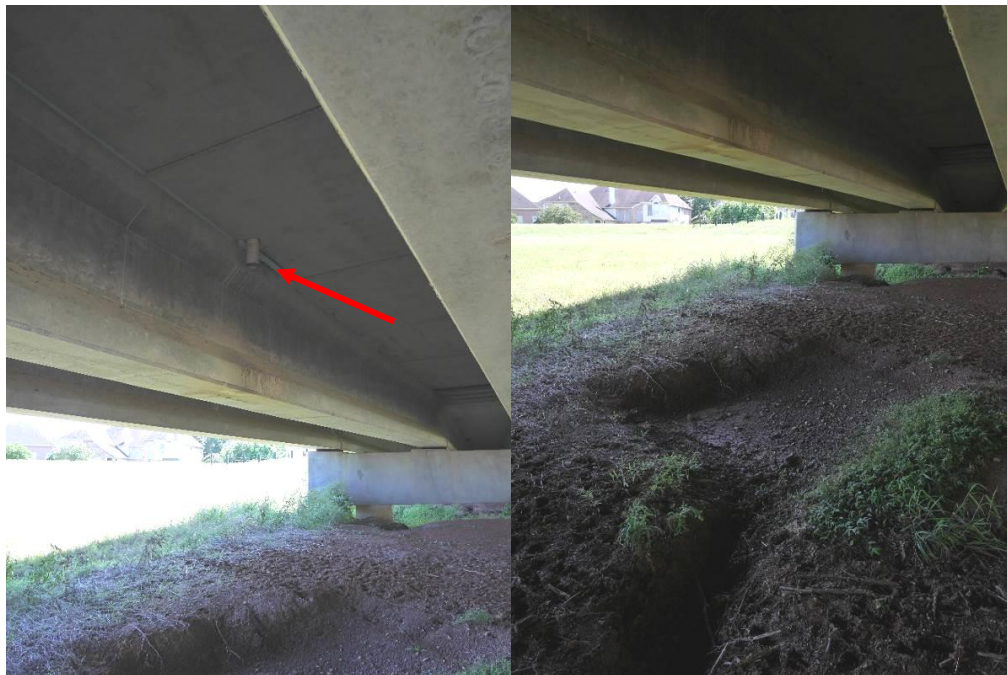
Figure 20. Erosion on Ditch H levee under the University Blvd Bridge due to flow impact from bridge drainage outfall (red arrow, September 10, 2017, 29.55902° N, 95.63744° W).

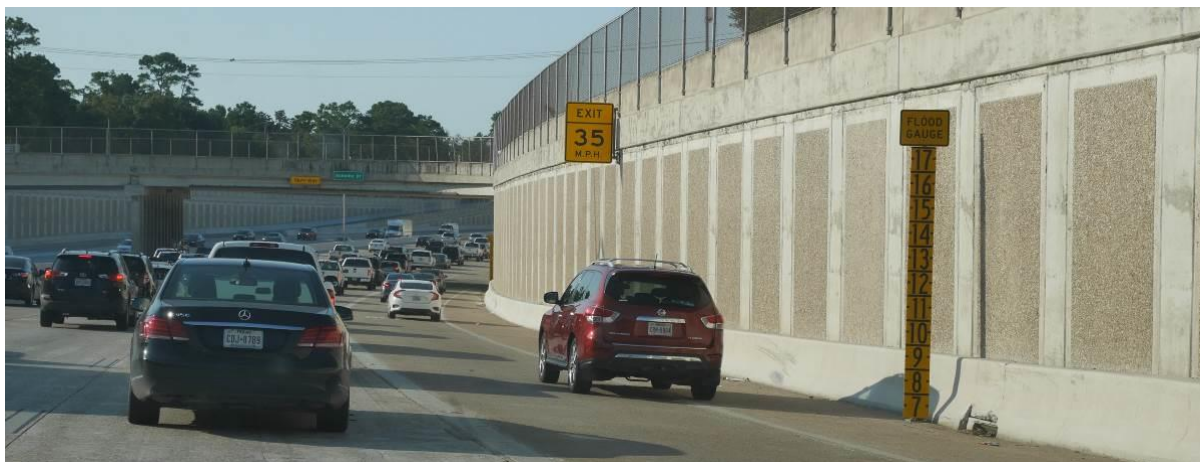
Figure 31. Beltway 8 / Boheme Drive underpass and flood depth signs (September 11, 2017, 29.76694° N, 95.56139° W).
