Seismological and geotechnical aspects of the $M_w=6.3$ L'Aquila earthquake in central Italy on 6 April 2009

Giuseppe Lanzo, Professor, University of Rome, Italy; email: giuseppe.lanzo@uniromal.it

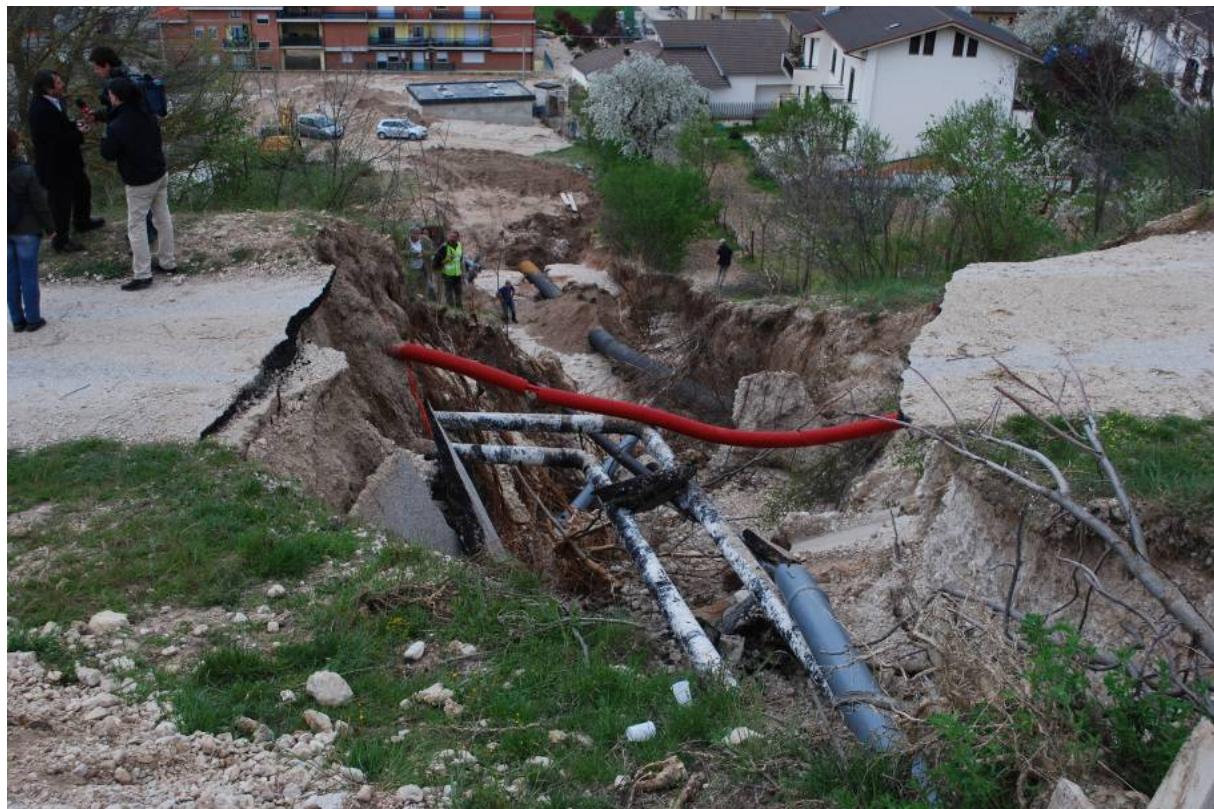
Figure 27. Paganica village: broken major water pipe (repaired) due to co-seismic rupture (Lat. 42,36537N Long. 13,46803E) (Photo by Mylonakis G.).

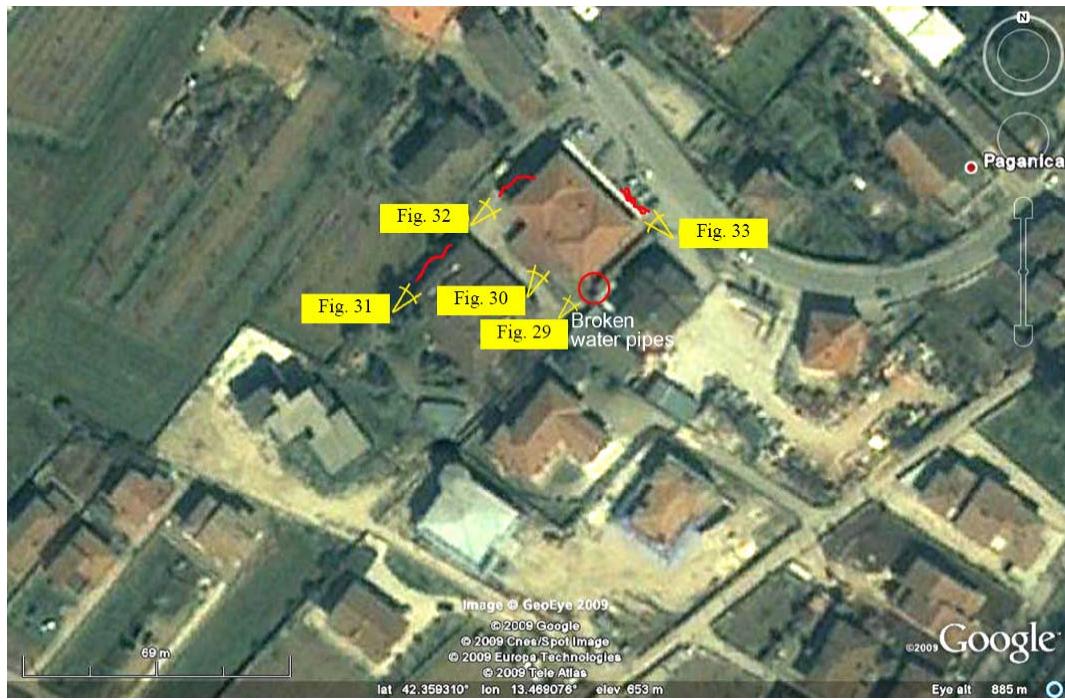
Figure 28. Plan view of Paganica site with marked positions of ground fissures, paved walkway cracks and broken water pipes. Directions of photo shots are indicated by yellow signs.

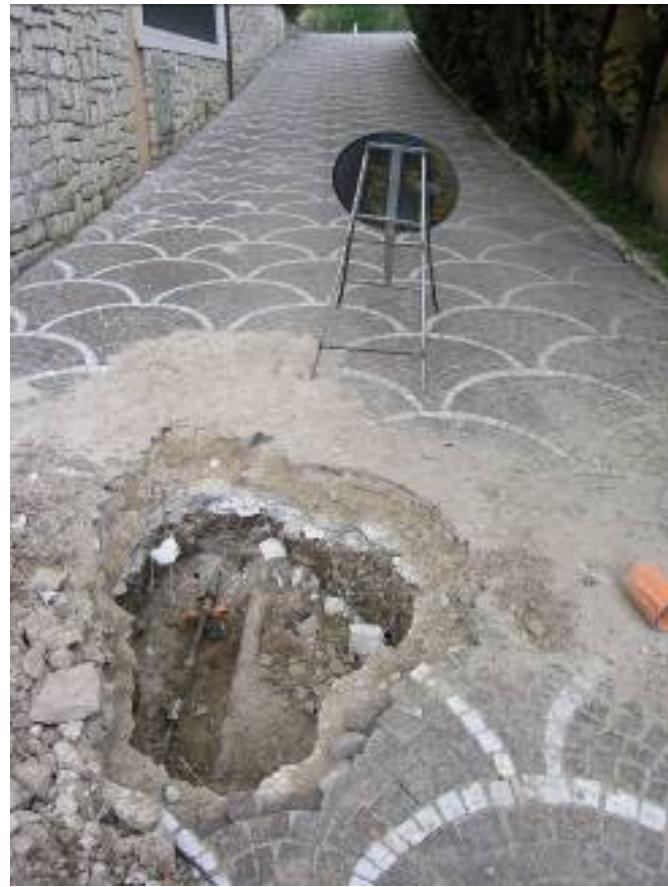
Figure 29. Failure of water pipe. (42.359335°N, 13.468954°E).

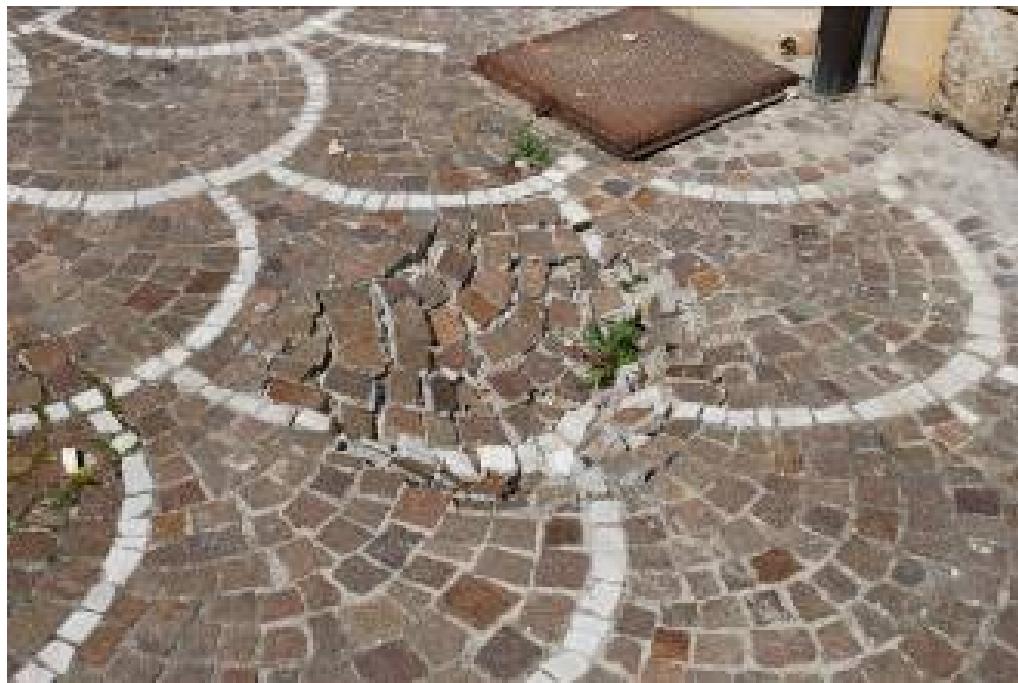
Figure 30. Local settlement close to piping system (42.359335°N, 13.468954°E).

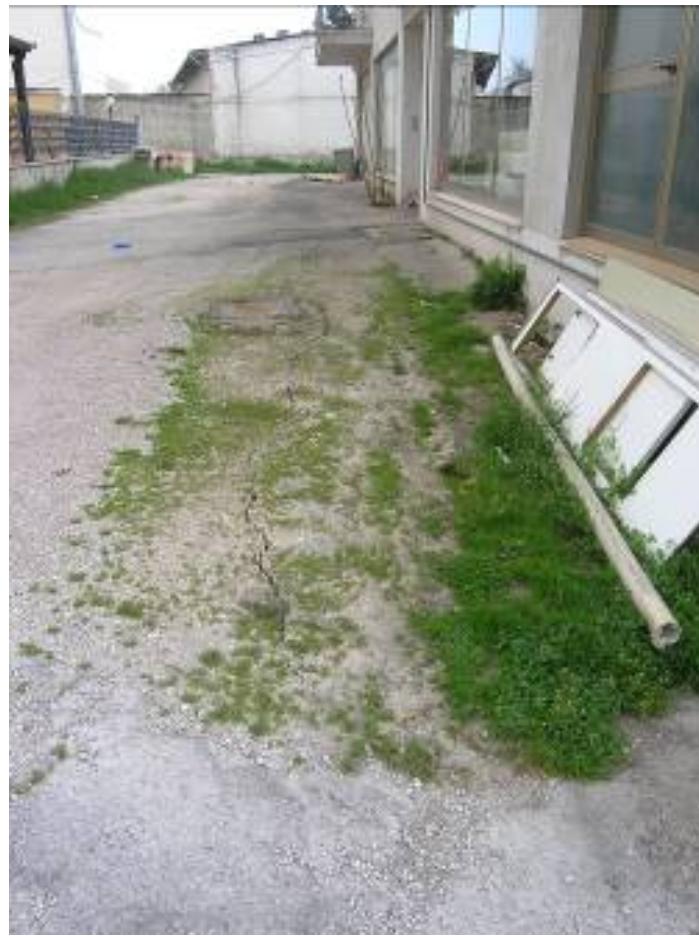
Figure 31. Ground fissures at the side of the building (42.359817°N, 13.468649°E).

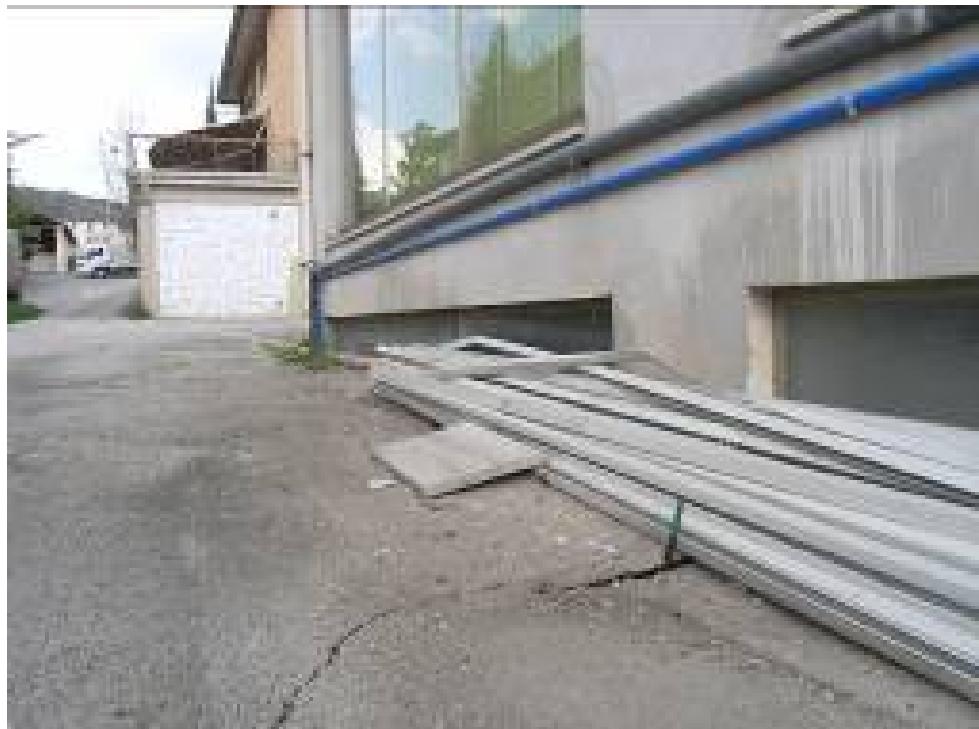
Figure 32. Ground fissures and settlement at the side of the building (42.359817°N, 13.468649°E).

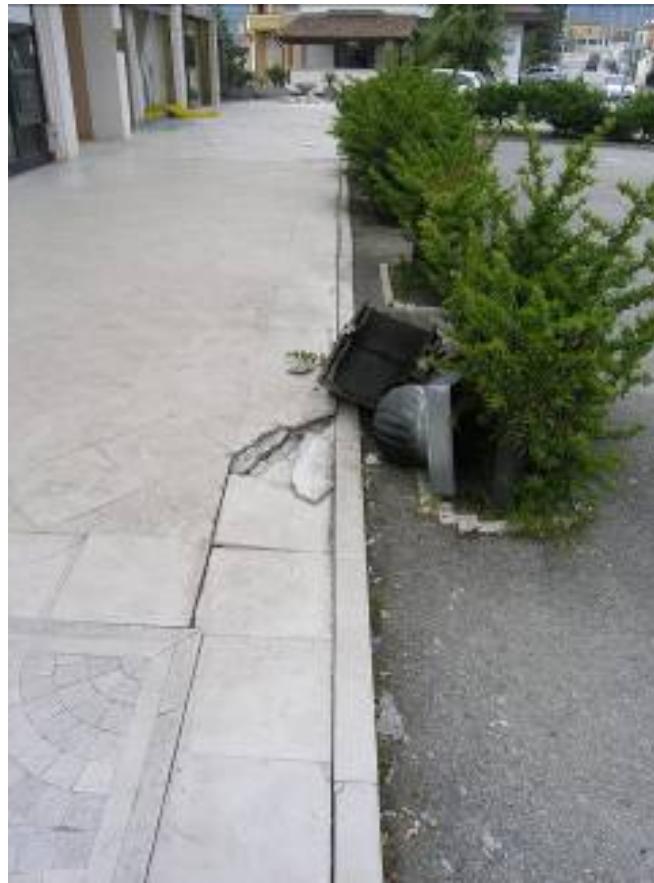
Figure 33. Separation cracks at sidewalk on front of building (42.359335°N, 13.468954°E).

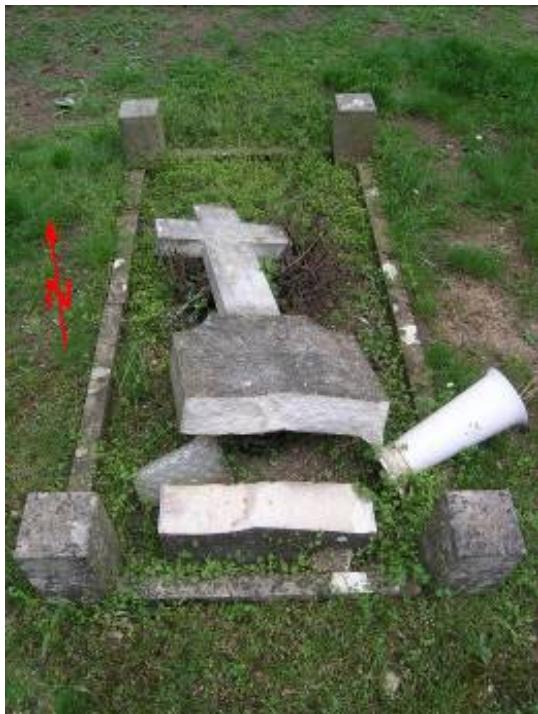
Figure 49. Grave markers breakage.

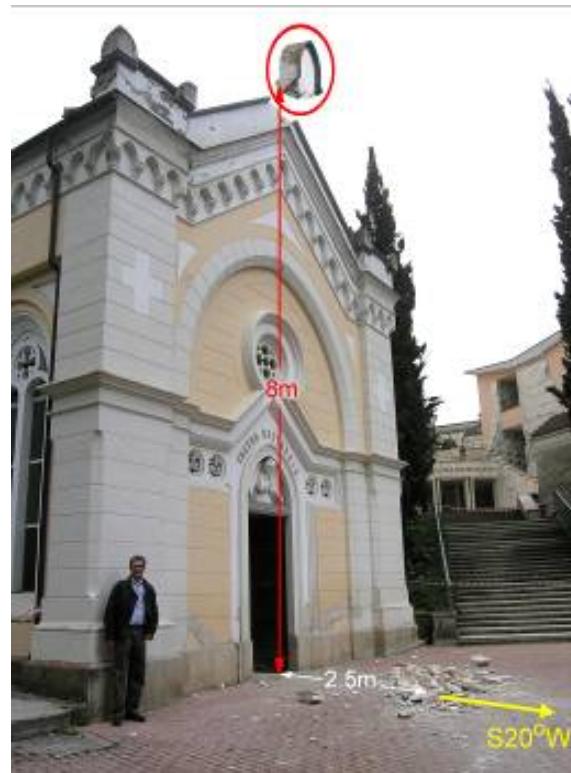
Figure 53. Fall of facade object at mortuary building.

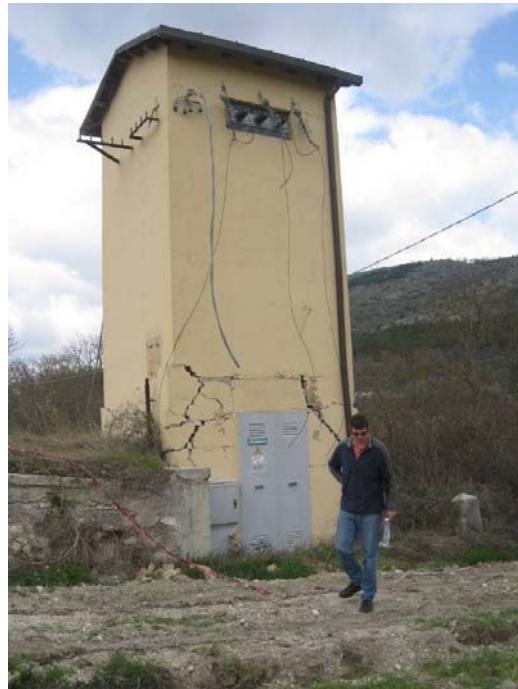
Figure 57. Heavily damaged seismometer station box (not in use at the time of the earthquake, no recording) on the northeast valley beneath the town of Castelnuovo. (42.2982°, 13.6295°).

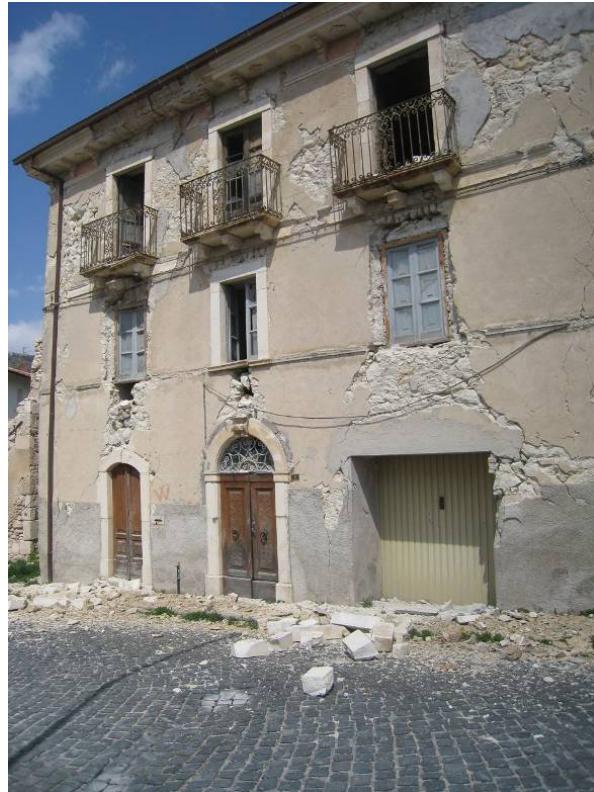
Figure 58. A typical heavily damaged structure in the lower elevation of Castelnuovo. Many structures in the lower elevation neighborhood had less observable damage. (42.2956°, 13.6274°).

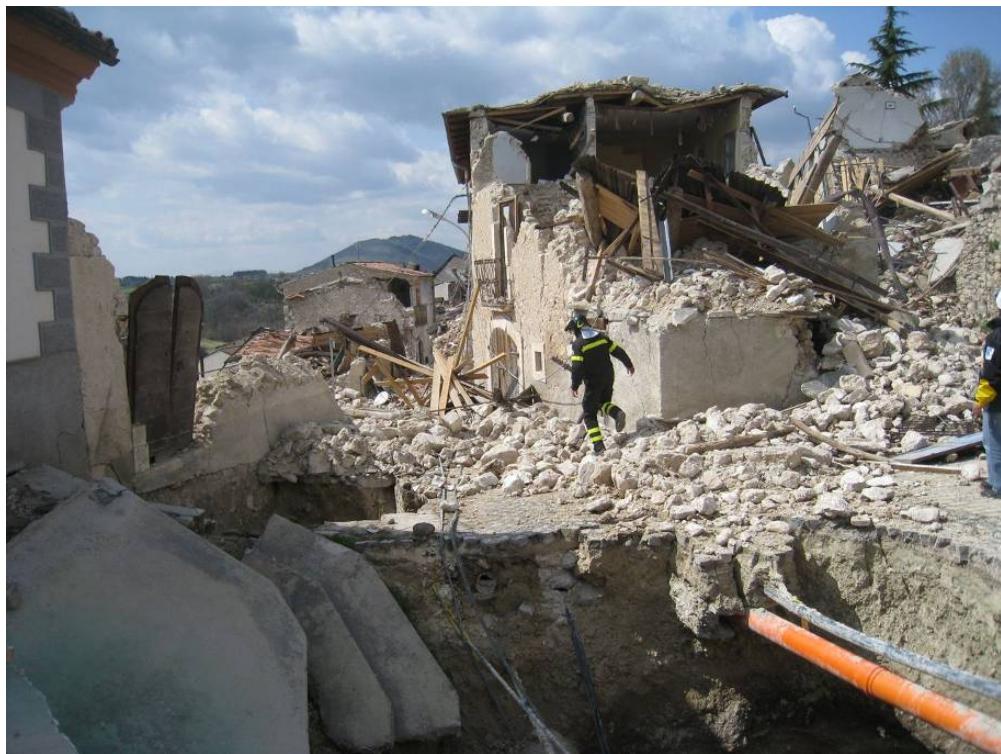
Figure 59. At the highest elevation of the hilltop town of Castelnuovo, almost all of the structures collapsed (D5) or were near collapse (D4). (42.2947°, 13.629°).

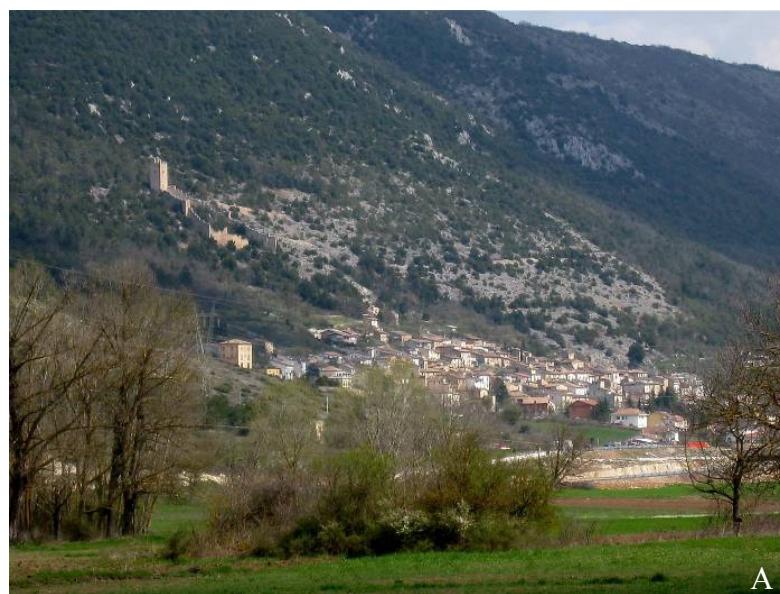
Figure 61. (A) The village of San Pio delle Camere built on Mesozoic limestone. This picture was taken from the lower flanks of Castelnuovo (from location 42.2898°, 13.6297° looking southeast).

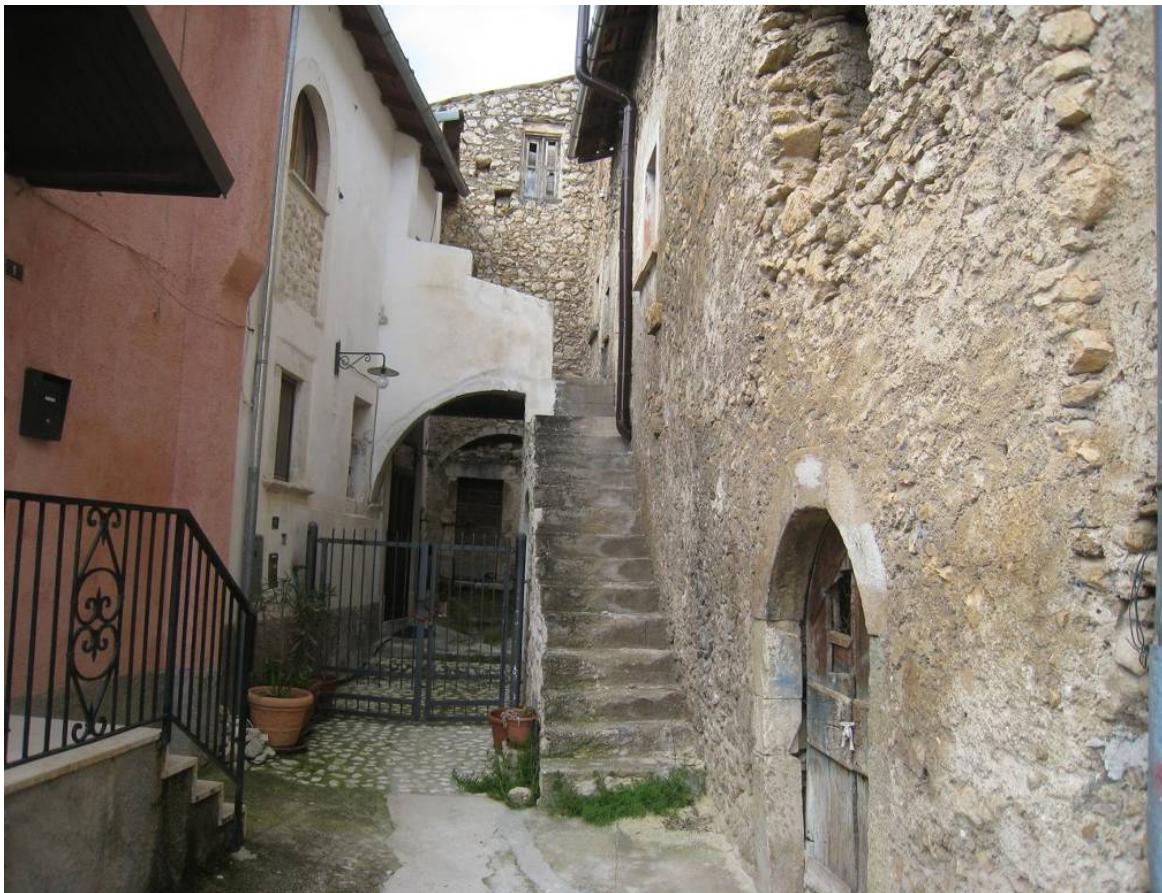
Figure 62. Typical unreinforced masonry structures in the village of San Pio delle Camere suffered no damage (D0), or slight cracking (D1). Structures in this village are similar to those in Castelnuovo. San Pio delle Camere is built on limestone bedrock.

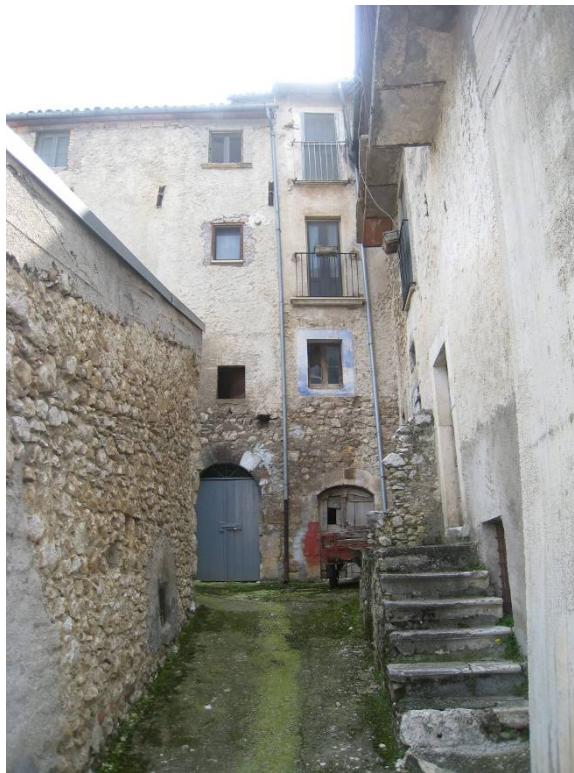
Figure 63. The reconnaissance team observed no damage to the town of Tussio. The town is built on Mesozoic calcareous bedrock (42.2657°, 13.6414°).

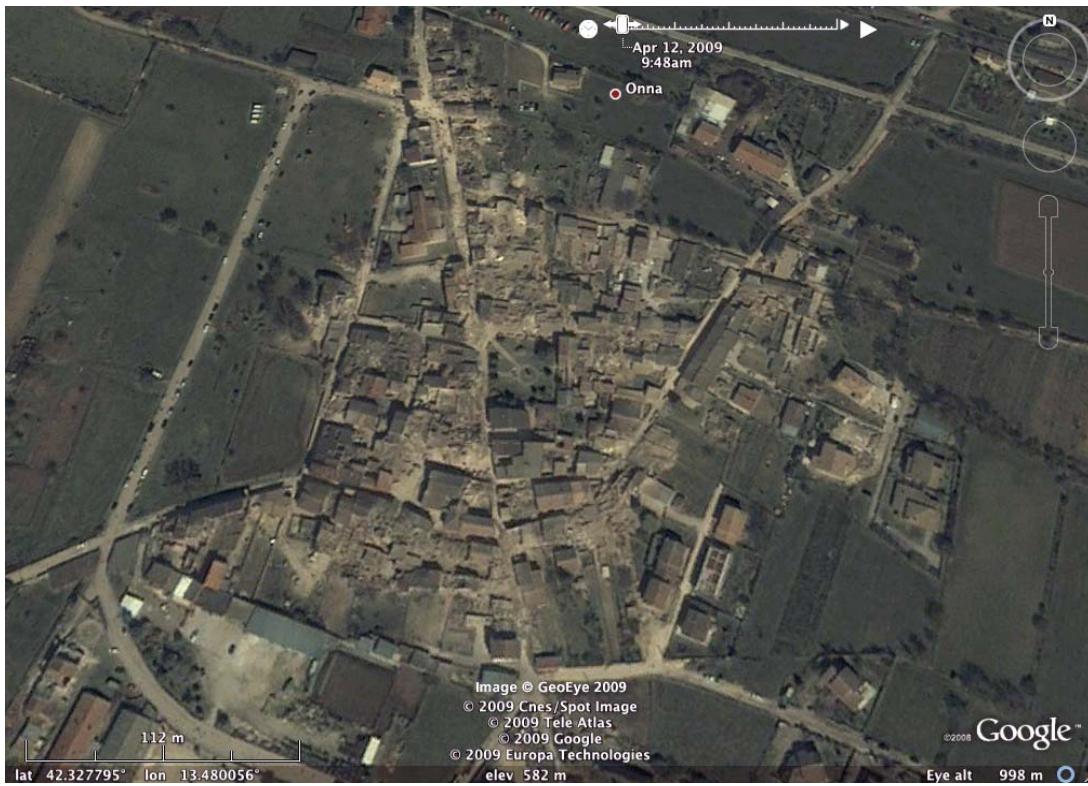
Figure 64. The village of Onna suffered D4–D5 damage in most of the unreinforced masonry structures. Reinforced concrete structures at the margins of the village performed well with only minor damage (D0-D2).

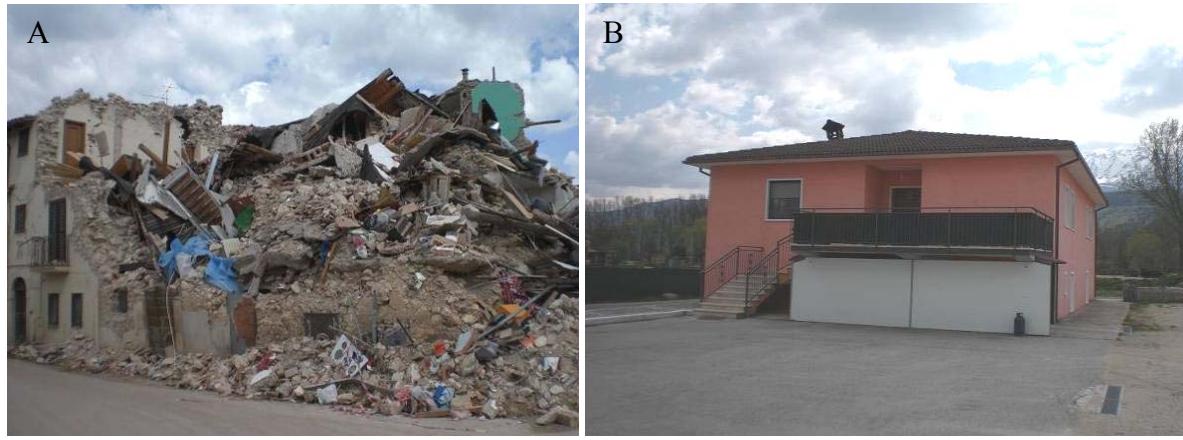
Figure 67. Onna. (A) D5 damage level on masonry building structures, (B) D0 damage on a RC building (except for the tilting of the chimney).

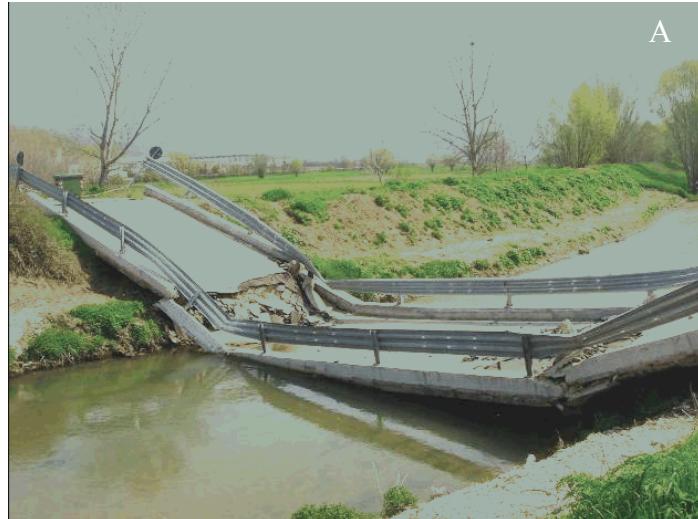
Figure 68. Onna. (A) Collapse (D5).

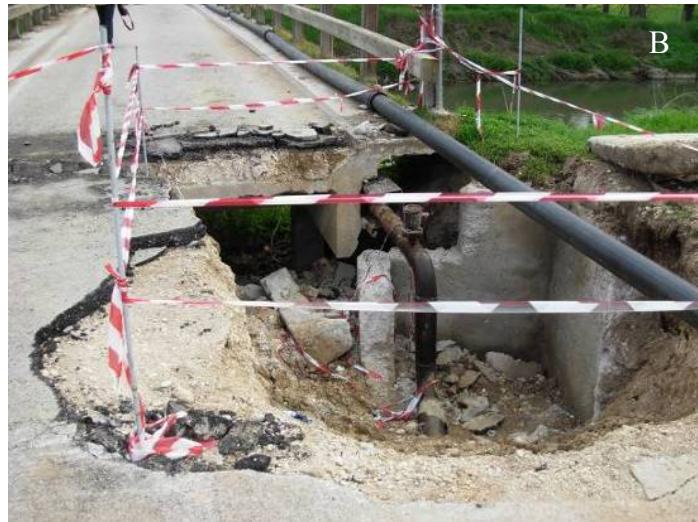
Figure 68. Omna. (B) Intense damage (D4) of RC bridges on the Aterno river.

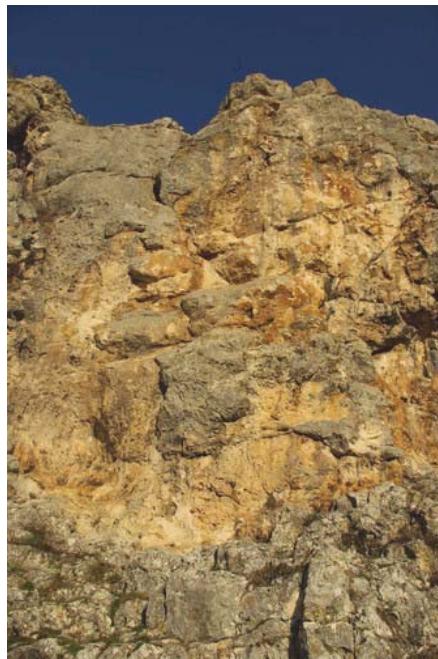
Figure 69. Monticchio: outcrop of the Jurassic limestone formation.

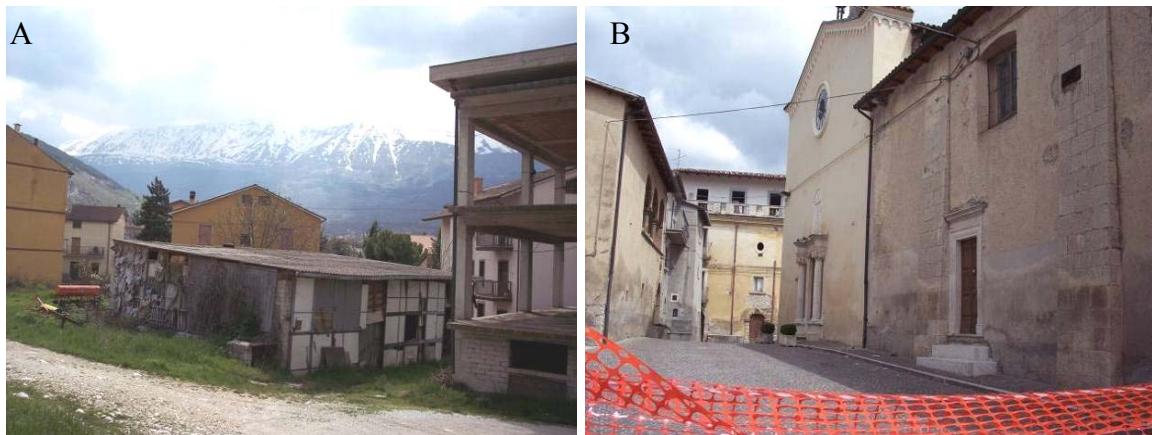
Figure 70. Monticchio. (A) D0 damage level on different building structures, (B) D0 damage on monumental masonry buildings.

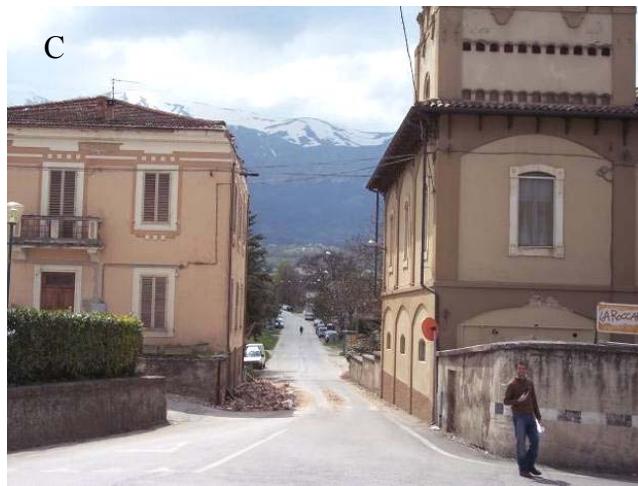
Figure 70. Monticchio. (C) D1 damage (fall of the cornice) on a masonry building.

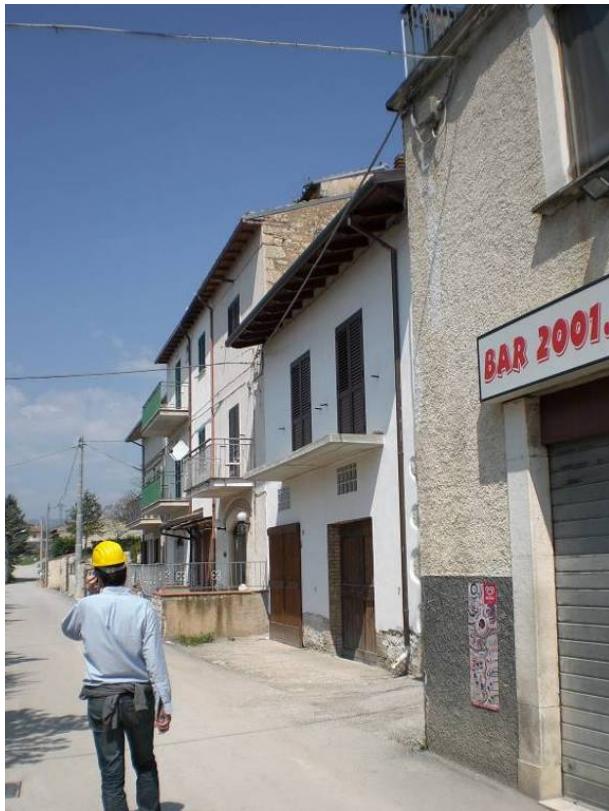
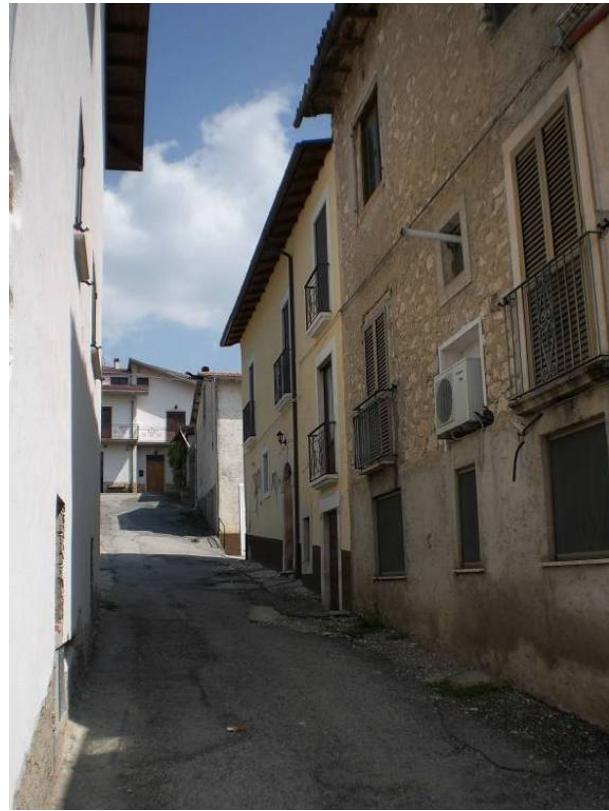
Figure 73. San Gregorio western part: masonry buildings with minor damages.

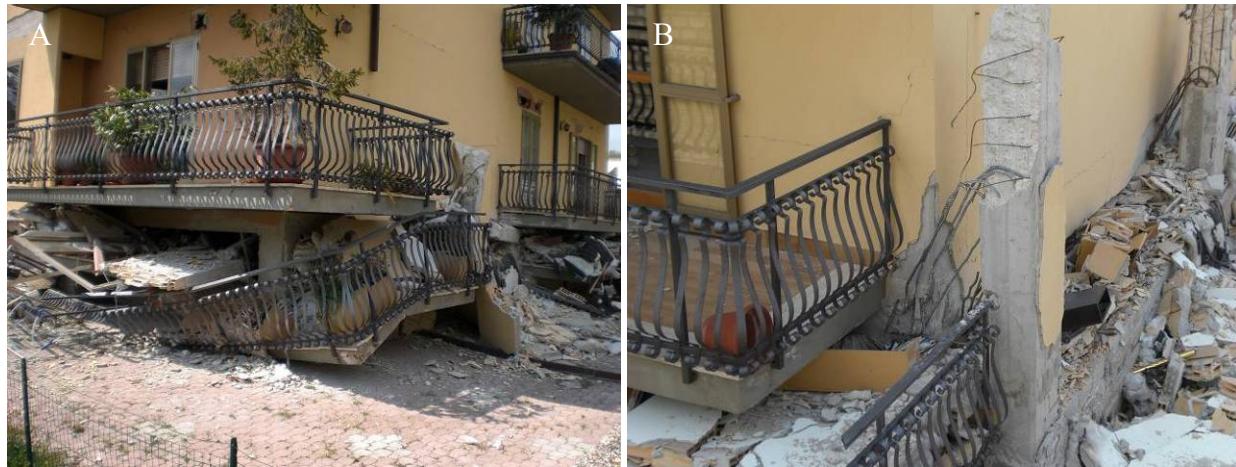
Figure 74. San Gregorio eastern part. (A) RC building “pancake” collapse, (B) Detail of sheared pillars.

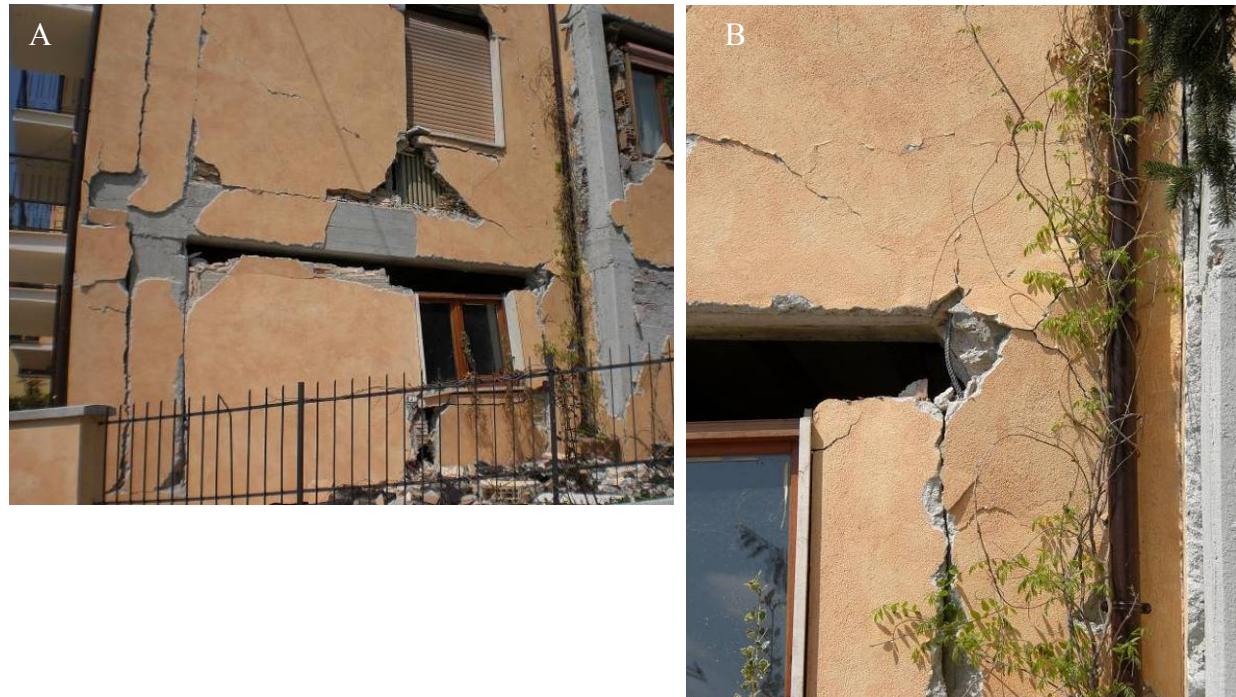
Figure 75. San Gregorio eastern part. (A) RC building with structural damage, (B) Detail of the damage to the beam-column connection.

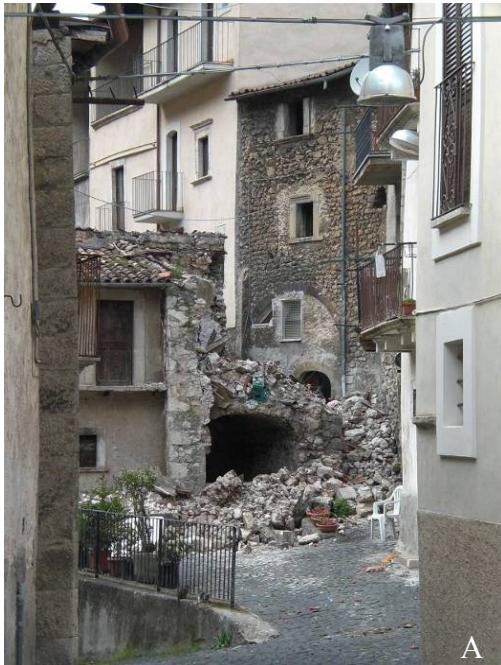
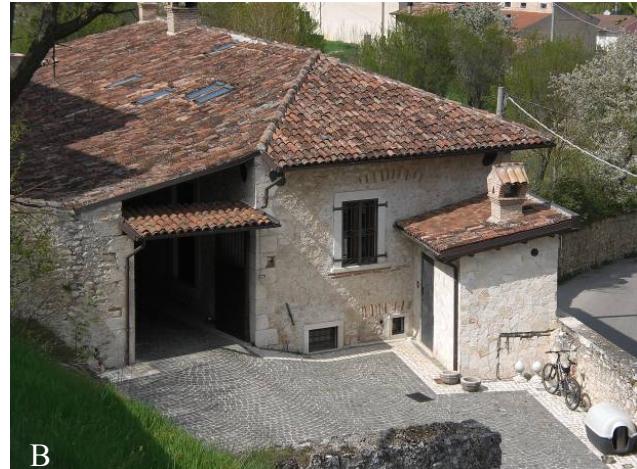
Figure 77. Fossa. (A) Collapse of masonry constructions in the historic center, (B) Strengthened masonry construction with no damage.

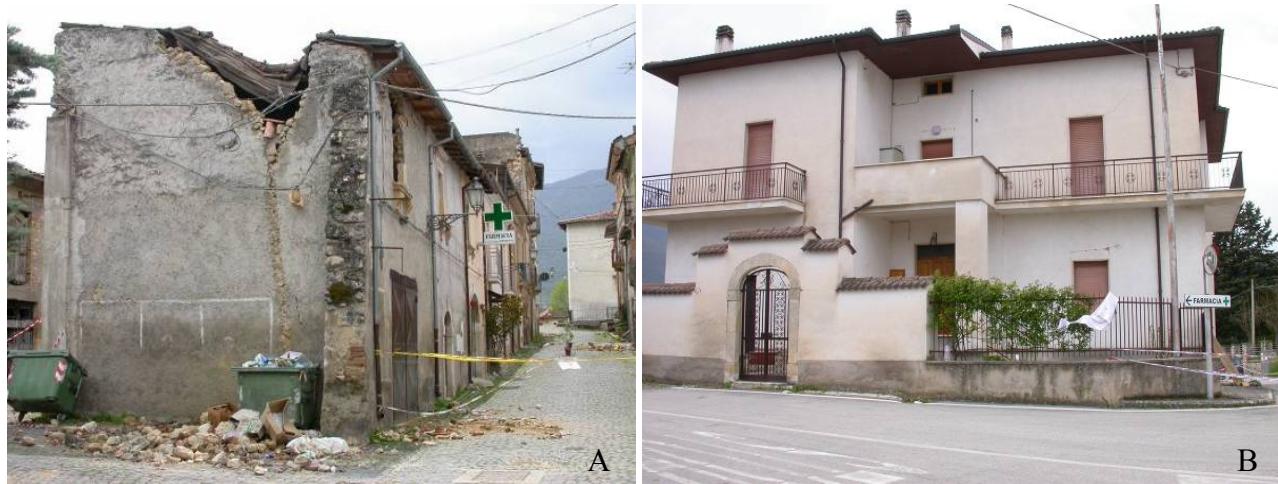
Figure 79. S. Eusanio Forconese village. (A) Partial collapse of masonry building (D4), (B) Slight damage to a RC building nearby (D1).

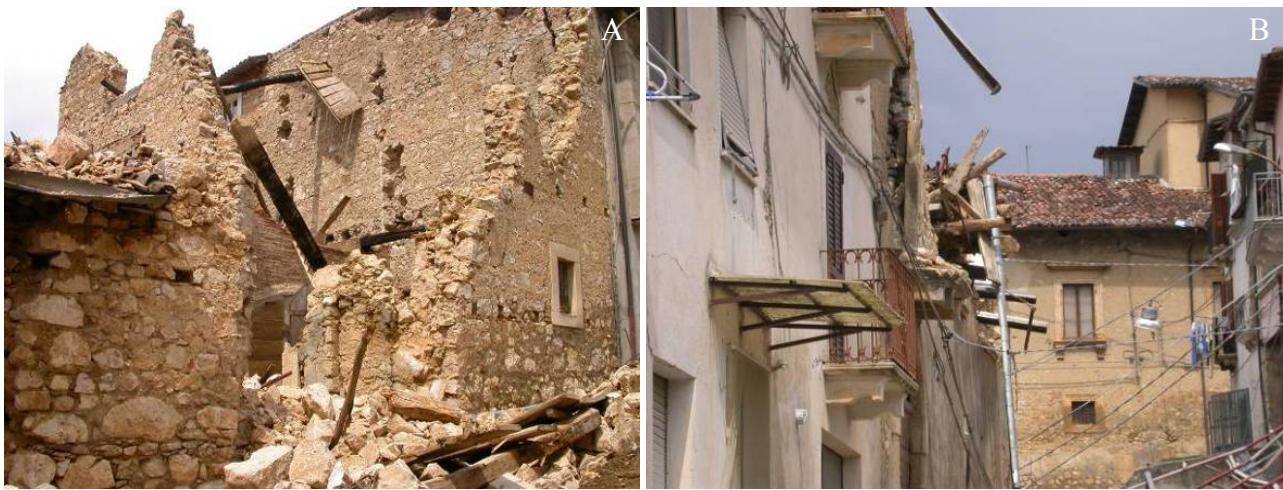
Figure 80. S. Eusanio Forconese. (A) Collapse of old masonry building (D5), (B) Partial collapse of masonry building (D4).

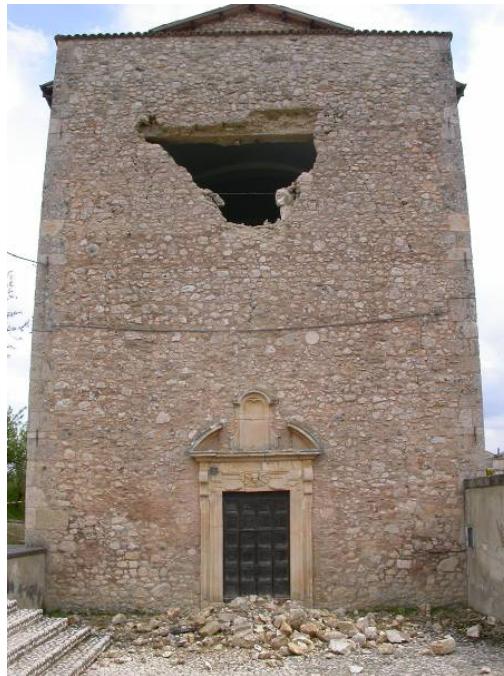
Figure 81. S. Eusanio Forconese: partial collapse of the masonry church (D4).

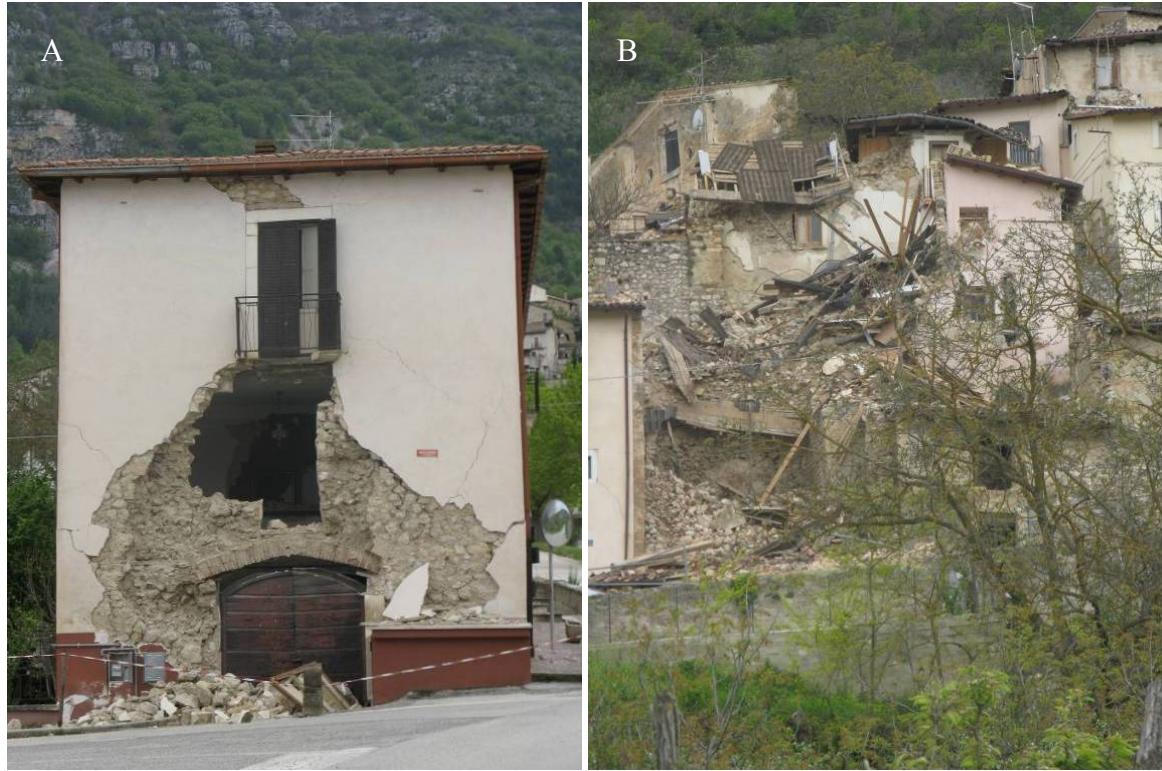
Figure 82. Casentino. (A) Partial collapse of the masonry building at the entrance of the village, (B) Collapse of old poor quality masonry buildings in the historic center.

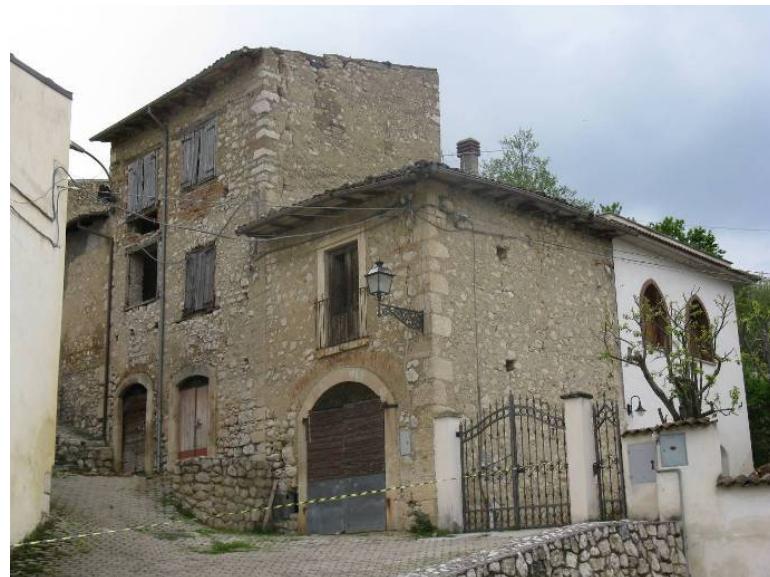
Figure 83. Casentino masonry buildings with some wall cracks.

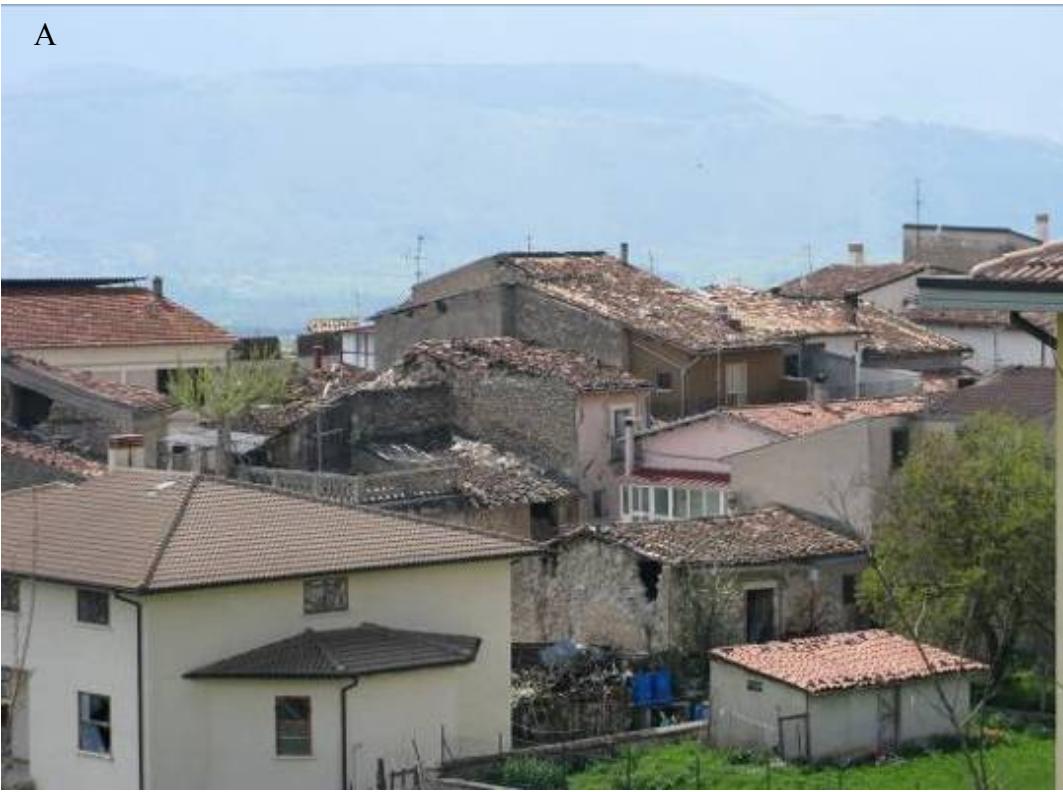
Figure 86. Poggio Picenze. (A) Variable damage (D3-D4) on masonry buildings of different style.

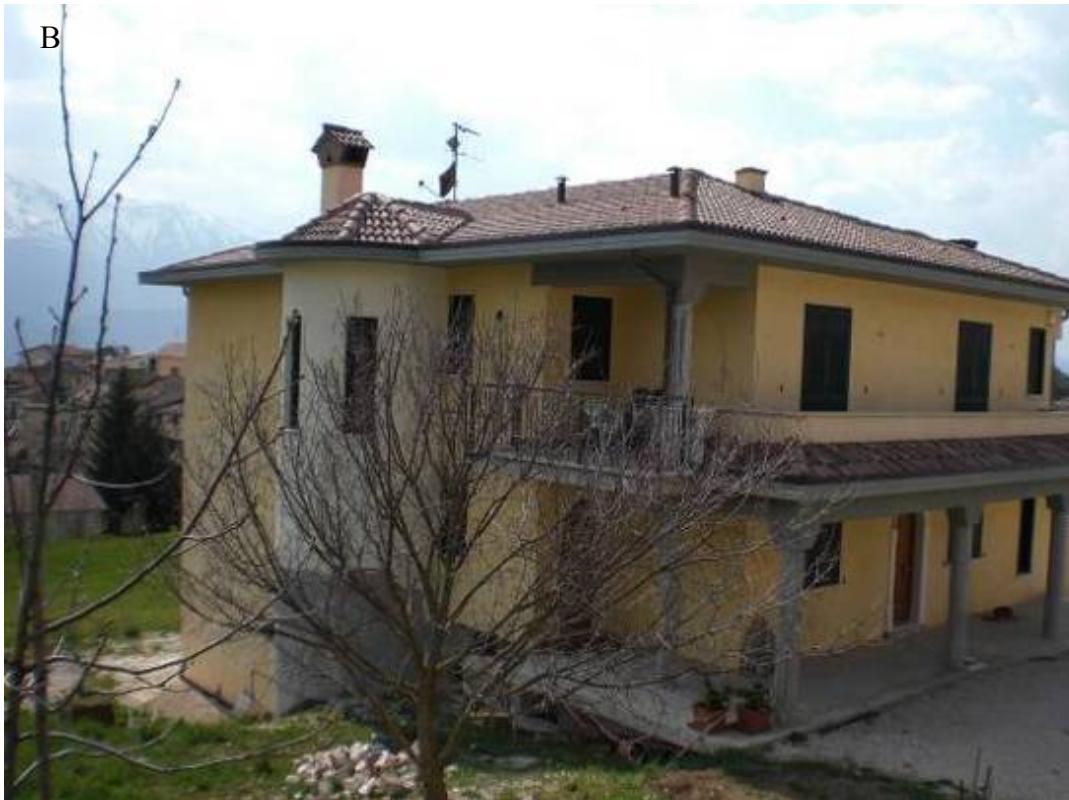
Figure 86. Poggio Picenze. (B) Undamaged RC house (D0) close to the (C) monumental church (D3).

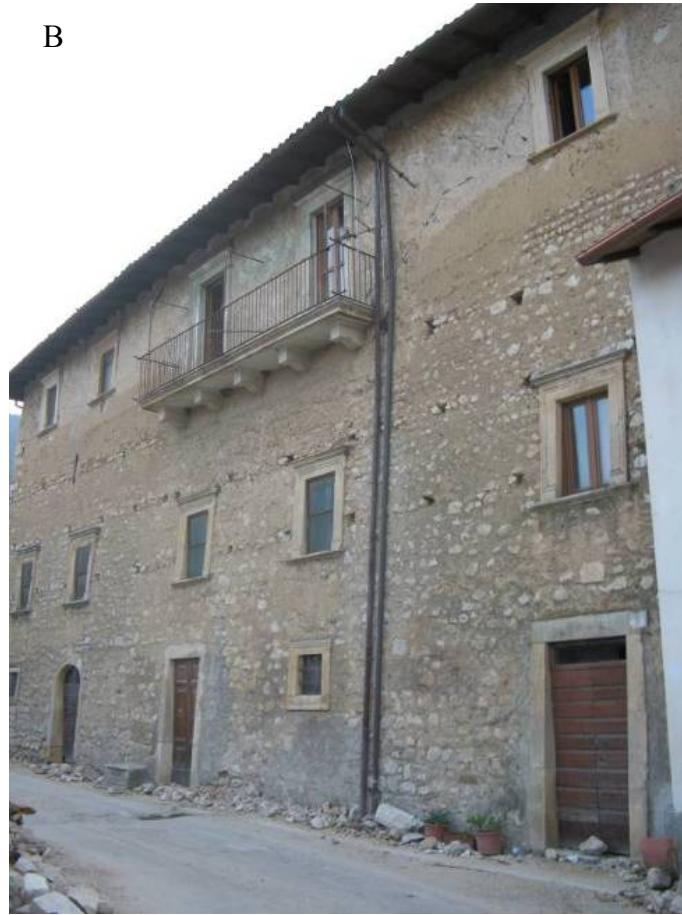
Figure 88. Villa S. Angel. (B) Reinforced masonry in the historic center with minor cracks in the highest story (D2).

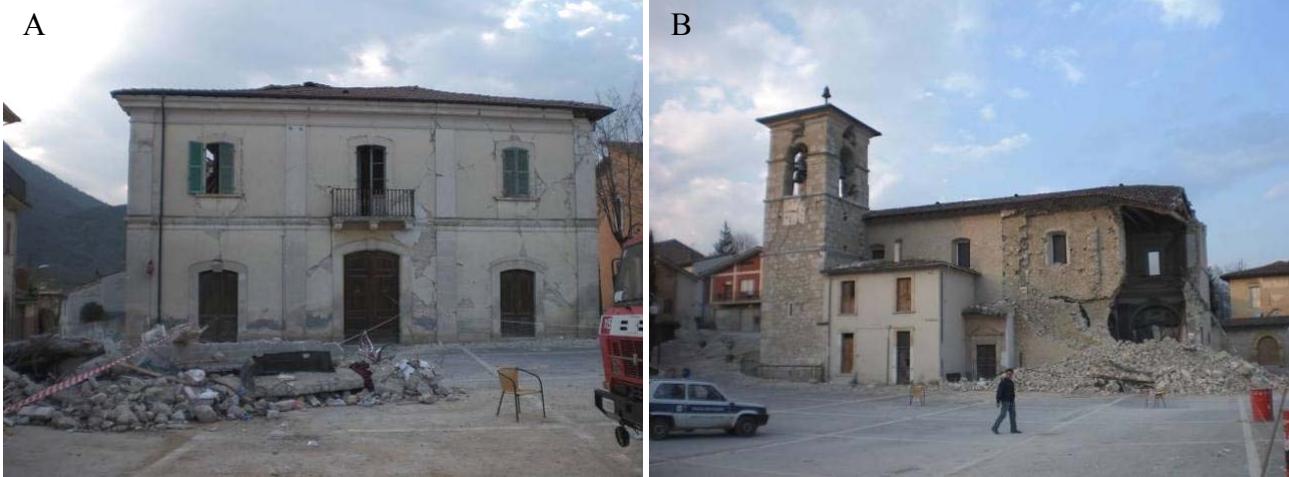
Figure 89. Villa S. Angelo, historic center with (A) masonry building crack,; (B) partly collapsed church.

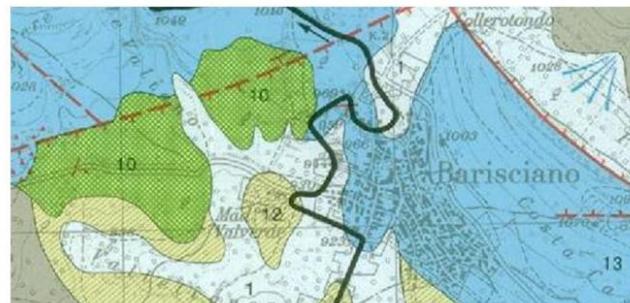
1	Alluvial and colluvial sediments (Holocene)
10	Fine cemented gravels (lower Pleistocene)
11	Carbonate silts with thin sand lenses (lower Pleistocene)
12	Alternate layers of carbonate silts (11) and breccia (13) (lower Pleistocene)
13	Limestone and breccia (lower Pleistocene)
14a 14b	Limestone (Cretaceous – upper Miocene)
