Seismological and geotechnical aspects of the $M_w=6.3$ L'Aquila earthquake in central Italy on 6 April 2009

Giuseppe Lanzo, Professor, University of Rome, Italy; email: giuseppe.lanzo@uniromal.it

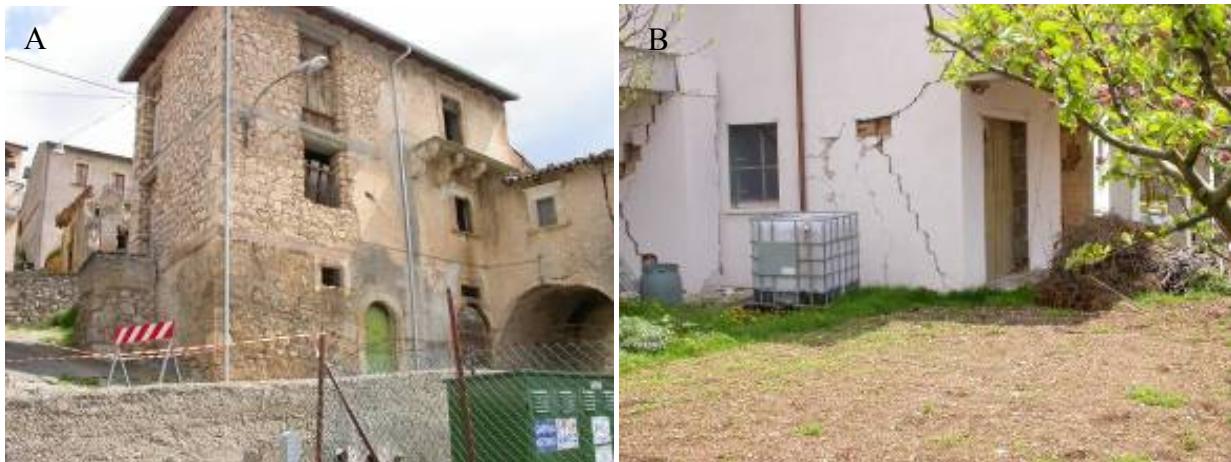
Figure 96. Barisciano. (A) Collapse (D5) of an old masonry building in background, (B) Damages (D1/D2) to RC buildings.

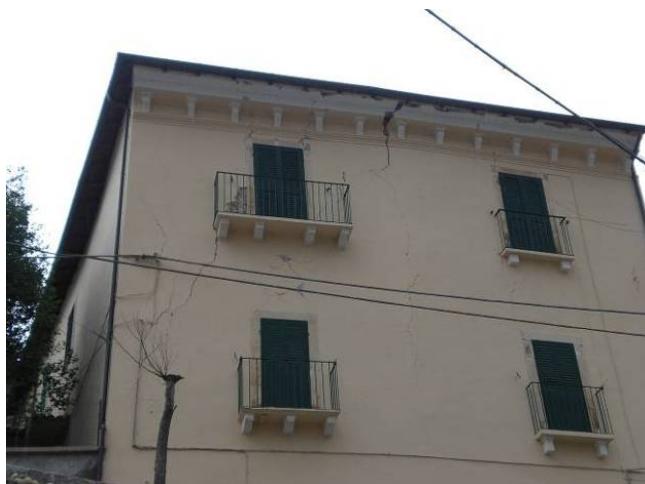
A large, two-story stone building with a partially collapsed roof and a collapsed chimney. The building is surrounded by rubble and debris. A tree is visible in the foreground.

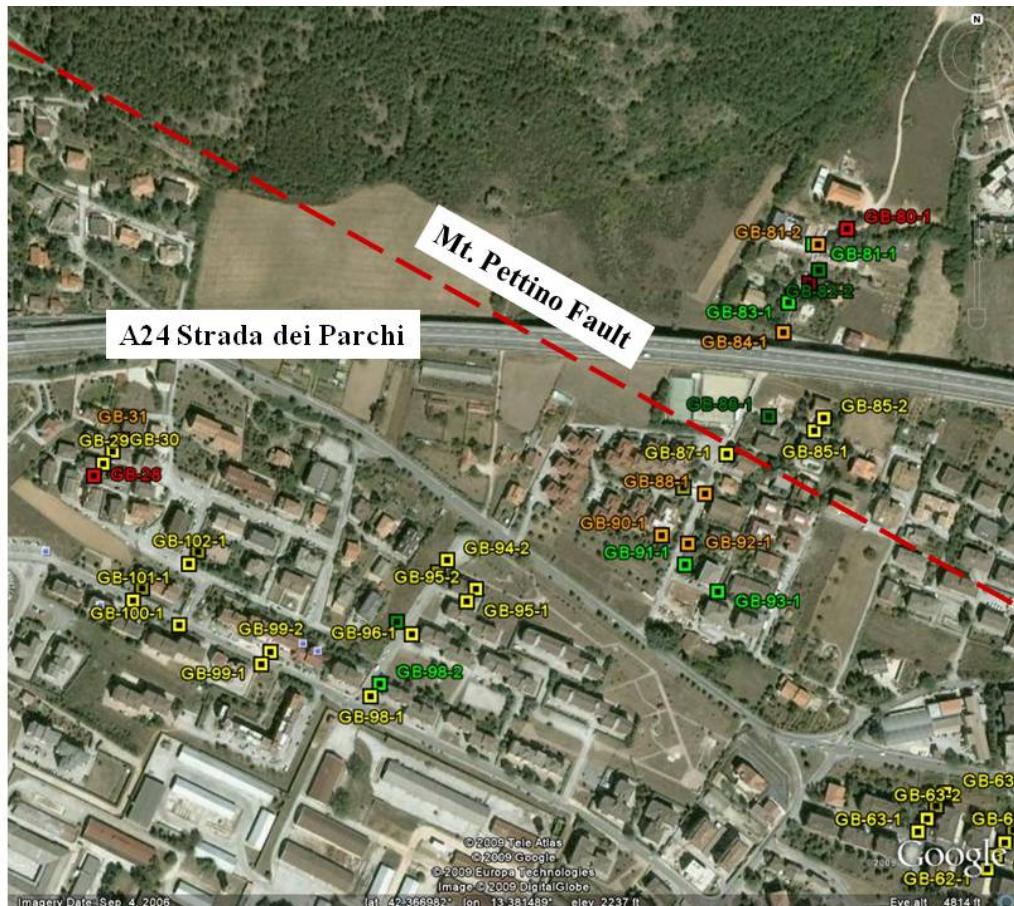
Figure 103. Zone (a) of the building damage survey along the Mt. Pettino Fault.

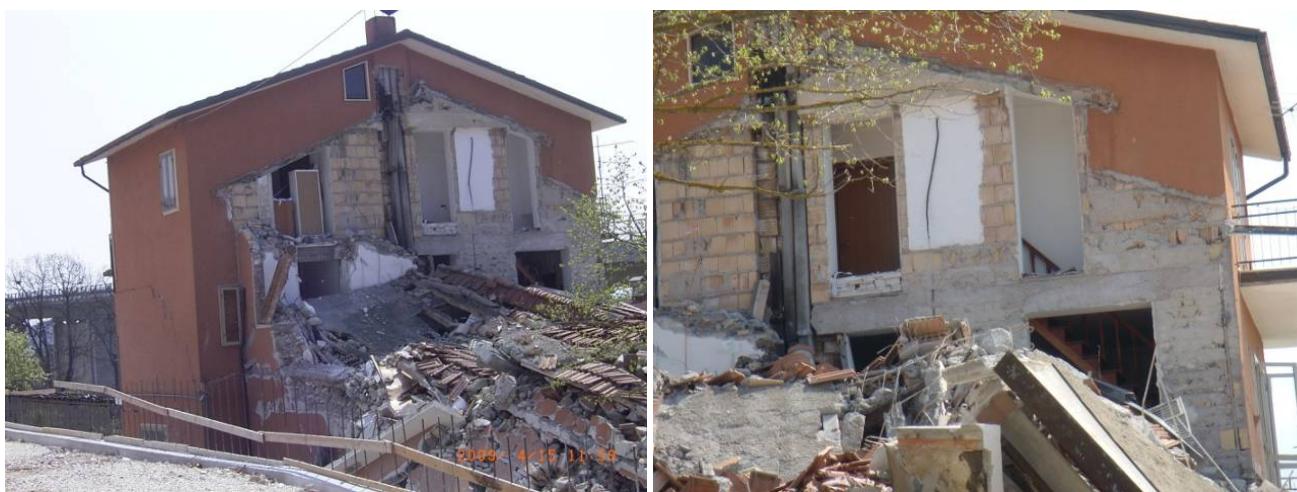
Figure 104. Masonry structure at waypoint GB-82-1.

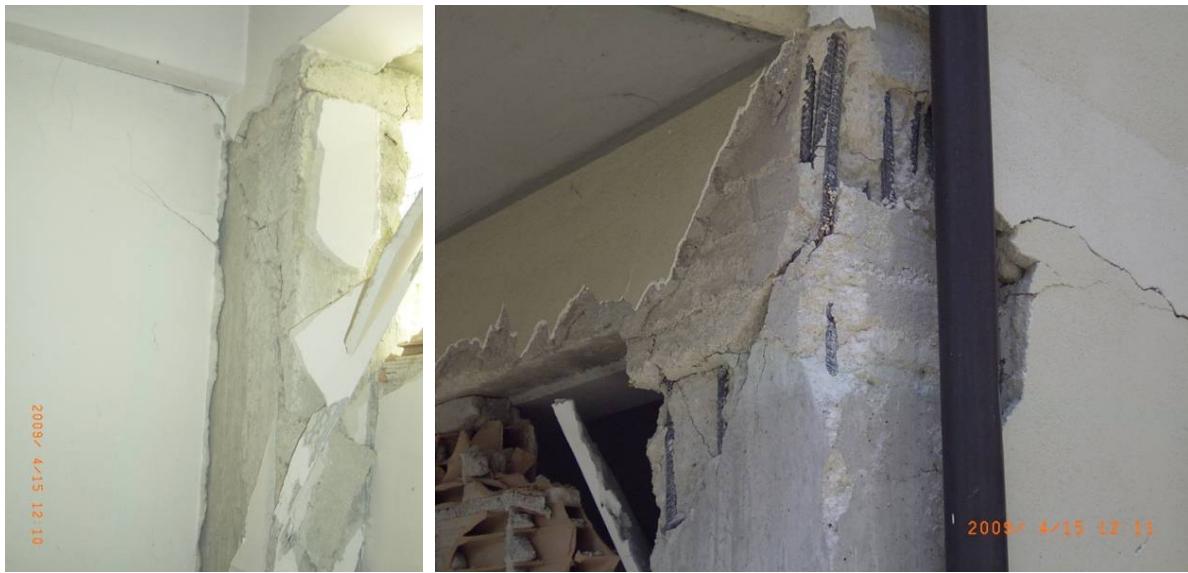
Figure 105. Example of D3 damage in the building at waypoint GB-88-1.

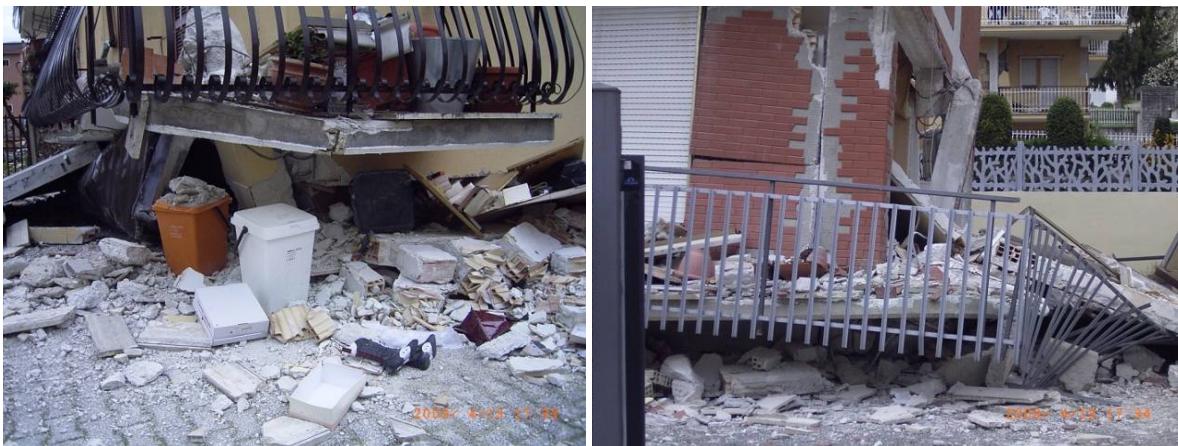
Figure 106. Example of D5 damage in the building at waypoints GB-27-1 and GB-28-1.

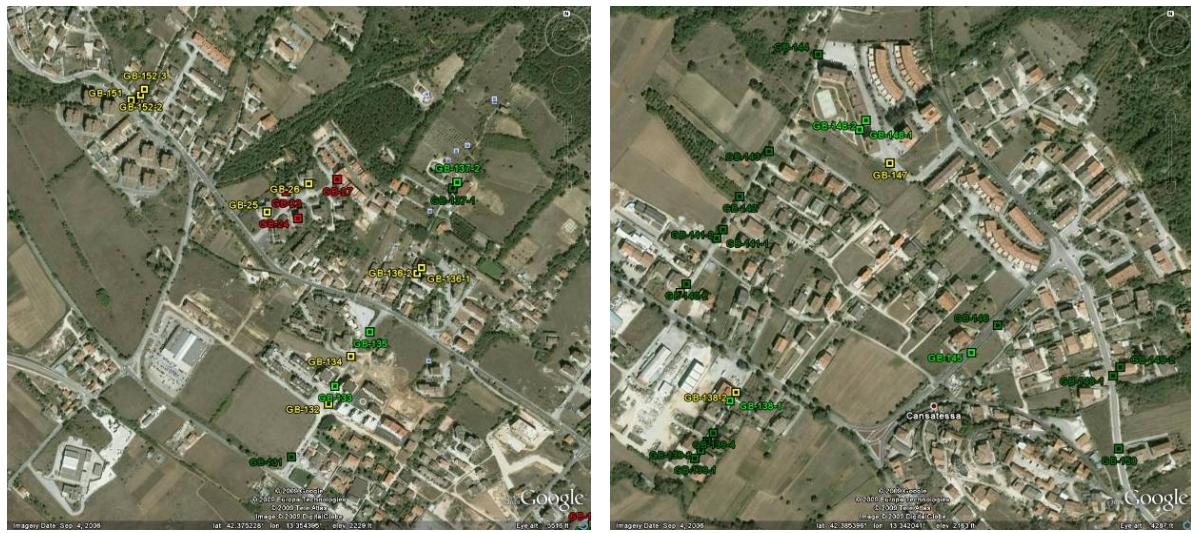
Figure 107. Results of the building damage survey along the Mt. Pettino Fault: Zones b, c, d, and e.

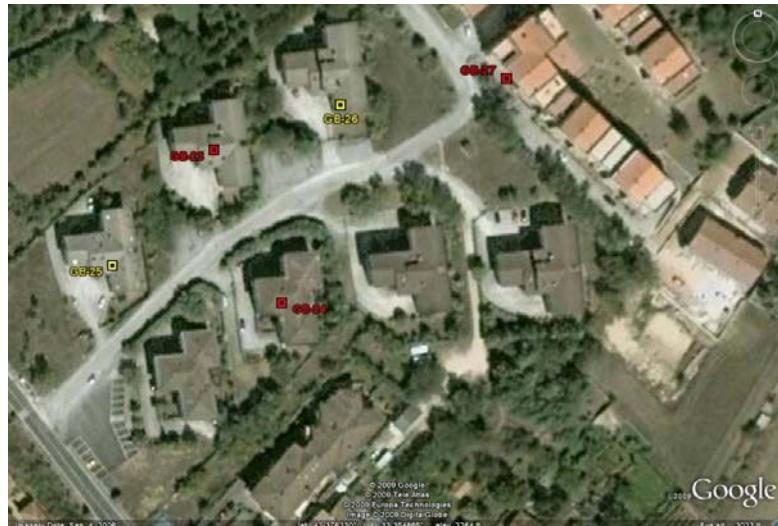
Figure 108. Cluster of damage in zone (d).

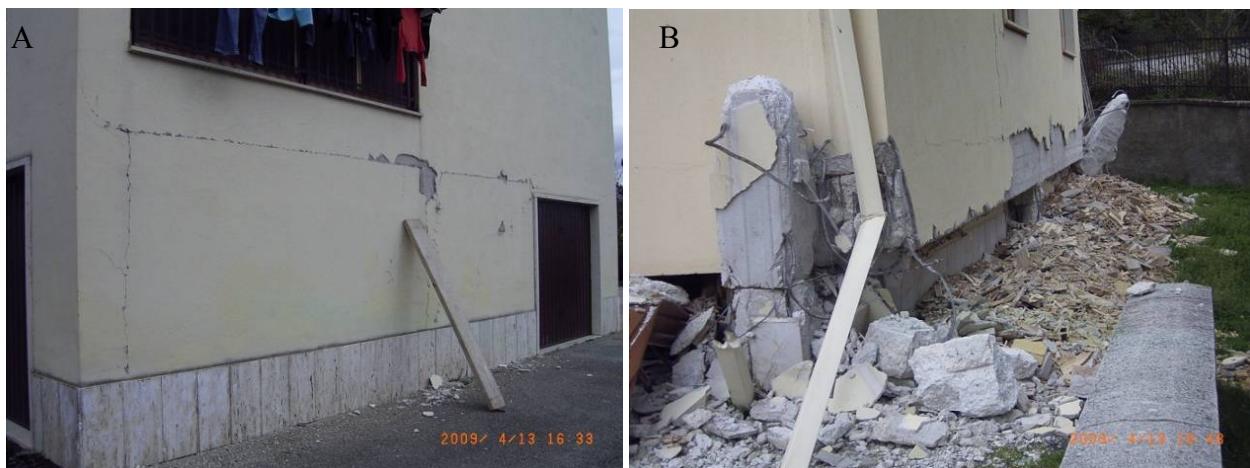
Figure 109. Damage on the structures in the cluster in zone (d). (A) Waypoint GB-22-1 (D1), (B) Waypoint GB-23-1 (D5).

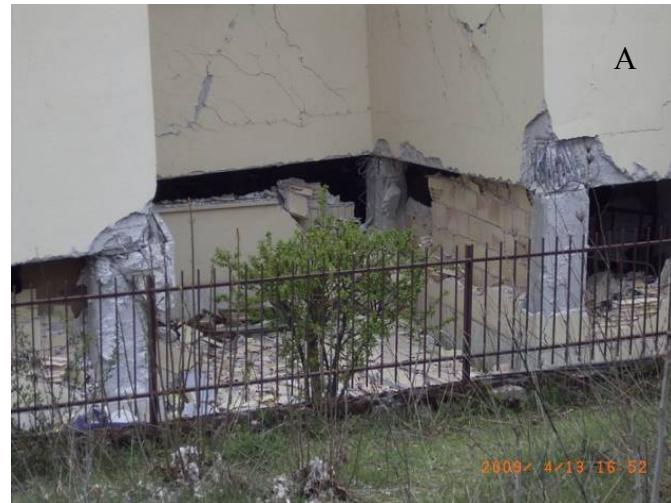
Figure 110. Damage on the structures in the cluster in zone (d). (A) Waypoint GB-24-1 (D5).

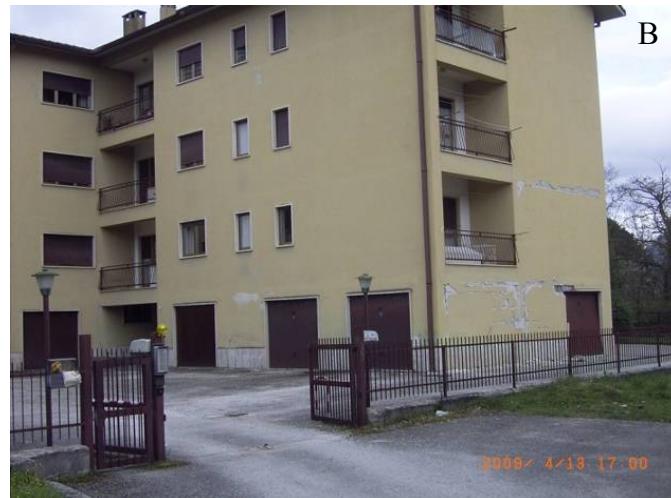
Figure 110. Damage on the structures in the cluster in zone (d). (B) Waypoint GB-25-1 (D2).

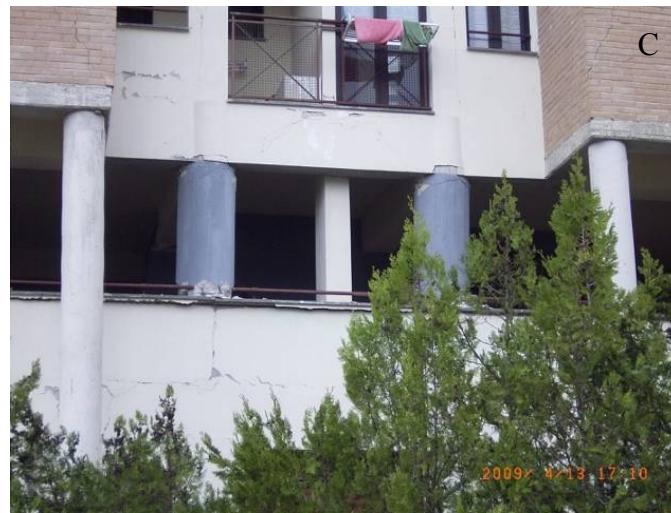
Figure 110. Damage on the structures in the cluster in zone (d). (C) Waypoint GB-26-1 (D2).

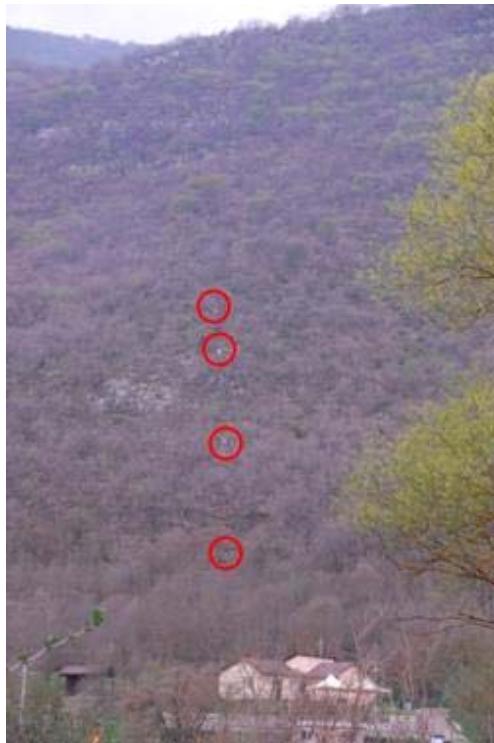
Figure 116. Additional impact marks as indicated by an alignment of fresh scars (42.255N 13.547E).

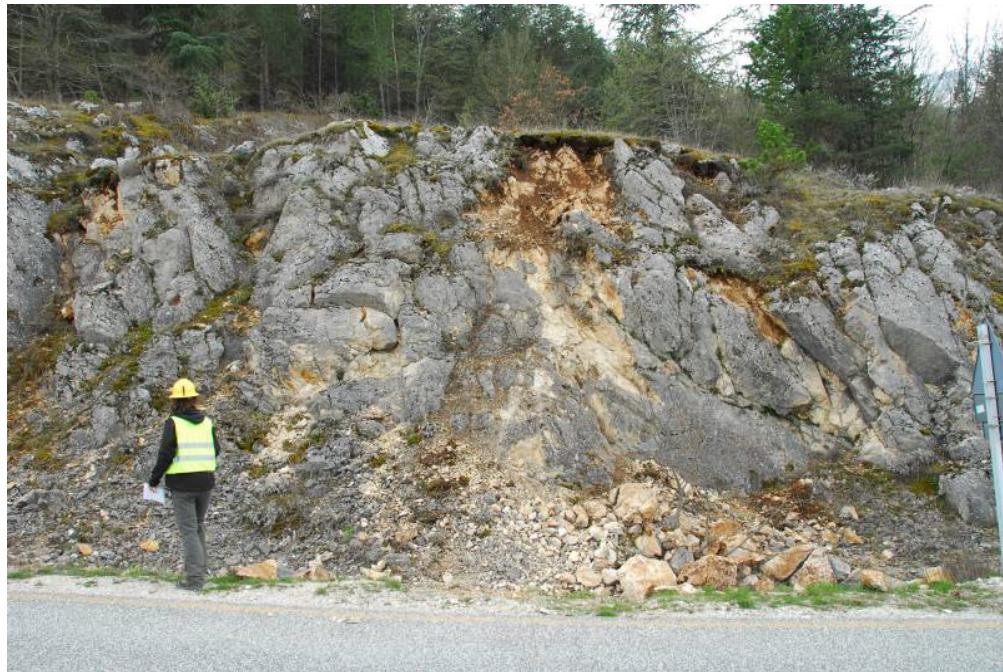
Figure 117. Shallow ravelling-type failure of weathered limestone blocks (42.278N, 13.467E).

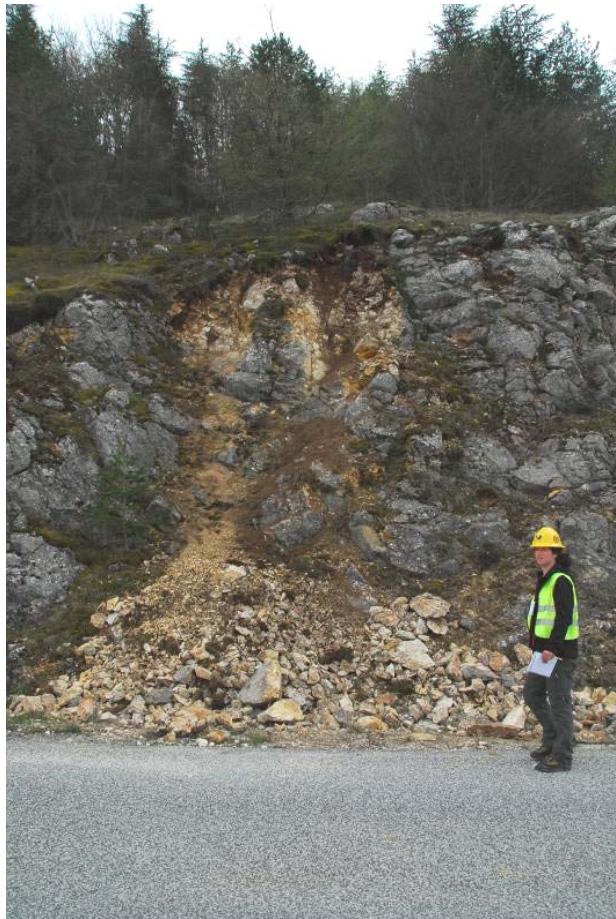
Figure 118. Shallow ravelling-type failure of weathered limestone blocks (42.278N, 13.468E).

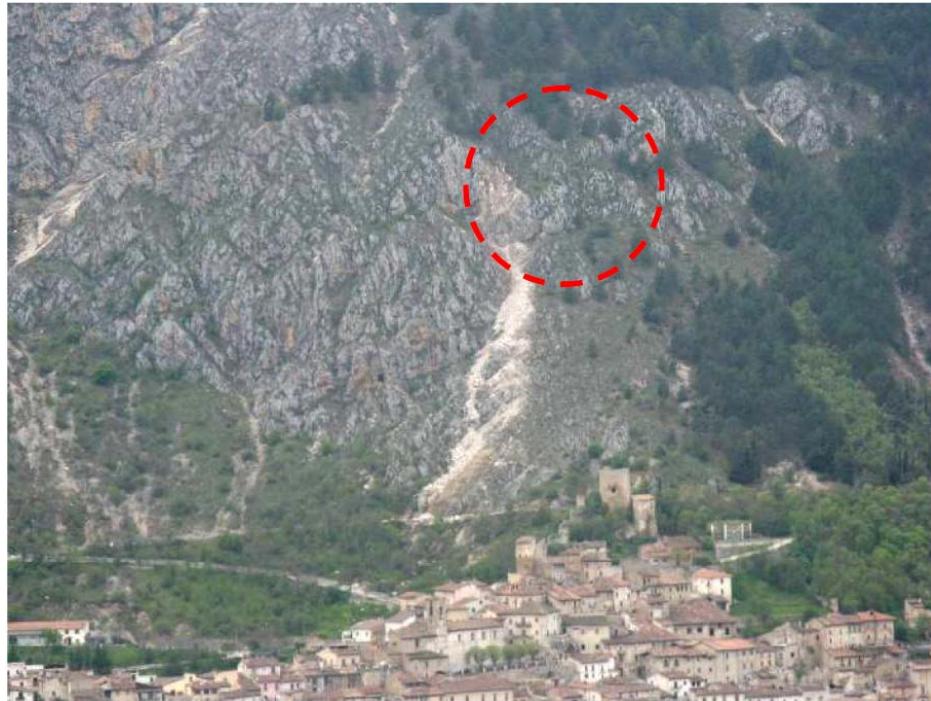
Figure 119. View of Fossa from Mt. Di Cerro. The detachment area of the rock failure that generated the rock avalanche is circled (42.29274N, 13.48575E).

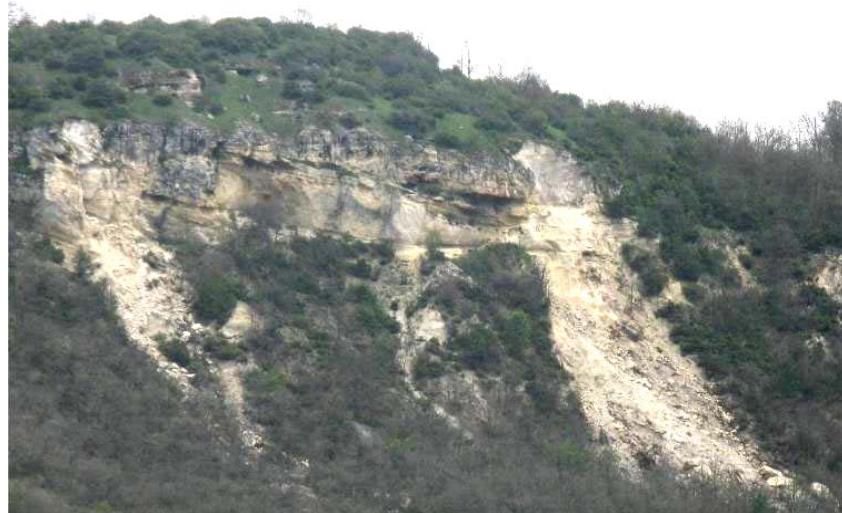
Figure 120. View of the cliff overlooking the northeastern side of Lake Sinizzo. Two failures in the overhanging thick layers of conglomerates are apparent with the related rock avalanches (42.292N, 13.580E).

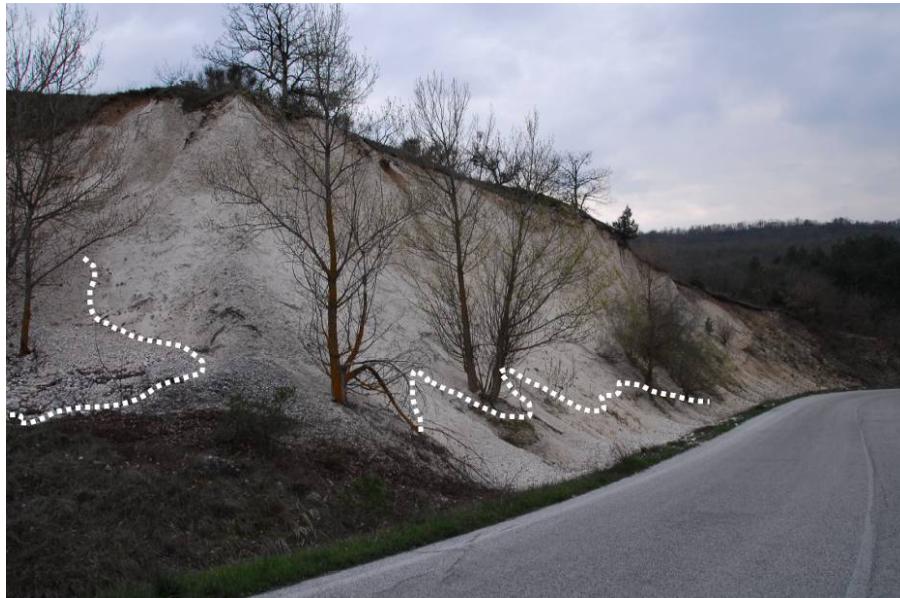
Figure 121. Minor ravelling of weakly cemented sand and gravel; dashed lines indicate the extent of freshly deposited talus along the base of road cut (Via Opi N42.261, E13.581).

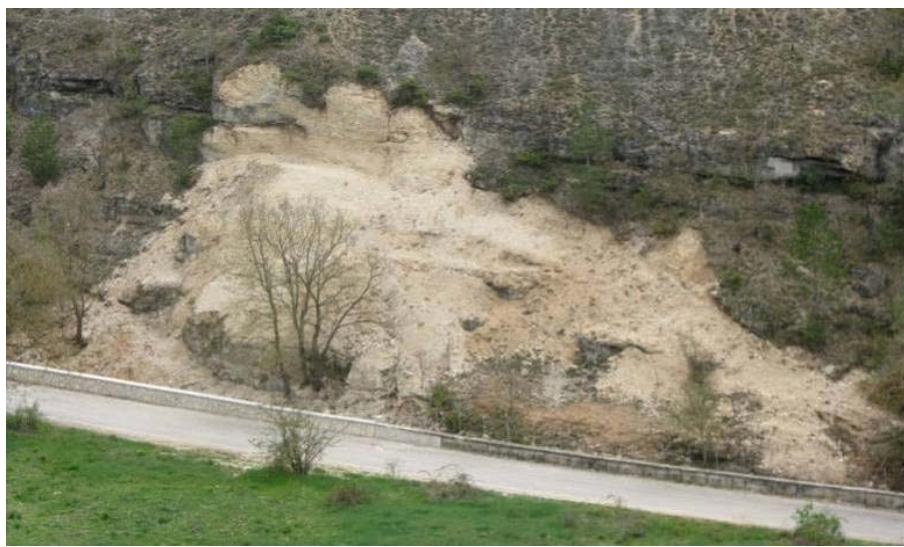
Figure 122. Ravelling along the road from S. Demetrio to Lake Sinizzo (42.28845N, 13.56442E).

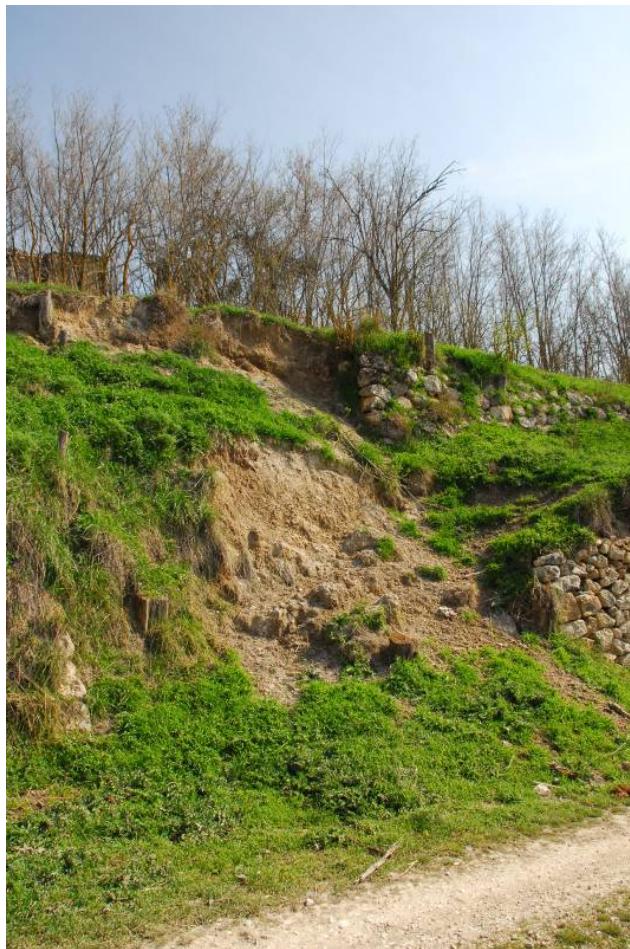
Figure 123. Shallow sloughing of regolith along road cut (southern flank of Castelnuovo N42.294, E13.628).

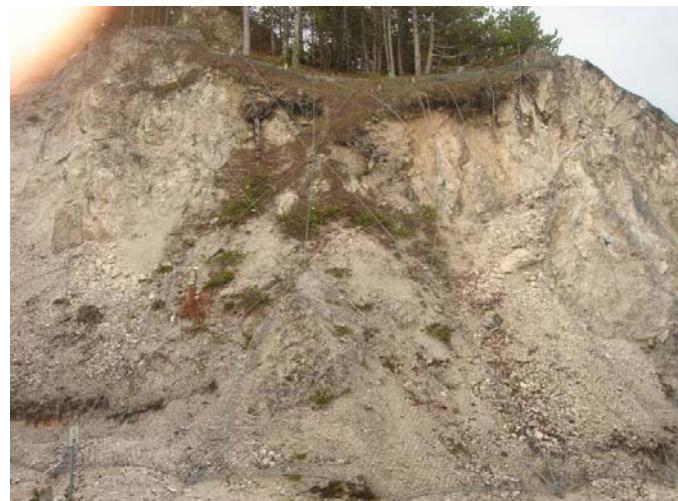
Figure 131. Ravelling in pervasively fractured/cataclastic limestones on a road cut retained by steel-net protections on SS80 at km 18.2: (DC-18-1) (42.4281N, 13.3460E).

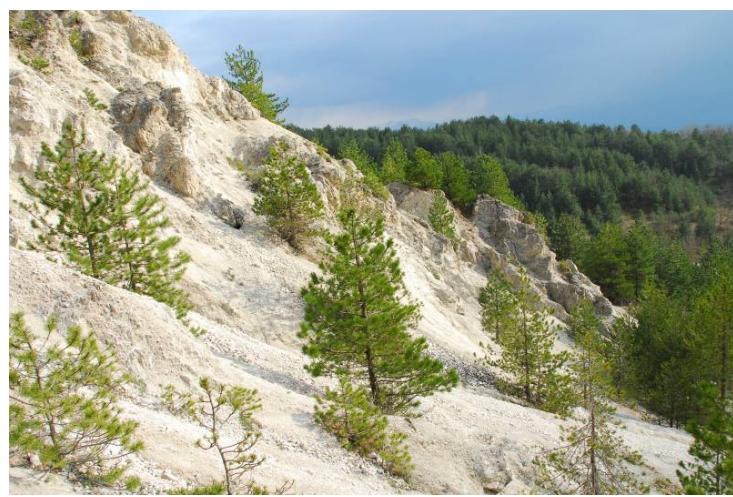
Figure 132. Characteristic erosional scars developed in cataclasite (42.434N, 13.334E).

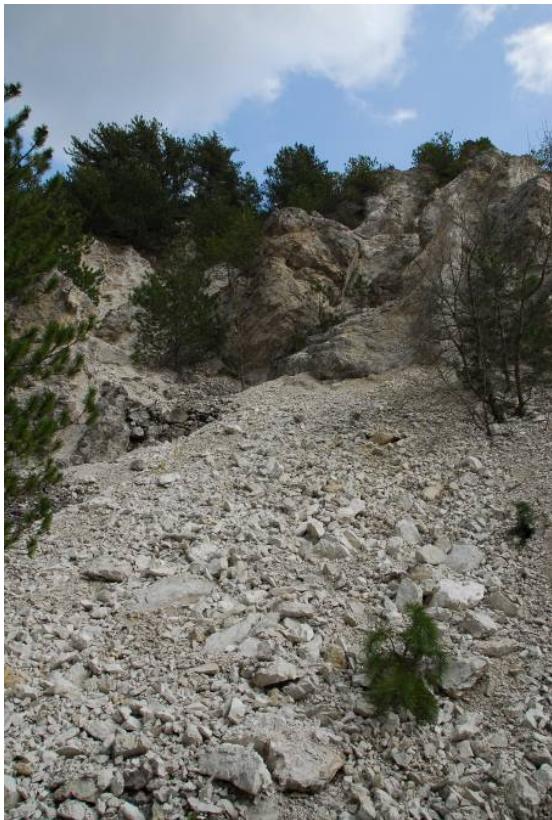
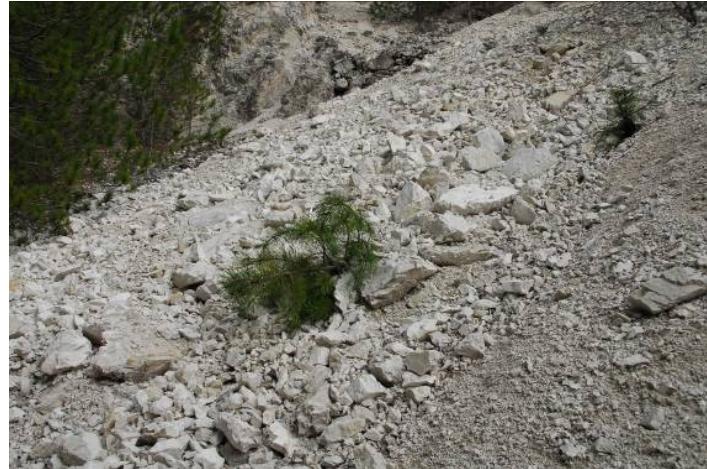
Figure 133. Characteristic ravelling-type failure in natural outcrops of cataclasite; partially buried pine trees evidence recent movement (42.434N, 13.334E).

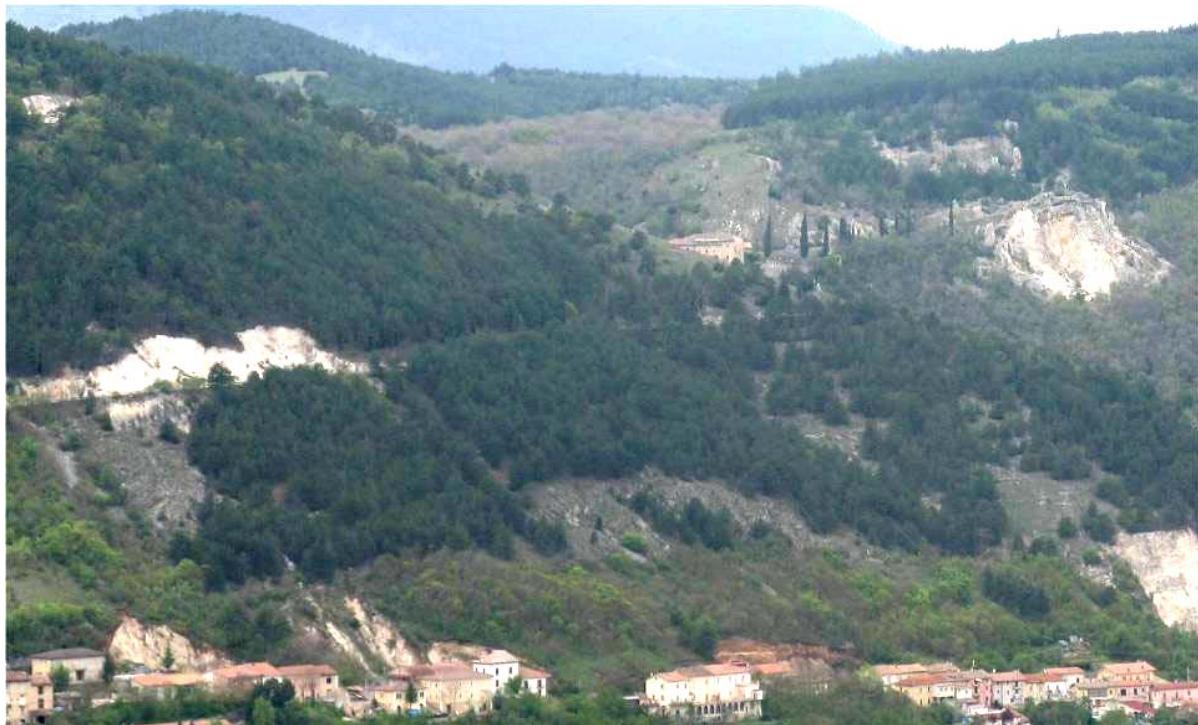
Figure 134. Slides in cataclasites along the road from Fossa to S.Angelo d'Ocre. Detail of the spur on the right is in fig 5.24 (42.29694N, 13.48469E).

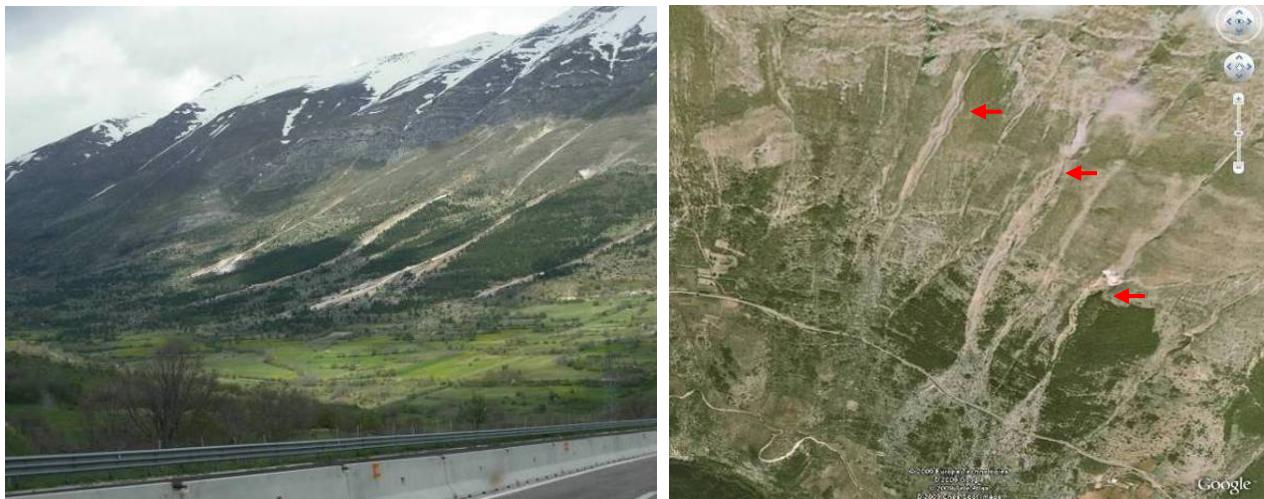
Figure 136. Left view of the Mt. San Franco flank on 4-30-2009. Right: image from Google Earth taken before the earthquake showing the debris flows (42.4368N, 13.5796E).

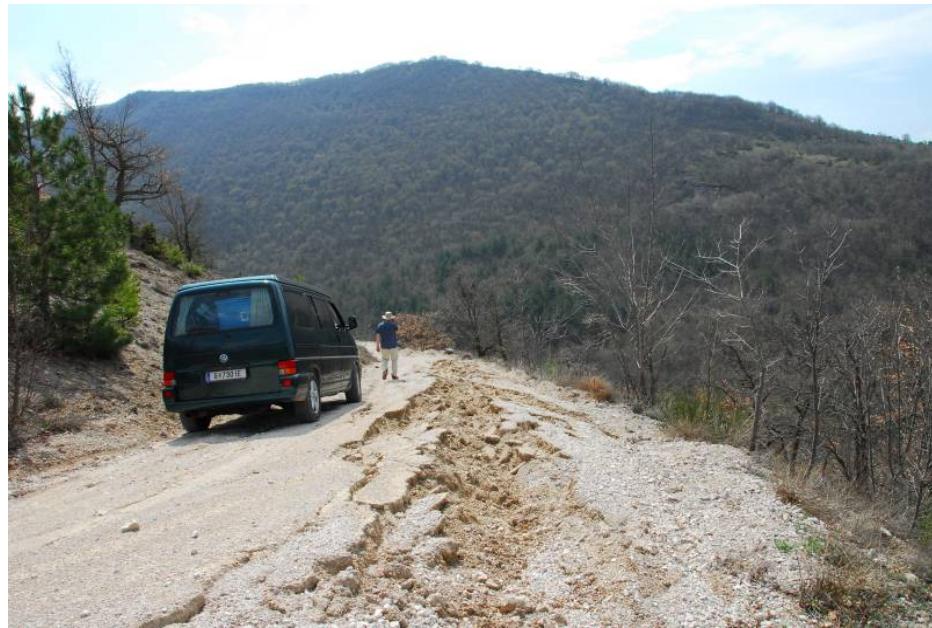
Figure 138. Failure of side-hill fill embankment (42.420N 13.376E).

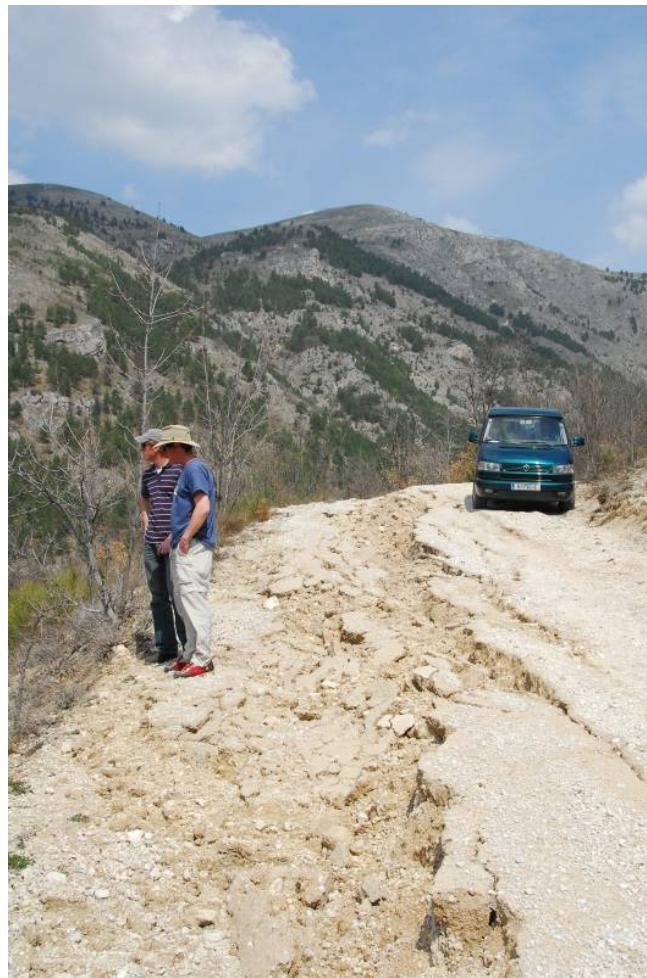
Figure 139. Failure of side-hill fill embankment (42.420N 13.376E).

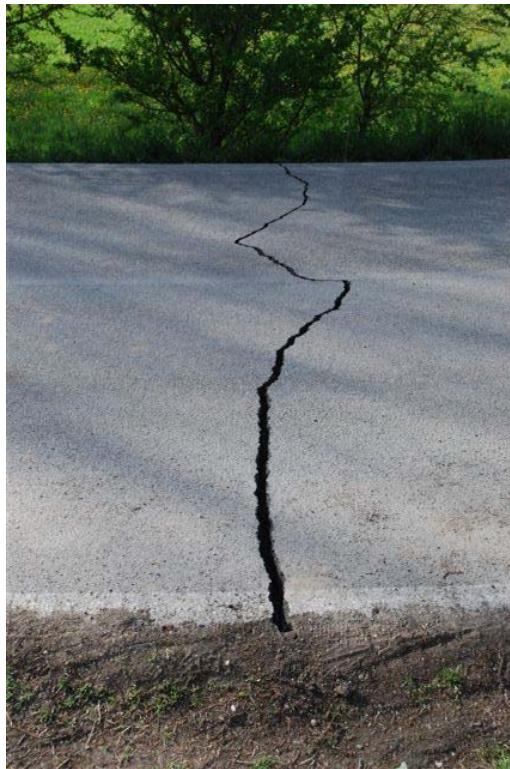
Figure 142. Typical tensile condition of road cracks, not extending into neighboring sub-base or approach fill embankment (42.324N, 13.478E).

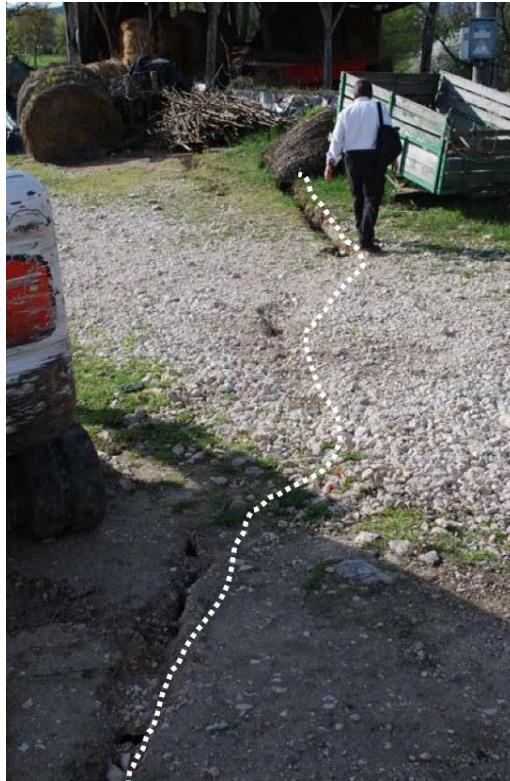
Figure 143. Ground cracks up to 1.0 m deep, 20 m long, and with maximum of 15 cm vertical displacement (down-dropped toward river) developed directly adjacent to bridge abutment (42.324N, 13.478E).

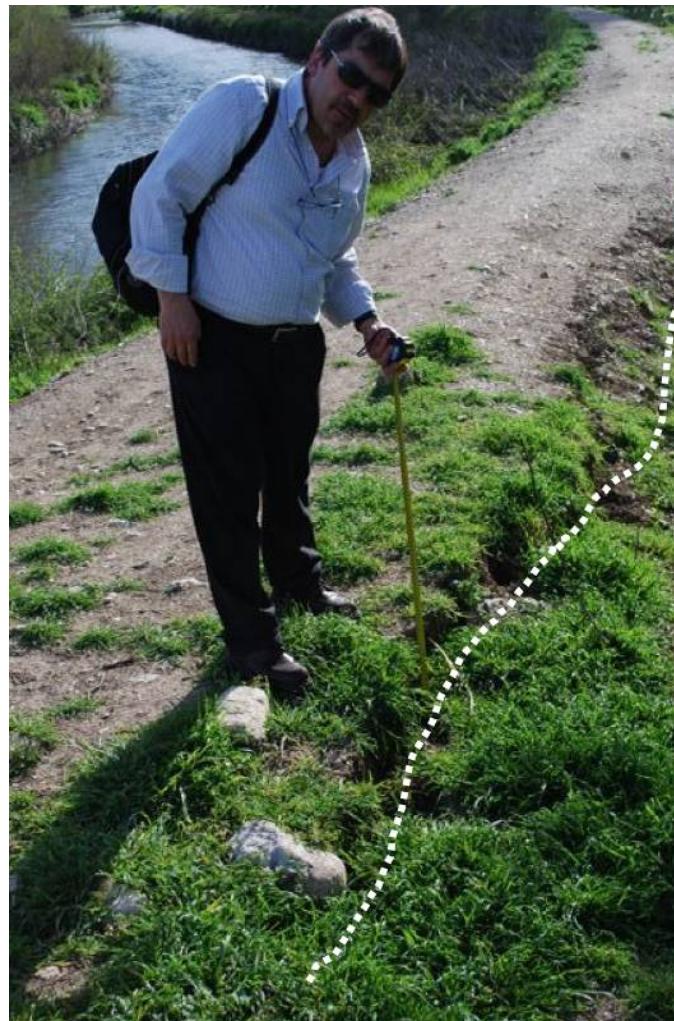
Figure 144. Ground cracks developed along levee crest adjacent to bridge abutment (42.324N, 13.478E).

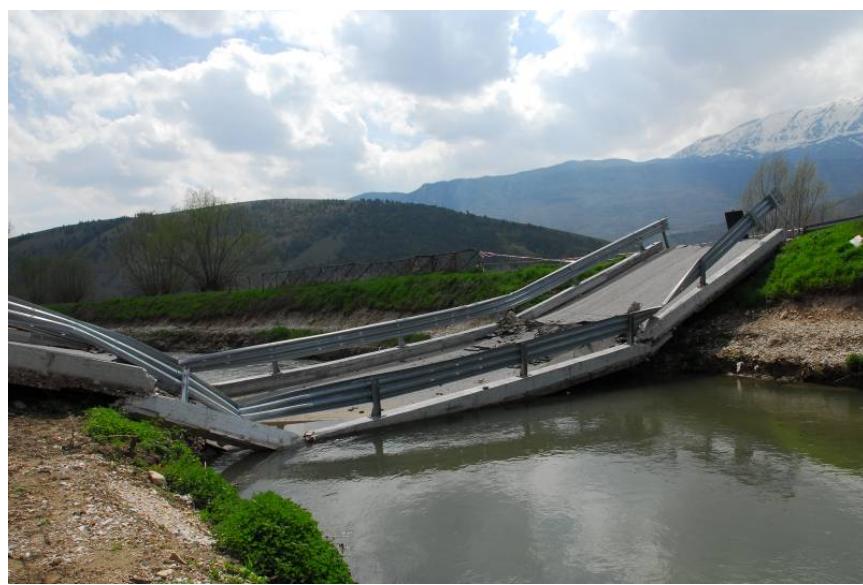
Figure 145. Bridge collapse along the Aterno River, approximately 450 m north of Monticchio (42.325N, 13.463E).

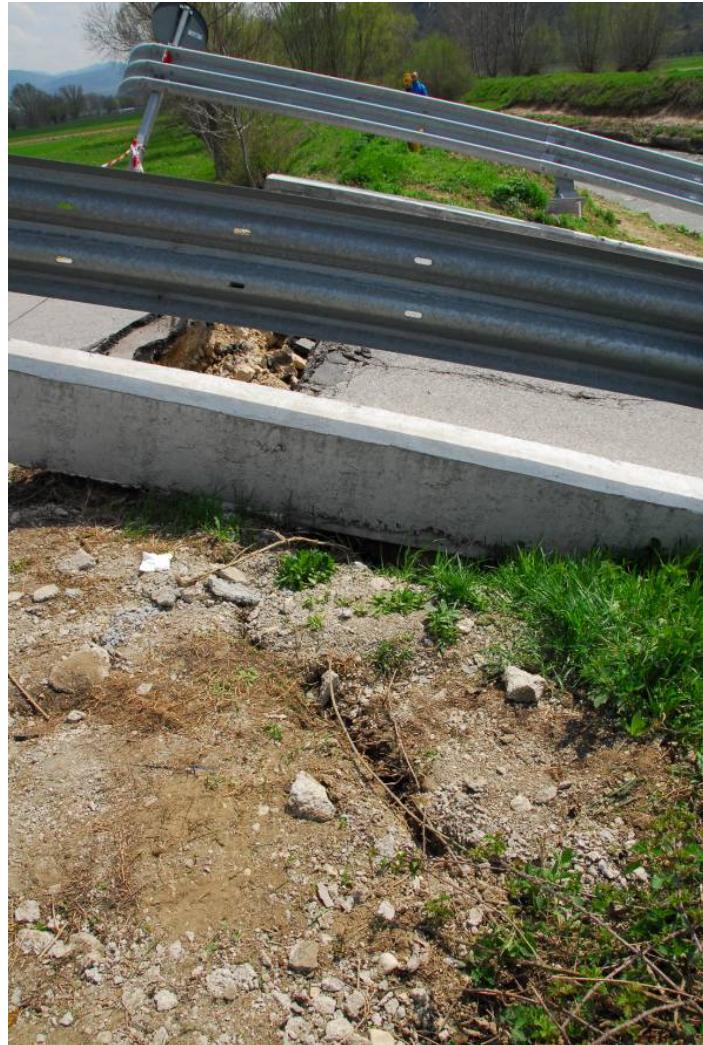
Figure 148. Ground cracking in levee directly beneath western abutment along northern side of Aterno River (42.325N, 13.463E).

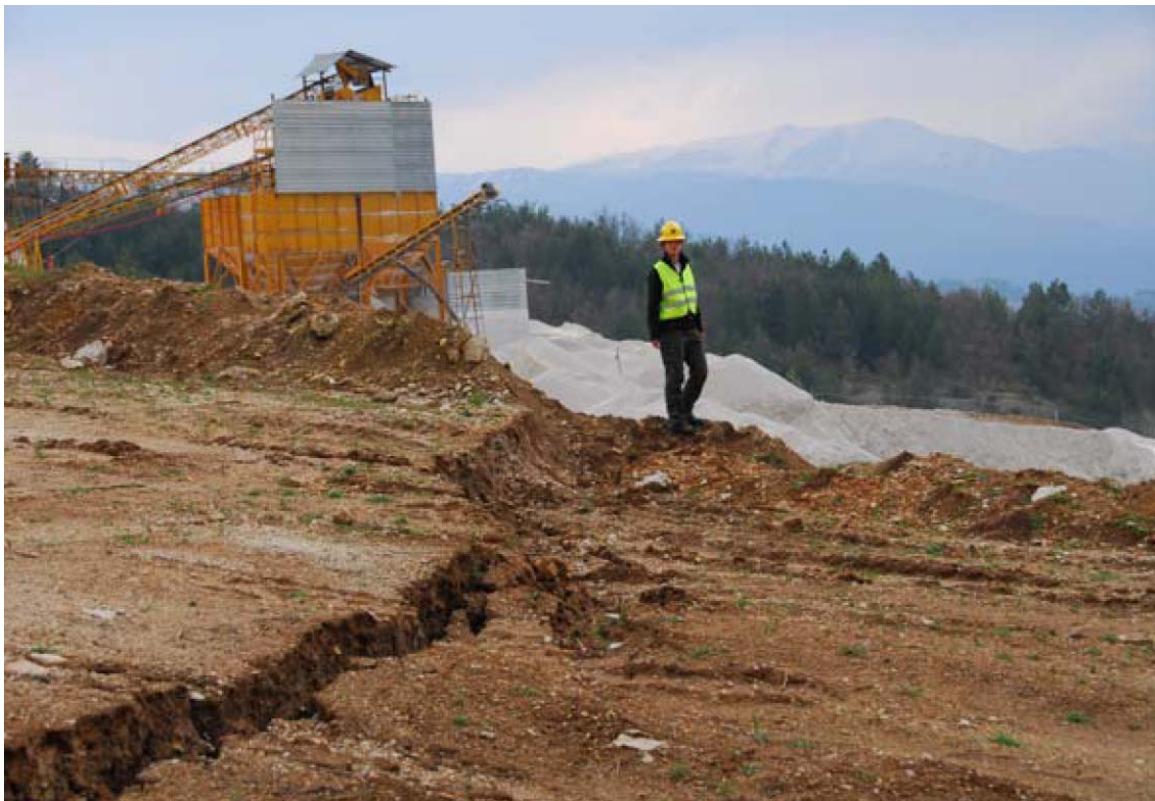
Figure 149. Shear failure developed in fill material, with vertical displacement increasing to approximately 40 cm at free slope face (42.435N, 13.330E).

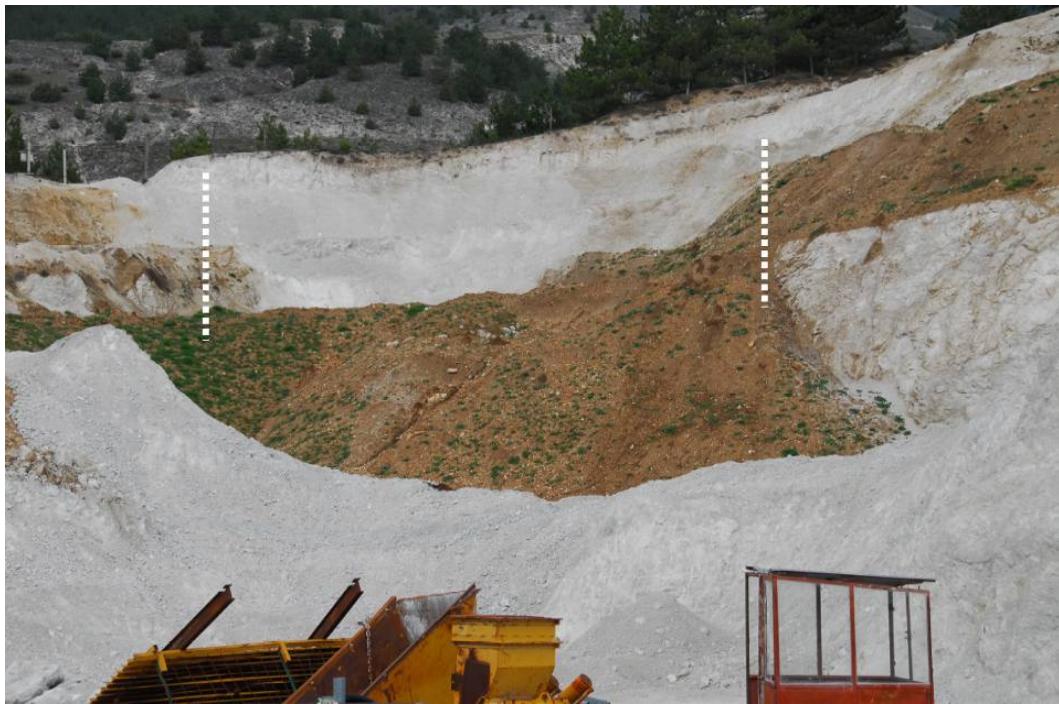
Figure 151. Graben structure (between vertical lines) and bedrock boundary conditions (42.435N, 13.330E).

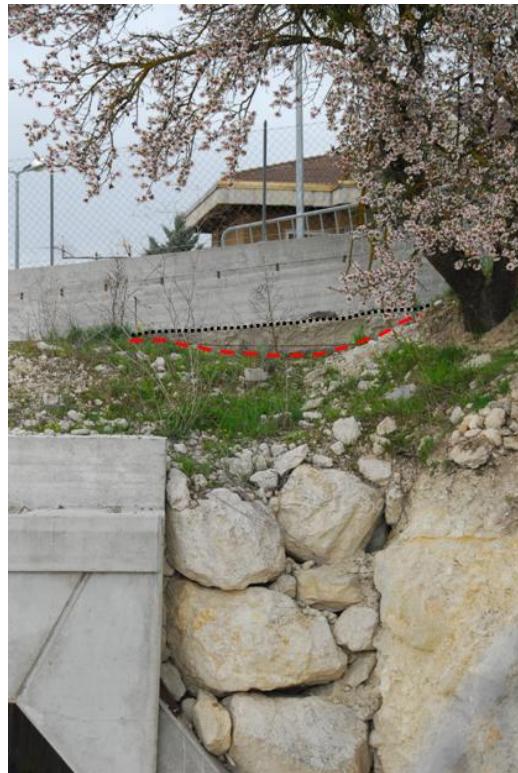
Figure 153. Settlement trough reaching 10 to 15 cm maximum, relative to the spanning parapet wall foundation (42.358N 13.415E).

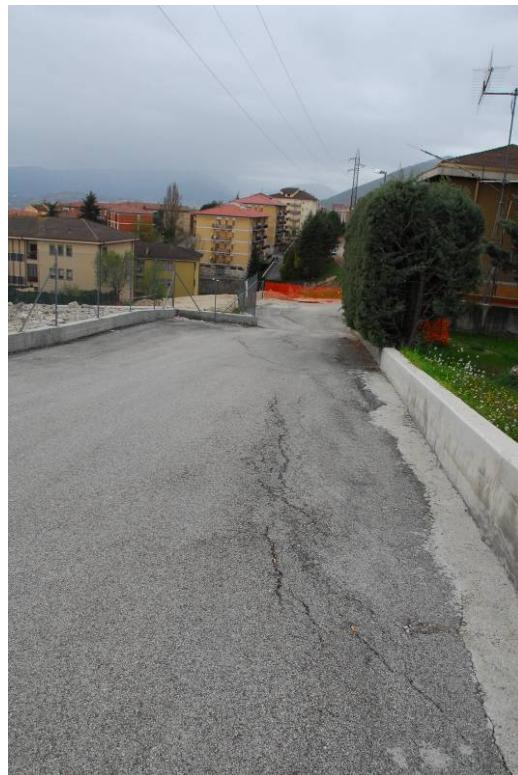
Figure 154. Cracks in the overlying asphaltic surfaces and a narrow settlement trend along the sidewall of the cut-and-cover structure (42.358N 13.415E).

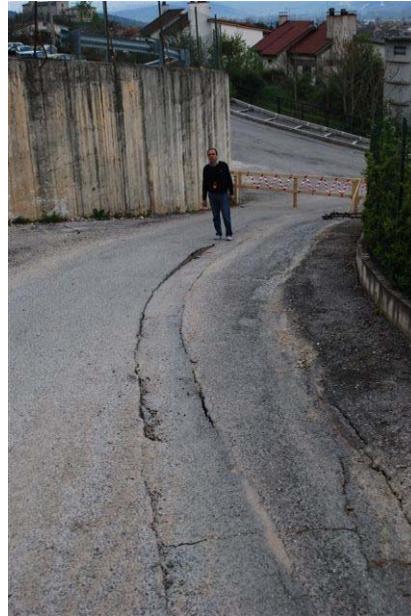
Figure 155. Seismic compression of trench backfill in the town of Paganica (42.365N, 13.465E).

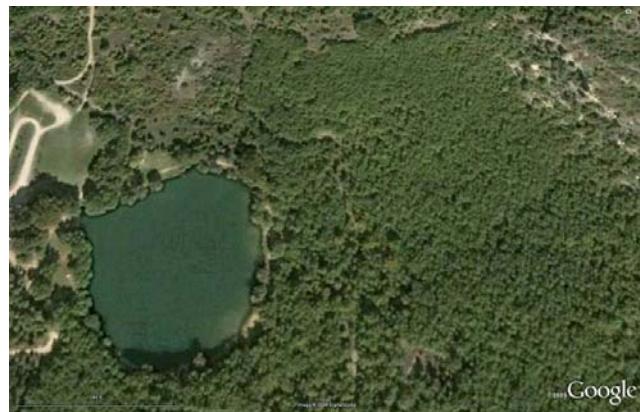
Figure 156. Overview of Lake Sinizzo with location of impounding embankment indicated by vertical white line (42.291N 13.576E).

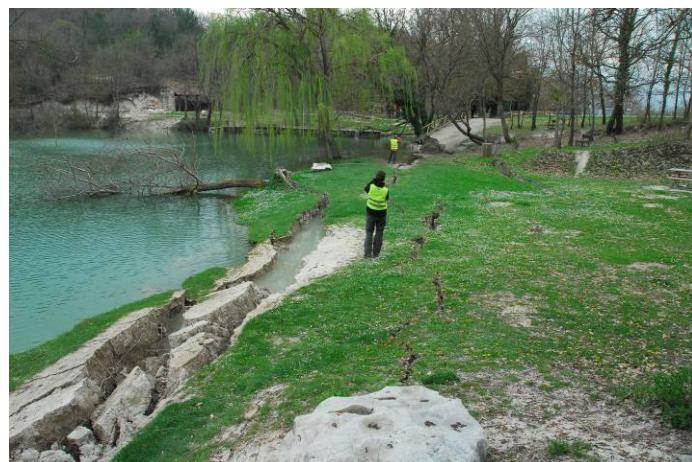
Figure 158. Ground cracks along the northwestern perimeter of Lake Sinizzo (42.291N, E13.576).

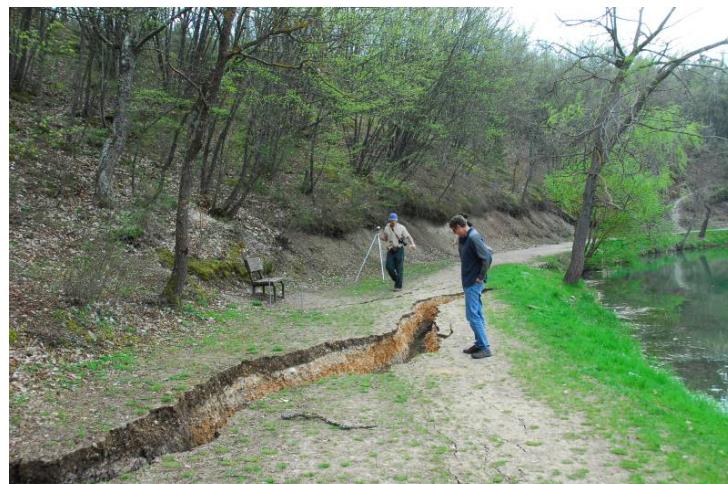
Figure 159. Ground cracks along the eastern perimeter of Lake Sinizzo (42.291N, E13.576).

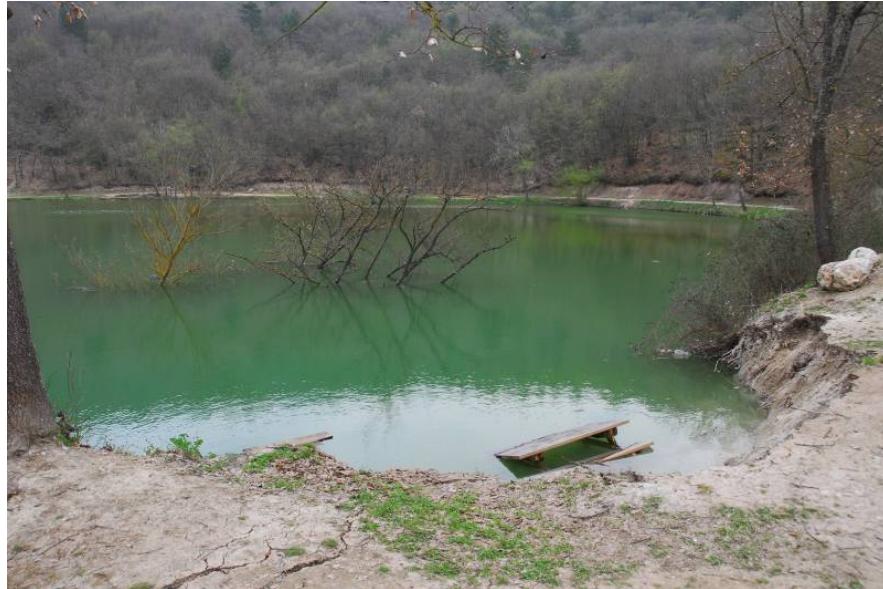
Figure 160. Submerged trees located several meters from the western margin of Lake Sinizzo; picnic table within arcuate landslide scar at shoreline. (42.291N 13.576).
