Seismological and geotechnical aspects of the $M_w=6.3$ L'Aquila earthquake in central Italy on 6 April 2009

Giuseppe Lanzo, Professor, University of Rome, Italy; email: giuseppe.lanzo@uniromal.it

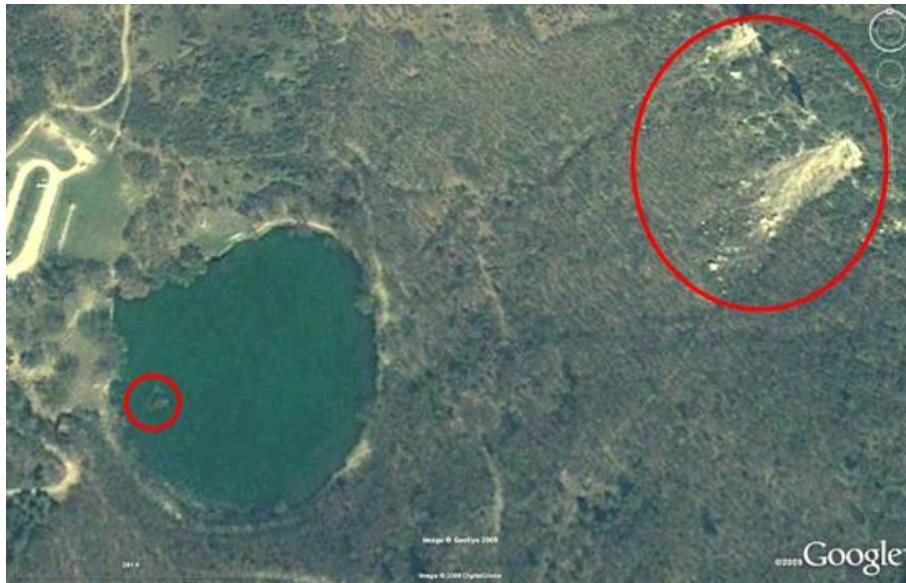
Figure 161. Post earthquake satellite imagery showing submerged trees within small circle and rock slope failures within large circle; compare to pre-earthquake imagery shown in Figure 146 (42.291N 13.576).

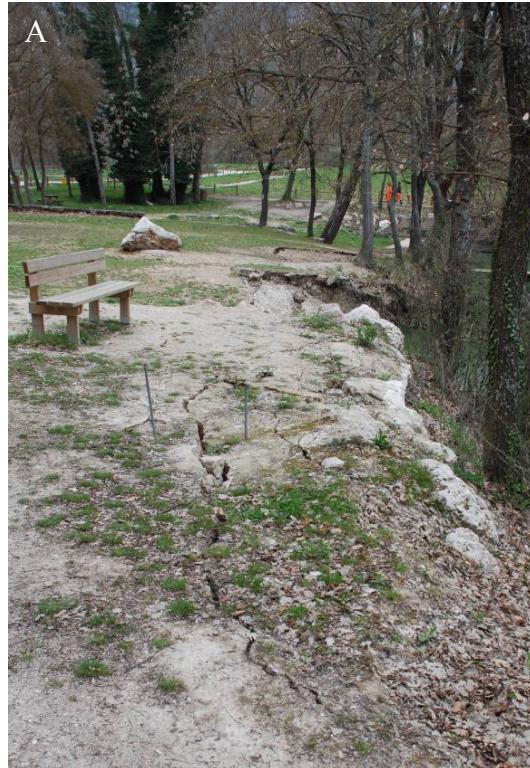
Figure 162. Ground cracks at the southwest corner of Lake Sinizzo (location WP 18) as observed on (A) 11 April 2009.

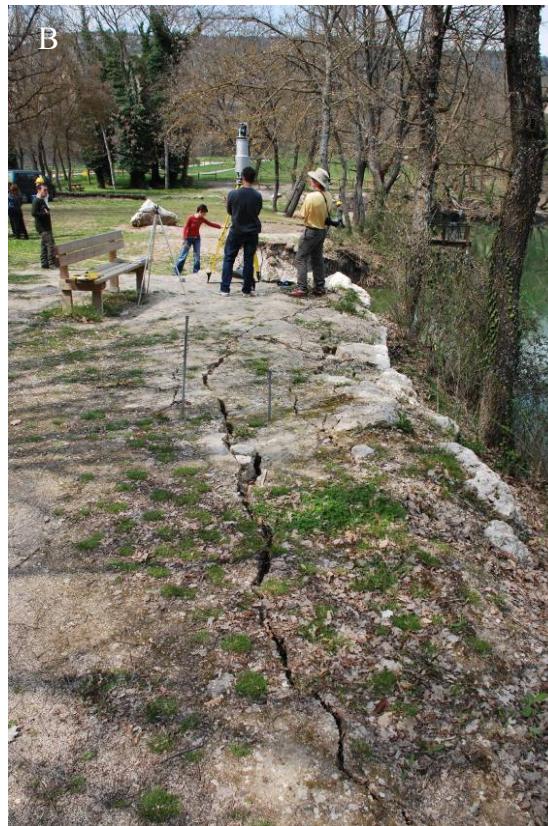
Figure 162. Ground cracks at the southwest corner of Lake Sinizzo (location WP 18) as observed on (B) 15 April 2009.

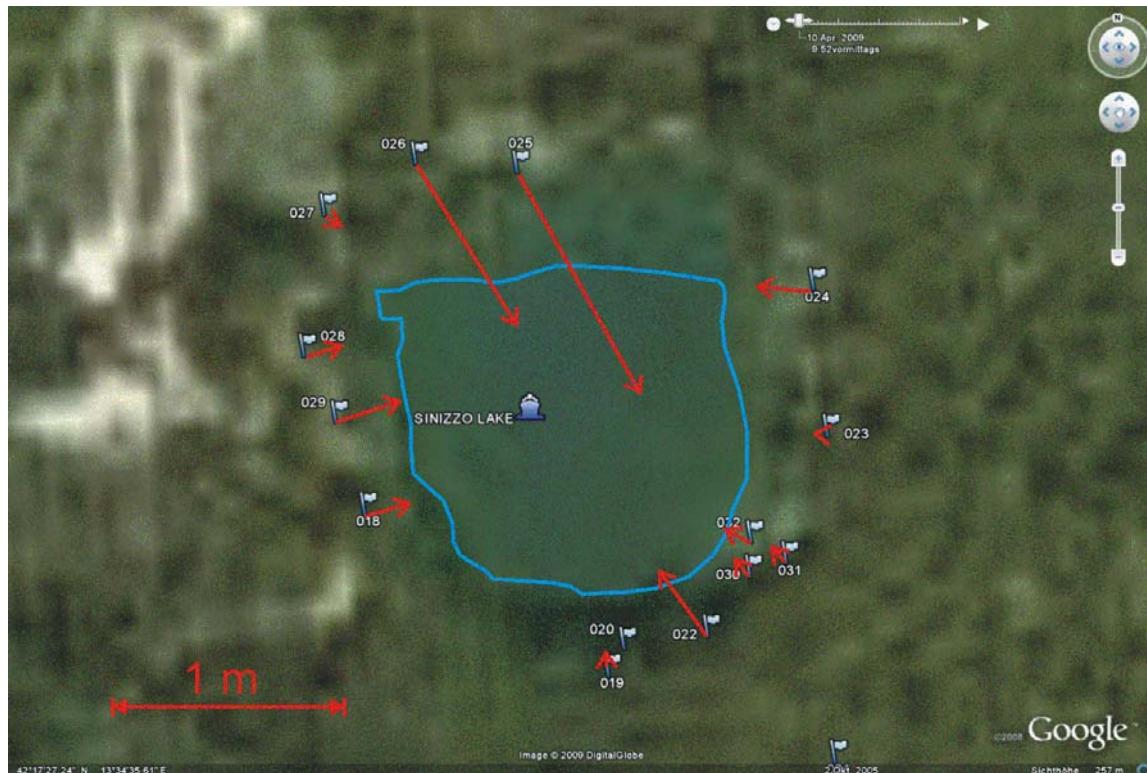
Figure 163. GPS way points indicating measurement locations around Lake Sinizzo. The red arrows indicate the orientation and maximum cumulative crack opening measured at each location.

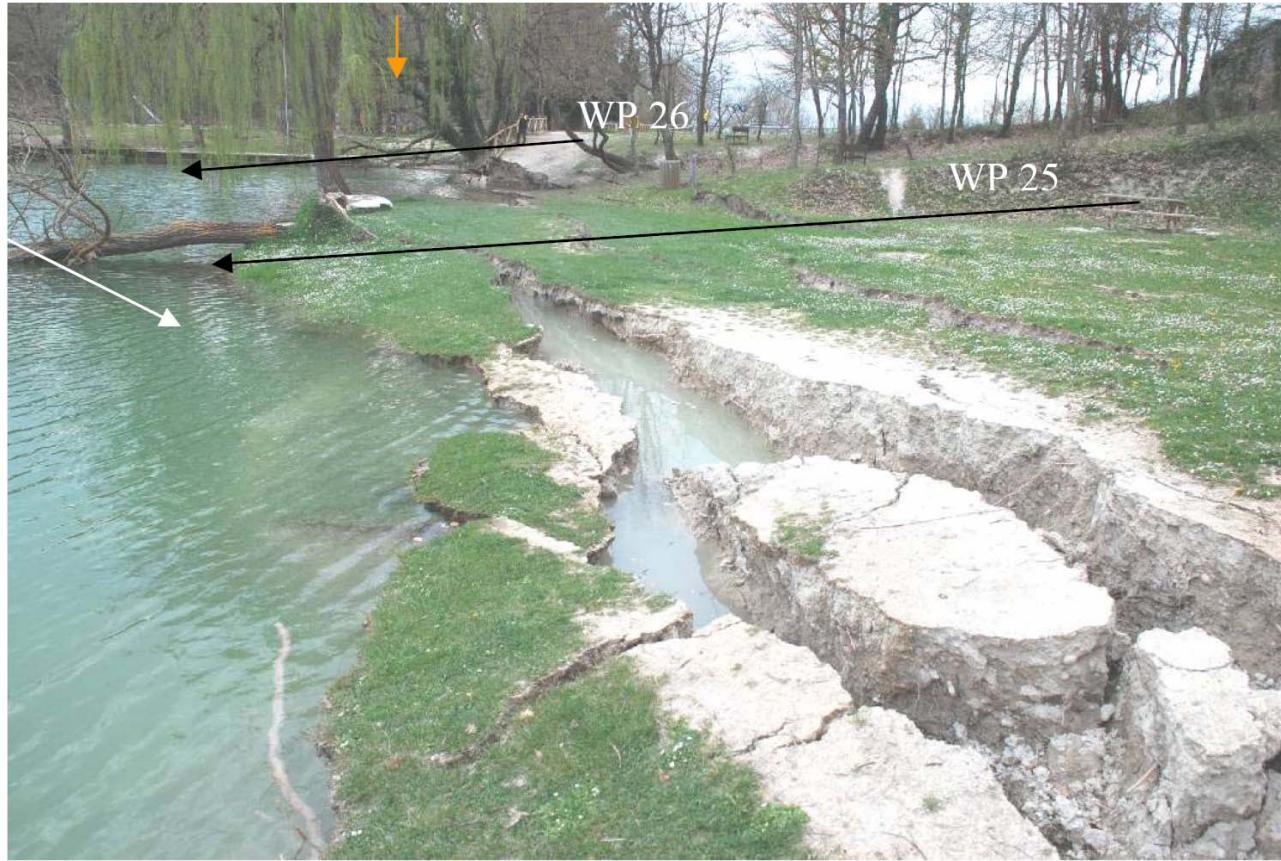
Figure 164. Blocks lying under the water (white arrow) were not included in the traverses (WP 25 and WP26). The orange arrow shows where the fence (and the slump below it) truncated the traverse at WP 27. (Photo E. Button).

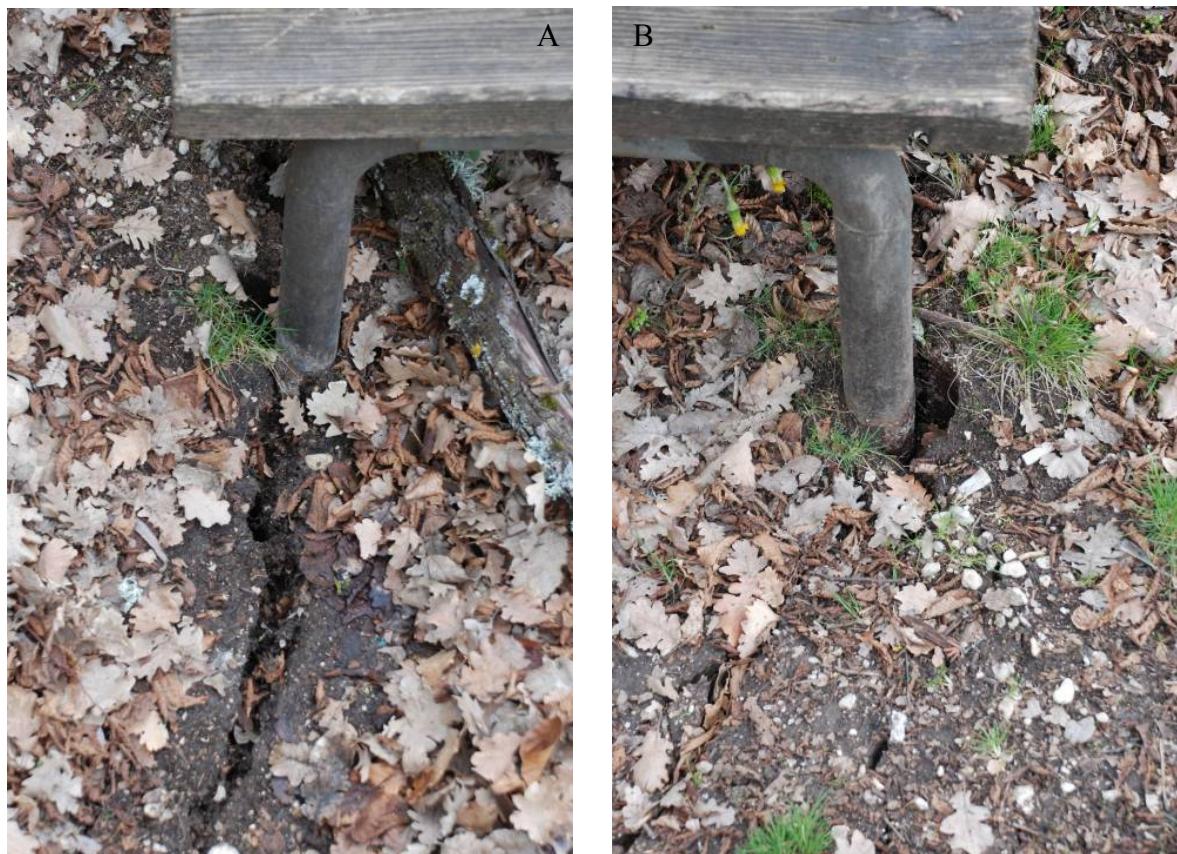
Figure 167. Characteristic deformations associated with the corners of the park bench at WP 31. (A) corner C2, (B) corner C3.

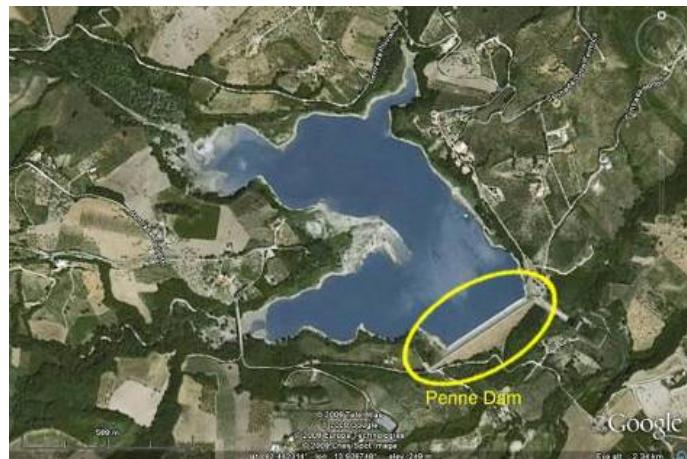
Figure 184. Location map for Penne reservoir and dam ($42.438809^{\circ}\text{N}$, $13.913265^{\circ}\text{E}$).

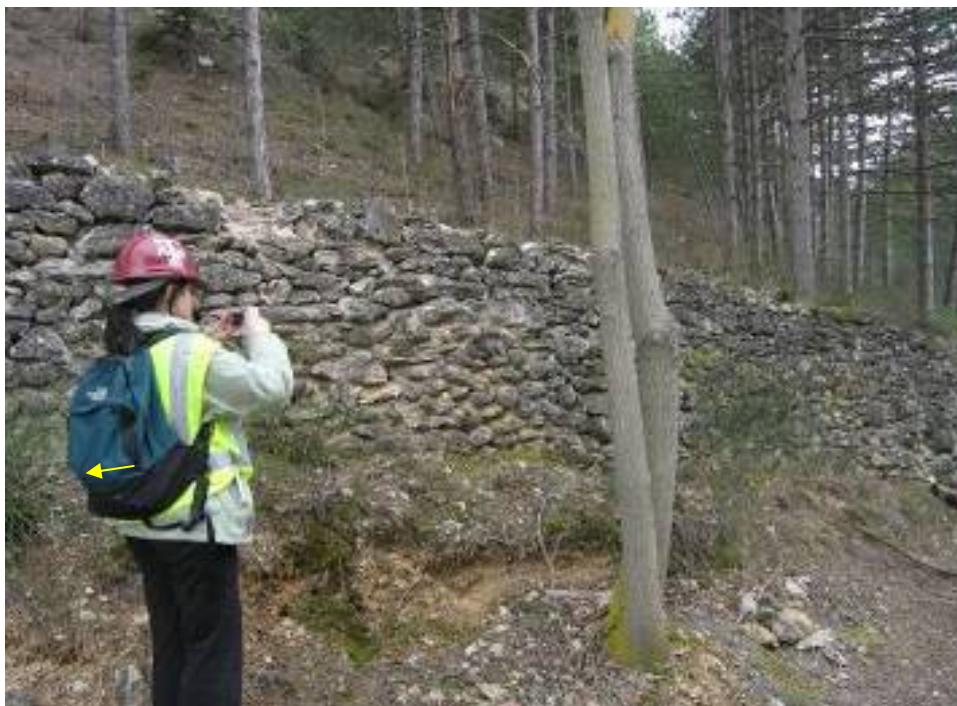
Figure 185. Minor damage on masonry wall in severely shaken Pettino area (42.374011°N, 13.367498°E).

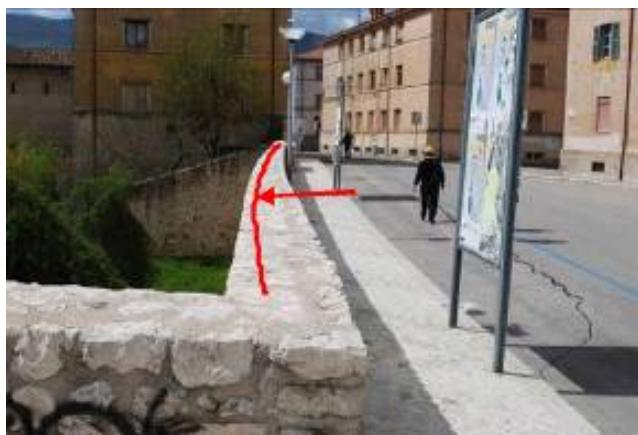
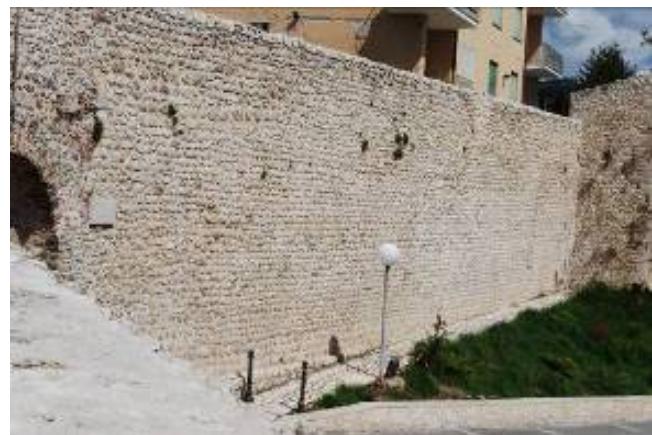
Figure 186. Stone masonry wall at L'Aquila city (42.348710°N, 13.403900°E). Note the (tolerable) outward movement at the center of the wall and the pavement cracks behind the wall.

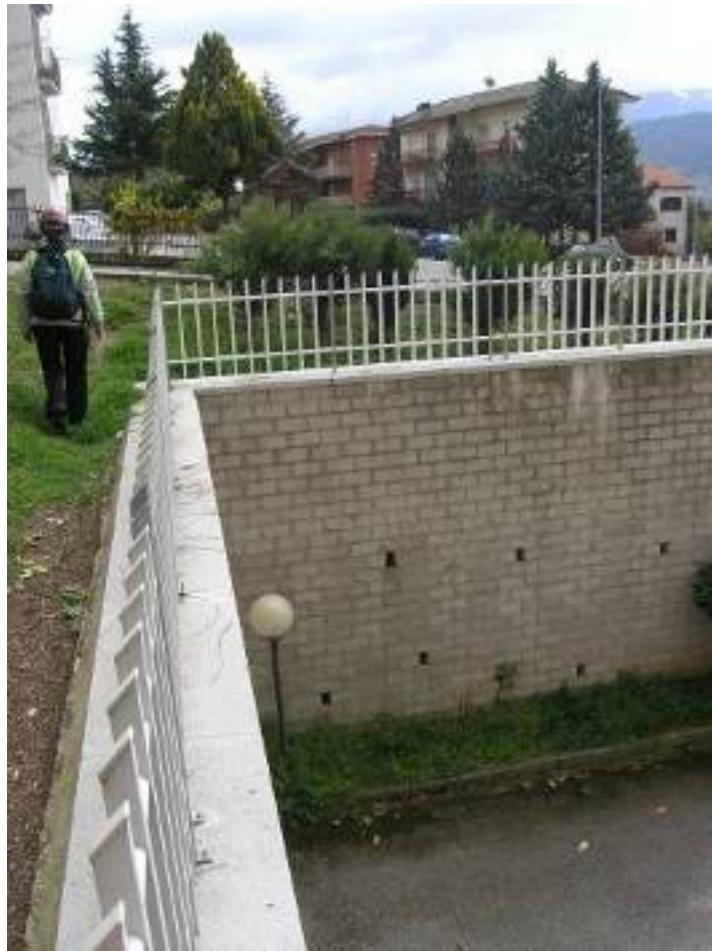
Figure 187. Undamaged wall at the severely shaken Pettino area (42.373050°N, 13.366106°E).

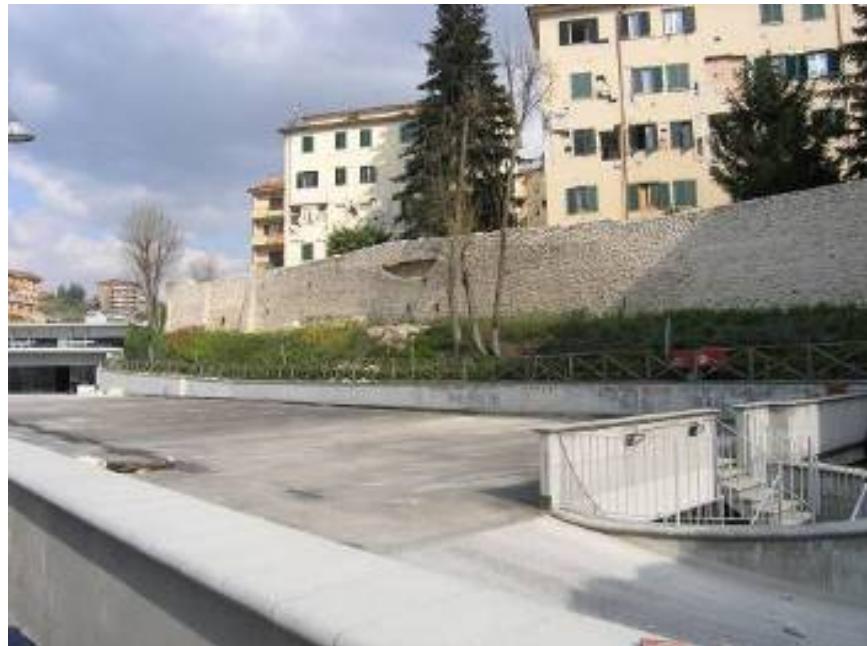
Figure 188. Damaged wall at downtown L'Aquila (42.356056°N, 13.389524°E).

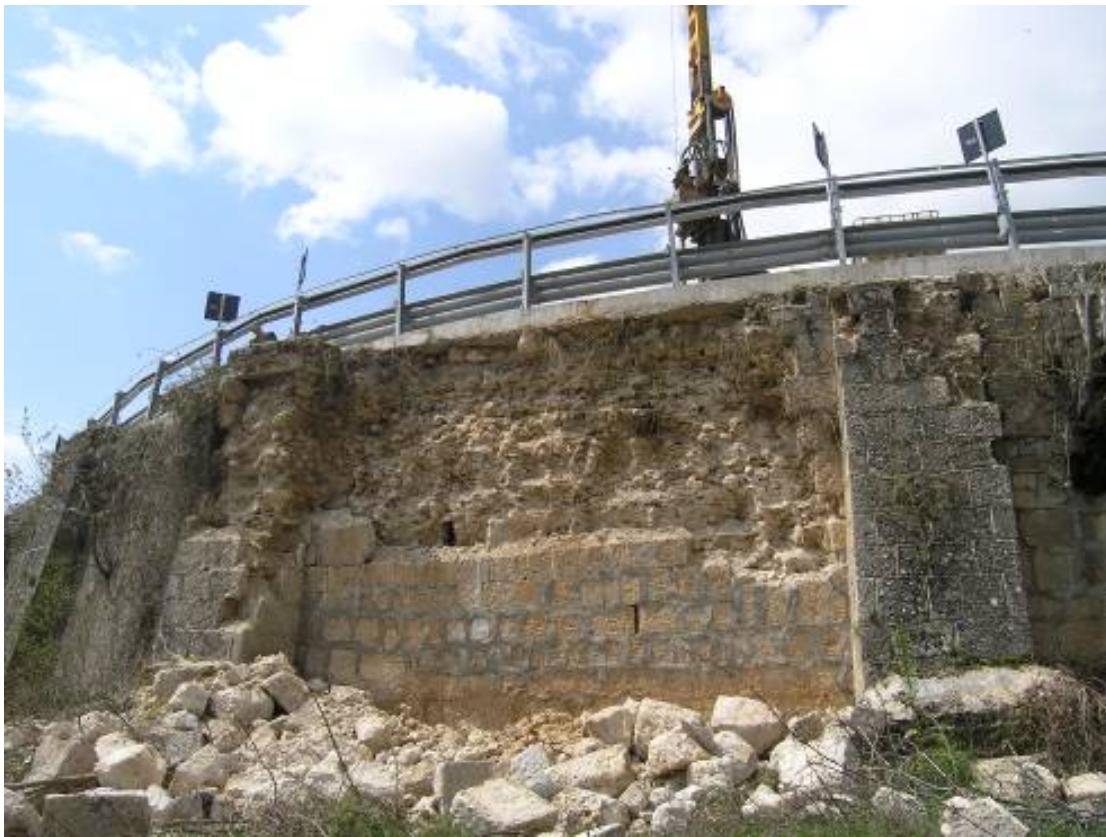
Figure 189. Partially collapsed wall at SS80 highway between L'Aquila and Campotosto (42.420510°N, 13.358394°E).

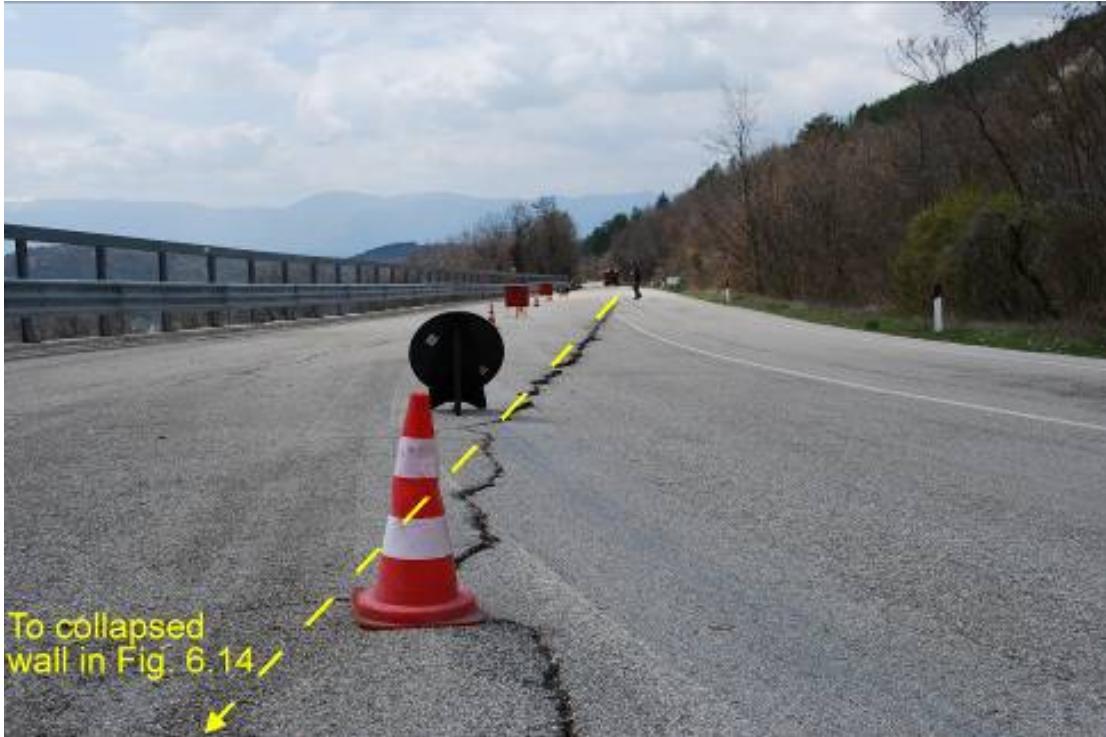
Figure 190. Pavement cracking in SS80 roadway (from L'Aquila to Campotosto) in the location of collapsed masonry retaining wall (42.420510°N, 13.358394°E).

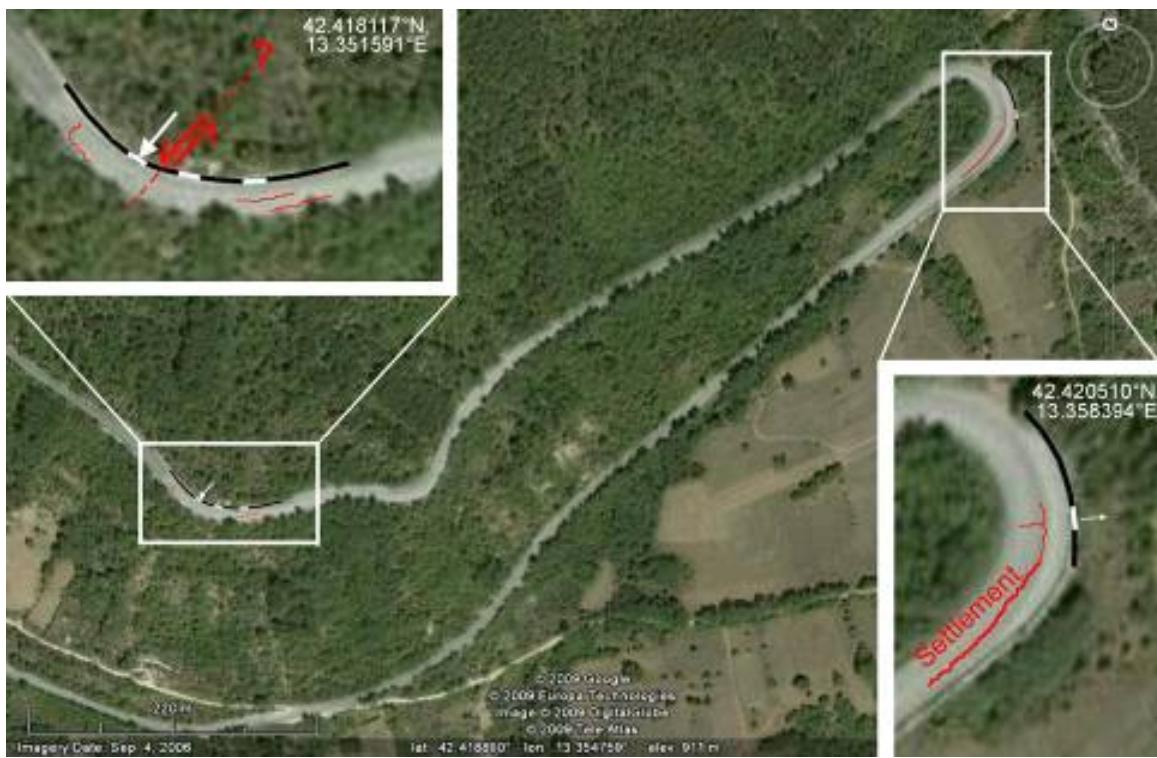
Figure 191. Locations of observed pavement cracking and associated retaining wall failures.

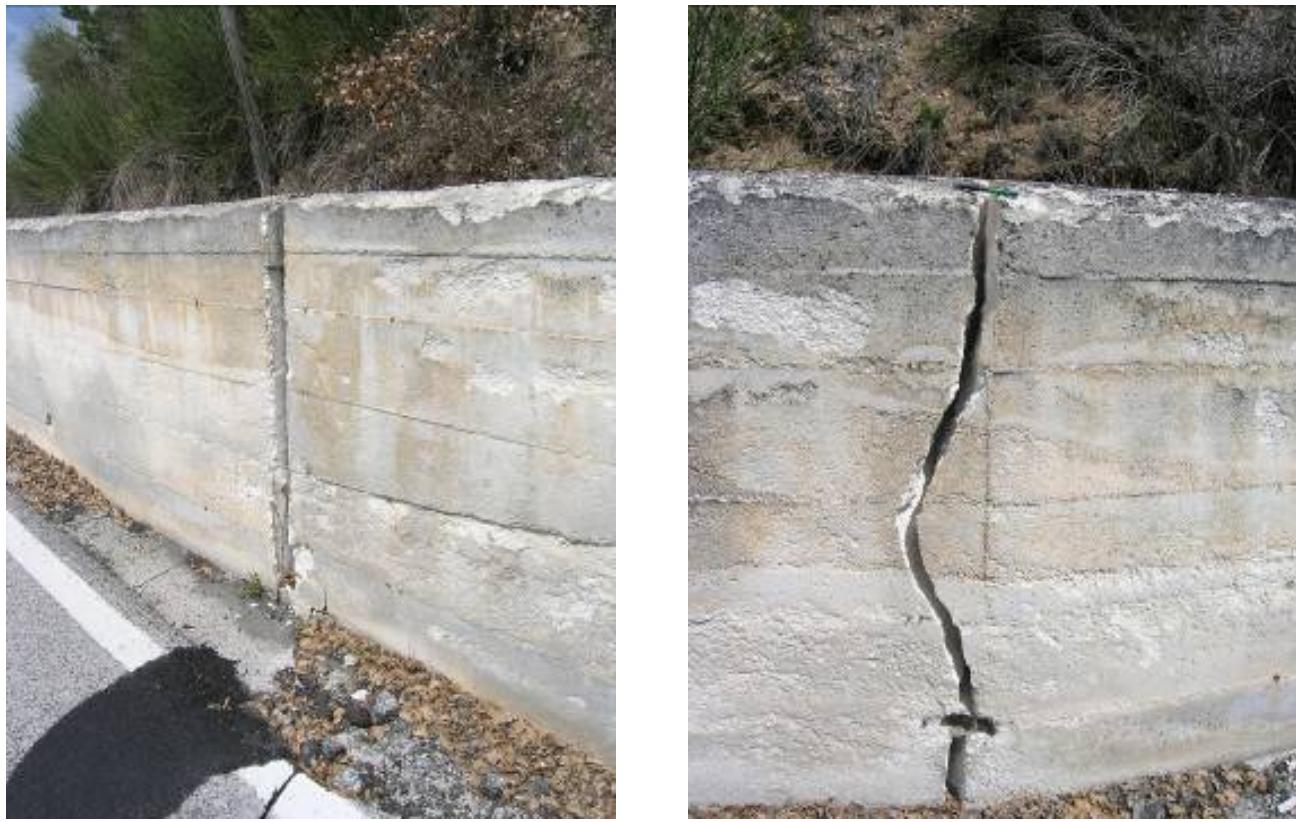
Figure 192. Ruptured retaining wall due to slope instability at SS80 highway between L'Aquila and Campotosto (42.418117°N, 13.351591°E).

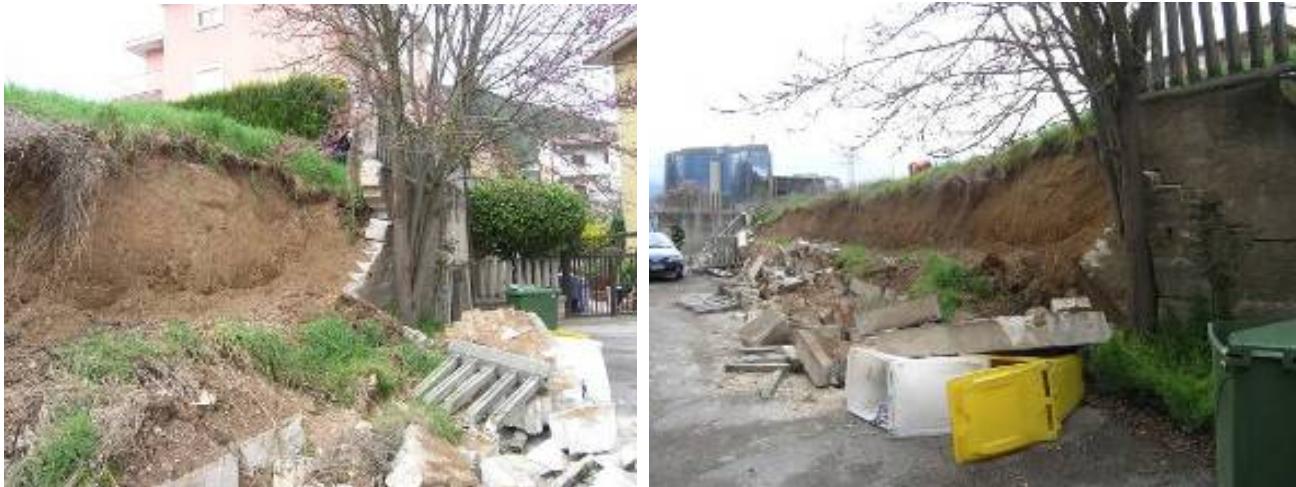
Figure 193. Toppling of masonry retaining wall at the outskirts of L'Aquila (42.366803°N, 13.376561°E).
