Expedient Mitigation of Collapsible Loess in Northern Afghanistan

Christopher T. SENSENEY, Assistant Professor, U.S. Air Force Academy, Colorado, 80840-6232, USA; email: christopher.senseney@usafa.edu

Reference: SENSENEY, C. (2013). *Expedient Mitigation of Collapsible Loess in Northern Afghanistan*

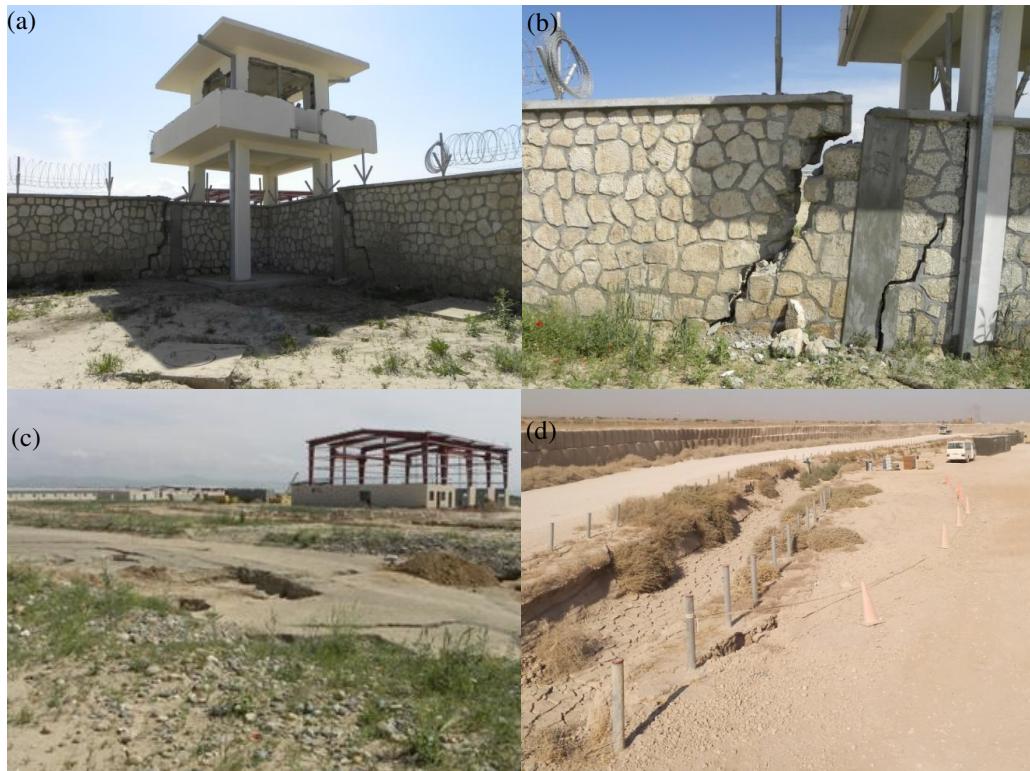
Figure 2. a. Damaged guardhouse and security wall in Kunduz, b. security wall damaged in Kunduz, c. settlement basin through a road in Kunduz, d. slope failure next to earthen drainage ditch in Mazar-e-Sharif as evidenced by coned off area.

The magnitude of collapse and resulting damage to infrastructure and facilities is primarily dependent on the amount of wetting. In low lying areas where water pools or flows after heavy rains, soil collapse often manifests itself in settlement basins or slope failure. Settlement basins typically occur near the perimeter of a facility beneath downspouts or on the edge of roads near drainage ditches. The facilities, in turn, experience differential settlement and structural damage, as evidenced by building settlements up to 10 cm (4 in) around Mazar-e-Sharif and Kunduz (Meier et al. 2009, SIGAR 2010). Settlement basins also cause failure to security walls (Fig. 2a-b) and damage roads (Fig. 2c). Slope failures damage the drainage system and render limited real estate unusable (Fig. 2d). Repairing damage wastes valuable resources that could be better utilized elsewhere.

A suitable drainage design at expedient military bases is open channel drains and a gravel cover over the ground surface. Cast in place concrete trench drains (as shown in Fig. 5a) should be trapezoidal or rectangular with depths generally ranging from 0.15-1.0 m (0.5-3.3 ft), depending on local hydrological conditions. The drain bottom and side walls must be reinforced to withstand earth pressure and anticipated loads. Grouted stone channels (see Fig. 5b) are also acceptable. Such channels are common in Afghanistan given the abundance of naturally occurring cobble stone deposits in river beds. Downspouts from buildings should feed into the drains. Ungrouted riprap-lined channels or earthen drainage ditches (see Fig. 2d) are not recommended because water infiltration may cause collapse and/or slope failure.

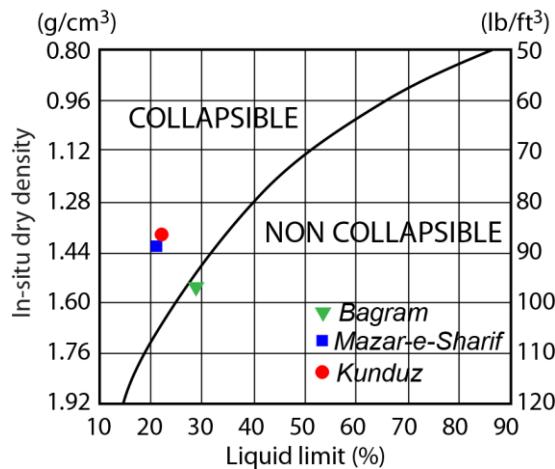
Figure 3. Gibbs and Bara (1962) criteria for determining collapsibility.

Of the methods to identify collapsible soil, two of the most common are the dry density and liquid limit graph (Gibbs and Bara 1962) and the one-dimensional compression test using an oedometer (Lutenegger and Saber 1988). By studying alluvial fan deposits in California with low dry density, Gibbs and Bara (1962) showed that when the saturated moisture content exceeds the liquid limit, the soil will likely collapse. Using this relationship, they developed the dry density versus liquid limit criteria in Fig. 3. The Gibbs and Bara approach is most applicable to clayey sands and sandy clays (NAVFAC 1986), but in the absence of a collapse test, it is a reasonable preliminary assessment for loess soils. Lutenegger and Saber (1988) introduced a collapse test that applies a vertical stress to a laterally confined, undisturbed sample of loess at its natural water content, and then introducing water to the specimen. A decrease in volume at a constant vertical stress is an indication of the collapse potential of the soil.

Soils from Afghanistan military bases in Kunduz, Mazar-e-Sharif and Bagram were evaluated for collapse using Gibbs and Bara's criteria and Handy's criteria. Sand cone tests were conducted and disturbed soil samples were collected at a depth of 0.5 m (20 in). Three sand cone tests and three samples were obtained from Kunduz and two sand cone tests and two samples each were obtained from Mazar-e-Sharif and Bagram. An average of the soil properties are given in Table 1 and an average of the particle size distributions in Fig. 4, where fine content less than 0.075 mm was determined using a hydrometer apparatus (ASTM 2007). The Kunduz and Mazar-e-Sharif soil exhibit a uniform distribution with particles concentrated in the range 0.01 to 0.06 mm, indicating the soils are loessial and will not compact well. On the contrary, the Bagram soil exhibits a more well-graded distribution, indicating the soil is not loessial and has higher potential for compaction. According to Gibbs and Bara's criteria, the Kunduz and Mazar-e-Sharif soil is collapsible, while the Bagram soil would fall just inside the non-collapsible region (see Fig. 3). According to Handy's criteria, the Kunduz soil has high probability of collapse, the Mazar-e-Sharif soil will probably collapse, and the Bagram soil has less than 50% probability. These results match what military forces have observed. As many as 48 sites in and around the Kunduz Airfield show signs of collapsed soil (SIGAR 2010) and an earthen drainage ditch near the Mazar-e-Sharif Airfield experienced slope failure from collapsible soil. No evidence of collapse has been observed at Bagram. Lutenegger and Saber's collapse test or other collapse tests were not used in this study because the equipment to obtain undisturbed samples and equipment to conduct necessary laboratory tests are not available in Afghanistan.

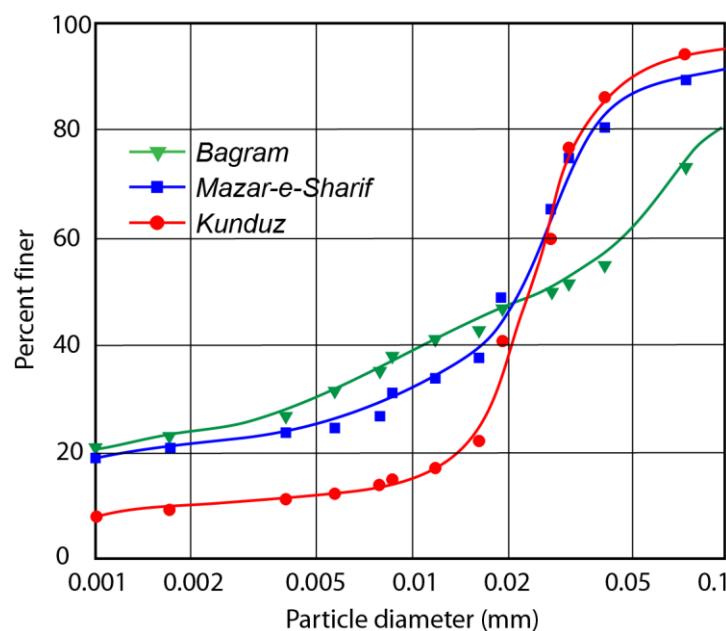
Figure 4. Particle size distributions of Kunduz, Mazar-e-Sharif and Bagram soil.

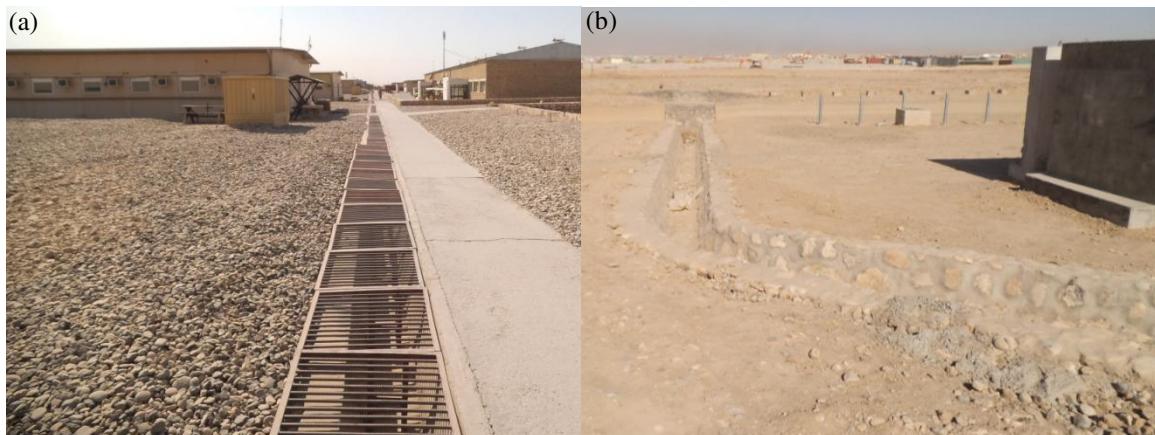
Figure 5.a. Cast in place concrete trench drain and gravel cover over the ground surface, b. grouted stone channel constructed with locally available cobble stones.
