Estimation of the Hydroconsolidation Susceptibility of the Anthropogenic Fill of the Historical Center of Thessaloniki, Greece

KEYWORDS: hydroconsolidation, anthropogenic historical fill, collapse settlement, oedometer simulation, Thessaloniki's Metro

Reference: Hatzigogos, N.P.T., Makedon, T.K., Tsindaris, G.E., Tsotsos, S.C. and Christaras B.C. (2016). *Estimation of the Hydroconsolidation Susceptibility of the Anthropogenic Fill of the Historical Center of Thessaloniki, Greece*. International Journal of Geoengineering Case histories, Vol.4, Issue 1, p.46-56. doi: 10.4417/IJGCH-04-01-04

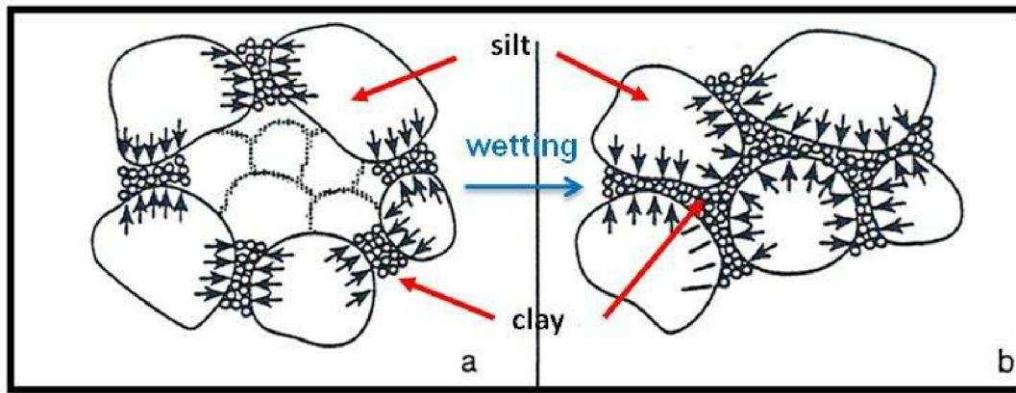
Figure 1. Collapse of a soil structure under load due to wetting (Knight, 1961).

The volumetric change behavior of a saturated soil is generally controlled by effective stress. However this behavior under unsaturated conditions cannot be estimated on the basis of effective stress alone but it is controlled by the changes of the soil moisture that result in changes of soil's matric suction (Khalili et al, 2004). The phenomenon of soil collapse can be manifested gradually and not necessarily as an immediate settlement, depending on the initial moisture content and the moisture variation range. If the soil is loaded under saturated conditions then it will consolidate without collapsing. If however its moisture content under constant loading is initially low (partially saturated) and is subsequently increased, then for low stress levels the soil will swell, whereas for higher stress levels it will sustain volume decrease due to structure collapse. Figure 1 shows the phenomenon of gradual collapse with increased wetting which is called hydroconsolidation; it occurs once and results in a new more stable soil structure (Knight, 1961).

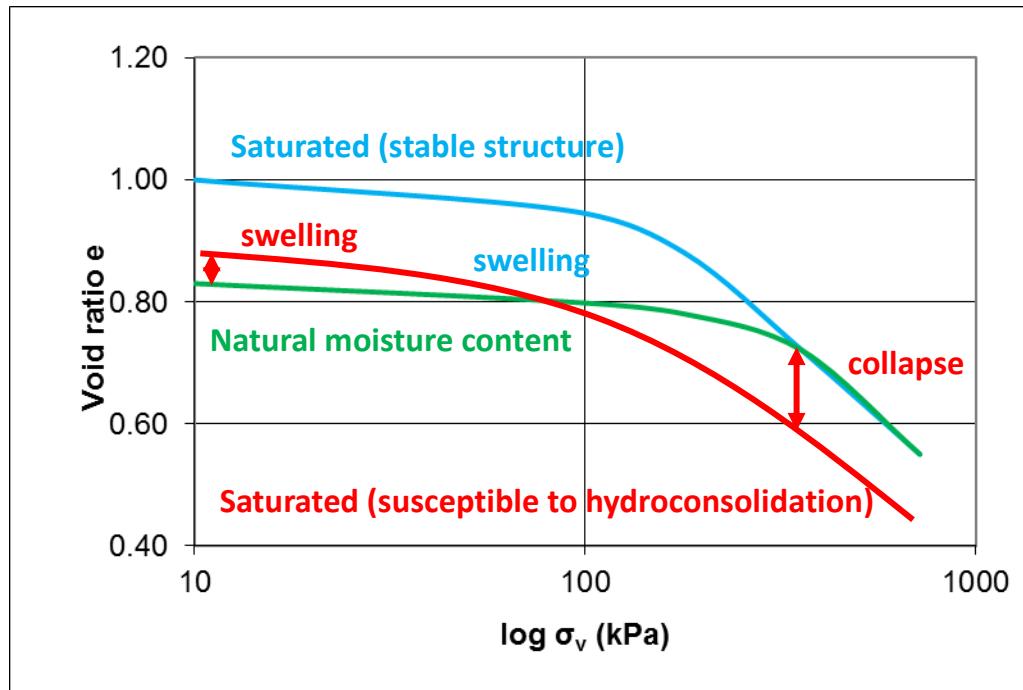
Figure 2. Soil swelling and collapse behavior after wetting under constant load (modified from Jennings & Knight, 1975).

Hydroconsolidation usually occurs in cases of wetting in soils of unstable granular structure due to technical interventions, in residual soils and in non cohesive man-made historical and urban non-engineered fills. The magnitude of settlements due to soil collapse depends on the soil's void ratio as well as the applied load. For low foundation stress levels from 100-300 kPa, research shows observed volume changes up to 10% and settlement as much as 15% of the thickness of the susceptible layers (Tromp, 1985). Hydroconsolidation is estimated via oedometer test with simulation of the loading procedure followed by sample inundation as in Figure 2 (Jennings & Knight, 1975).

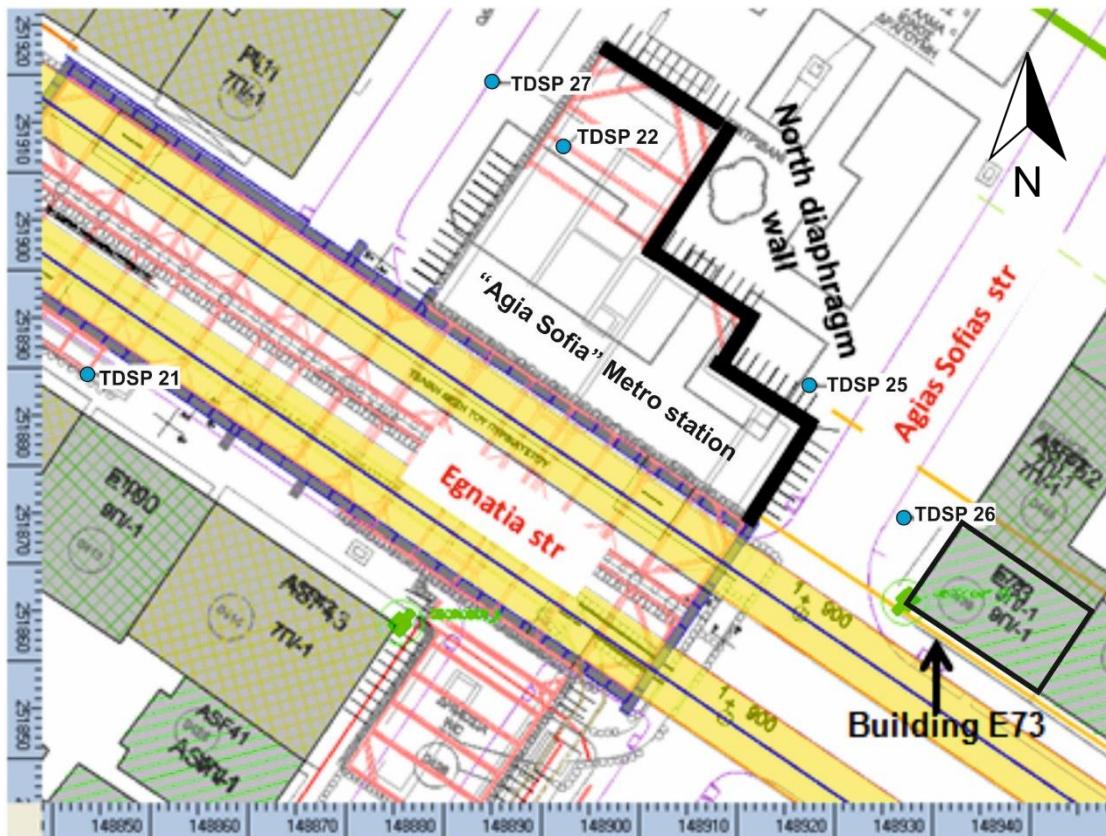
Figure 3. Planar view of the construction of diaphragm walls and piezometers (TDSP 21-27) in "Agia Sofia" Metro Station, along with building E73.

The area of investigation is adjacent to the construction site of the "Agia Sofia" station of Thessaloniki's Metro. During the construction of the station's north diaphragm walls displacements were observed on an adjacent block of flats at the corner of Agia Sofia and Egnatia streets (building E73). The displacements resulted in the deflection of the building towards SW. Systematic measurements of the displacements on the foundation ground were carried out to investigate the phenomenon as well as measurements of the groundwater level in piezometers of the construction area as shown in Figure 3.

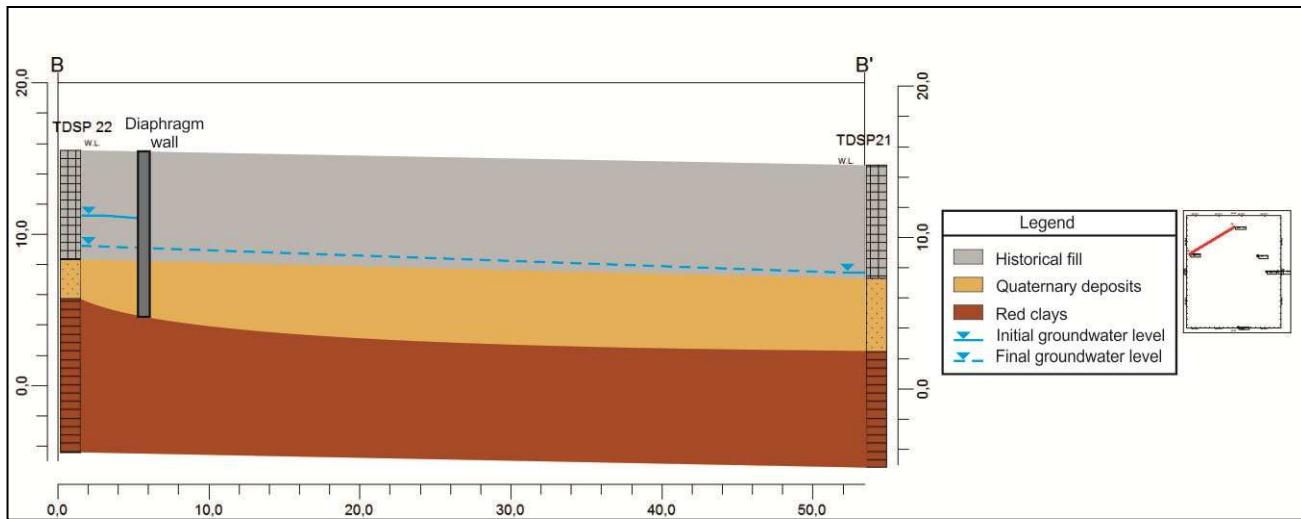
Figure 6. Geological cross section in NE-SW direction along boreholes TDSP22-TDSP21.

The data used in the analysis were obtained by exploration boreholes that were drilled for Thessaloniki's Metro in the study area. Based on these data the historical fill has a local thickness of 9-10 m whereas the Quaternary deposits that are encountered only at the western part of the study area overlying the red clays have a thickness of 3 m. This stratigraphy forms a perched water table in the historical fill as shown in Figures 5 and 6, with an underground flow direction NE-SW that follows the morphology of the red clays. The underground flow is oriented by a backfilled underground flow network formed on the red clays that were in the past, before urbanization, the surface level formation. Figure 5 shows a map of the isodepth curves of the red clays formation which is the natural boundary of the historical fill. The groundwater level presents insignificant seasonal changes due to the existing structure that prohibits surface water percolation. As a result an unsaturated zone of significant thickness is created above the groundwater table and the geo-materials of this zone have not sustained any wetting during the past.

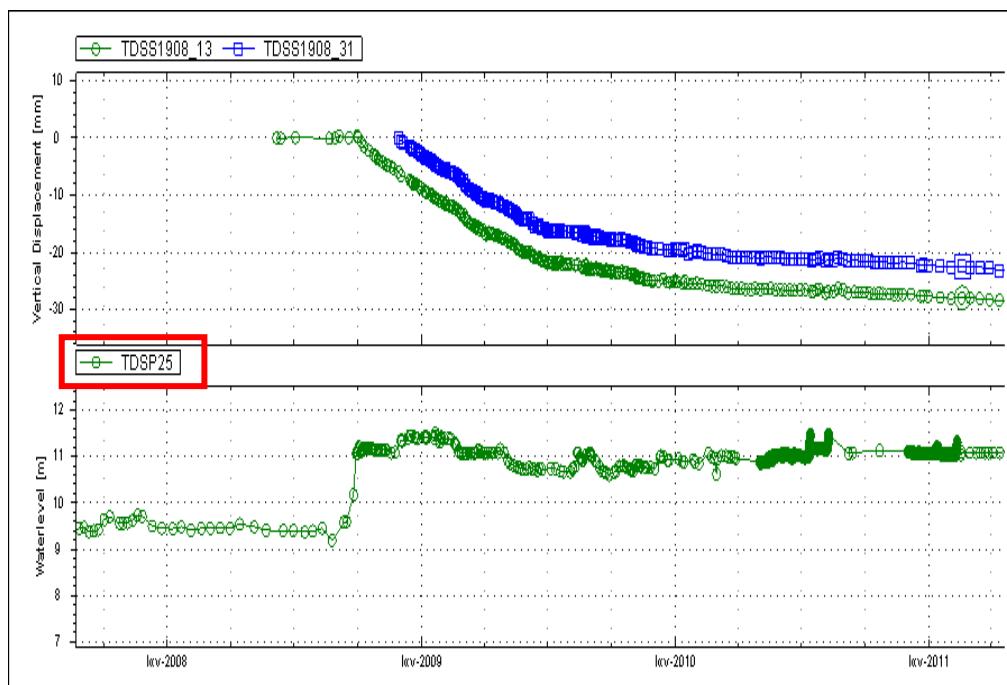
Figure 7. Settlement in building E73 following the rise of the water table (borehole TDSP25).

The works in the station begun with the construction of the northern side diaphragm walls. This created a cutoff barrier to the underground flow of the perched water table resulting to a significant local rise in piezometers TDSP22, TDSP25, TDSP26 and TDSP27 shown in Figure 7, as water flow is bypassing around the diaphragm walls. After the bypass to the SW the water level drops back to the normal level and that is why no rise is detected in piezometers TDSP21 and TDSP24 that are located S-SW of the diaphragm walls. The total rise reached 1.5 m and displacements - settlements were simultaneously observed on the aforementioned building (E73) at the corner of Egnatia and Agia Sofia streets. These displacements resulted in a deflection (inclination) of the building towards Egnatia str. (the free face of the building). The displacement reached 30 mm in a time period of 3 years starting from September 2008 (Figure 8). An additional issue that required interpretation was that the displacements did not affect equally the entire area of the building foundation but only its W-SW section and they were observed during a rise and not a drop of the groundwater level.

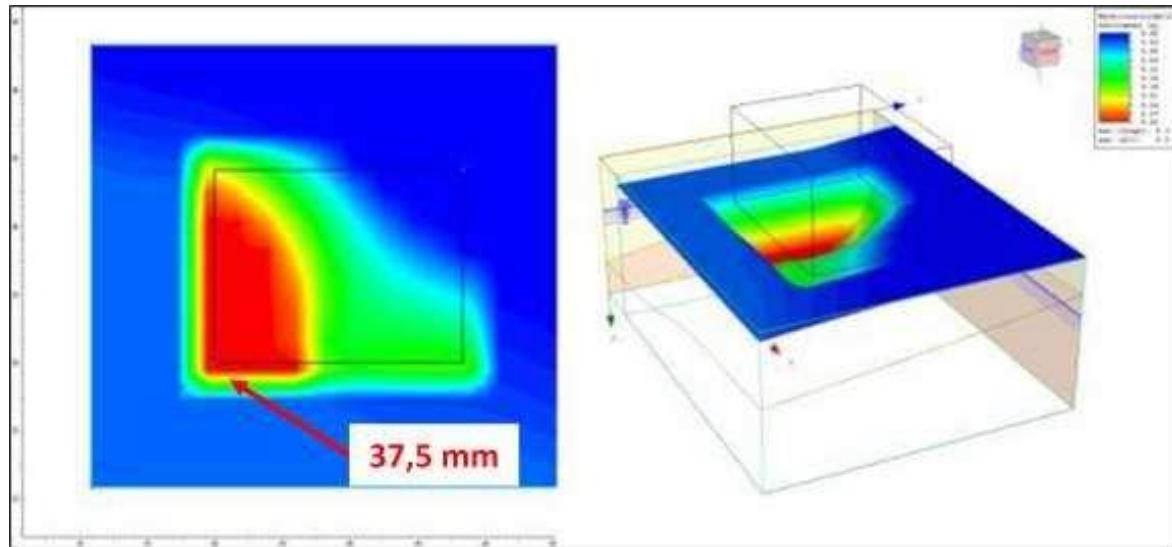
In comparison to the in situ measurements, the anticipated settlements were calculated introducing the layer parameters from the geological model, the groundwater lever rise and the hydroconsolidation characteristics of the layer estimated from the laboratory tests in Settle 3D and the results are shown in Figure 13. As seen from the results there is an uneven distribution of settlements with increased values for the Agia Sofia str. side of the building with a maximum value of 3,75 cm on the SW corner (Figure 13). The Egnatia str. side shows decreasing values of displacements towards E. The calculations correspond to the in situ measurements which also show a gradual decrease of the displacements on the building from SW to NE.

Figure 13. 2D and 3D analysis of hydroconsolidation settlement in building E73.

The differential distribution of settlements is due to the fact that the thickness of the susceptible historical layer (which experienced a maximum groundwater level rise of 1.5 m) is uneven because of its SW dip. Therefore the layer is located
