St. Isaac Cathedral (St. Petersburg, Russia): A Case History

ABSTRACT: *St Isaac's Cathedral in St. Petersburg was completed in 1858 after 40 years of construction; it is today the fourth largest domed Cathedral in Europe. The underlying soil is a relatively soft saturated sediment and carries this 3155 MN structure that is 100 meters high with an imprint of 92 m by 100 m. It is founded on a 7.5 m thick mat of granite and limestone blocks resting on relatively short timber piles of different lengths. The Cathedral has progressively experienced significant deformation including differential settlement causing cracks in the pillars and tilting of the porticoes. The paper summarizes the available geotechnical engineering and engineering geology aspects of the soil on which the Cathedral is built as well as classical issues such as foundation ultimate capacity and settlement analysis through simple calculations and numerical simulations. It also includes some less classical issues such as the influence of microbial activity on the behavior of the Cathedral through the changes the microbes and their activity create in the engineering properties of the soil and in the groundwater compos

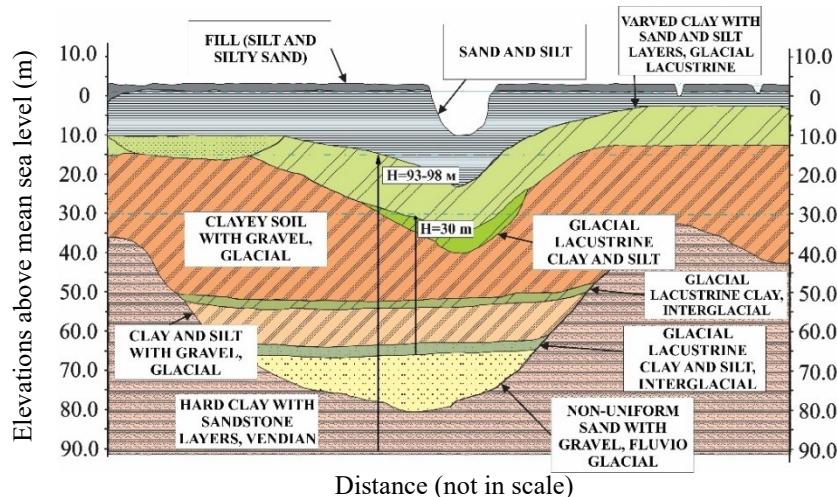
Figure 2. Soil stratigraphy below the downtown St. Petersburg.

Fig. 2 shows a typical soil profile through downtown St. Petersburg. The two main strata from the geological point of view are surficial non-lithified saturated sand-with-clay deposits of quaternary age which are about 400,000 years old underlain by an older lithified clay strata called the Upper Vendian clay which is about 600 million years old. The quaternary soils were deposited during a series of periods including three glacial periods, two interglacial periods, an upper glacial period and a post glacial period. The thickness of the quaternary deposits varies from 20 m to 120 m and the elevation of the top level of the lithified Vendian clay depends on the erosion depth of the ancient rivers into the lithified Vendian clay. The thickness of the quaternary deposits is 20-25 m outside the buried river valleys and 20-120 m inside the buried valleys.

The buildings in downtown St. Petersburg including the historical monuments are mostly founded on the postglacial deposits; these deposits are characterized by coarse grain fills and organic swamp soils with a thickness of 2-11 m, very fine and fine sand of marine and lacustrine origin and of Holocene age with a thickness of 6-12 m, and clayey soils including fat varved clay and lean clay of lacustrine-glacial origin with a thickness of 8-15 m. Under the postglacial deposits is a layer of moraine that consists of silt and lean clay with a gravel content of 5-15%. The thickness of this moraine varies from 10 to 20 m.

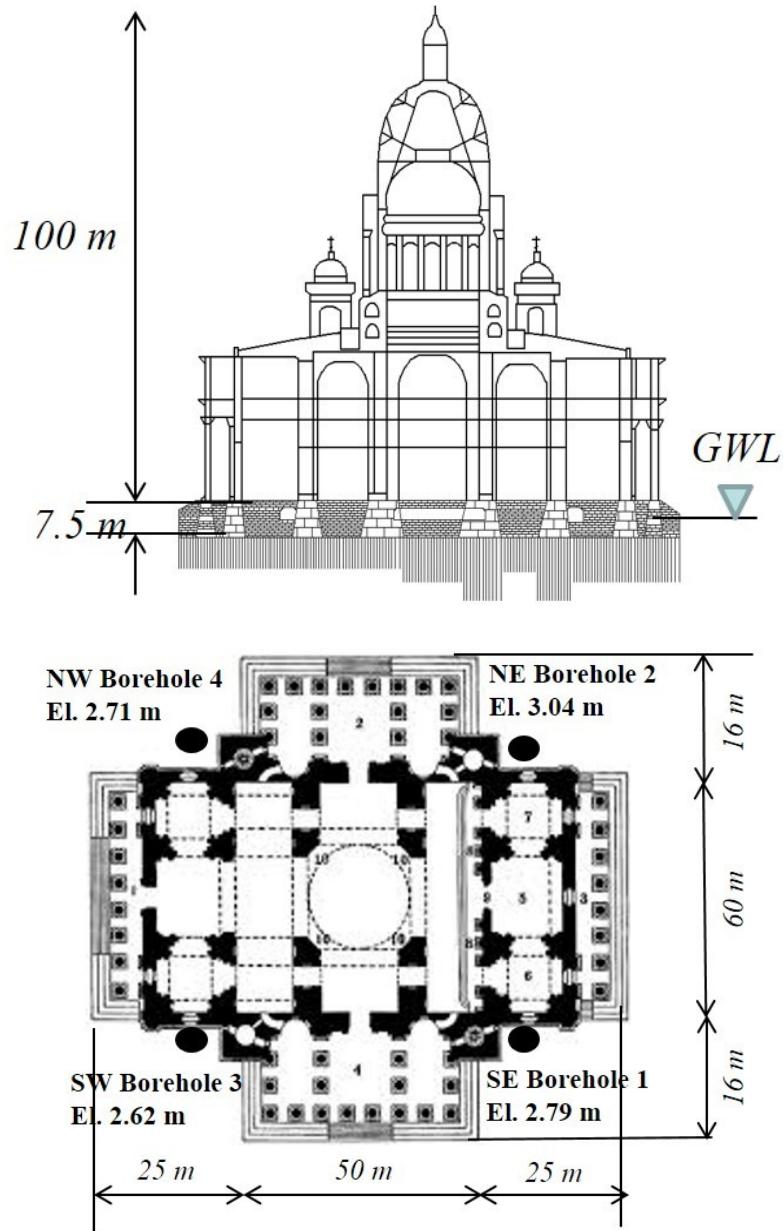
Figure 3. Cross section and plan view of St. Isaac Cathedral

The pile cap consisted of a full-size mat made of massive granite blocks under the most heavily loaded elements, with limestone masonry for the remainder of the foundation. The mat was 7.5 m thick and rose 2.5 m above the ground level. In the 7.5 m thick mat, 2.5 m by 2.5 m galleries were constructed. The weight of the mat is estimated to be 997 MN (Sotnikov, 1986). The total height of St. Isaac Cathedral is 100 m (Fig. 3). The overall length of the Cathedral with porticoes is 100 m, and its width is 92 m. The total weight of the Cathedral structure above the mat is 2158 MN for a total weight on the soil below the mat of 3155 MN. This makes St. Isaac Cathedral the heaviest building in Saint Petersburg. The outside dimensions of the mat are 100 m long by 92 m wide. The mat is in the shape of a cross (Fig. 3) and has a total area of 7600 m^2 . The average pressure under the mat is therefore 415 kPa. The weight of soil removed for the 5-m deep excavation using a unit weight of soil equals to 20 kN/ m^3 is 760 MN and the corresponding pressure is 100 kPa. Therefore, the net pressure for the Cathedral is 315 kPa.

The foundation of the Cathedral posed serious problems as the soil was quite soft. Eventually Montferrand used a technique which had been commonly used for centuries in Venice: thousands of wooden piles driven into the soil to provide a solid foundation. Construction of the new foundations started with a 5-m deep excavation. Then pine timber piles 0.26 m in diameter and 6.4 m to 10.7 m in length were driven. Montferrand decided to use the 13000 existing piles from the Cathedral built by Rinaldi which were 0.26 m in diameter, 10.5 m long under the columns and 8.4 m long elsewhere. The total number of piles used for the construction of St. Isaac Cathedral was about 24000. The bottom of the piles is in the saturated postglacial marine and lacustrine sand and silt as well as the lacustrine-glacial clay; the piles act as friction piles as the end bearing is small compared to the friction capacity.

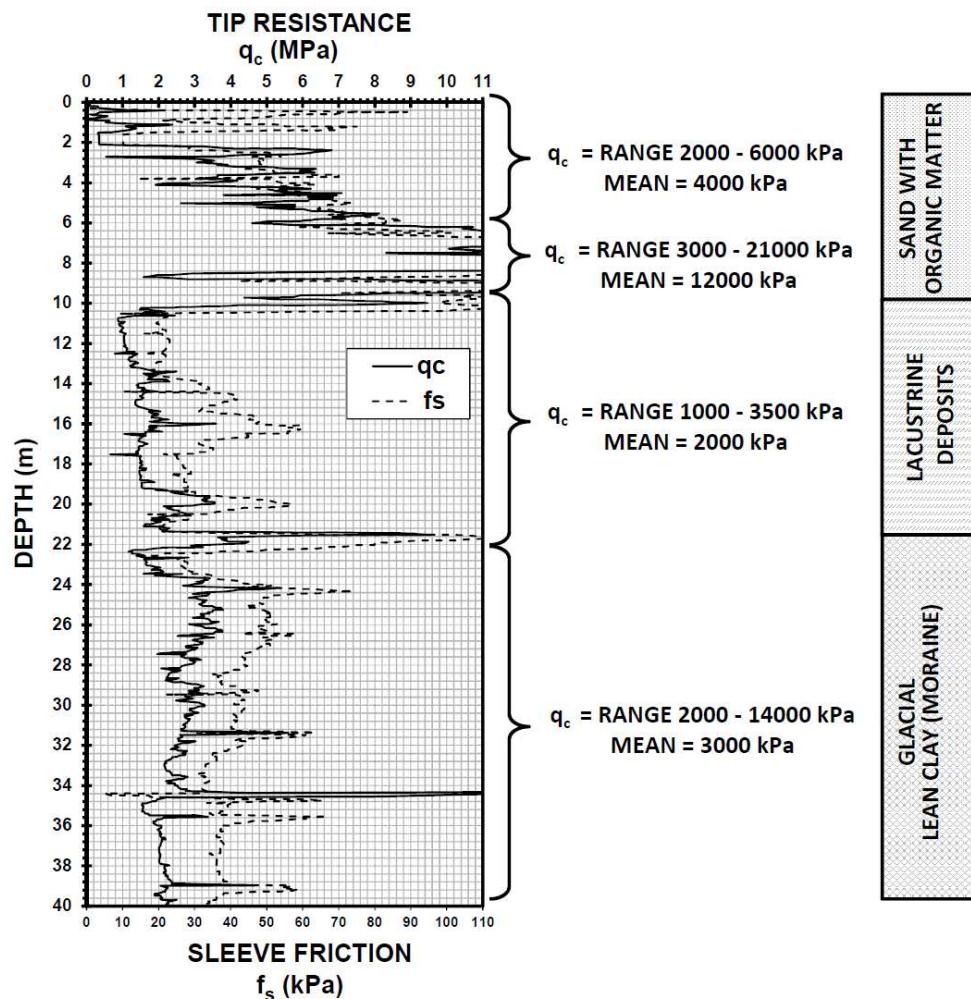
Figure 4. CPT profile near St. Isaac Cathedral.

St. Isaac Cathedral is located on one of the islands of the Neva River about 300 m from the left river bank. Ground elevation around the Cathedral varies from 2.62 m to 3.04 m a.s.l. A total of 8 existing borings were identified at the site of the Cathedral (Table 1). These borings varied in depth from 20 m to 50 m. The first four borings were drilled in 1954 to a depth of 50 m. In 2009, four additional borings were drilled along the Cathedral perimeter at approximately the same location; two were down to 50 m, and two down to 20 m (Fig. 3 and Table 1). A cone penetration test (CPT) was also carried out near the location of the borings in 2009 (Fig. 4). The stratigraphy obtained from one of the CPT penetration resistance profile is also shown on Fig. 4.

Using Fig. 4 and a lower-bound cone tip resistance of 1500 kPa together with a cone bearing capacity factor of 0.35 (Briaud, 2013) the bearing capacity is 615 kPa. This is much higher than the bearing capacity based on the Skempton (1951) equation and when compared to the applied pressure of 415 kPa gives a much more reassuring factor of safety against bearing capacity failure of $615/415 = 1.48$. The low bearing capacity based on the undrained strength from the samples may be due to sample disturbance. Indeed, the cone N_k factor linking the undrained shear strength of the cone tip resistance is back-calculated to be about 50; this is unusually high.

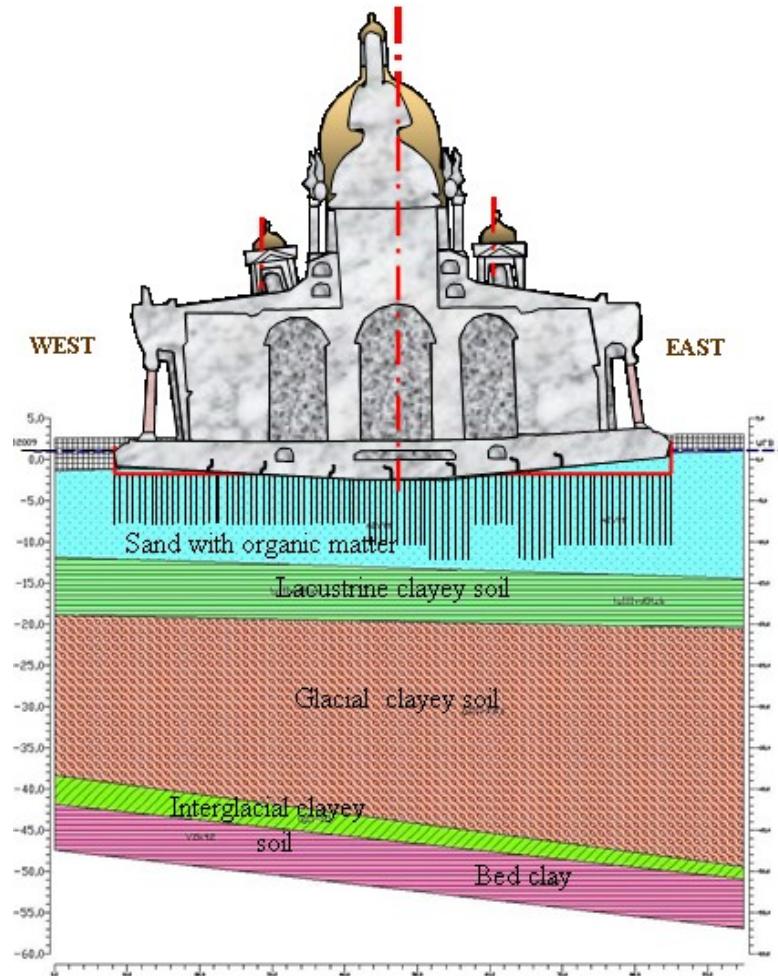
Figure 5. Soil profile of St. Isaac Cathedral.

All the results from the borings in Table 1 were used to determine the underlying stratigraphy, soil type, and soil properties. A summary stratigraphy is shown in Fig. 5. The quaternary soil deposits consist of saturated soft sandy and clayey layers down to a depth of 44.5 m or more. The Upper Vendian clay is found at a depth of 44.5 m on the southwest corner of the Cathedral while it could not be found at a depth of 50 m on the northeast corner of the Cathedral because the boring stopped at a depth of 50 m. The quaternary deposits include inter-moraine, glacial, lacustrine glacial, and lacustrine marine origin formations, overlain by fill deposits and peaty soils (Fig. 5).

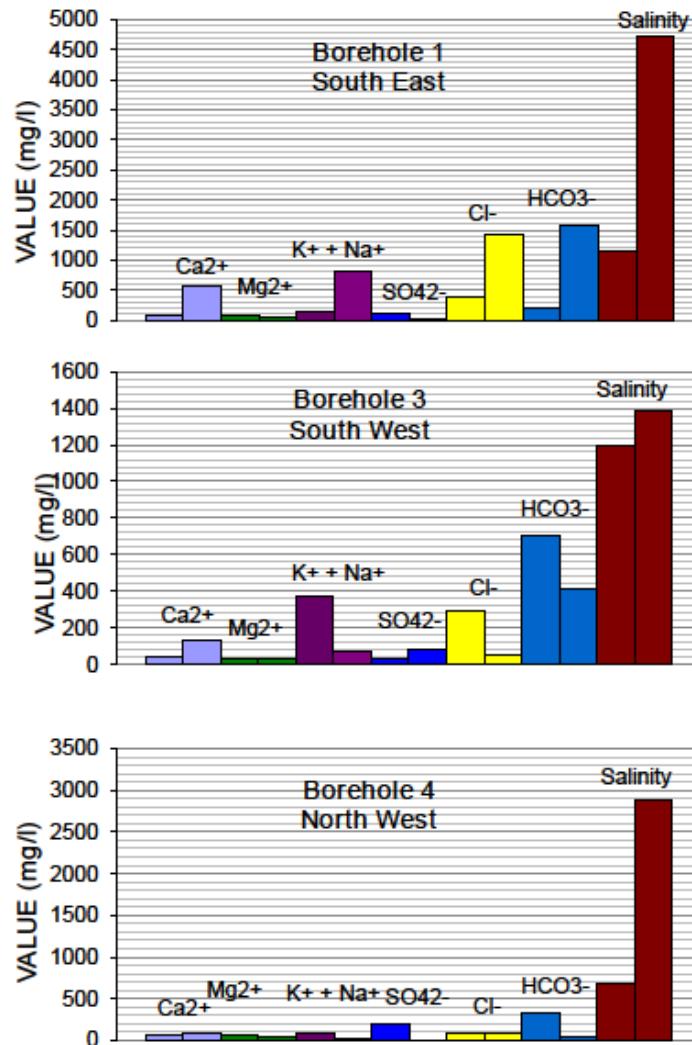
Figure 6. Chemistry of groundwater (1954 and 2009 data).

A comparison between the groundwater chemistry in 1954 and 2009 shows that during that 55-year span there has been a considerable change in groundwater chemistry (Fig. 6). In the bar graphs, each chemical is represented by two side-by-side columns; the first column gives the concentration in 1954 and the second column in 2009. During that period (1954-2009), a dramatic increase in water salinity can be observed indicating an increase in groundwater contamination. The salinity of uncontaminated groundwater is typically around 1000 mg/l. High contents of chlorides (1418 mg/l) and sulphur (81.8 mg/l) also indicate contamination by sewage. Furthermore, the increase in calcium content suggests leaching from the limestone blocks and the limestone-based mortar from the foundation mat located below the groundwater level.

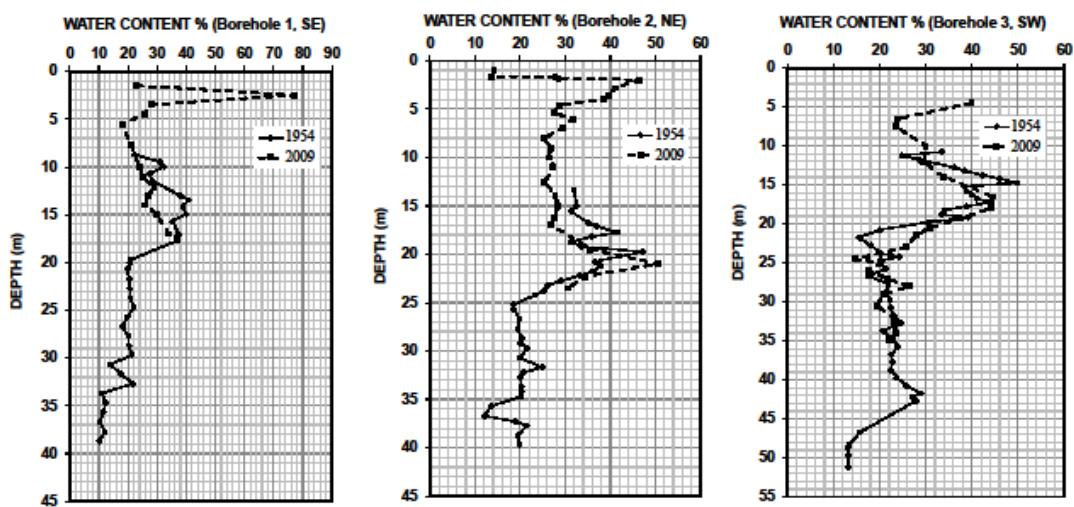
Figure 7. Variation of natural water content versus depth at different locations.

Soil properties were obtained in 1954 and 2009 and are combined in the following figures. The natural water content is presented in Fig. 7 and the plasticity index in Fig. 8. Fig. 7 indicates that there is no clear trend in the evolution of the water content with time and that the largest water contents occur in the layer of silty sand with peat at a depth about 3-5 meters and in the varved clay at the depth of 15-20 meters. Fig. 8 indicates that the varved clay at a depth of 15-20 meters exhibits the highest plasticity.

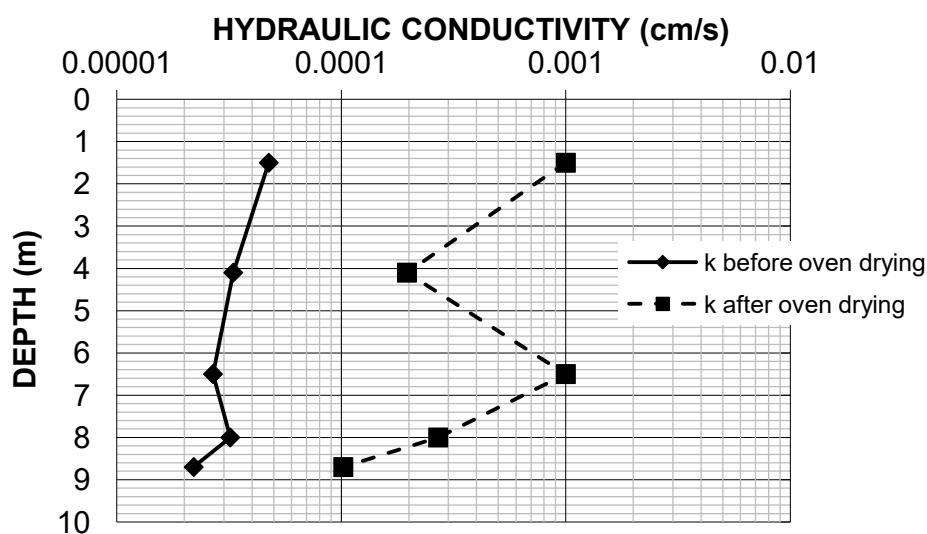
Figure 9 - Hydraulic conductivity of sand vs. depth before and after oven drying.

Falling head permeameter tests were performed in 2009 on the silty sand samples (Fig. 9) and indicated relatively low hydraulic conductivity varying from 1.1×10^{-5} to 6.8×10^{-5} cm/sec. These low values are likely due to the presence of organic matter clogging the pore space in the sand (Dashko et al. 2015, 2016). Permeability tests were also performed on the silty sand after oven drying the samples at 105°C ; the permeability of the dry silty sand increased to 1×10^{-3} to 1×10^{-4} cm/sec (Fig. 9). This likely occurred because the drying process burnt some of the organic matter thereby increasing the size of the pores.

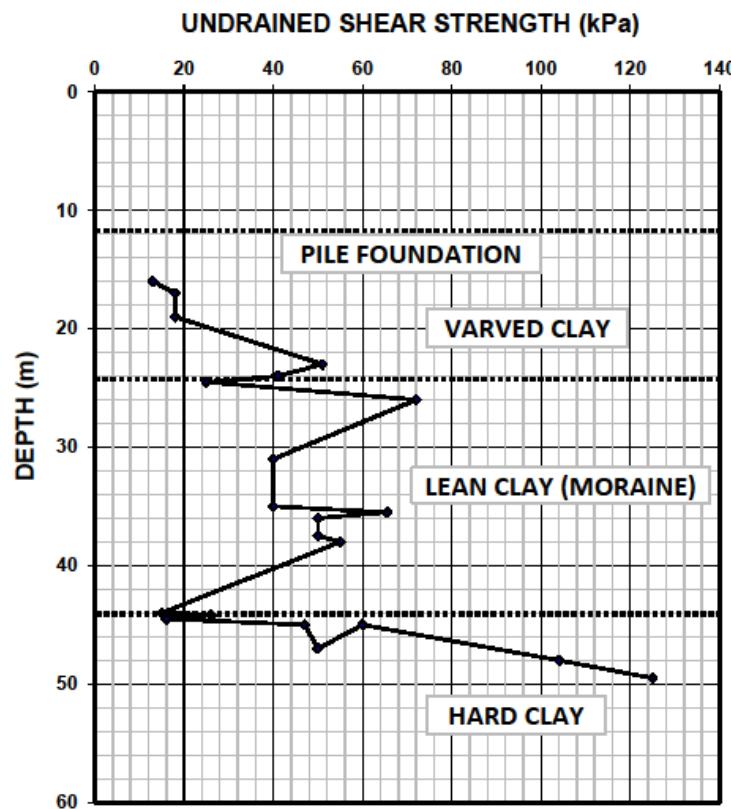
Figure 10. s_u profile versus depth.

The shear strength properties, cohesion and angle of internal friction, available from the archives of 1954 are limited to direct shear test results (Table 3). In 2009, unconsolidated undrained triaxial tests were performed. The undrained shear strength (s_u) vs. depth profile obtained from these tests is shown in Fig. 10. Figs. 11 and 12 show the deviator stress vs. normal strain for some of the tests; the samples failed mostly in general deformation mode (barrelling) rather than along a single plane of failure. As indicated by the stress strain curves, the varved lacustrine clay underlying the pile foundation is very soft with s_u values between 18 and 20 kPa. The glacial clayey soil below that glacial soil has s_u values which vary with depth from 18 kPa at the top of the layer to 125 kPa at depth. This significant variation could be due to the micro-fissures present in the upper zone of that clay layer which weaken the global strength.

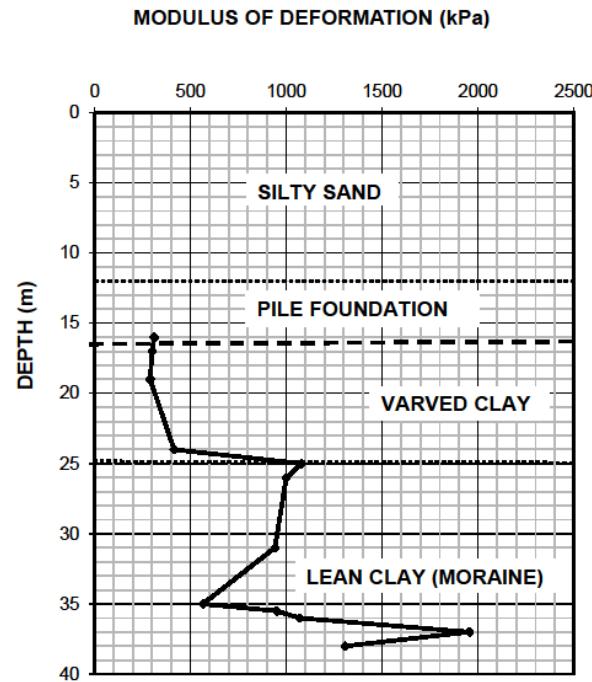
Figure 13. Undrained soil modulus versus depth.

Values for the modulus of deformation of the soil were calculated from the triaxial test results. They are presented in Table 4 while Fig. 13 shows the modulus profile versus depth. The modulus E was obtained as the slope of the initial linear part of the deviator stress vs strain curve. The red lines on Fig. 11 and 12 show examples of how the linear part was selected. The modulus equation is:

Where σ_1 is the major principal stress, v is Poisson's ratio taken as 0.5 for undrained behaviour, σ_3 is the minor principal stress, and ε_1 is the principal normal strain. The modulus (E) reaches 5000 kPa in the top layer of lacustrine marine soil,

becomes much lower in the glacial lake clayey soil with values between 290 to 1000 kPa, and then increases slightly in the moraine from 415 to 2000 kPa. Additional soil properties are shown in Table 4.

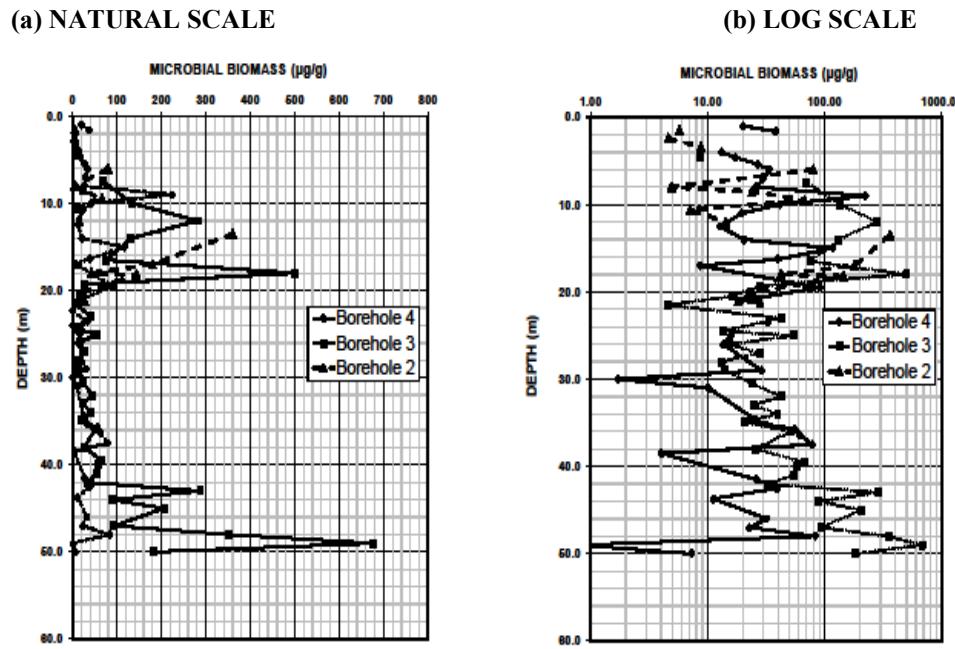
Figure 14. MM in soil vs. depth (2009 data): (a) natural scale, (b) decimal log scale.

for some St. Petersburg soils by Dashko and Shidlovskaya (2015). The microbial mass and biofilms create slippery substances which coat the particle contacts and facilitate the movement of particles with respect to each other (lower modulus of deformation and lower strength) and clog the pores (lower permeability) (Dashko et al. 2013a, 2015). Indeed, for example, hydrogen sulfide (H_2S) as a metabolic product of sulfate-reducing bacteria in anaerobic state and bivalent iron (Fe^{2+}) leads to the generation of hydrotroilite $FeS \cdot nH_2O$ in the form of black and dark grey powder that was observed in all soil samples below the groundwater level. Fig. 14 shows the MM distribution through the soil profile. The peaks of MM at 20 m and 50 m depth correspond to the lacustrine varved clay (up to 500 micrograms per gram) and to the Vendian clay (up to almost 700 microgram per gram).

The sand layers are made of very fine sand with more than 50% of the particles by weight in the range of 0.05-0.1 mm and some in the range of 0.1-0.25 mm. These sand layers are found at depths between 2 and 8 m. Hydrometer analyses indicate that the sand does not settle much during the first 24 hours when mixed with distilled water; indeed after 24 hours the volume of suspended sediments is still about 95%.

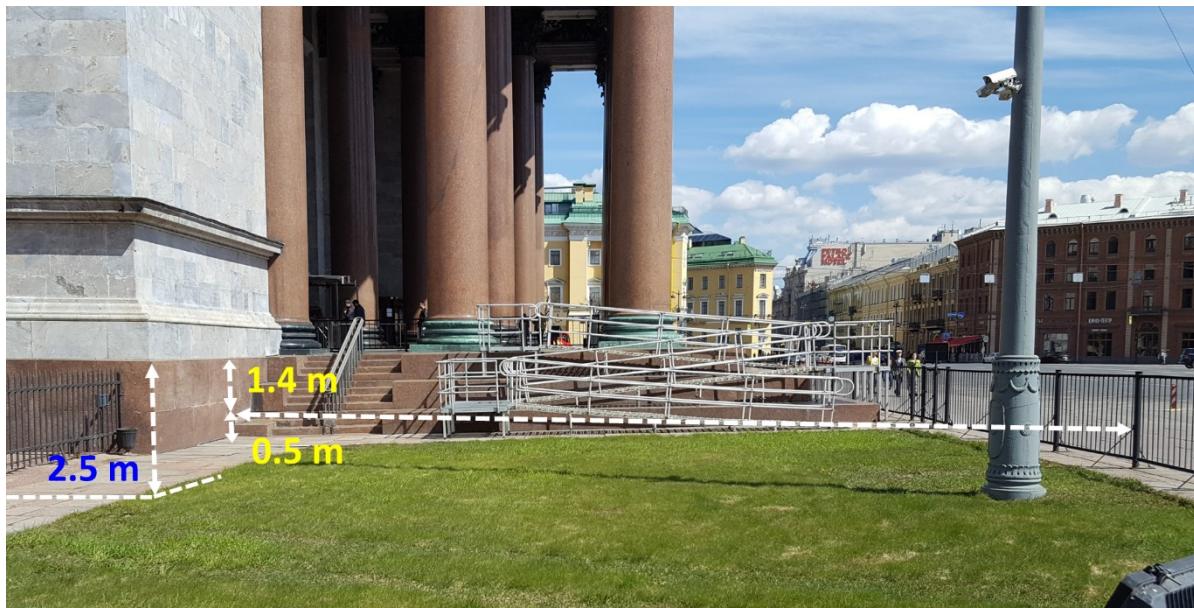
Figure 15. Settlement measurements at the southwest corner.

Settlement calculations are usually done by using the results of consolidation tests or by using the modulus of drained triaxial tests as the settlement has taken place over the last 150 years. None of this data was available to the authors. However, settlement measurements were made as follows (Fig. 15, 16): At the time of construction the 7.5-m thick mat was 2.5 m above the ground surface. Today the mat was measured to be 1.9 m above the ground surface at the southwest corner and 1.8 m above the ground surface at the northwest corner. This indicates that the Cathedral has sunk 0.6 and 0.7 m at those corners respectively. Furthermore, the ground surface at the base of the Cathedral is lower than the street level by 0.5 m at the southwest corner and 0.35 m at the northwest corner. These simple measurements allow one to conclude that the total settlement of the Cathedral is of the order of 1 m.

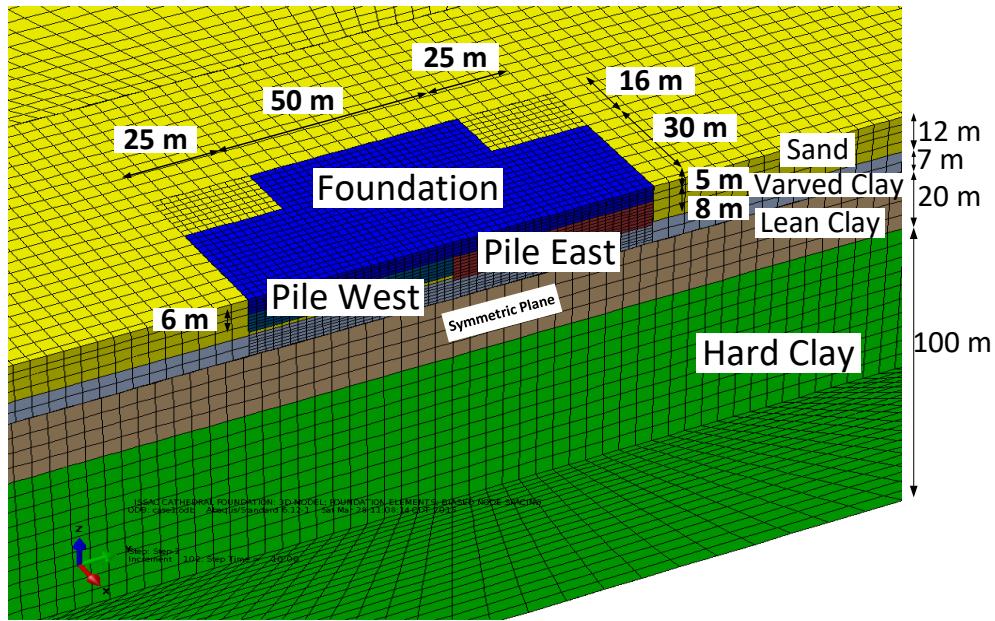
Figure 17. Mesh dimensions, Cathedral dimensions and soil stratigraphy.

A numerical simulation of the behavior of the Cathedral was conducted using ABAQUS 3D (ver. 6.12, 2012) to better understand the behavior. The simulation domain included the soil mass, the pile foundation, and the mat on top of the piles with an applied distributed pressure to represent the load from the Cathedral. The mesh representing the soil mass was 700 m long, 400 m wide and 140 m deep. The stratigraphy was a 12-m thick layer of sand, a 7-m thick layer of varved clay, a 20-m thick layer of lean clay, and a 100-m thick layer of hard clay (Fig. 17). The plan view of the foundation was selected to match the records. The piles under the Cathedral are longer under the East side than under the West side (Fig. 5); they were represented by an 8-m deep block under the East side and by a 6-m deep block under the West side (Fig. 17). The mat is 7.5 m thick with 5 m below the ground surface; it was represented by a 5-m thick block while the 2.5 m above ground were added to the weight of the structure. In total the mesh contained 243,700 eight-node brick elements with reduced integration (C3D8R) [ABAQUS, 2012]. All the nodes on the vertical boundaries of the soil mass were fixed in the horizontal direction and free to move in the vertical direction; the nodes on the bottom boundary were fixed.

The materials included the soil, the foundation mat and the piles. Again, the choice of the soil model was limited by the information available to the authors. For the soil, the clay layers were simulated as elastic plastic materials using the modulus which would match the observed settlement (trial and error with values in proportion to the cone penetrometer profile) and the measured undrained shear strength as input. The sand layer was modeled as an elastic material as were the piles and the mat foundation. The material properties are shown in Table 5 and 6. For the mat, a likely optimistic modulus of concrete ($E = 20$ GPa) was selected for the foundation stones. Since the piles were represented by a solid block, an equivalent modulus for the block was calculated by using an average modulus based on matching the global AE stiffness where A is the cross section of the material and E is the modulus of that material:

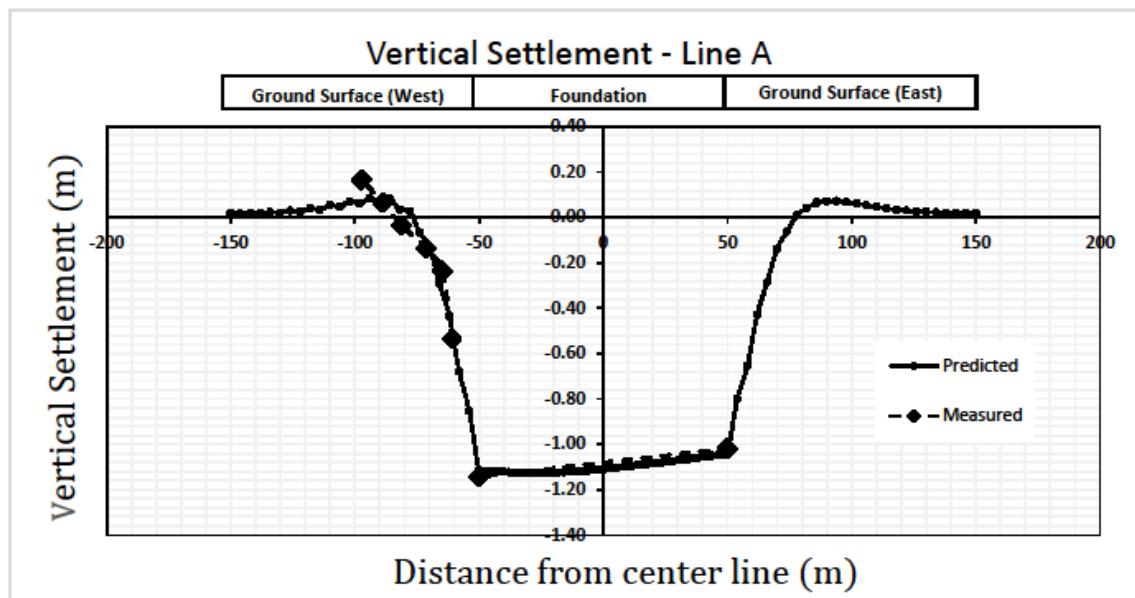
Figure 18. Ground surface settlement around and under the Cathedral.

Fig. 18 shows the settlement of the Cathedral along the centerline East-West axis for the case that matches the measured total settlement of 1 m. A tilt is observed due to the uneven depth of the pile foundation; indeed, the Cathedral does not settle evenly due to the different lengths of piles in the foundation (Fig. 19) and the calculated difference in elevation between the eastern most point and the western most point of the Cathedral is 0.16 m. A parametric study was also conducted to investigate the influence of the structural parameters on the results. Fig. 20 shows the impact of the modulus of the foundation material on the bending of the foundation mat and associated distortion of the structure leading to increased cracking. Additional results of the analysis including ground surface settlement profiles, contours of vertical settlement with depth, and stress distribution in the soil mass can be found in Mohammadrajabi et al. (2015).

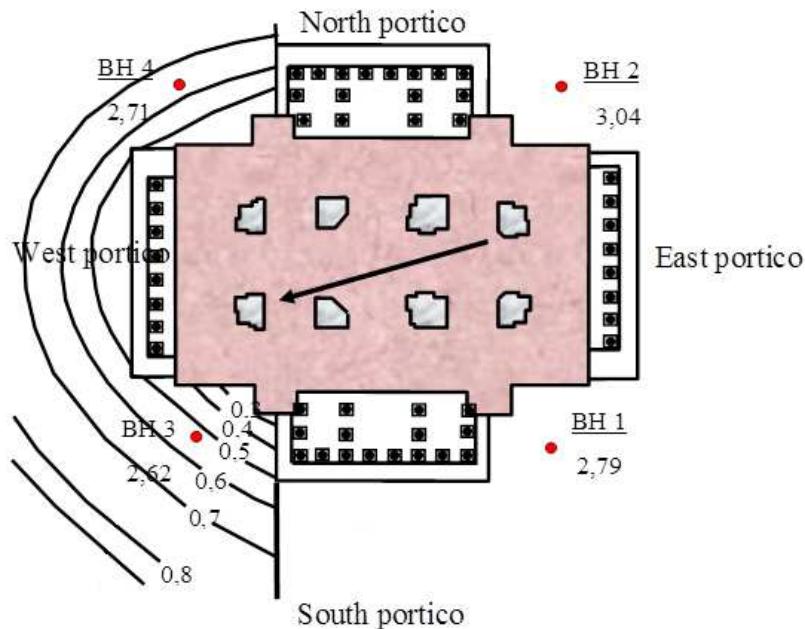
Figure 21. Ground surface survey around the Cathedral (Sotnikov, 1986).

The survey of Sotnikov (1986) gave the elevation contours of the ground surface West of the Cathedral (Fig. 21). These elevation contours were used to create a settlement profile along a direction perpendicular to the contours. This settlement profile is plotted on Fig. 18 and is compared to the numerical simulation predictions. The match on Fig. 18 is reasonably good and gives some credibility to the theoretical work. As explained previously and as shown on Figs. 15 and 16, the Cathedral has likely settled about 1 m including some punching of the mat into the soil. Fig. 23 shows the plastified elements in the stress field at the Cathedral edges; this certainly indicates a very likely yet limited and localized punching failure at the edges.

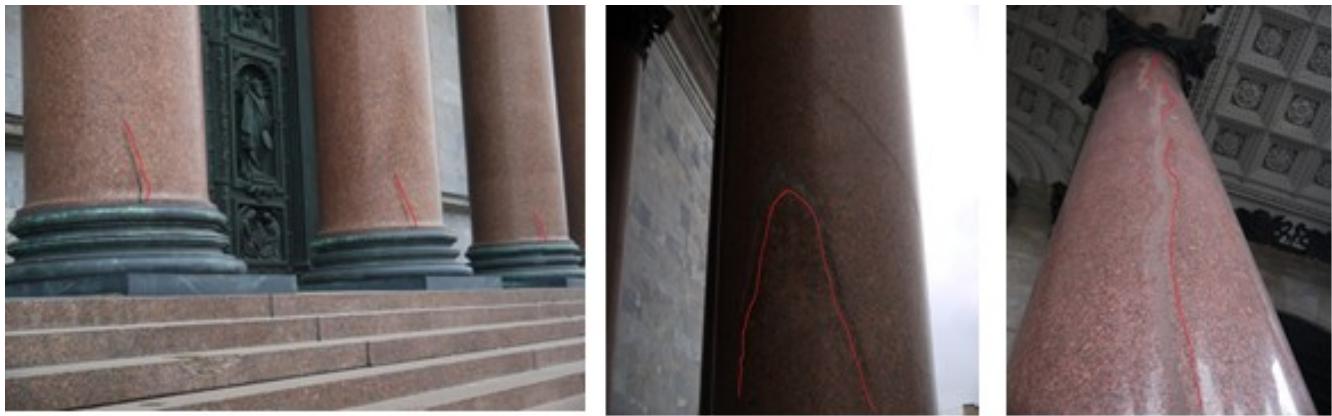
Figure 22. Intensifying cracks in the columns.

The magnitude of this differential settlement continued to increase as well as the severity of the cracks in the columns and the tilting of porticoes. In 1950, the deterioration of the bearing structures was documented including cracks in the pilonnes, the arches, and the columns (Florin, 1954; Butikov, 1974). In 1983, a survey of the ground surface near the southwest end of the Cathedral was performed and indicated a maximum difference in elevation around the southwest part of the Cathedral of 0.85 m (Sotnikov, 1986, Fig. 21). The summary results of all the surveys performed at different times are shown in Table 7. Today the differential settlement has intensified causing additional cracking in the pillars supporting the dome, tilting of porticoes, deformation and dilapidation of the columns (Fig. 22).

St Isaac Cathedral in St Petersburg, Russia, is a remarkable historical monument and among the World Heritage Monuments. It is a very heavy structure founded on soft soils. The engineering properties of these soils including stiffness, strength, and permeability are decreasing as they are affected by an increase in microbial activity. These microbes are multiplying because of the organic soils (peat) and the leaking sewage. The pressure under the mat foundation is 415 kPa, the net bearing pressure is 315 kPa while the estimated ultimate bearing capacity of the soil is 279 kPa when using the results of laboratory undrained shear strength and 615 kPa when using the tip resistance of the cone penetrometer sounding. Based on limited measurements, the settlement of the cathedral is estimated to be around 1 m. The elastic settlement equation and a series of numerical simulations are used to back-calculate the moduli that match the observed settlement. These back-calculated long term modulus values are related to the cone penetrometer tip resistance through the relationship $E = 2.5 q_c$. The differential movement over the 100-m length of the structure is about 25 cm due to the uneven distribution of the piles below the foundation. The dishing effect of the mat combined with the long term creep of the soft soil leads to continuous cracking of the structure and of the columns supporting it. Future monitoring of the structure is necessary to better assess the situation and develop an action plan to avoid further deterioration.
