# Geobarrier System for Protection Against Rainfall-induced Slope Failure

The objective of this paper is to present a case study of a GBS system that was constructed at Orchard Boulevard, Singapore. The paper presents the overall design, and construction procedures of GBS for slope at Orchard Boulevard. Furthermore, the performance of the GBS in response to rainfall infiltration is discussed in the paper based on the field monitoring data and the results of the finite element seepage and slope stability analyses.

GeobARRIER System for Protection Against Rainfall-induced Slope Failure. International Journal of Geoengineering Case Histories, Vol.5, Issue 1, p. 26 - 42. doi: 10.4417/IJGCH-05-01-03

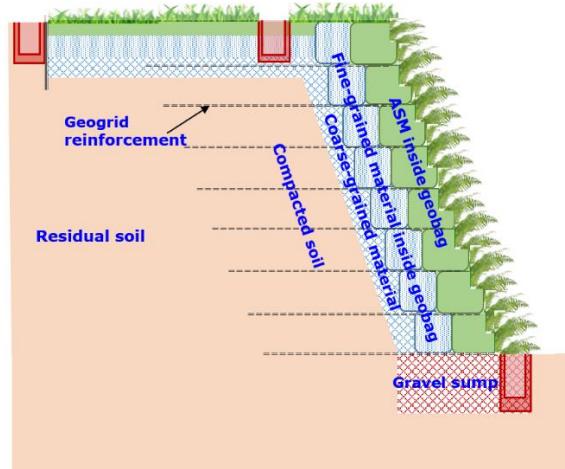
compacted residual soil as reinforced fill, geogrids as reinforcing element, and combination of bags filled with recycled material and ASM as facing. The capillary barrier system is made of bags filled with fine-grained recycled material laid on top of a layer of coarse-grained recycled material. The green cover is vegetation planted in bags filled with ASM. The system was also enhanced with proper drainage system including gravel sump below the toe to collect the rainwater from the fine-grained layer and drain it out to the main drainage system as well as two rows of surface drain at the crest to collect run-off. The surface drainage is located at a suitable distance so that the reinforced soil will not be affected by seepage from behind the system. The schematic diagram of GBS is shown in Figure 1.

Figure 1. Schematic diagram of GBS.

In the final stage of the GBS construction (at the crest of the slope), the coarse-grained material was placed directly above the ground surface behind the fine-grained material bag. Then, geofabric was placed on top of the coarse-grained material before the placement of the fine-grained material. Another geofabric layer was placed before laying ASM on top of the fine-grained material. Then, two surface drains were constructed at the specified locations. The crest of the GBS slopes were then covered by turfing on the ASM layer. These steps are illustrated in Figure 3d. Vegetations were planted in each pocket of the ASM geobags upon the completion of the GBS slopes. The diagram of the completed GBS is shown in Figure 1.

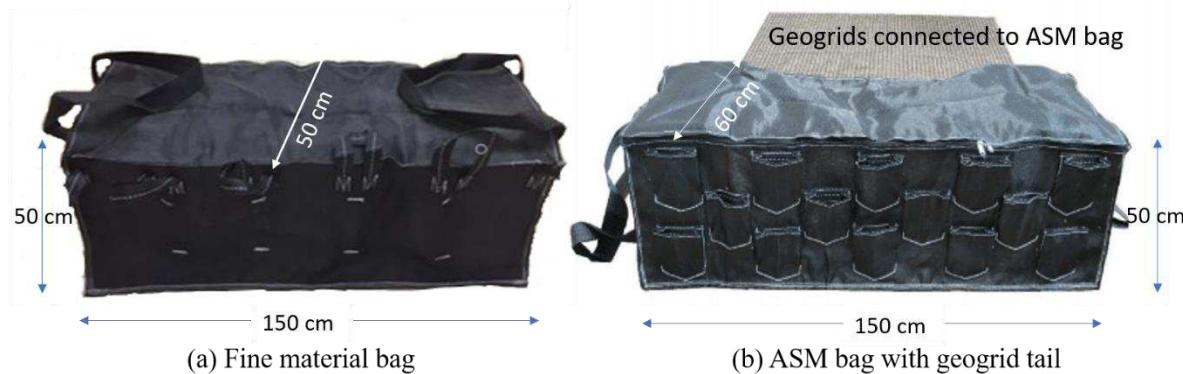
Figure 2 shows the geobags used for fine-grained material and ASM. The dimension of ASM geobag is 0.6 m width × 0.5 m height × 1.5 m length while the dimension of the geobag for the fine-grained material is 0.5 m width × 0.5 m height × 1.5 m length. The ASM bag is supported by specially designed pockets for planting different types of plants. The ASM bag is also connected to geogrids used as a reinforcing element. The bi-axial geogrids should be made from high-quality polyester yarn fibres with high tensile strength with a design life of 120 years and a tensile strength of 12 kN/m @ 2% strain and 30 kN/m @ 5% strain.

Figure 2. Geotextile bags for fine material and ASM.

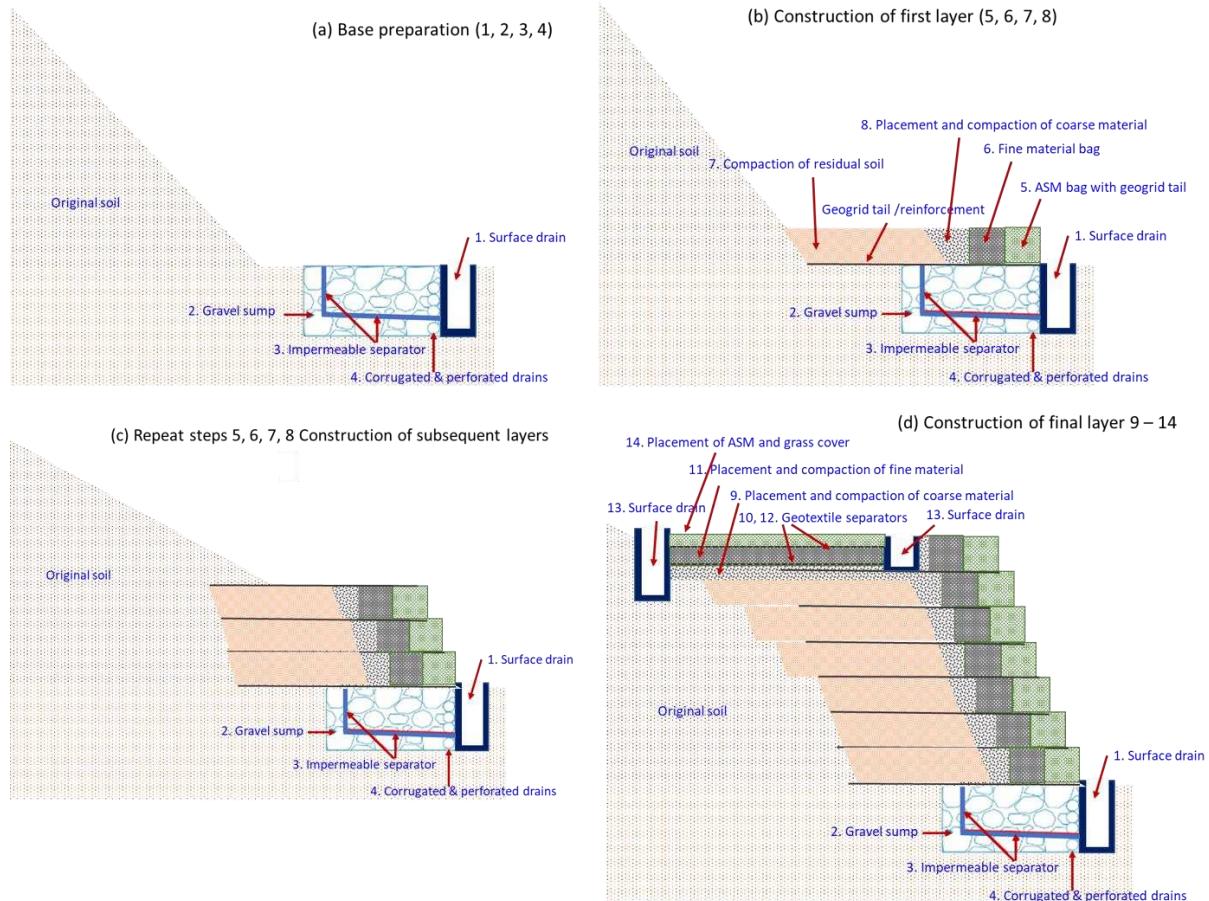
Construction of GBS was started with the excavation of the original slope to the required dimensions and depth of the GBS slope. A compacted gravel layer was placed at 1 m depth from the ground surface below the toe of the slope. The gravel layer was required near the slope toe in order to drain out the water from the GBS system into the main drain. During a rainfall event, some amount of water was expected to infiltrate into the ASM, the fine-grained and the coarse-grained layers before being discharged into the gravel sump at the base of the slope. Three corrugated perforated pipes were prepared to drain out water to the gravel sump, one from the coarse-grained layer, two from the fine-grained layer and one from the ASM layer. All pipes were wrapped with geotextile to avoid migration of soil particles that may block the pipe holes. The water from gravel sump was directed to the surface drain and then was channelled to the main drain. These stages are illustrated in Figure 3a.

The fine-grained material and the ASM were placed carefully into the geobags prior to the placement at the designated locations. The fine-grained material was compacted at a relative density between 70% and 90%. The placement of geobags was carried out in stages of 500 mm height. Each stage was started with the placement of the ASM geobag. The geogrid attached to ASM geobag was stretched up to its maximum length. Then, the geobag containing the fine-grained material was placed behind the ASM geobag. Residual soil was compacted to 90% compaction level to form a reinforced fill, leaving a 20 cm space between the compacted soil and the bag with the fine-grained material. Then, the coarse-grained material was placed and compacted to the required dry density. These steps are illustrated in Figure 3b and are repeated until the layer before the final level was reached (Figure 3c).

Figure 3. Construction stages of GBS.

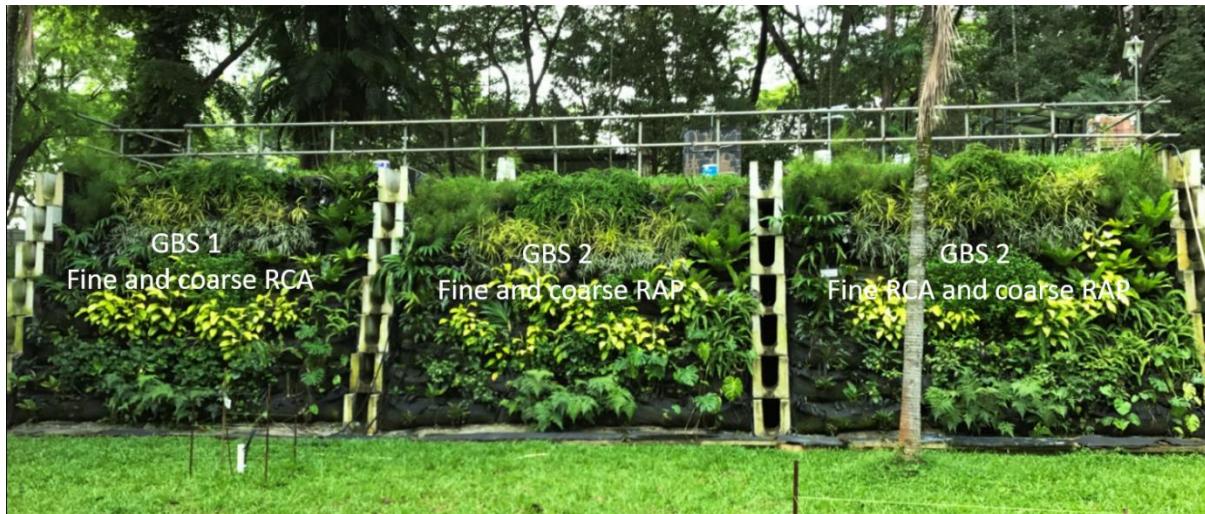
Three GBSs were constructed at Orchard Boulevard in Singapore with a slope height of 4 m and a slope angle of 70° (Figure 4). The original slope was inclined at 35°, thus the construction of the GBSs involved excavation of the slope to the designed slope angle. Preliminary site investigation indicated that the groundwater table was located at about 2 m and 6 m below the ground surface at the toe and crest, respectively. In other words, the residual soil below and behind the slope was in an unsaturated condition. The results from index properties for residual soil at Orchard Boulevard indicated that the residual soil

Figure 4. GBS at Orchard Boulevard.

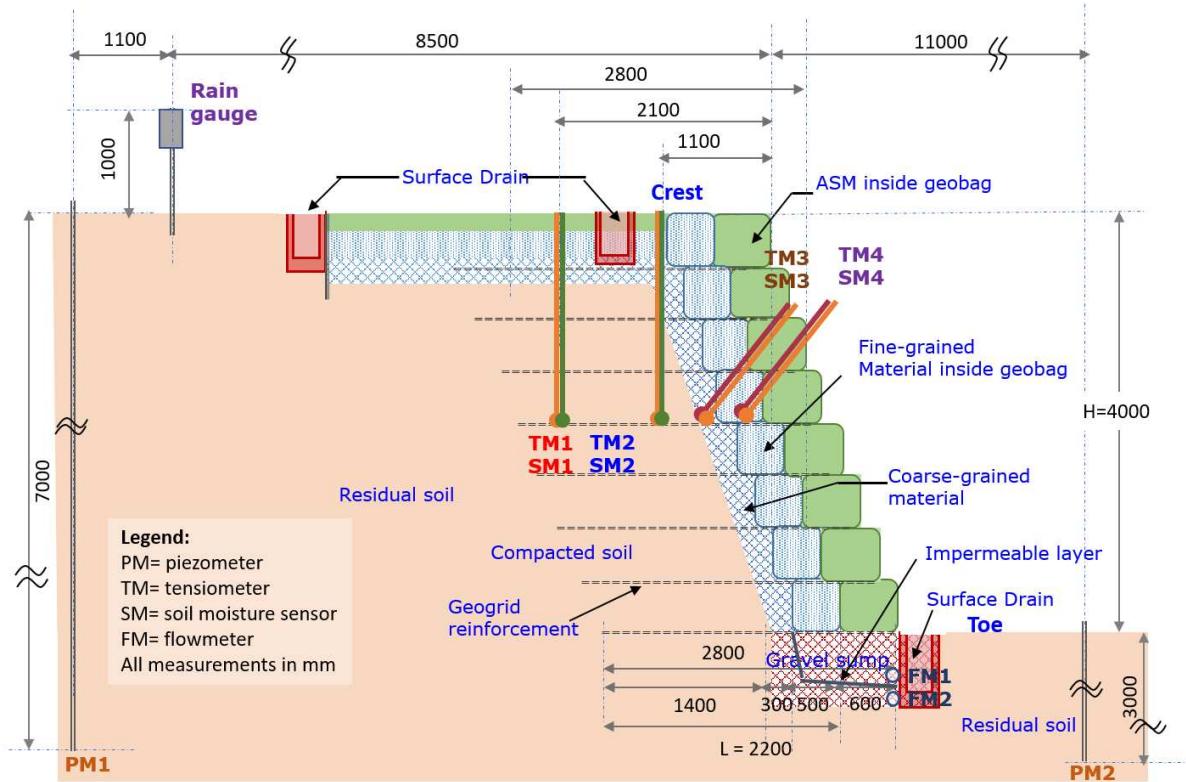
The presence of geobag at the interface between the fine- and coarse- grained materials did not interfere with the effectiveness of the capillary barrier system (Rahardjo et al. 2018a). The GBSs at Orchard Boulevard consisted of eight layers of geobags with a 2.8 m- long geogrids. The geogrids were secured in between two layers of geobags and connected to the ASM bags (Figure 2). A 0.3 m thick of coarse-grained material (coarse RCA or coarse RAP) was laid on the reinforced soil before the placement of bags of fine RCA or fine RAP (Figure 3). A cross-section of the GBSs at Orchard Boulevard is shown in Figure 5.

Figure 5. Cross-section of GBS at Orchard Boulevard with instrumentations.

The GBSs were instrumented to monitor their response to actual rainfall. The site was instrumented with a rain gauge to monitor rainfall and two piezometers (PM1 and PM2), located near the toe and crest respectively, to monitor groundwater table. Each GBS was instrumented with four pairs of tensiometers (TM) and soil moisture sensors (SM) to monitor pore water pressure (PWP) and volumetric water content (VWC). Two pairs of tensiometers and soil moisture sensors (TM1- SM1 and TM2-SM2) were installed vertically from the crest to monitor the pore water pressures and moisture contents of the compacted residual soils. The other two pairs of tensiometers and soil moisture sensors (TM3-SM3 and TM4-SM4) were installed perpendicular to the sloping face. These instruments measured the pore water pressure and moisture content of the coarse- and fine-grained materials, respectively. In addition, two flowmeters were installed in the gravel sump of each GBS to measure water flow from the fine-grained layer (FM1) and coarse-grained layer (FM2). The measurements by flow meters were intended to observe if there was a breakthrough from the fine-grained layer to the coarse-grained layer. The positions of all tensiometers, soil moisture sensors and flow meters in the GBSs are shown in Figure 5. All instrumentation readings were collected by a data logger at a 10-minute interval regardless of rainfall events. The data logger sends all data to a server (PC) using general packet radio service (GPRS) system over the internet. User Accounts were set up to allow all members involved in the slope project to assess the system over the internet any time, anywhere, obtaining the latest information about the slope's "health conditions". The collected data can be displayed on the webpage in time-history plots and other necessary charts for easy reference.

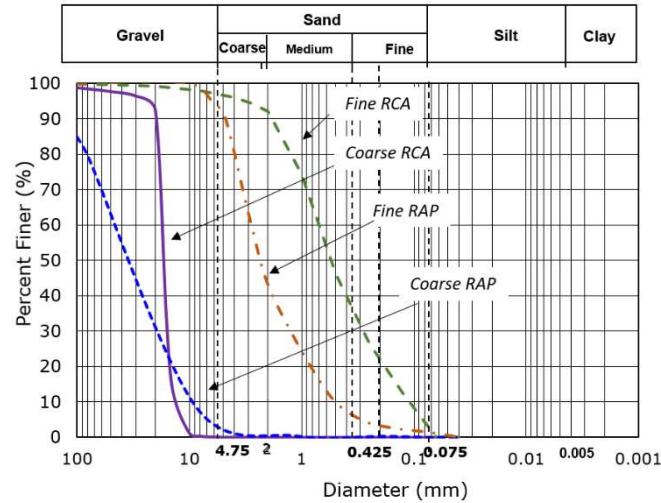
The configuration of the capillary barrier was evaluated based on several criteria. Smersud and Selker (2001) proposed that for an effective capillary barrier, the ratio of particle size (defined as  $d_{50}$ ) of the coarse- and fine-grained materials should be greater than 5. Furthermore, Rahardjo et al. (2007) suggested some criteria based on: i) the water-entry value,  $\psi_w$ , of the coarse-grained soil (preferably  $<1$  kPa); ii) the ratio between the water-entry value of the fine-grained material and the coarse-grained material ( $\psi_w$ -ratio) to be greater than 10, iii) the saturated coefficient of permeability of the fine-grained non-cohesive material (preferably  $>10^{-5}$  m/s). The grain size distributions of coarse RCA and fine RCA as well as coarse RAP and fine RAP are shown in Figure 6 while the drying and wetting SWCCs of the materials are presented in Figure 7.

Figure 6. Grain size distribution of fine RCA, coarse RCA, fine RAP and coarse RAP.

The required properties derived from Figure 6 and 7 for the evaluation of capillary barrier effect are summarized in Table 2. Evaluation of the properties shows that the  $d_{50}$  ratios of the coarse and fine materials of GBS1, GBS2, and GBS3 were 13, 14 and 70, respectively which were greater than 5. The  $\psi_w$ -ratio of the fine- and coarse-grained materials of GBS1, GBS2, and GBS3 were 150, 32.5 and 188, respectively, which were greater than 10. The water-entry value ( $\psi_w$ ) of coarse RCA and RAP were 0.1 and 0.08 kPa which were less than 1 kPa. The coefficient of saturated permeability of fine RAP was  $4 \times 10^{-4}$  m/s, which was greater than  $10^{-5}$  m/s; however, the coefficient of saturated permeability of fine RCA was  $1 \times 10^{-6}$  m/s, less than  $10^{-5}$  m/s. The evaluation showed that the combinations of the fine- and coarse-grained materials used in GBS1, GBS2, and GBS3 fulfilled all the criteria except for the coefficient of saturated permeability of fine RCA. Thus, in general the combinations of fine- and coarse-grained materials used in GBSs at Orchard Boulevard were effective as capillary barrier.

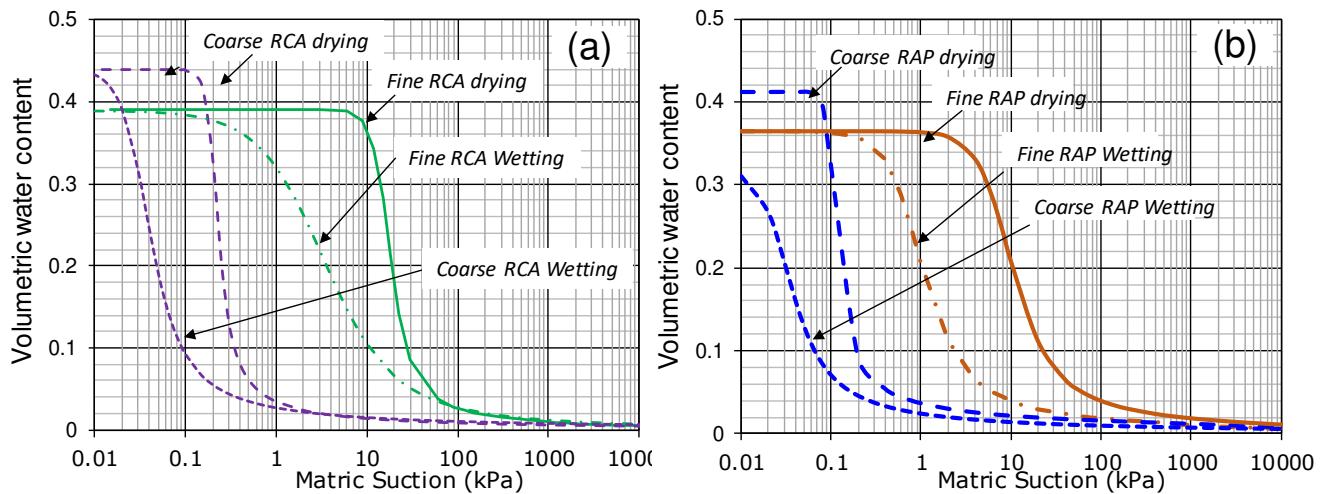
Figure 7. SWCCs of (a) fine RCA and coarse RCA and (b) fine RAP and coarse RAP.

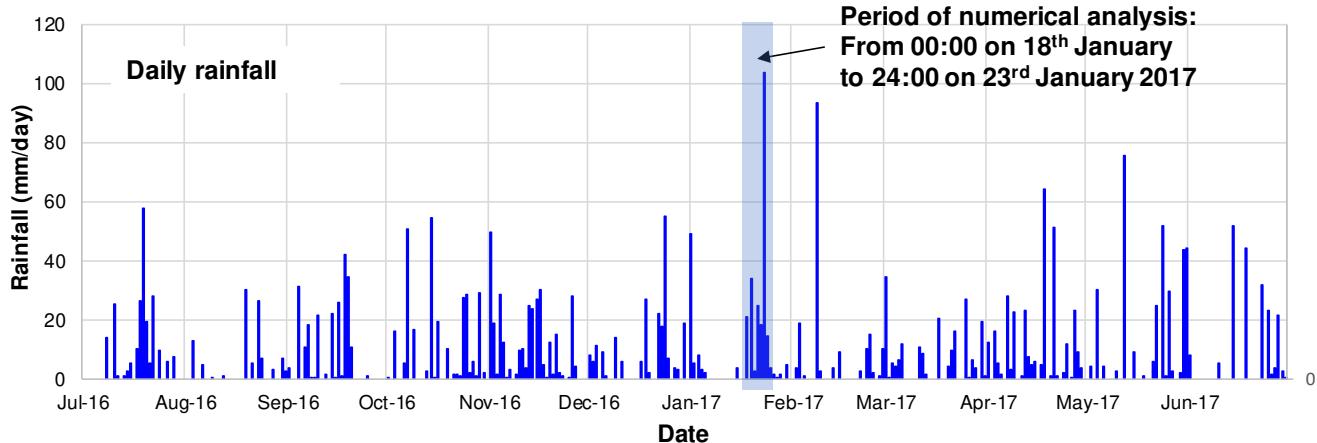
The performance of the GBSs at Orchard Boulevard was monitored for one year i.e. from 1<sup>st</sup> July 2016 to 30<sup>th</sup> June 2017. Figure 8 shows daily rainfall during the monitoring period. Rainfall monitoring at the study site indicated that the monthly rainfalls were quite different from the typical trend in Singapore. The cumulative yearly rainfall was 2819 mm which was higher than the average annual rainfall in Singapore based on the long term record from NEA Singapore (1981–2010) i.e. 2166 mm (National Environmental Agency, 2018). The number of rainfall days during the monitoring period was 178 days, which was higher than the average annual number of rainfall days in Singapore (167 days) (National Environmental Agency, 2018). The maximum daily rainfall occurred during the monsoon period in January 2017 i.e. 103.8 mm. The month of January 2017 started with a dry period for about two weeks and ended with a very wet period towards the end of the month. Therefore, rainfalls in the second half of January 2017 were selected for numerical analysis of the response of GBSs to rainfall infiltration.

Figure 8. Daily rainfall during the monitoring period (1<sup>st</sup> July 2016 – 30<sup>th</sup> June 2017).

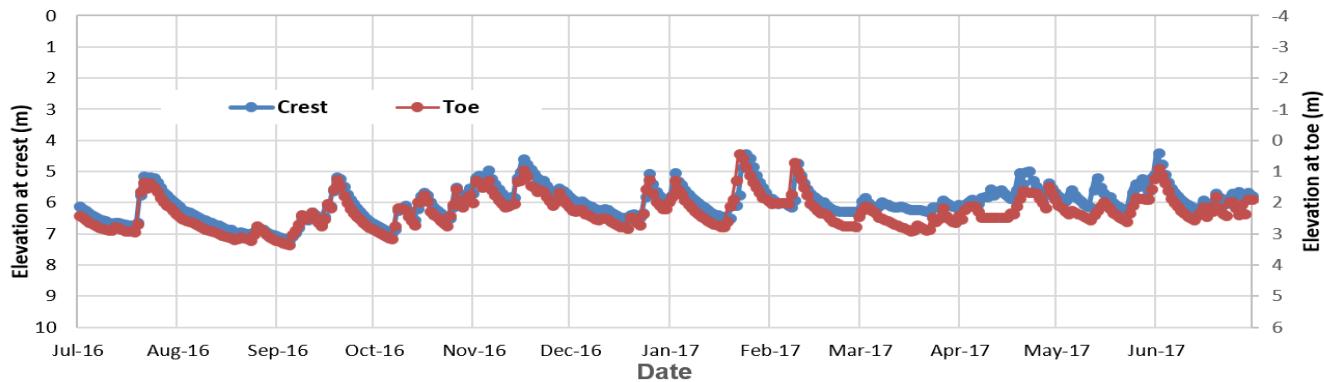
Figure 9 shows the groundwater fluctuation in response to rainfall. The difference on the elevation at crest and elevation at toe (4 m) is considered in this figure. The initial groundwater table recorded by PM1 was -6.05 m with reference to the ground surface at the crest while PM2 recorded a groundwater table at -2.37 m with respect to the ground surface at the toe. The highest groundwater table during the field monitoring was -4.37 m below the ground surface at the crest (PM1) and -0.44 m below the toe. In other words, the groundwater table never rose above the ground surface during the monitoring period.

Figure 9. Groundwater table fluctuation in response to rainfall.

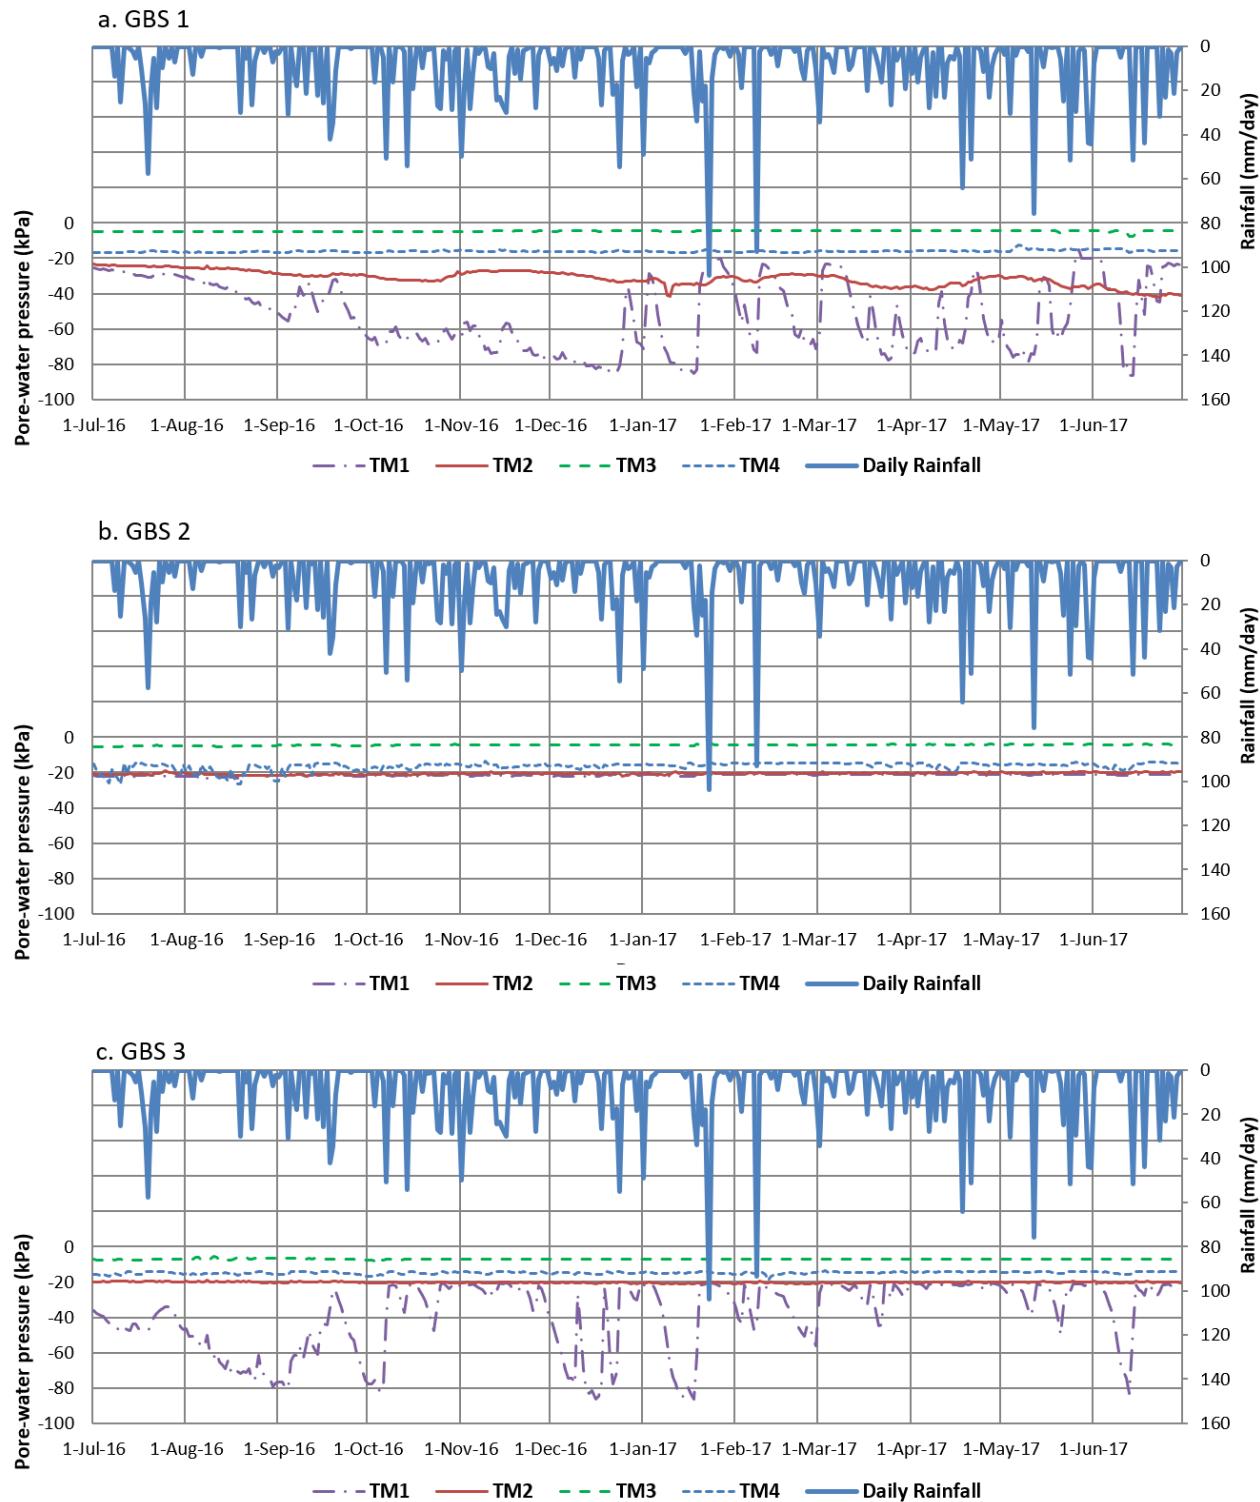
Transient pore water pressure (PWP) and volumetric water content (VWC) recorded by tensiometers and soil moisture sensors in GBS1, GBS2, and GBS3 during the monitoring period are presented in Figures 10 and 11. TM1 and TM2 were located in the compacted soil; however, the location of TM1 was closer to the border between the compacted residual and the original soil. Thus, the soil around TM1 was expected to be more affected by the change in the moisture content as compared to the soil around TM2. The PWP recorded by TM2 (1.1 m from slope face) in GBS 1 varied from -24 to -42 kPa whereas in GBS2 and GBS3 the PWP were almost constant at -20 kPa. The VWCs recorded by SM2 were almost constant at 40% for GBS1, 34% for GBS2 and 26% for GBS3. This could be due to the uneven compaction of the reinforced soil. PWP recorded by TM1 (2.1 m from slope face) in GBS2 only varied between 20 and 24 kPa while the variations recorded by TM1 in GBS1 and GBS3 were quite significant. During the long dry period, the PWP of TM1 could reach -86 kPa, but the reading recovered as soon as rain started to fall. The large fluctuation in PWP recorded by TM1 could be due to the effect of uneven compaction near the end of the reinforced soil zone. The corresponding VWC recorded by SM1 was between 10% and 30% in all GBSs. The PWP in coarse materials (TM3) was almost constant with time while the readings from TM4 (fine materials) fluctuated slightly between -12 and -19 kPa. Correspondingly, the VWC recorded by SM3 was constant while the VWP recorded by SM4 varied from 20% to 30% in GBS1 and from 10% to 20% in GBS2 and GBS3. Flowmeters were installed in the gravel sump to observe if there was a breakthrough from the fine-grained layer to the coarse-grained layer. The one-year monitoring shows that the flow meters did not record any flow from both the fine- and coarse-grained layers. This shows that rainwater mostly became run off or absorbed by the ASM layer.

Figure 10. PWP recorded by Tensiometers in GBSs during monitoring period.

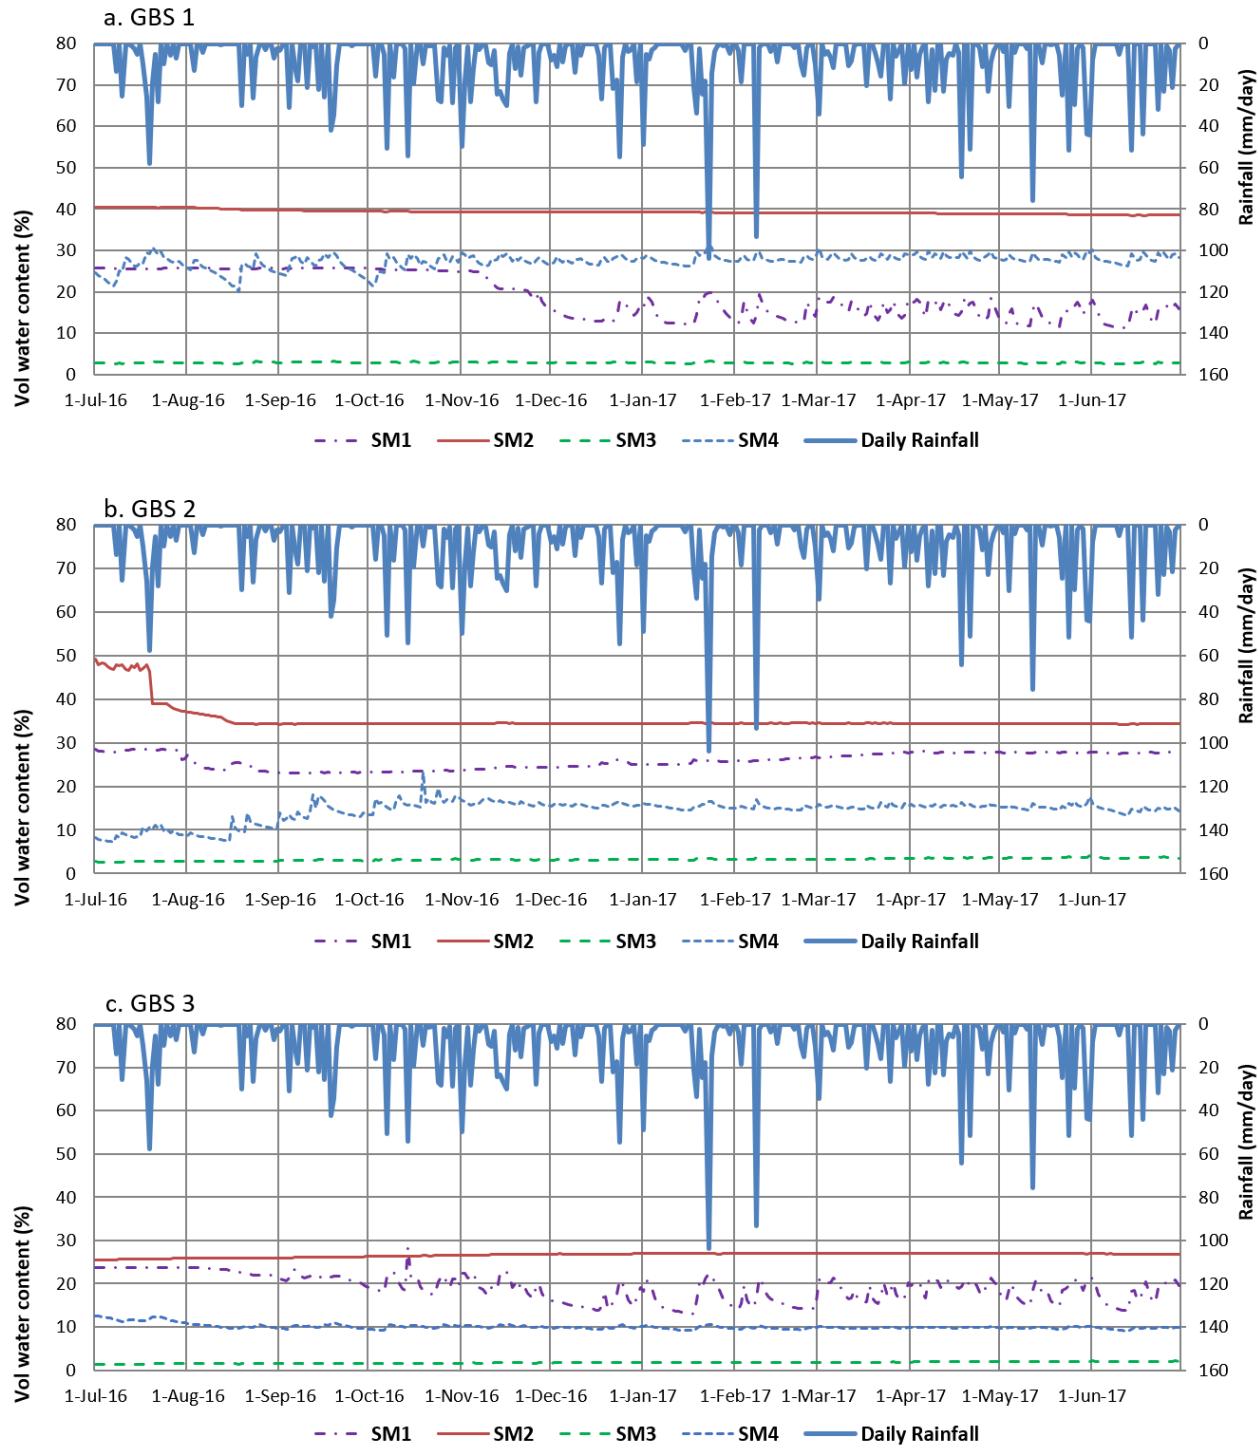
Figure 11. VWC recorded by soil moisture sensors in GBSs during monitoring period.

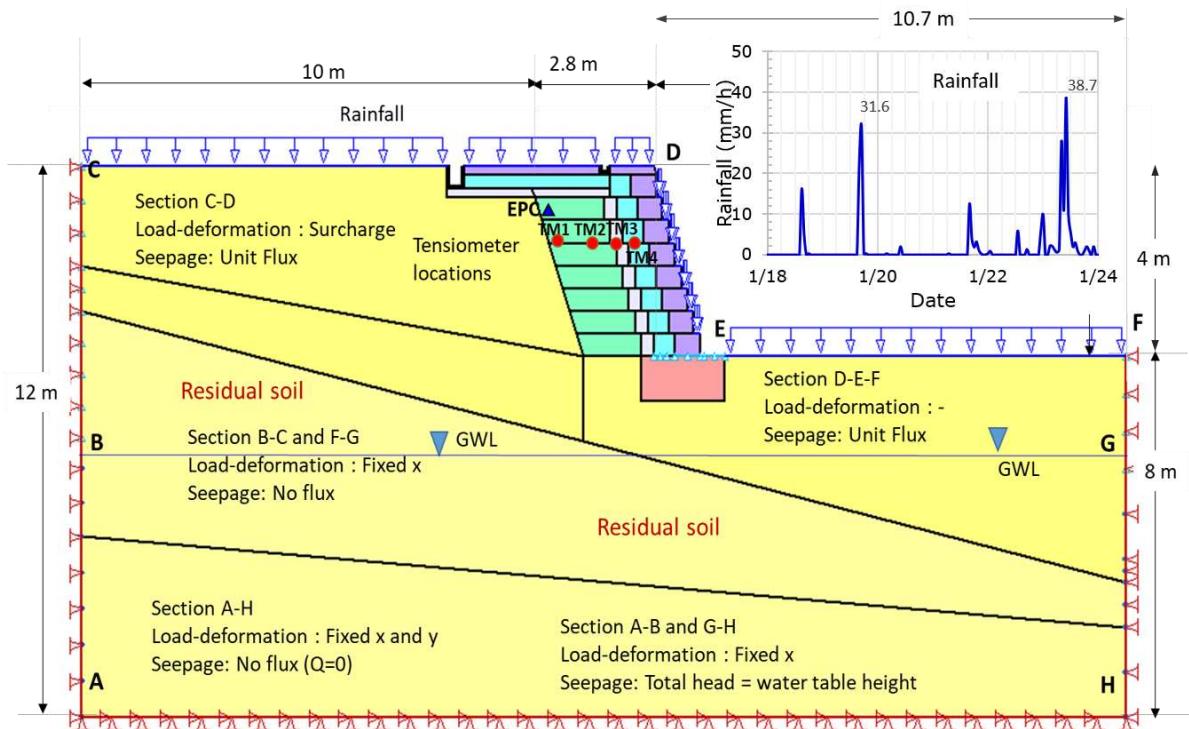
Numerical analyses were carried out to study the response of GBS1, GBS2 and GBS3 in Orchard Boulevard to extreme rainfalls that occurred from 18<sup>th</sup> to 23<sup>rd</sup> January 2017 using SEEP/W program (Geoslope International, 2012a). The finite element model adopted in this study was a two-dimensional plane strain model. The boundary conditions applied to the finite element model are illustrated in Figure 12. The left and right boundaries were set at 10 m from the crest and toe of the sloping

wall, while the bottom boundary was set at 8 m from the ground surface at the toe of the slope. The mesh consisted of 3593 rectangular and triangular elements. For seepage analysis, no flow boundaries were simulated by assigning a nodal flux  $Q$  equal to zero at the bottom and both sides of the slope model above the groundwater level (GWL). A constant total head  $h_w$  was applied on each side boundary below GWL. Rainfall was applied to the ground surface as a flux boundary  $q$ . Ponding was not allowed to occur on the ground surface. This means that the pore water pressure on the ground surface was not allowed to be higher than 0 kPa. This condition simulated the actual condition whereby the excess rainwater on the slope would become surface flow or runoff. The initial pore-water pressure within the residual soil behind the GBS wall was set based on the depth of groundwater table from the ground surface while the initial pore-water pressure within the GBS was set as the pore-water pressure condition on 18<sup>th</sup> January 2017.

Figure 12. Finite element mesh and boundary conditions.

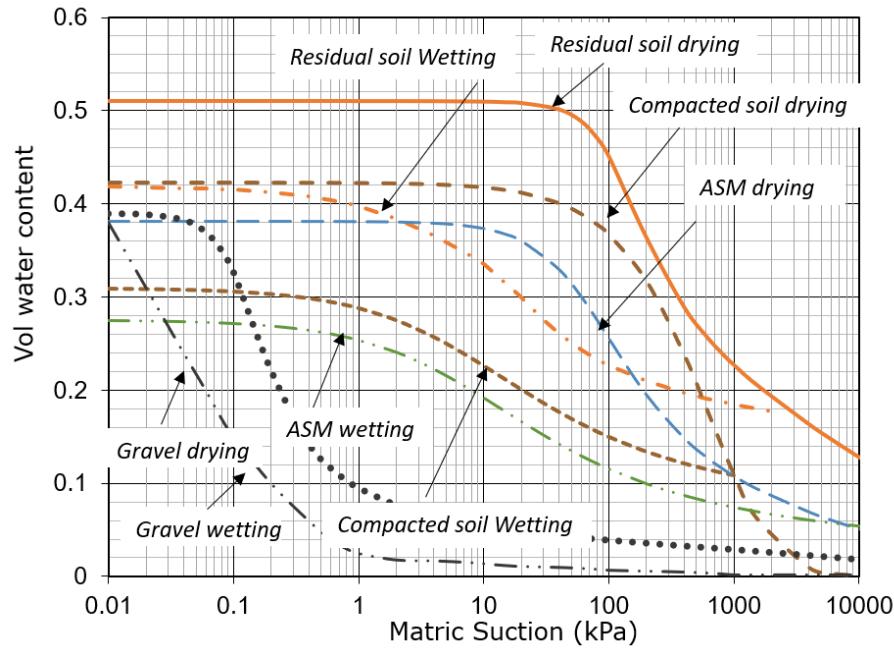
The drying and wetting SWCCs of the residual and compacted residual soils as well as the ASM and gravel are shown in Figure 13 while the drying and wetting SWCCs of the fine and coarse RCA as well as the fine and coarse RAP are shown in Figure 7. Wetting SWCCs were used in the numerical analysis to replicate the wetting process due to the extreme rainfall. In addition, Bashier et al. (2016) indicated that the use of wetting SWCC and permeability function is associated with worst scenario since the numerical analysis results predicted a higher infiltration rate. Hence, the factor of safety is the lowest if the numerical analysis incorporates wetting SWCC and permeability function. The wetting permeability function was determined from the SWCC wetting curves of all materials using a statistical method (Child and Collis-George, 1950) are shown in Figure 14.

Figure 13. SWCC of Residual and compacted residual soil, and ASM and Gravel.

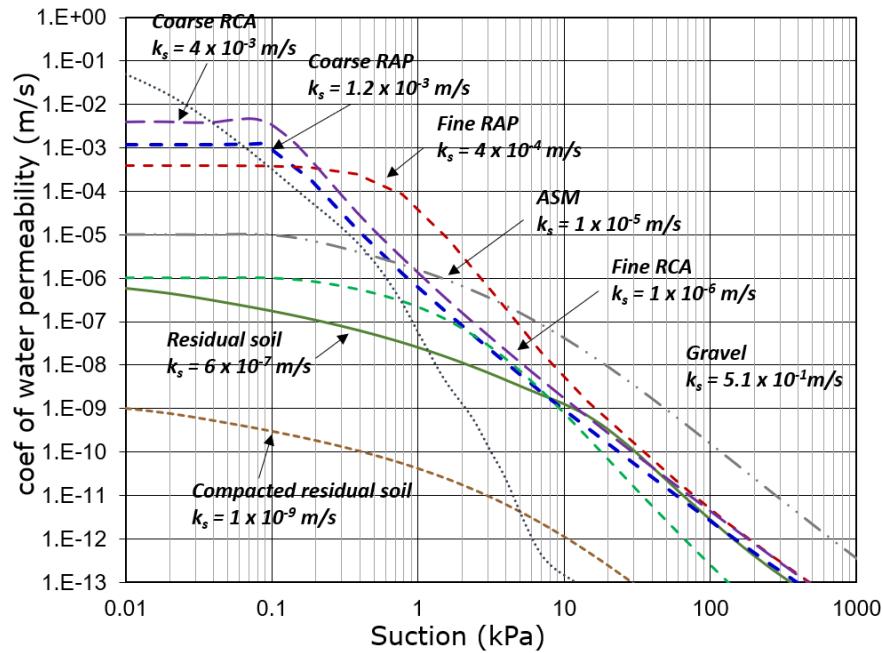
Figure 14. Permeability functions of all materials used in GBS.

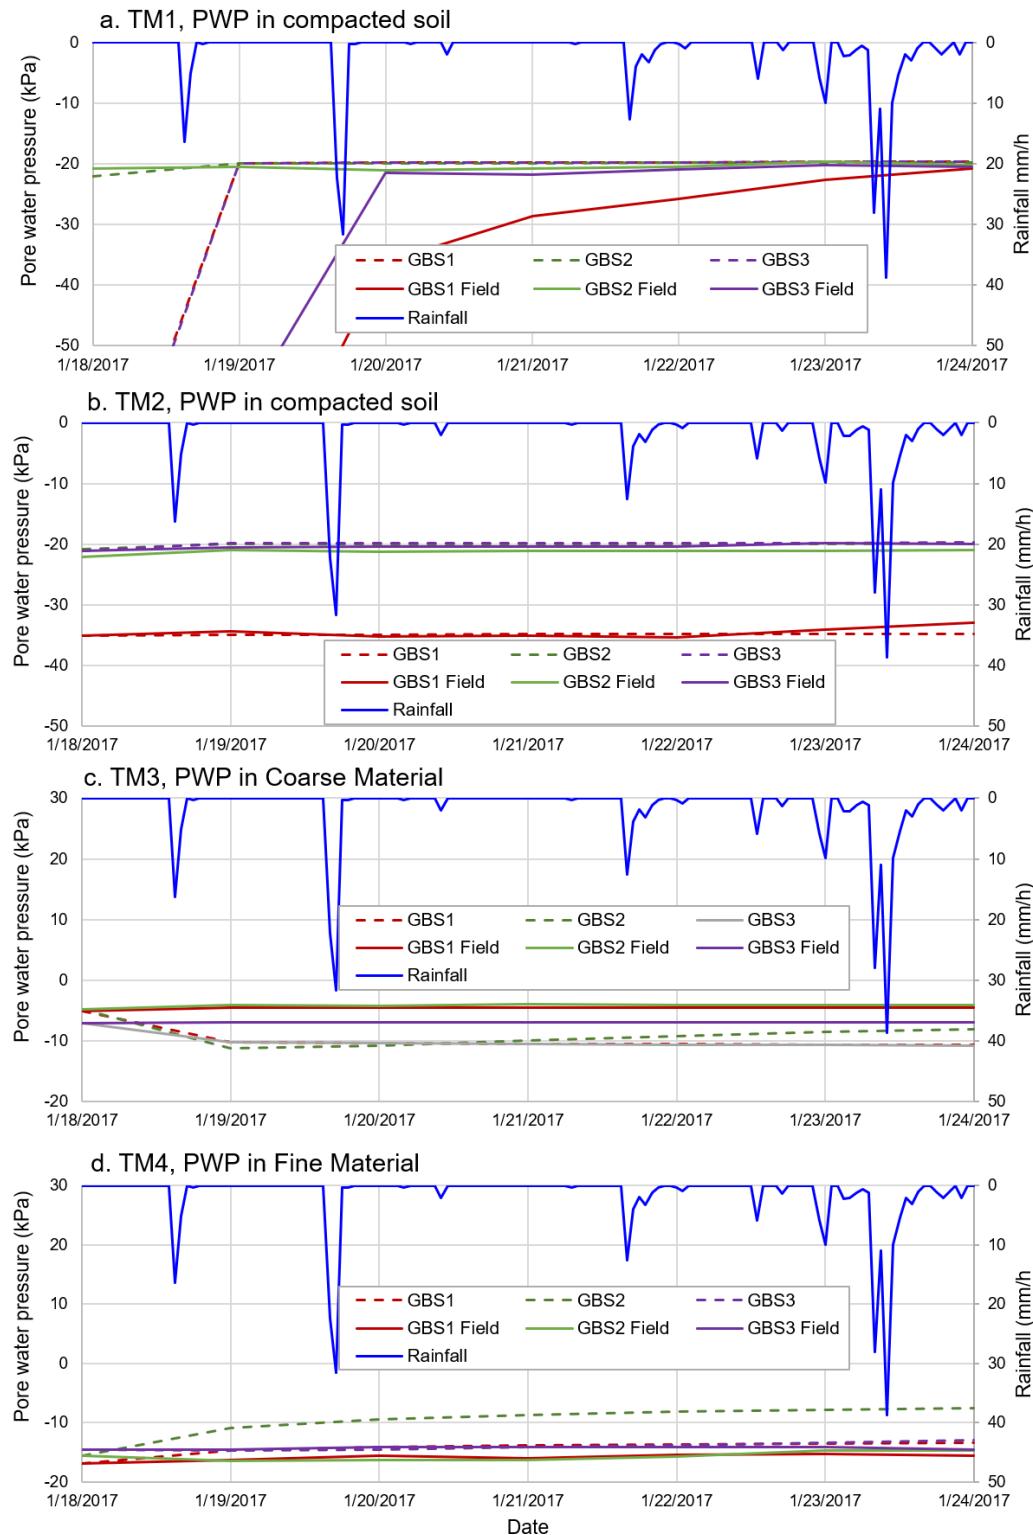
Pore-water pressures predicted by numerical analyses at locations of TM1, TM2, TM3, and TM4 are presented in Figure 15. Spatial function was used in the numerical analyses based on PWP recorded by the tensiometers at 00:00 on 18<sup>th</sup> January which presents the condition after two-weeks of dry period in January 2017. Thus, the recorded PWP by TM1 in GBS1 and GBS3 were very low i.e. about -85 kPa. However, both field and numerical analyses show that the PWP responded immediately to 16.3 mm rainfall at 15:00 on 18<sup>th</sup> January even though the numerical analyses predicted a faster response to rainfall.

Note: Field measurements = solid line  
 Numerical analysis results = dashed lines

Figure 15. Transient PWP predicted by seepage analysis as compared to field data.

The fast response of soil around TM1 to rainfall (Figure 15) could be due to its position close to the border between the compacted soil and the original soil. However, the PWP became constant at about 20 kPa after rainfall. The numerical predictions of PWP at TM2 were in agreement with field data. The constant PWP shows that water did not actually seep into the compacted soil in the GBS at the location of TM2. The numerical analyses predicted lower PWP in the coarse layer (TM3) and higher PWP in fine layer (TM4) as compared to the field measurement. However, the difference was not significant.

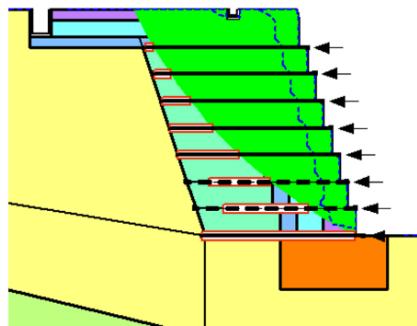
Figure 16 shows the critical slip surface obtained from stability analyses of the slope with GBS at the end of rainfall. Since the PWP was generally constant, the factor of safety was almost constant with time. The transient FOS for all GBS is shown in Figure 17.

Figure 16. Critical slip surface slope stability analysis.

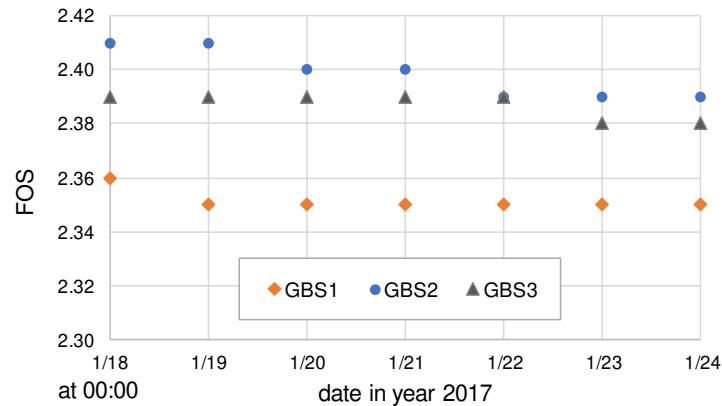
Figure 17. Transient Factor of safety predicted by slope stability analysis.
