# Electrical Resistivity at Internal Erosion Locations in Levees

Reference: Tucker-Kulesza, S., Rutherford, C. and Bernhardt-Barry, M. (2019). Electrical Resistivity at Internal Erosion Locations in Levees. International Journal of Geoengineering Case Histories, Vol.5, Issue 2, p. 55 - 69. doi: 10.4417/IJGCH-05-02-01

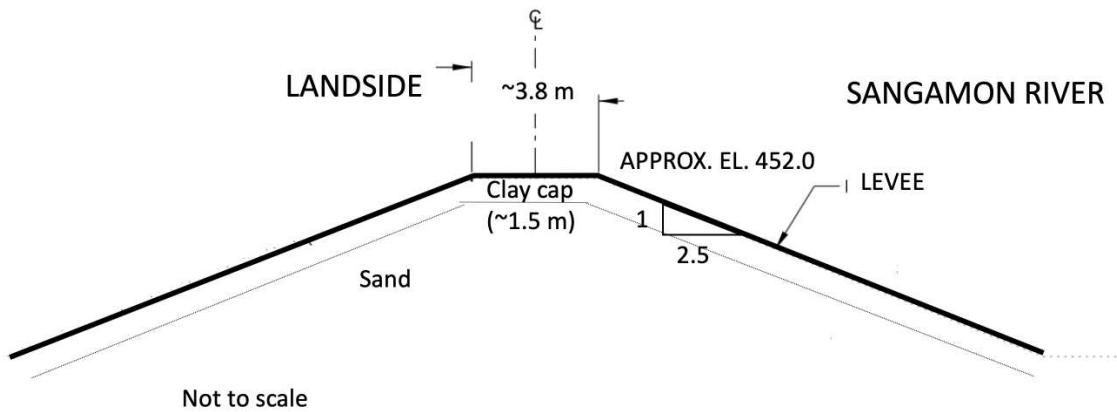
The material that is now utilized as the Hager Slough Levee was initially stock-piled by dredging river delta material as a means to provide a straightened channel to mitigate the risk of damage from flood events and to provide drainage for the upstream agricultural fields. Holes were left in the spoil piles to allow the Sangamon to connect to its floodplain. In the 1970s, downstream farmers wanted protection from flood events and filled in the gaps in the spoil piles with sand and clay. The downstream farmers also built a clay tieback levee at the confluence of Indian Creek and the Sangamon River, creating the Hager Slough Special Drainage District. The upstream tieback was a clay levee built by local interests in the early 1900s and is part of the Clear Lake Drainage District. Together the two districts share responsibility for providing flood risk management to approximately 5,700 Ha of farmland. The districts meet at the intersection of the Sangamon channel spoil pile and Black Slough. Over the years, the river-dredged materials were capped with a clay layer. A simplified typical cross-section of the levee is shown in Figure 3. The crest was approximately 3.8 m wide and the levee height approximately 4.57 m at the surveyed levee section in this study.

Figure 3. Hager Slough Levee pre-repair simplified cross-section.

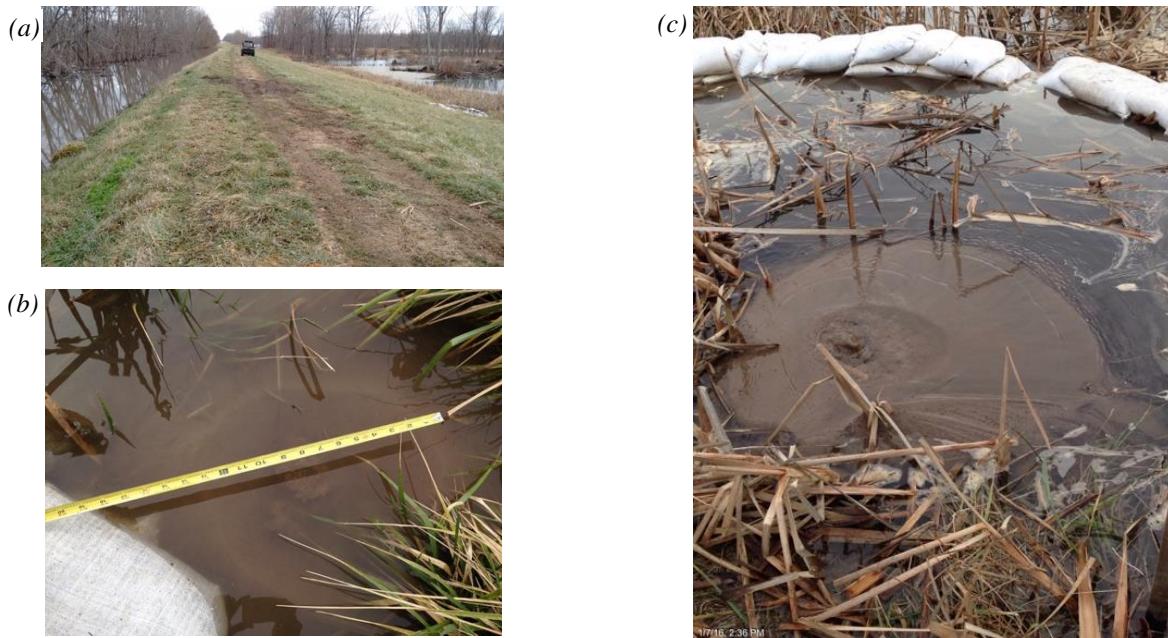
The levee district officials and the USACE engineers have observed a large number of sand boils at the Hager Slough Levee toe during flood events over the last thirty years (Bishop et al. 2015). In December of 2015, unusual winter storms related to a strong El Niño weather pattern in the Midwest sent large volumes of water into rivers and drainage areas, causing historic flooding in Illinois. As part of the flood protection systems investigation in Illinois, a team from the Geotechnical Extreme Events Reconnaissance (GEER) Association was mobilized to investigate the impacts of record and near-record flood crests and the performance of levee systems (Rutherford et al. 2016). The Hager Slough Levee was inspected and damage in multiple locations was documented on January 8, 2016. There were upwards of 15 active (carrying material) sand boils and many inactive (clear flowing water) sand boils from previous flood events which were documented during the reconnaissance. New (active at the time) sand boils generally formed adjacent to the existing boils. There were upwards of 41 sand bag rings placed by the levee district in coordination with the USACE in the 0.4 km levee stretch covered during the site visit. Many of the sand bag rings contained numerous sand boils and seeps. The sand bag rings were typically 2.43 – 3.00 m in diameter and 0.610 – 1.22 m in height (Figure 4).

Figure 4. Observed damage during December 2015 flood event: (a) crown of levee, (b) 0.33 m diameter active sand boil, (c) active sand boil (Rutherford et al. 2016).

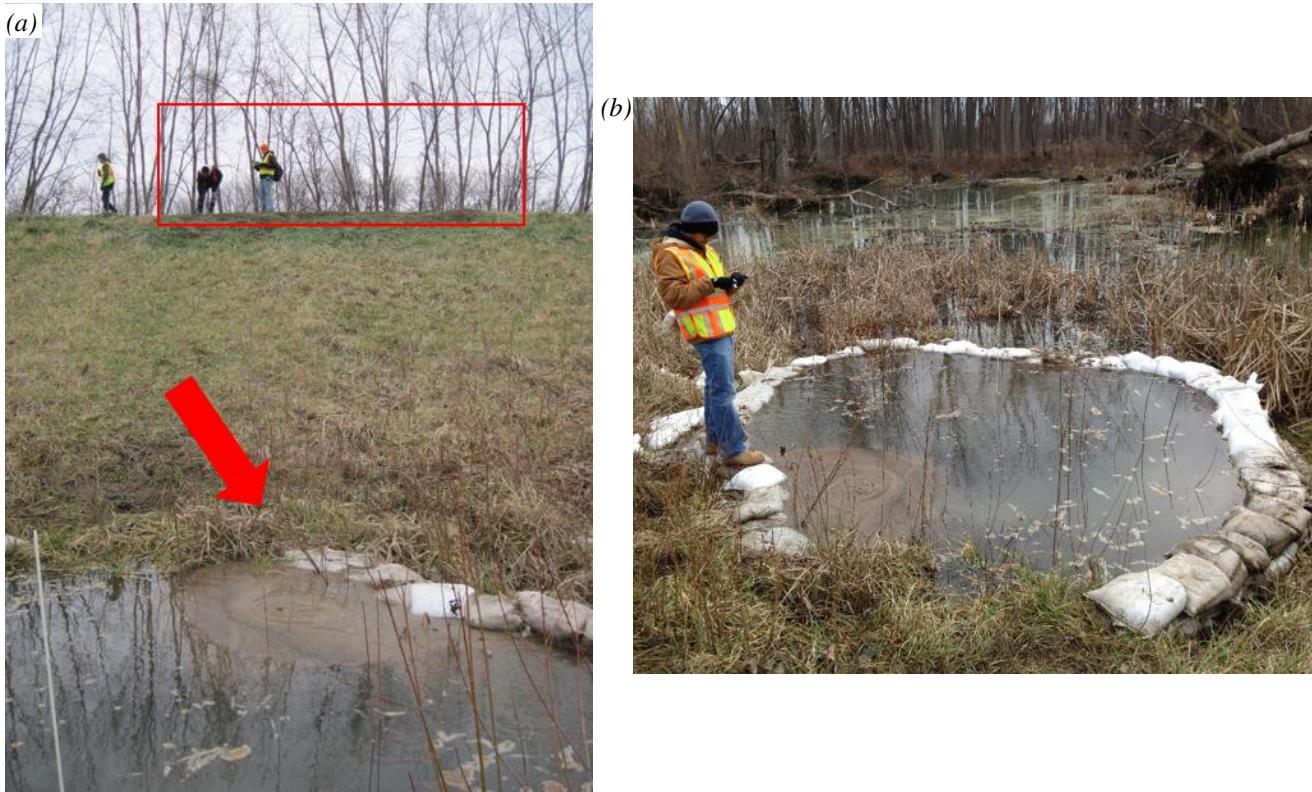
Settlement of the levee crown occurred in several locations during the 2015 flooding which required repair (repair images not available). Subsidence of the levee crown in these locations was observed to be adjacent to sand bag rings (Figure 5), suggesting that the subsidence was due to material loss. The objective of the geophysical investigation described in this study was to evaluate if ERT can be used as an imaging technique to detect zones of material loss within the levee. Such a system would enable improvement of remediation methodologies following flood events where sand boils occur. ERT may also be used to evaluate if a levee is damaged internally despite the lack of external physical evidence (e.g., sand boils). Following this introduction are a brief background on ERT and the research methodology. The ability of ERT to identify material removal has been investigated by performing a series of ERT surveys and supported with soil borings and a laboratory electrical resistivity measurement of the material in the sand boils. A discussion of the field and laboratory results is presented, including limitations of this case history, followed by conclusions and recommendations.

Figure 5. December 2015 flood reconnaissance: (a) settlement of crown with active sand boil at toe of levee, (b) active sand boil with sand bag ring (Rutherford et al. 2016).

Following the field investigation and surveys presented in this study, the USACE completed rehabilitation work to mitigate the seepage issues on the Hager Slough Levee. A 960.4 m sand seepage berm was constructed on the landside toe of the levee and a turtle mitigation berm was constructed on the riverside toe of the levee in July 2017. The berms were constructed using approximately 60,000  $\text{m}^3$  of sand dredged from the adjacent Sangamon River channel.

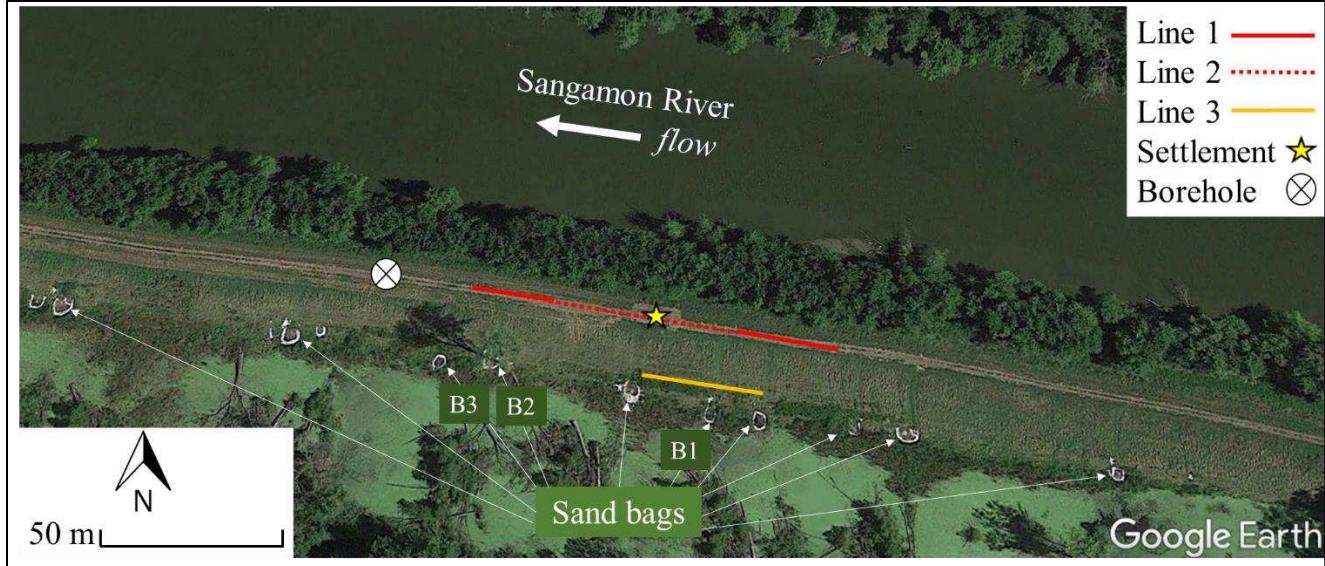
Three ERT surveys were conducted at the Hager Slough Levee. The survey locations were chosen in an area where damage was apparent (i.e., crown settling and sand bags around previous sand boils) and borehole data were available for ground truthing. The crown settlement was estimated between 0.12-0.14 m based on survey data. The three survey lines are shown in Figure 7. Two overlapping survey lines were conducted along the levee crown and one was conducted parallel to a 5 m diameter sand bag ring shown in Figure 7 at the landside toe. Stainless steel stakes were used as contacts between the 56 electrodes on the cables and the subsurface. The electrodes were spaced at 2 m, 1 m, and 0.5 m in Lines 1, 2, and 3 respectively. Lines 1 and 2 were aligned so that the visible 2 m wide depression from the crown settling was approximately in the middle of the surveys (marked with a star in Figure 7). The larger electrode spacing in Line 1 allowed for deeper measurements while the 1 m spacing in Line 2 resulted in more detailed measurements near the surface. The relative elevation at each electrode was collected with a total station, although the elevation change cannot be seen in the crown surveys (Lines 1 and 2) due to the length of the survey relative to the elevation changes. The closest borehole was approximately 73 m west of the crown settlement, where samples were collected by the USACE through the levee to 9.45 m in 2013.

Figure 7: Survey locations; white rings are remaining sand bags from January 2015 flooding (Google Earth 2015). B1, B2, and B3 indicate where grab samples were collected for the laboratory analysis.

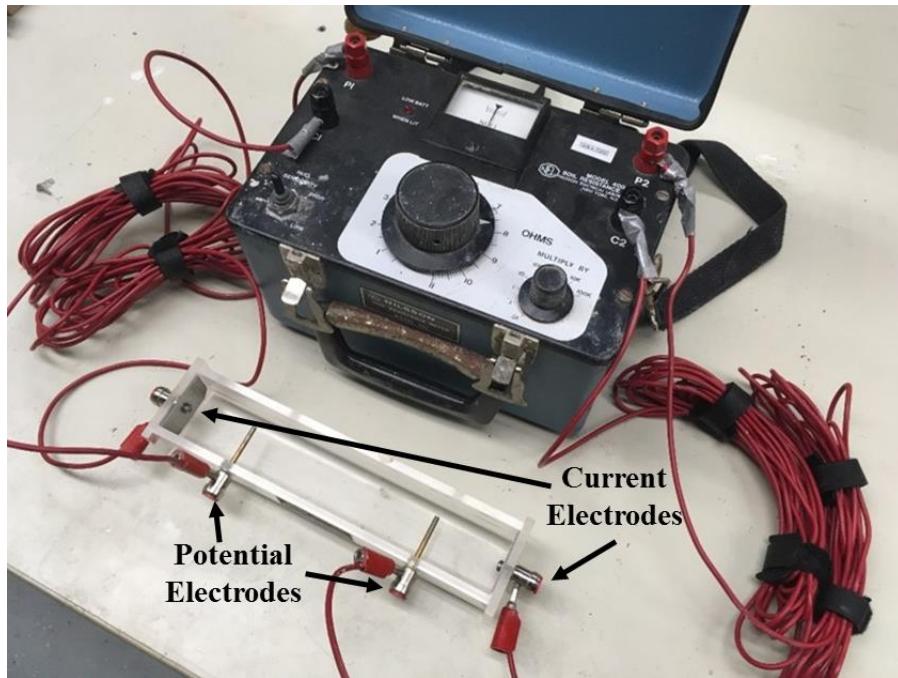
the sand bags. A Nilsson Resistance Meter Model 400 attached to a M.C. Miller Large Soil Box (270 mL volume) was used to obtain the electrical resistivity for the laboratory specimens (Figure 8). The soil box uses a 4-electrode array in which electrical current is passed through the soil using two external (current) electrodes and the voltage potential is measured across two internal (voltage) electrodes inserted into the soil (Herman 2001). The electrical resistivity of the specimen in the soil box can then be calculated using

where  $R$  is the electrical resistance measured by the voltage electrodes in Ohms ( $\Omega$ ),  $A$  is the cross-sectional area of the specimen in  $\text{cm}^2$ , and  $l$  is the distance between the voltage electrodes in cm (ASTM G57 – 06, 2012). The cross section to length ratio ( $A/l$ ) of the soil box used was 1 cm, meaning that the measured electrical resistance ( $\Omega$ ) has the same numerical value as the electrical resistivity ( $\Omega\text{cm}$ ).

Figure 8. Laboratory resistivity setup.

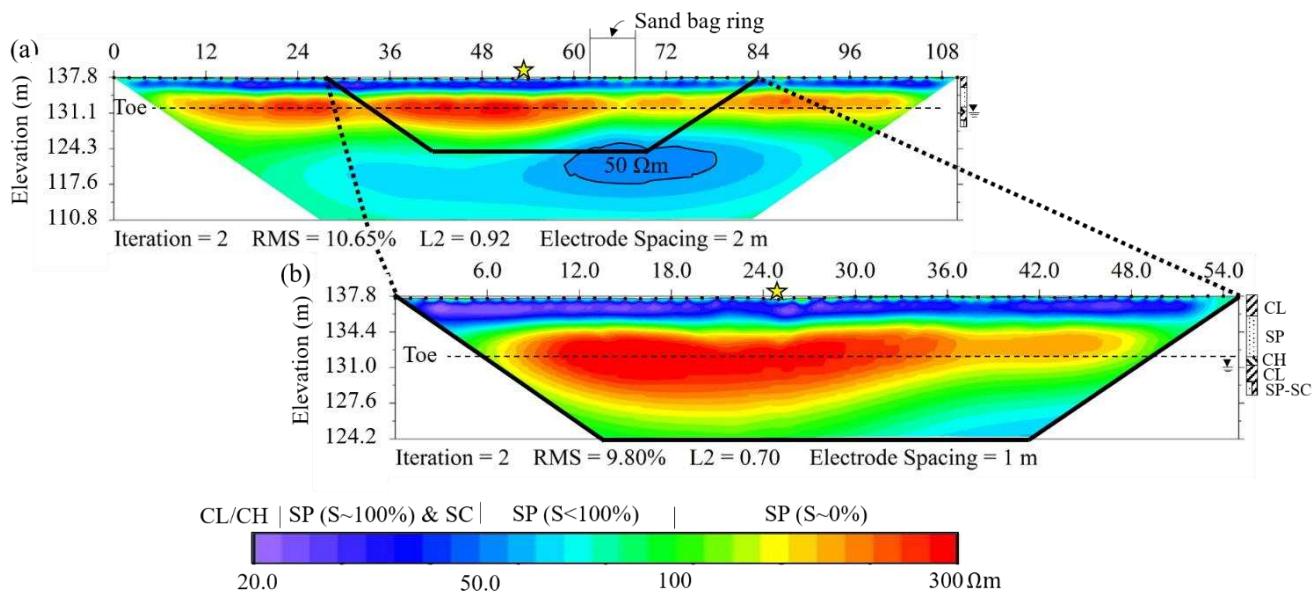
Three ERT surveys were conducted at the Hager Slough Levee: two survey lines on the crown of the levee and one survey line at the landside toe. Figure 9 shows Line 1 (top, a) and Line 2 (bottom, b), which were conducted along the levee crown as shown in Figure 7. The depression in the crown is again marked with a star on each inverted image and the survey alignment with a ring of sand bags at the toe of the levee is also shown. The horizontal distance along the crown is depicted on the top

of each survey and the elevation above sea level is on the side of each survey, both in m. Line 1 was 110 m long with a maximum survey depth of 27 m (El. 110.8 m). The approximate location of the native soil based on the height of the levee is shown with a dashed line in Figure 9. Borehole data were available approximately 73 m west of the first electrode in Line 1. Because of the depth of investigation and scale of Figure 9(a), the borehole data are also shown to the right of Figure 9(b) so that the stratigraphic units could be aligned with the image and compared with geophysical interpretations.

The soil stratigraphy based on the borehole consisted of: 1.4 m of sandy lean clay (CL), 4.2 m of poorly graded fine sand (SP), 0.3 m of fat clay (CH), 1.5 m of sandy lean clay (CL), and 1.3 m of poorly graded sand with clay (SP-SC) until the boring was terminated. The water level was noted at El. 132.2 m, near the interface of the fat and lean clays as shown in Figure 9. The river level was measured at approximately the same elevation. The color-coded electrical resistivity scale and approximate Unified Soil Classification System (USCS) classifications, based on the borehole data and general soil type classifications of ERT data, are shown beneath the inversions (ASTM D2487 2011; Everett 2013; Sharma 1997). The observed electrical resistivity from the ERT profile in Figure 9(a) is a low resistivity layer of 25–40  $\Omega\text{m}$  in the top 2 m over a layer of higher resistivity (~150–300  $\Omega\text{m}$ ). The higher resistivity layer thickness varies from approximately El 135.8 m to El 129.8 m along the profile in Figure 9(a). The layer of higher resistivity aligns well with the SP layer identified in the borehole from approximately 60 m to 110 m along the profile. From 0 m to 60 m, the high resistivity layer penetrates to El 129.8 m, where the deepest point is at the 48 m marker on Figure 9(a). Note that this point was located two electrode spacings from the depression in the crown. The bulk electrical resistivity beneath the high resistivity zone was between 60 and 80  $\Omega\text{m}$  in the rest of the inversion, except beneath the 60 to 74 m markers where a zone of lower resistivity (47–50  $\Omega\text{m}$ ) was noted. No resistivity measurements are shown outside the trapezoidal ERT inversions because ERT measurements are only marginally sensitive in these regions.

Figure 9. Crown surveys: (a) Line 1 with 2 m electrode spacing; (b) Line 2 with 1 m electrode spacing.

Line 2 (Figure 9(b)) was conducted at half the electrode spacing of Line 1. The outermost 14 electrodes on both sides of the central point in Line 1 were removed and installed between the remaining 28 electrodes. The alignment of Figure 9(b) within Figure 9(a) is shown with a black trapezoid on Figure 9(a). The larger electrode spacing in Figure 9(a) increased the penetration depth of the survey; however, near surface resolution was lost as a trade-off. Therefore, the lower resistivity band is more apparent in Figure 9(b) than in Figure 9(a), varying from 20–25  $\Omega\text{m}$ . A band of higher resistivity (200–300  $\Omega\text{m}$ ) is again noted beneath the low resistivity layer along the surface. In Figure 9(b), the depth of this higher resistivity layer varies from El. 134.4 m to El. 129.4 m. There is a bowl shape of the higher resistivity layer in Figure 9(b), with the maximum curvature approximately 3 electrode spacings from the depression in the crown of the levee. The small pocket of lower resistivity (60  $\Omega\text{m}$  in Figure 9(b)) is observed in the lower right side of the inversion, though the depth of penetration of this signal did not allow the entire region to be captured. Although the borehole data were approximately 99 m from this survey,

the data are shown along with the measured groundwater table in Figure 9(b). The soil stratigraphy aligns well with the geophysical measurements in the upper 5 m of the levee from 36 to 48 m along the profile.

There are relatively thin layers between the higher and lower resistivity zone discussed in both surveys. These should not be interpreted as additional soil layers, but rather as smoothing effects. ERT surveys collect bulk measurements with depth, and a trade-off of the mathematically stable Occam style smooth inversion smears at sharp boundaries, preventing the defining of sharp layer interfaces with depth. This smearing effect is especially noted in Figure 9(a) where the resistivity in the upper 2 m appears to be higher and less uniform than in Figure 9(b), where higher resolution data were collected near the surface. The smearing effect is still noted between the two layers in Figure 9(b), though it is minimized.

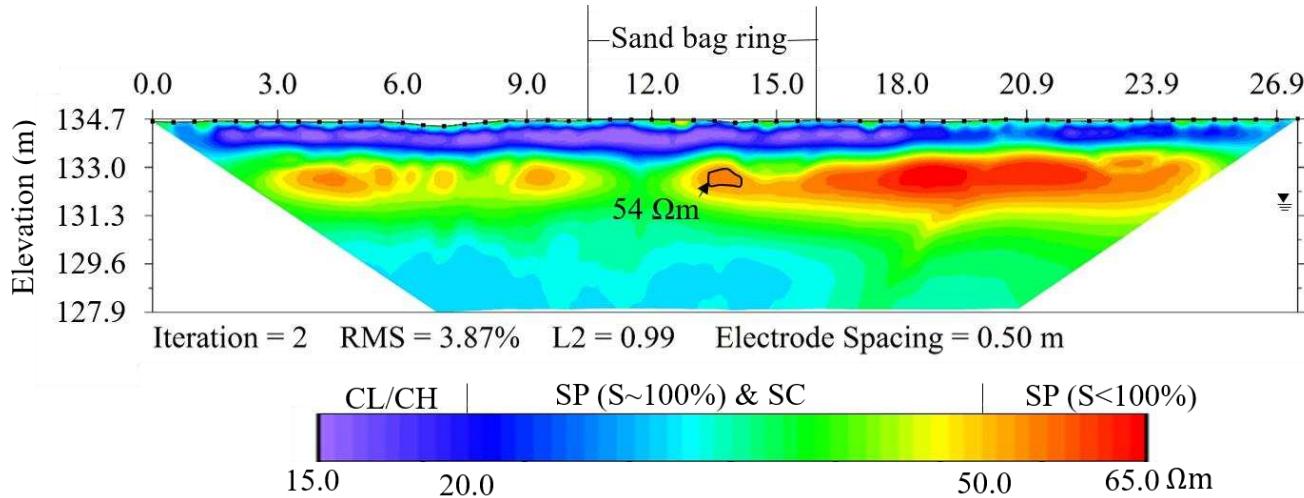
Line 3 (shown in Figure 10) was conducted approximately 3 m above the levee toe on the land side of the levee. The survey in Figure 10 was approximately 5.1 m from the center of the sand bag ring labeled in Figure 9(a). No nearby borehole data were available; the depth to the groundwater table based on the boring from the crown of the levee, however, is shown on the right side of the inversion. The uppermost layer to El. 133.9 m was low resistivity, from 15 – 20  $\Omega\text{m}$ , similar to the upper layer in Figure 9(b). There is a layer from El. 133.7 m to El. 132.7 m that has resistivity values between 30 and 75  $\Omega\text{m}$ . The bottom layer is less than 30  $\Omega\text{m}$  and likely corresponds to the approximate groundwater table as shown. Note that relative resistivity color scheme was changed in Figure 10 to improve visualization of the inversion.

Figure 10. Line 3, survey near the landside toe that was 5.1 m uphill of sand bag ring.

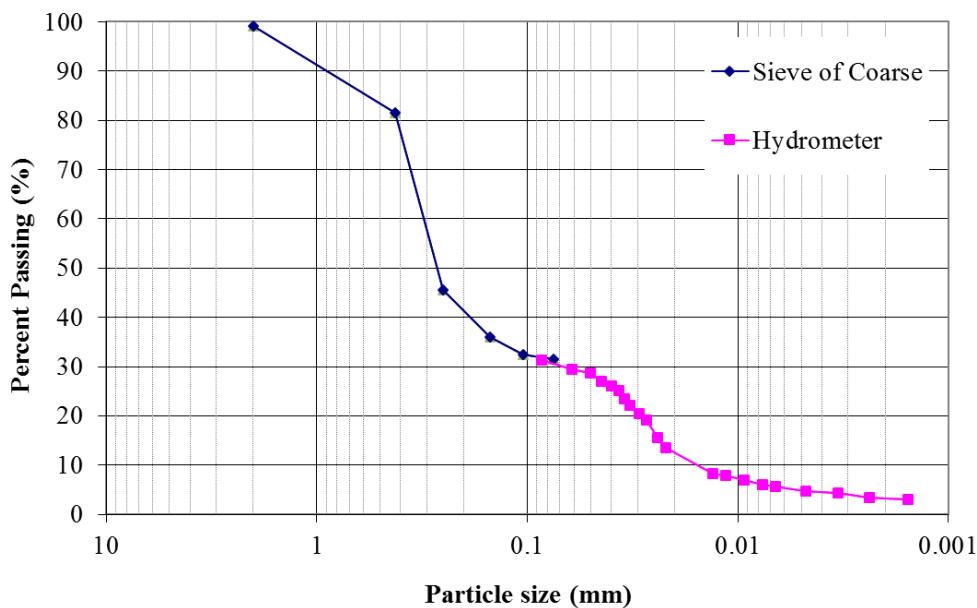
Sample B1 classified as a silty sand (SM) based on the USCS classification (ASTM D2487 2011); however, there was no SM identified in the soil borings by the USACE. Determination of the percent fines by washing (ASTM D1140 2017), particle size analysis of the coarse fraction by sieve (ASTM D6913 2017), and particle size analysis of the fine-grained fraction by hydrometer (ASTM D7928 2017) were conducted to determine whether this soil was a mixture of the sand fill and clay levee material shown in the boring log or a foundation soil located deeper than what was captured in the USACE boring. Figure 11 shows the particle size distribution curve for sample B1. The soil contained approximately 68% sand particles and 32% fine-grained particles passing the No. 200 sieve, of which approximately 3.5% were clay sized particles (i.e.,  $< 0.002 \text{ mm}$ ). This soil was comprised of approximately 28% silt sized particles. The large fraction of silt size particles and the fact that a silty soil was not identified on the boring log suggested that the soil came from locations deeper than what was captured by the available boring. The low percentage clay fraction obtained also indicated that this soil was a different soil altogether and was not a mixture of the sand and clay soils resulting in a SM classification. The liquid limit and plastic limit of sample B1 were determined to both be 19 (following ASTM D4218 2017), resulting in a non-plastic designation for the fines.

Figure 11. Particle size distribution for sample B1 retrieved from Sand Boil 1.

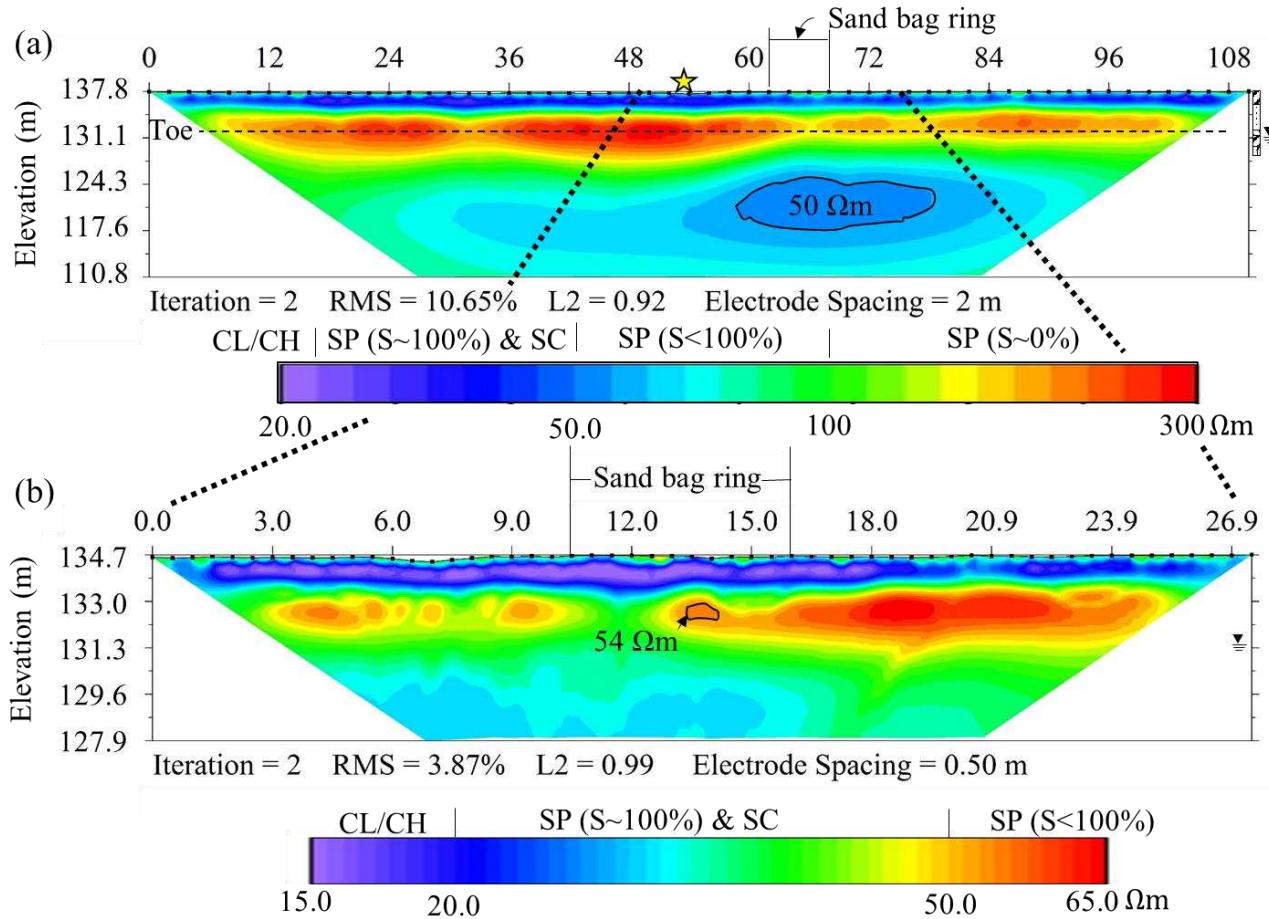
The objective of this study was to identify the electrical response of suspected seepage channels nondestructively using electrical resistivity measurements. The Hager Slough Levee was selected because of the extensive numbers of sand boils that were observed in the 2015 flooding (Rutherford et al. 2016), the site availability which allowed access to the sand boil materials for laboratory testing, and the borehole data collected by the USACE in preparation for levee repairs. Three ERT surveys were conducted: two aligned with apparent damage to the crown and one with a sand bag ring that was 11.5 m east of the crown settlement. Figure 12 shows Line 1, the 2 m spacing survey conducted at the crown, and Line 3, conducted near the landside toe of the levee. The dashed lines show the alignment between the two surveys. Note that the color scale between the two surveys is different to improve visualization.

Figure 12. Alignment between Line 1 at the levee crown and Line 3 near the levee toe.

The uppermost clay layer is apparent in both surveys, although it is clearer in Figure 12(b) where the electrode spacing is smaller and the near surface resolution greater. The electrical resistivity of clayey soils (CL/CH) is typically between 1 - 20  $\Omega\text{m}$  (Everett, 2013). As shown in Figure 3, the levee was constructed of sand with a clay cap. Therefore, a zone of higher resistivity was anticipated beneath the clay layer. The sandy material (electrical resistivity between 150 - 300  $\Omega\text{m}$ ) was noted in Line 1 and aligned with the nearby borehole data; however, it was not present in Line 3. Note from Figure 12 that the approximate interface between the levee and foundation materials was at El. 133.5 m, therefore minimal sand was expected at Line 3. Line 3 allowed for a more focused interpretation of the anomalous zone of 50  $\Omega\text{m}$  that aligned with the sand bag ring in Line 1. Zones of relatively higher resistivity between 50 - 65  $\Omega\text{m}$  were identified in Line 3, including one discrete zone that was centered along the alignment of the ring of sand bags at the toe of the levee. Figure 12(a) also includes a zone of lower resistivity (approximately 50  $\Omega\text{m}$ ) that aligns with the ring of sand bags and extends to the edge of Line 3. The

remaining material beneath the toe of levee in Figure 12(a) is between 70 - 100  $\Omega\text{m}$  and likely a partially saturated coarse-grained material based on the location of the groundwater table from the USACE data.

By combining the laboratory and field electrical resistivity with the approximate areas of seepage based on the sand bags at the site, it was likely that these zones of 50-60  $\Omega\text{m}$  in Line 1 and Line 3 represent the zones in which the seepage and material transport occurred, carrying these soils under the levee and to the sand boils at the levee toe. In Line 1, the seepage channel appears to spread between the 58 and 76 m markers, but again resolution is lost with depth. Line 3 aligns with the Line 1 damage, showing higher resistivity from approximately 13 to 26 m. More discrete zones where material may have been moved under the levee and to the sand boils are seen in Line 3. The regions of the seepage channels in Line 3 are much closer to the surface than in Line 1 because they are closer to the sand boil “exit” and the material is working its way to the surface. The change in electrical resistivity within these potential seepage channels relative to the undisturbed soils may be due to a combination of many factors. The seepage force displacing the particles will likely alter the soil porosity as particles are displaced. The pore fluids within this seepage channel may be different than the native pore fluid, changing the ionic composition of the pore water. The seepage may have caused the removal of finer particles, or the removal of surface conductance of the fine particles. Unfortunately, the cause of the change in electrical resistivity relative to the native soil could not be identified because no samples could be collected from the identified anomalies beneath the levee at the time of the ERT survey. Therefore, the primary limitation of this study was that these interpretations of the seepage channels were based on laboratory and field resistivity measurements alone. Subsequent ground truthing where the surveys were conducted is the only way to definitively support this interpretation.
