Geotechnical Effects and a 6-Year Outlook of the 2012 Hurricane Sandy in the Eastern United States

ABSTRACT: Hurricane Sandy was the deadliest and most destructive event of the 2012 Atlantic hurricane season. It originated as a storm off the coast of West Africa that turned into a tropical wave in the southwestern Caribbean Sea, and then into a hurricane that moved slowly north along the United States East Coast. Numerous regional coastal communities and urban centers in New Jersey (NJ) and the New York City (NYC) metropolitan area experienced widespread flooding, extreme winds, and heavy damage that disrupted daily life and business in Lower Manhattan, the world's financial capital. Consequences with great geotechnical engineering interest include: (i) modification of the regional coastal geomorphology due to storm surge, with the birth of new inlets, erosion, scour of soil at the shorelines; (ii) damage in coastal communities that revealed the vulnerability of residential building foundations not designed according to modern flood protection standards; and (iii) interruption of service of buried structures and below ground infrastructure due to flood damage to non-structural com

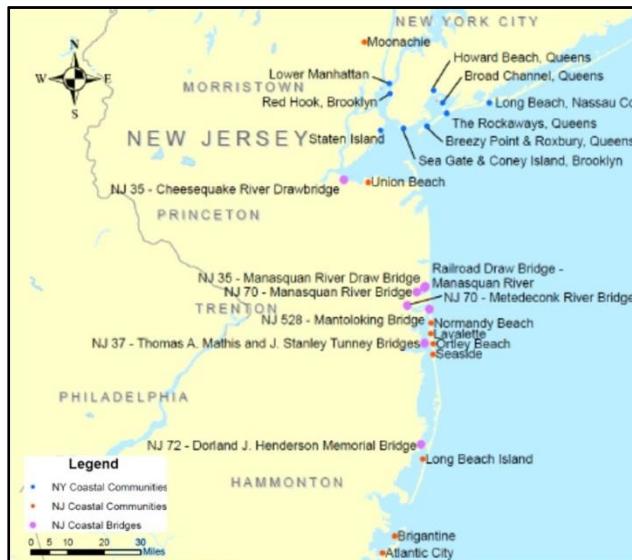
Figure 3. GEER NYC and NJ teams' observation locations following the storm, and sites of information gained through collaboration with city and state agencies over the subsequent weeks (GEER, 2014).

Following an initial meeting held on November 2, 2012, two major GEER reconnaissance groups were formed to cover the NYC boroughs and NJ, as some NYC subway and bus lines were only been partially restored and significant portions of the subway, road, and commuter rail network remained non-functional. The initial goal was to visit accessible areas and collect perishable data, which were later supplemented with background information. In the days following the storm and in subsequent weeks (in collaboration with the NYC Department of Buildings and other city and state agencies), the GEER-NYC team collected data in Manhattan (Lower West and East Sides and the Battery Park waterfront), Staten Island (beachfront), Brooklyn (Red Hook, Bridge Park), and Queens (Rockaways, Long Beach, Broad Channel). The GEER-NJ team visited the coastal area from Brigantine to Belmar, Atlantic and Ocean cities, Longport, Ship Bottom and Long Beach Island, Seaside Heights, and Ortley. The observation location sites are shown on the map of Fig. 3.

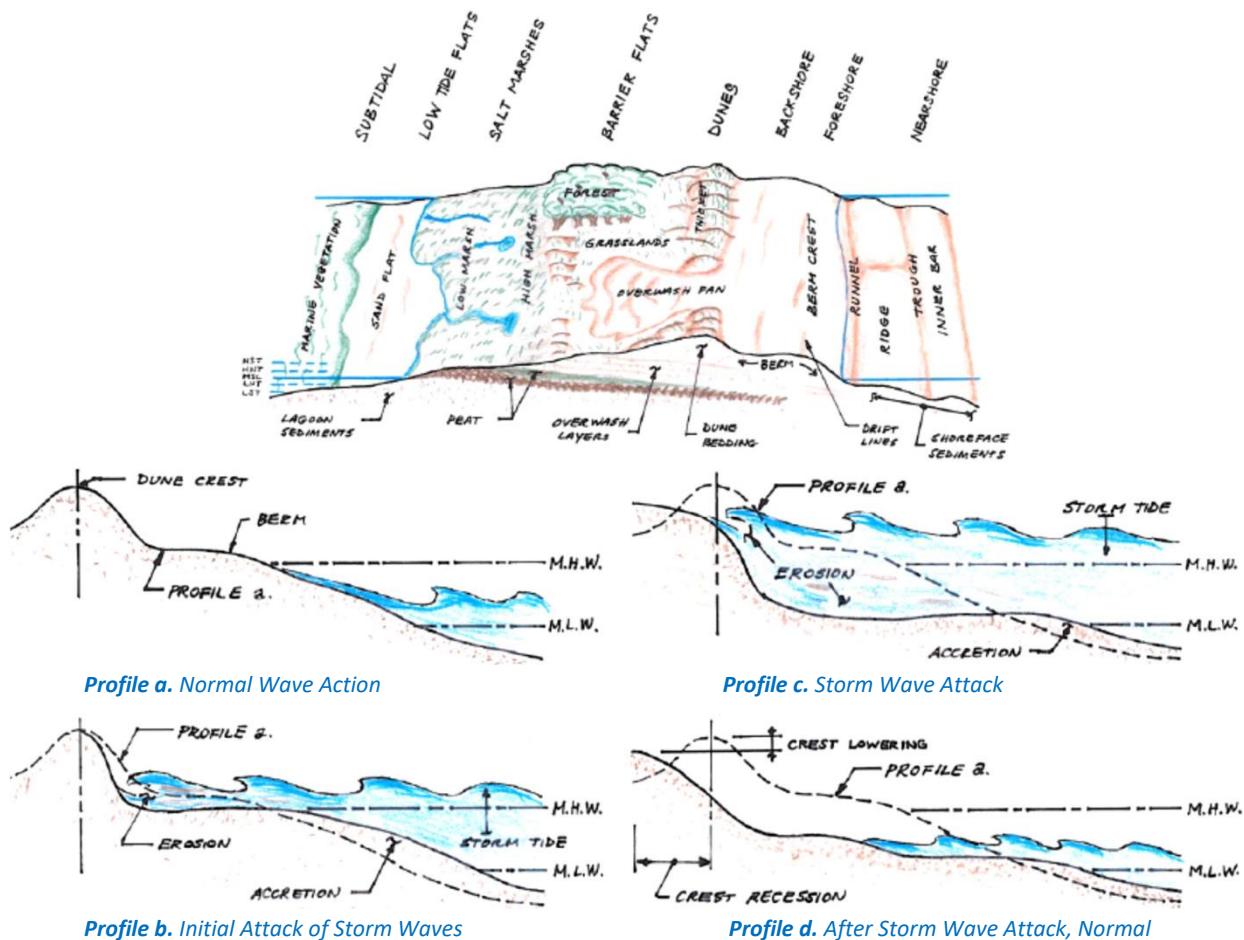
Figure 4. Barrier environments (top) and beach profile changes (bottom) in response to a coastal storm (Refs: A. Dyer from Leatherman, S.P., 1979; Godfrey, 1976; and U.S. Army Corps of Engineers, 1974).

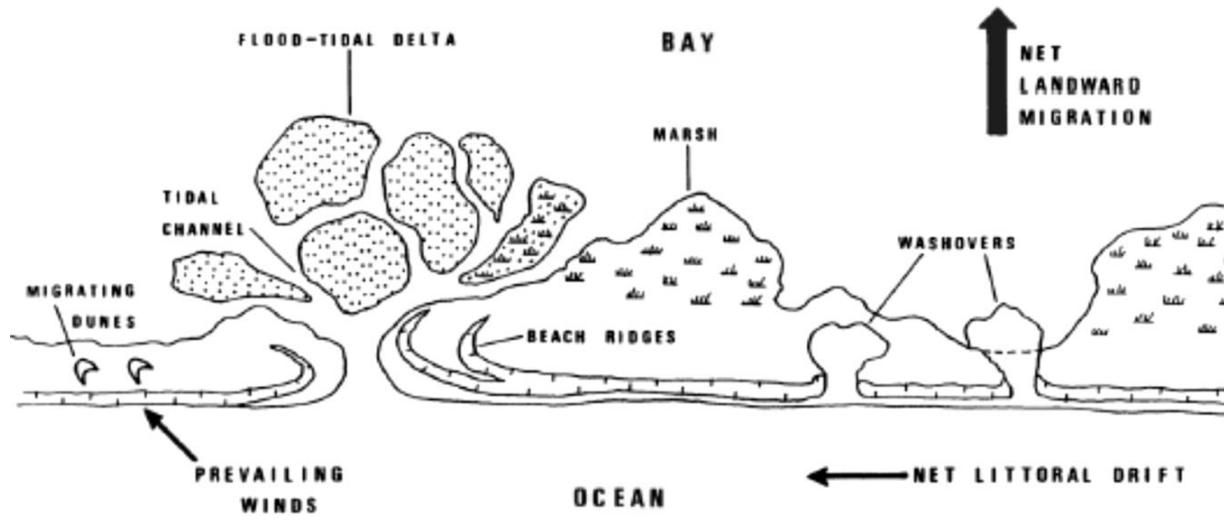
Figure 5. Geologic processes that build up a barrier island, allowing landward migration with sea level rise (Johnson, 1982).

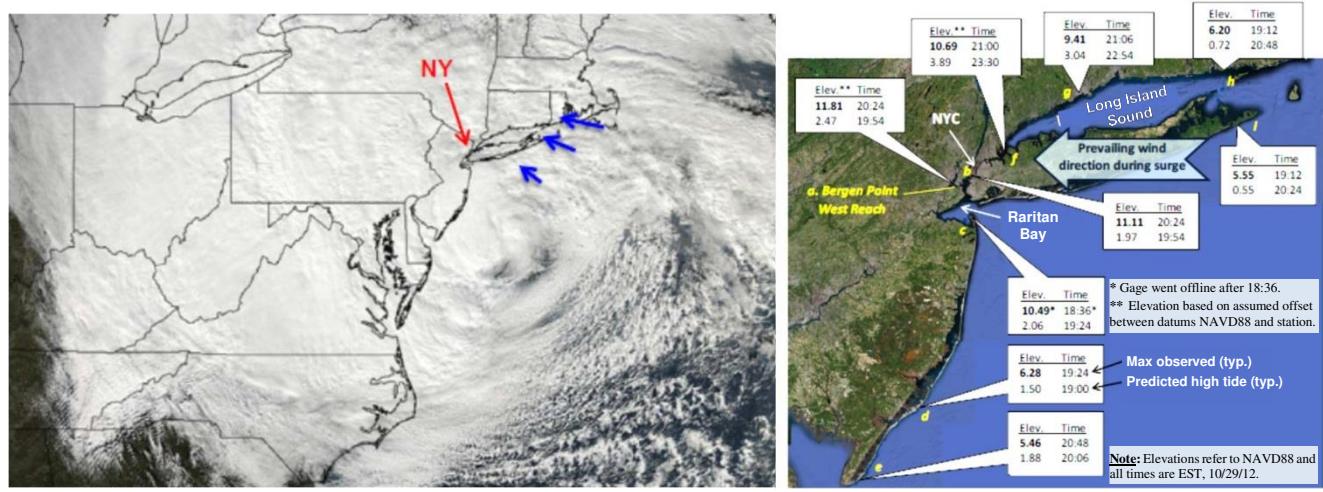
Figure 6 depicts the wind direction, fetch, coastline shape, and normal tidal cycle. The counterclockwise wind currents caused an eastern high velocity wind direction over LI and NYC. This pattern was verified by the GEER team's observation that many of the thousands of fallen trees in LI fell to the west. The following factors contributed to an increase of the surge:

- The westward direction of the winds created a long fetch distance from the east towards Raritan Bay and LI Sound.
- The “constricted” shape of both the Raritan Bay and LI Sound narrowing to the west caused the surge height to increase as it moved into those areas due to a “funneling” effect.
- The slow storm movement resulted in the maximum surge being superimposed above the astronomical high tide.

Figure 6. Hurricane Sandy's circulation on 10/29/12 at 2:20 pm EDT; blue arrows show wind direction close to landfall in southern NJ (left; nasa.gov/hurricanes/h2012_Sandy). Observed and predicted tide from NOAA stations (right).

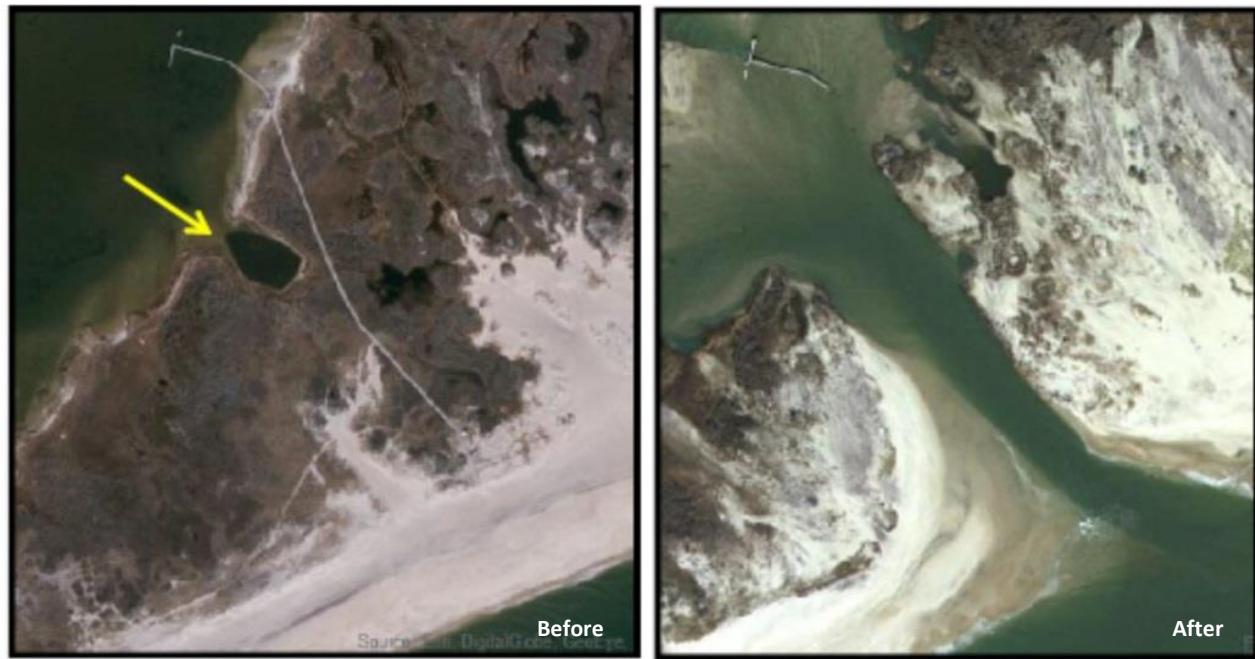
The storm surge significantly modified the coastal NY/NJ geomorphology, with the birth of new inlets and severe erosion and scour of soil on the shorelines (Fig. 7). While devastating in their path, these effects were largely consistent with predictions.

Figure 7. Fire Island, LI: New inlet with narrowing point by embayment in yellow arrow (Ref: tmappsevents.esri.com/).

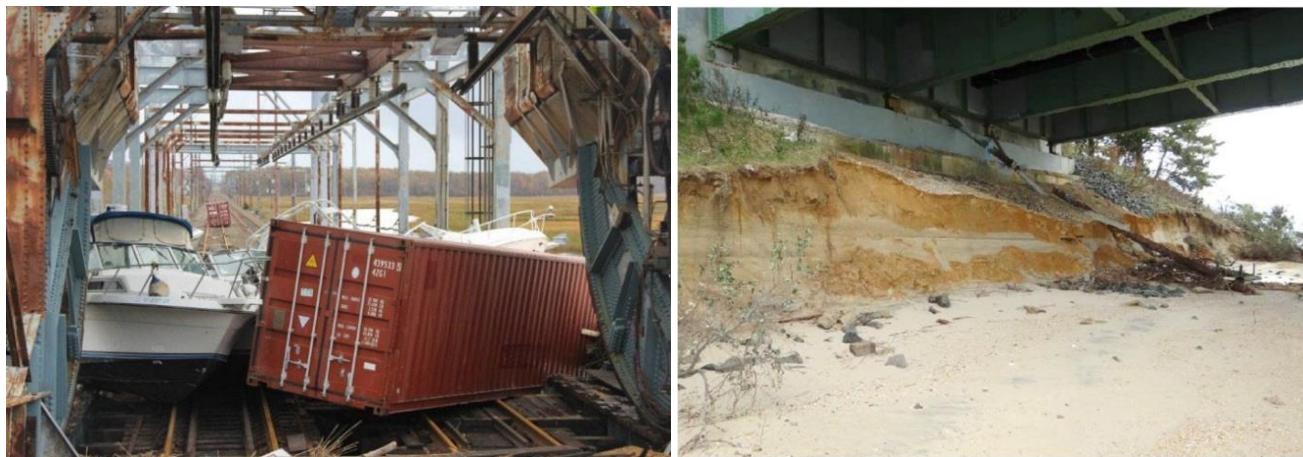
GEER observations of seven NJ bridges (NJ 35 - Cheesequake/Manasquan River Drawbridges; Railroad Drawbridge - Manasquan River; NJ 70 - Metedeconk River; NJ 37 - Mathis/Stanley Tunney; NJ 528 - Mantoloking; NJ 72 - Henderson Memorial) and data by the NJ Department of Transportation, Transit Authority, and Ocean County Engineering suggest that bridges remained mostly serviceable immediately or soon after the storm. Two primary themes of damage were identified: (i) flooding effects to drawbridges (e.g., Morgan Drawbridge, Fig. 8) and their electrical systems, and (ii) soil erosion at approaches and abutments (often supported on structures formed by fill within a perimeter soldier pile wall) in several bridges, averaging at 1.5 m (5 ft) of soil removal (e.g., Fig. 8: Rt. 72 Bridge, Fig. 9: Mathis Bridge). The exception was the Mantoloking Bridge that was unserviceable for a long period due to undermining of its abutments and approaches. Figs. 10 and 11 show large floating debris, including houses, that destroyed the T-wall, forcing the coping and sidewalk to cantilever out by about 3 m (10 ft).

Figure 8. Morgan Drawbridge (left; NJ Transit) and Rt. 72 abutment erosion, looking south-east (right; NJDoT).

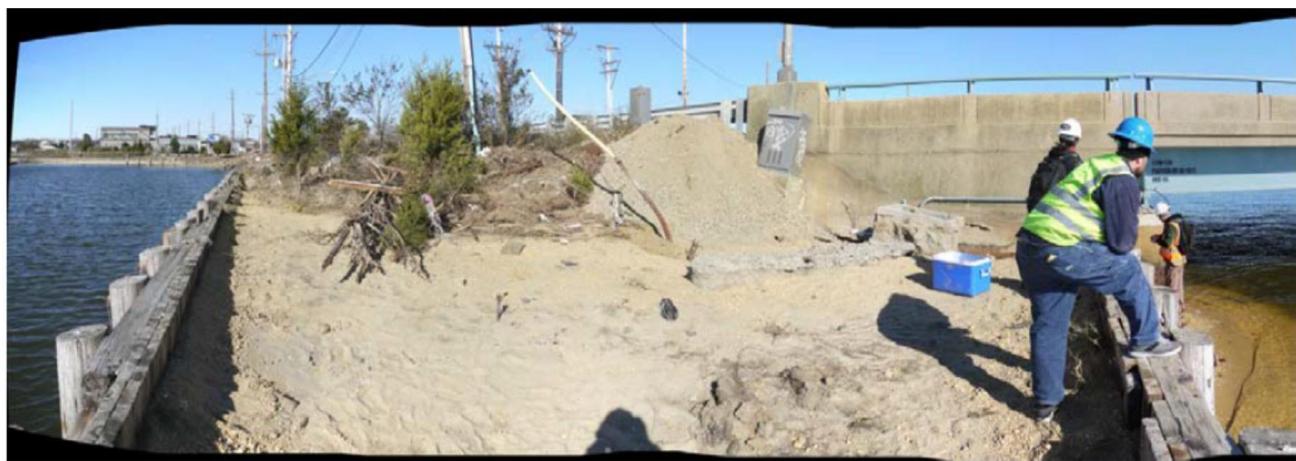
Figure 9. Erosion at Mathis Bridge southwest abutment (eastbound Rt37) ($39.949350^{\circ}\text{N}$, $74.113902^{\circ}\text{W}$; GEER 2014).

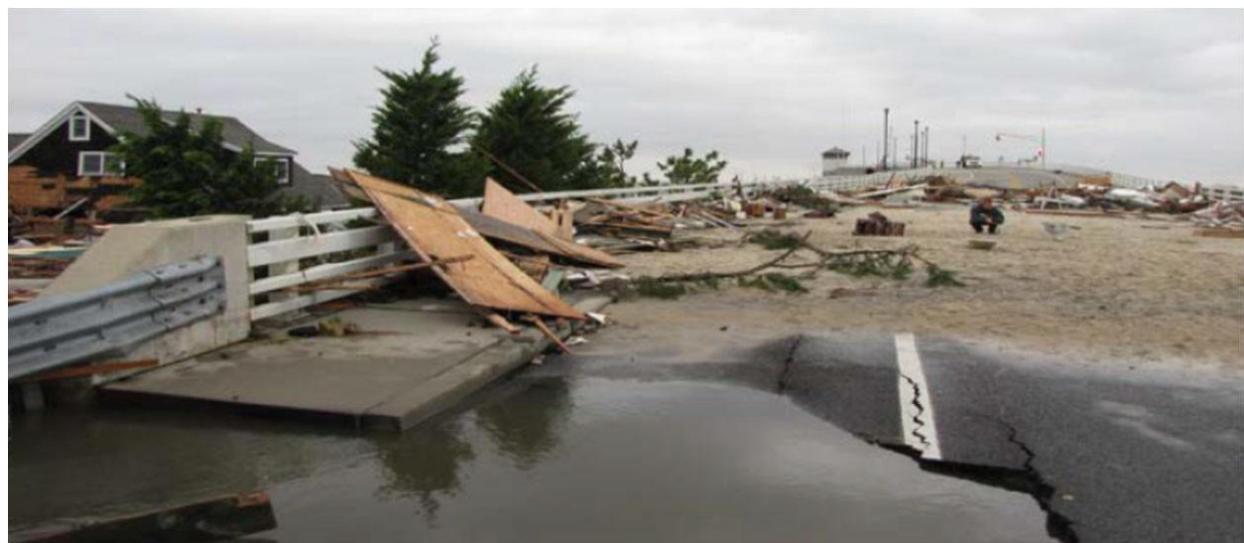
Figure 10. Foundation undermining at east abutment of Mantoloking Bridge ($40.040058^{\circ}\text{N}$, $74.051886^{\circ}\text{W}$; GEER, 2014).

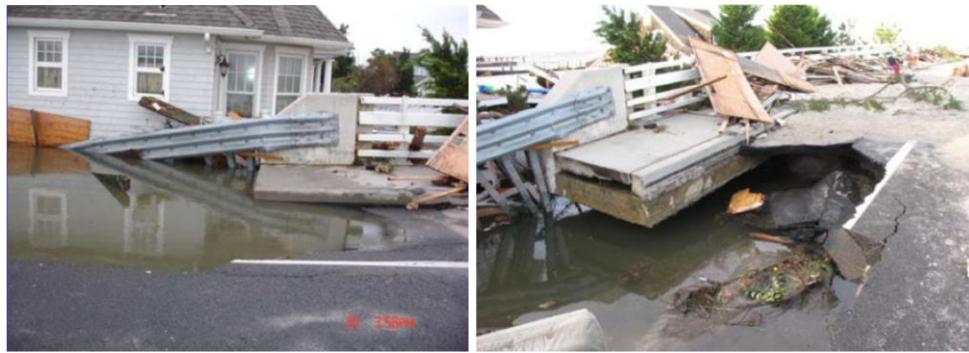
Figure 11. Mantoloking Bridge east abutment erosion (40.040058°N, 74.051886°W, Ocean Ct. Eng., 2012; GEER, 2014).

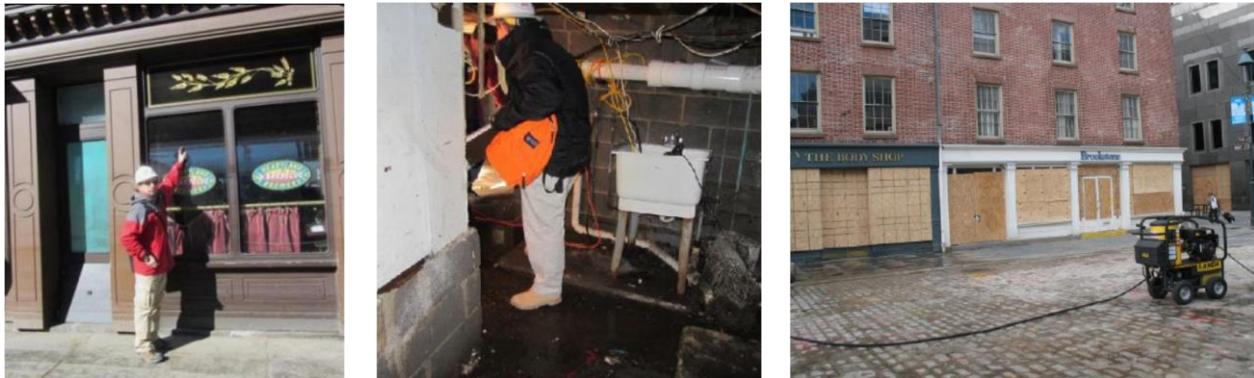
Damage in the dense urban NYC area of lower Manhattan was primarily related to flood inundation. High water marks and evidence of flood damage to approximately 1.2-2.1 m (4-7 ft) above street level were observed throughout low-lying neighborhoods (e.g., South Street Seaport) and water front areas (Fig. 12). Below-grade subway stations, tunnels, parking garages, and excavations experienced widespread flooding. While access to many of these locations was restricted to the GEER team due to ongoing recovery work, evidence of flood inundation was visible from the surface, e.g. at the Battery Park underpass and Bellevue Hospital. Based on reports in the days and months following the storm, the flooded tunnels included the Brooklyn Battery, Holland, and Queens-Midtown highway tunnels, the PATH rapid transit tunnels, NJ Transit / Amtrak / LI Railroad Hudson and East River rail, and seven subway tunnels. Several subway stations and open excavations were flooded, including South Ferry, which flooded to the ceiling, as well as an excavation at the World Trade Center site (Figs. 13-14).

Figure 12. South Street Seaport (40.706685°N, 74.003554°W), 11/4/12: High water line on window of a restaurant (left); typical flooded basement (middle); flood damage (right). (GEER Report, 2014).

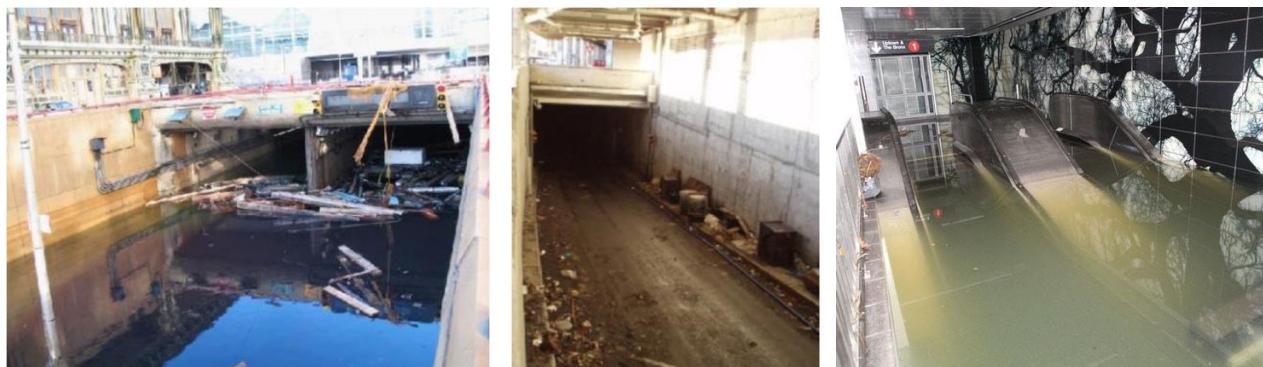
Figure 13. Flooded Battery Park underpass (40.701600°N, 74.011742°W) on 11/4/12 (left, by GEER 11/3/12); E30th St. (40.739830°N, 73.973263°W) Bellevue Hospital (middle, by GEER 11/3/12); South Ferry station (right, by MTA 10/30/12).

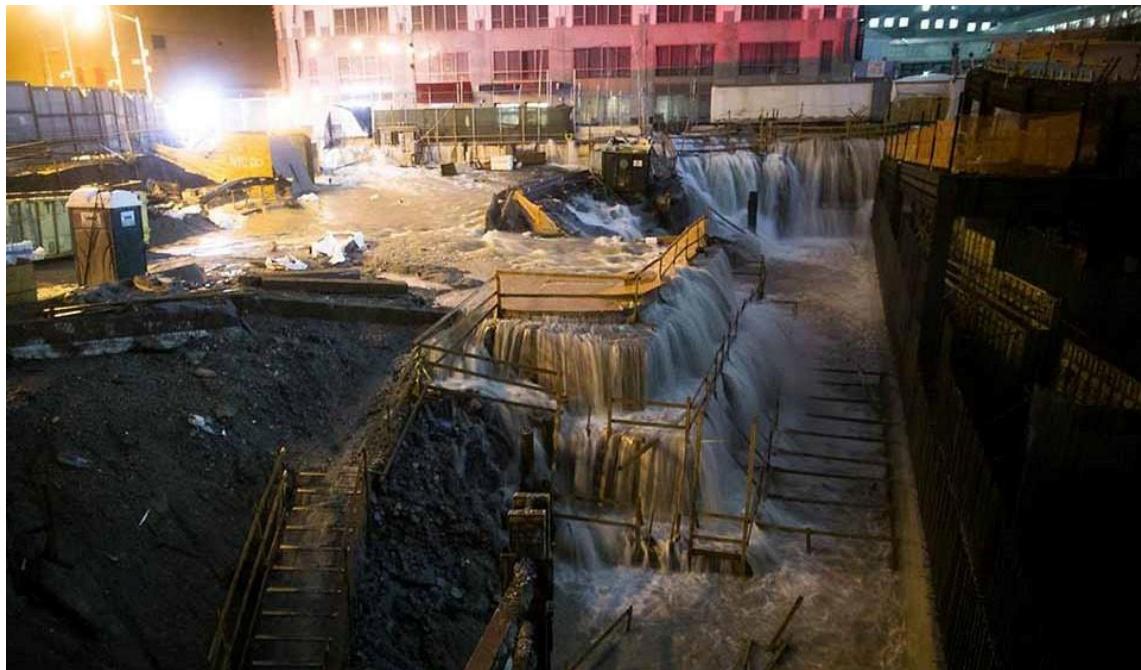
Figure 14. Open excavation flooding at the World Trade Center site (Photo: Associated Press).

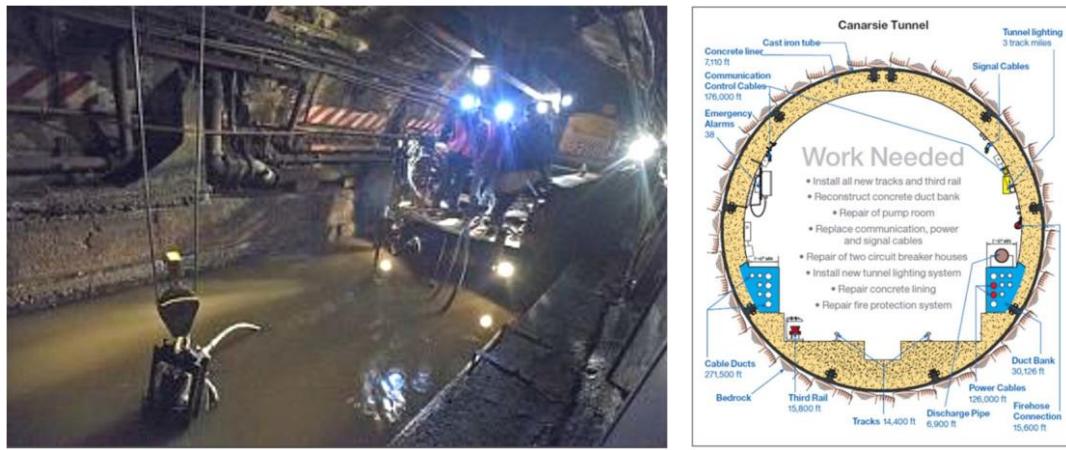
While most tunnels experienced minimal structural damage, utilities and ventilation systems were severely damaged and required lengthy repairs. Indicatively, the [R] Montague St. subway and the World Trade Center PATH tunnels were out of service for 2-3 months. The R line was taken out of service again in 2013 for lingering flood damage repairs. The Canarsie Tube of the [L] subway line was inundated with 265,000 m³ (7M gallons) of saltwater that caused corrosion of cabling, circuit breakers, and disabling of power/track equipment. The duct bank alongside the track, which provides walkway for emergency egress, sustained heavy damage and exhibited a partial collapse. With an initial 15-month shutdown plan, a complete overhaul is still necessary today, in 2020 (Fig. 15), as the L line is critical with a large portion of its daily 400,000 riders travelling to 14th Street stations, some of which are not easily reached by other lines. The Queens [A] Rockaway subway line was out of service for nearly seven months due to two major washouts at the earth embankment crossing Jamaica Bay, which exposed the old Long Island Rail Road (LIRR) infrastructure (Fig. 16).

Figure 15. Canarsie tube of [L] line: damage from Sandy (left) and work needed to repair it (right) (MTA, 2017).

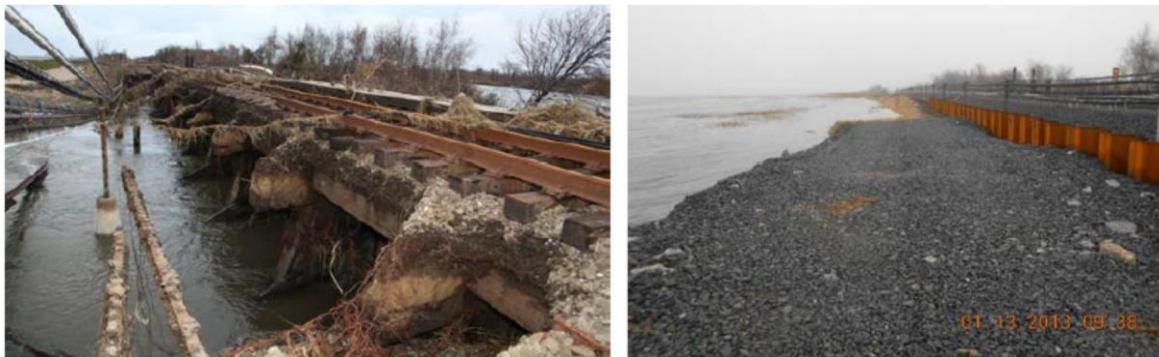
Figure 16. Earth embankment washouts in Queens, along Rockaway subway [A] line after Sandy with old LIRR infrastructure exposed (left) and post mitigation work (right). Photos by Khinda, ed. (2013).

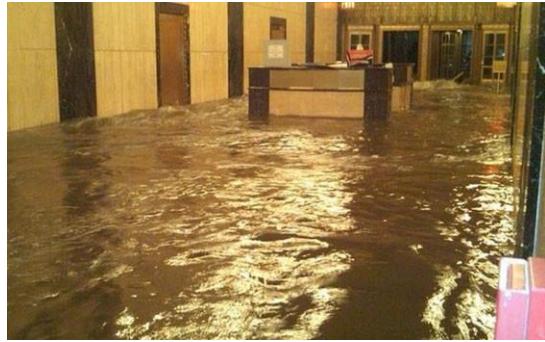
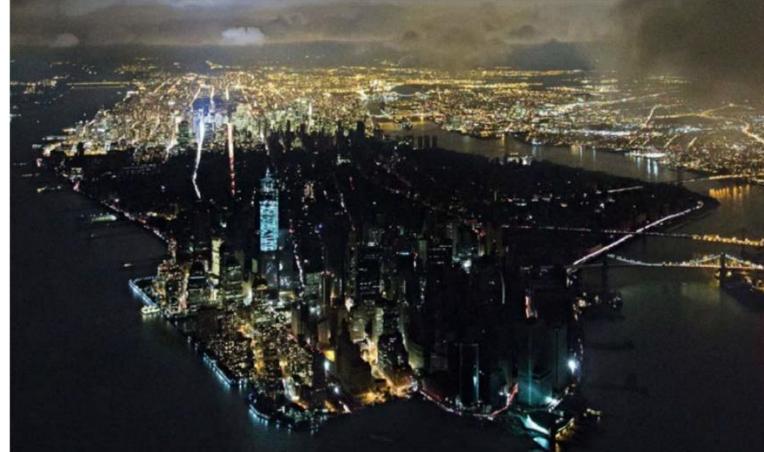
The storm surge exceeded predictions and caused unprecedented damage to the infrastructure of Consolidated Edison (Con Ed), which supplies electricity to nearly all of NYC's 3M customers (representing 8.3M people and 250,000 businesses) and provides 41% of the city's natural gas service. Precautionary measures were taken, including sand bags and "aqua dams" (polyethylene berms filled with water) at substations and vaults, pre-emptive de-energizing of equipment, isolation of 26 steam main segments, and the pre-emptive shutdown of the East River generating station and the Brooklyn Navy Yard co-generation steam plants. Still, the East River, E13th St., and Seaport substations were flooded, resulting in the loss of almost a third of NYC's

generating capacity south of 34th St. for four days, thus causing severe delays to the recovery effort and the restart of subways (Fig. 17).

Figure 17. Flooded lobby of the Verizon building (left, Photo by Governor A. Cuomo); Power outage south of 34th St., 10/29/12 in Lower Manhattan which lasted for four days (right, Photo by I. Baan, NY Magazine).

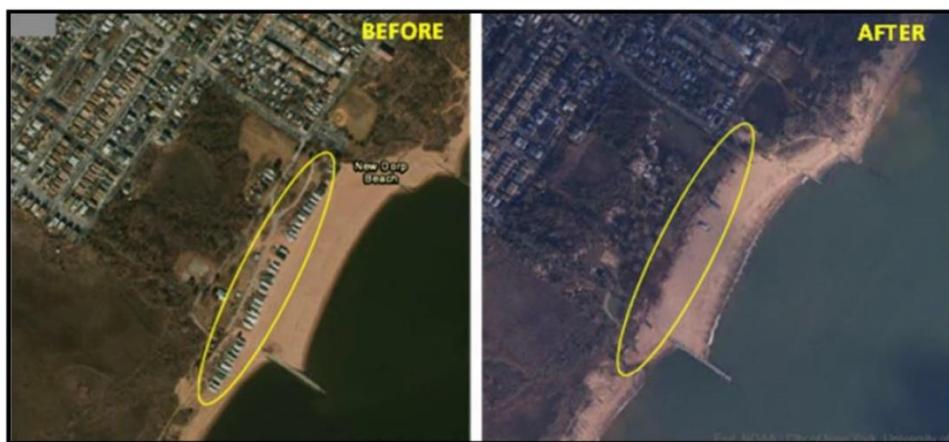
Storm surge, flooding, and erosion impacted residential housing and municipal infrastructure foundations in coastal areas investigated by the GEER team (Fig. 3). Destruction of wood-frame houses in Staten Island (SI) was common, as observed based on the “before” and “after” aerial photos of a row of houses (Fig. 18), which were completely removed by the storm. This area is underlain by glacial outwash sands, often overlain by man-made fill. Most of the structural/foundation failures occurred in dwellings built prior to 1938, typically developed as summer residences in areas with direct exposure to open ocean, constructed less robustly than modern, permanent-residence, homes (Eschenasy, 2013). Moving inland, dunes, and vegetated strips had a positive effect in reducing the damage.

Figure 18. Aerial photographs from New Dorp Beach, SI, before and after Sandy. Row of houses completely removed and debris moved inland. (Images from tmappsevents.esri.com/website/swipe_sandy/).

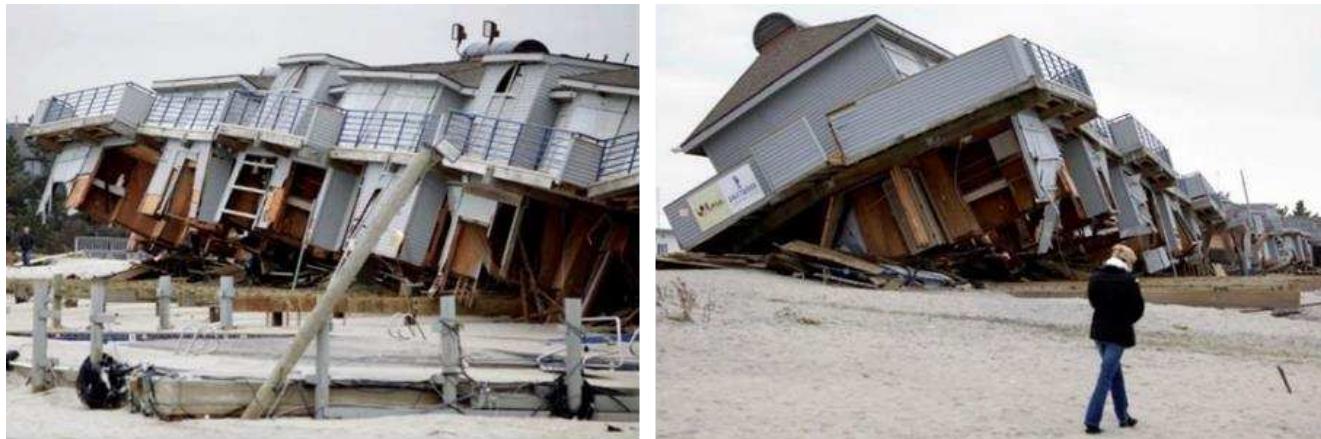
A common damage pattern among wood frame houses was the pulling off their foundation due to inadequate anchorage (e.g., Sea Bright, NJ, Fig. 19). These houses were subject to flotation, which not only causes distress, but removes dead load from foundations, making them more susceptible to breakage. Particularly, Concrete Masonry Unit (CMU) wall foundations and piers performed poorly, and were found buckled, broken, or completely removed, causing tilt, dislocation, or collapse of the superstructure (Fig. 19). In Sea Gate, Brooklyn, a concrete beachfront retaining wall foundation was undermined by erosion and subsequently broke, while the soil behind the wall was washed out (Fig. 20). In Breezy Point and Roxbury, Queens, two-story wood-frame homes, on CMU block wall and pier foundations, sustained major structural damage, including being pulled off their partially or completely destroyed foundations (Fig. 20). On the other hand, foundations of high-rise residential buildings (typically piles) generally performed well.

Figure 19. Sea Bright, NJ, beach cabana ($40.350086^{\circ}\text{N}$, $73.972954^{\circ}\text{W}$) pulled off its base (Photo by AP/Wenig; 11/19/12).

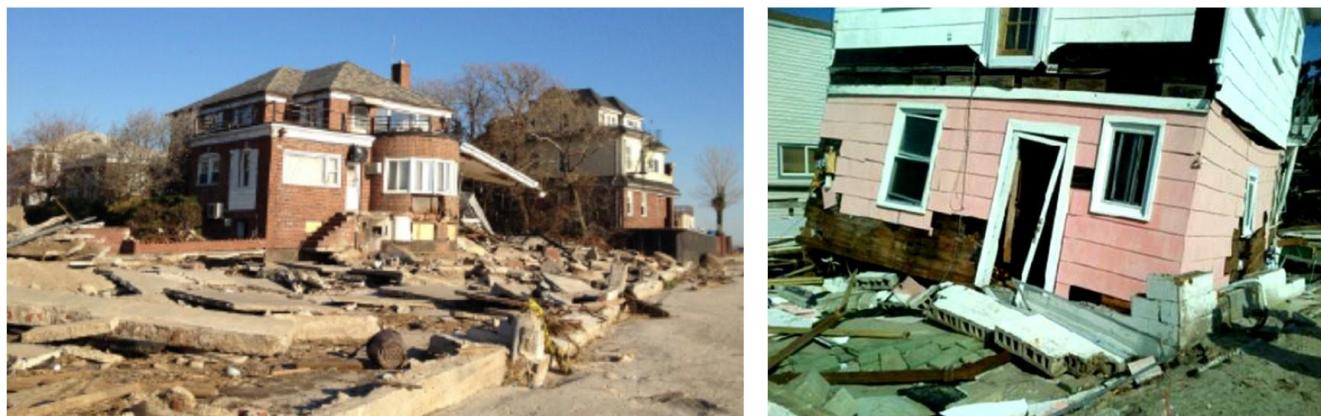
Figure 20. Undermining of beachfront retaining wall and loss of retained soil, Sea Gate, Brooklyn (left, 11/9/12); Destroyed CMU wall foundation, Breezy Point, Queens (right, 11/12/12). Photos by NYCDoB (GEER, 2014).

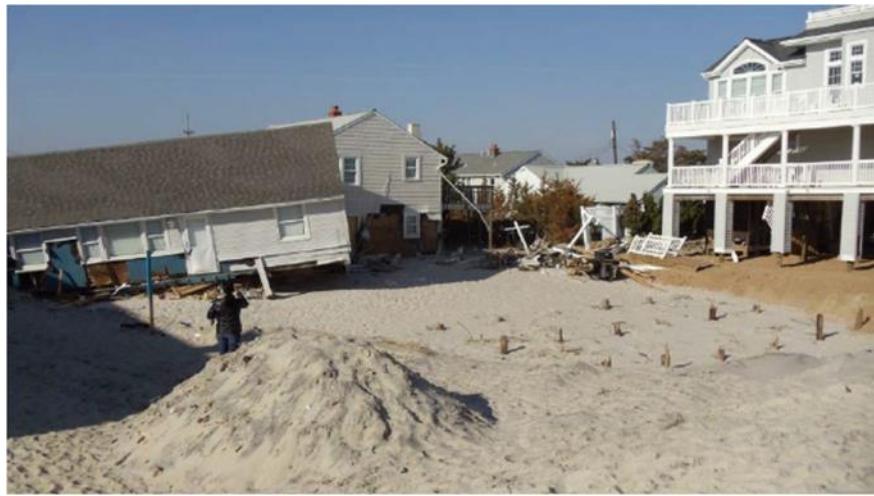
A spectacular failure was observed by the GEER team at a two-story home at Pehola Park, Long Beach Island, which was sheared off its piles due to storm surge forces as well as wave action. Only the upper story of the home was visible, found near its original location. The site's approximate ground elevation was 2.35 m (7.7 ft) and the high-water mark was about 0.7 m (2.3 ft) above ground. The surrounding homes were intact, with the only difference being that this home was at a lower elevation than the others (Fig. 21). This pattern of lower story disappearance and/or flattening was observed in other areas as well.

Figure 21. Timber piles remain in place after a home was sheared off in Pehola Park (39.610016N, 74.206657W, GEER, 2014).

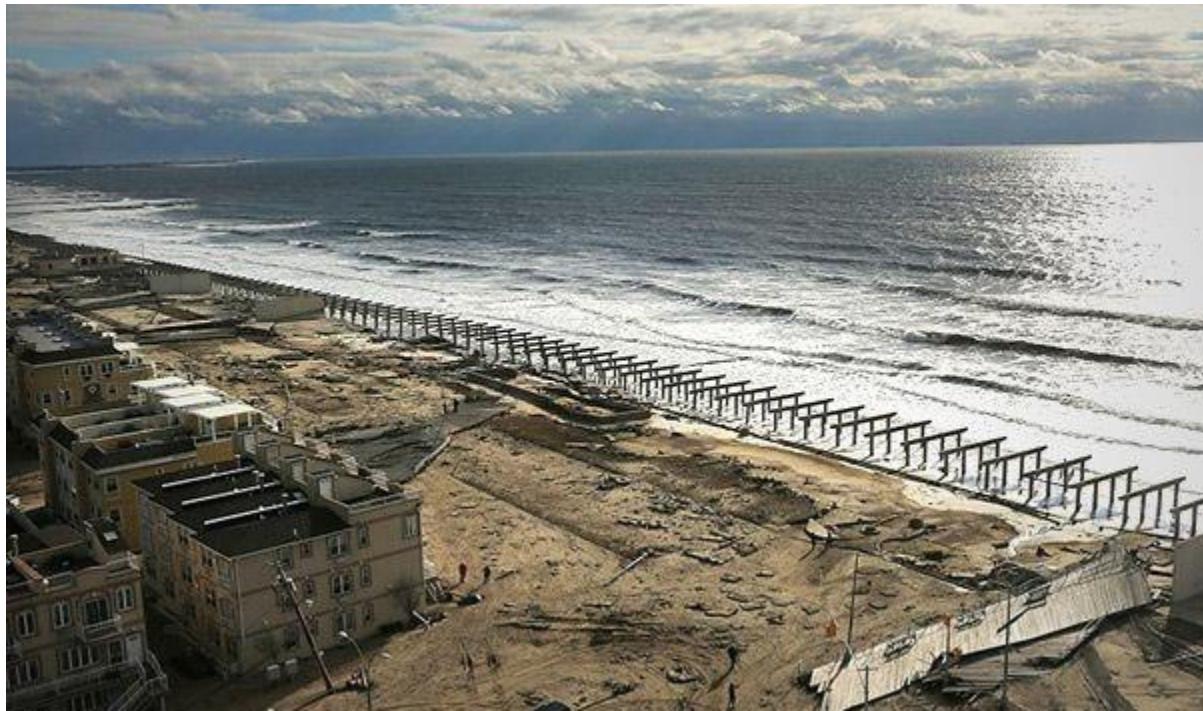
concrete pile-supported wooden boardwalks, and some homes are separated from the beach by concrete or sheet pile retaining walls. In Rockaways, Queens, the boardwalk had been lifted off its piers and damaged or destroyed over its entire length, with debris carried up to 60 m (~200 ft) inland (Fig. 22).

Figure 22. Damage to Boardwalk at Rockaway Beach, Queens (40.583445°N, 73.81553°W). Photo by cnbc.

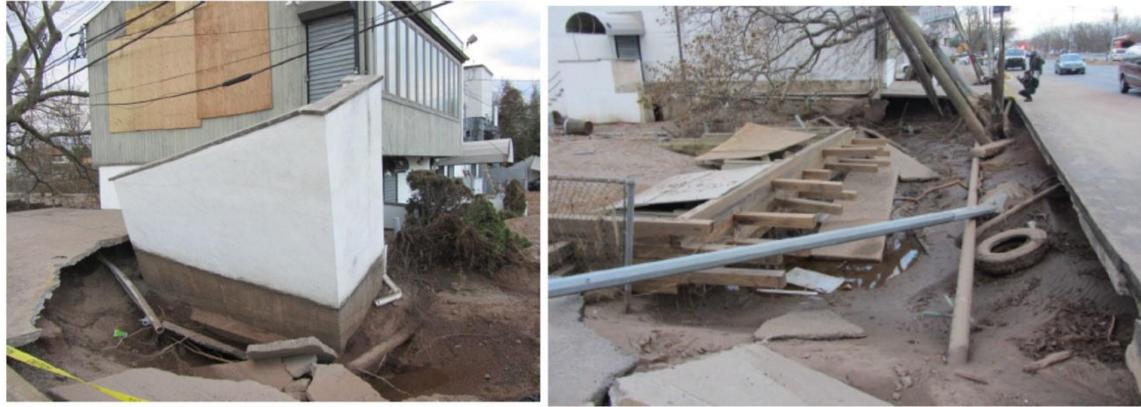
Severe soil erosion was observed along Father Capodanno Blvd in Midland Beach, Staten Island (SI), where sinkholes undermined the street, curb line, sidewalks, utility poles, and house foundations (Figs. 23, 24). Throughout the area, wood decks, trees, cars, and other debris had been deposited inland. Concrete wall foundations generally sustained little or no structural damage, though they sometimes experienced erosion and scour along their perimeter.

Figure 23. Scour undermining at Seaver Ave & Father Capodanno Blvd, SI ($40.575944^\circ N, 74.083015^\circ W$, 11/4/12). Damage to stair foundation and drain (left) and sidewalk, utilities, and light pole foundation (right). Photos by GEER (2014).

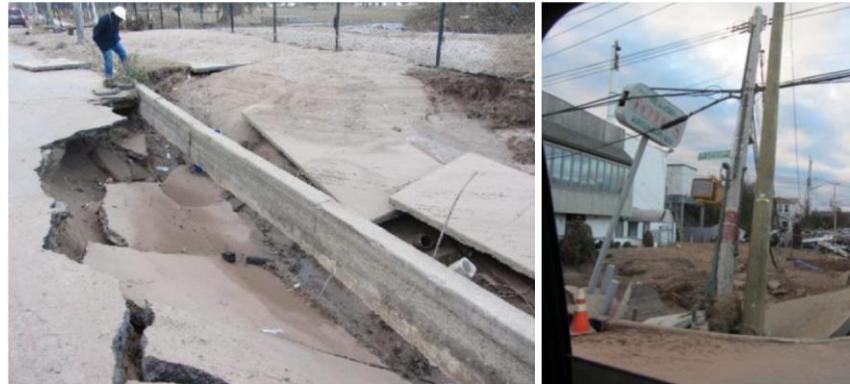
Figure 24. Scour undermining of street and utilities at Seaview Blvd, SI ($40.579283^\circ N, 74.077849^\circ W$, 11/4/12, GEER, 2014).

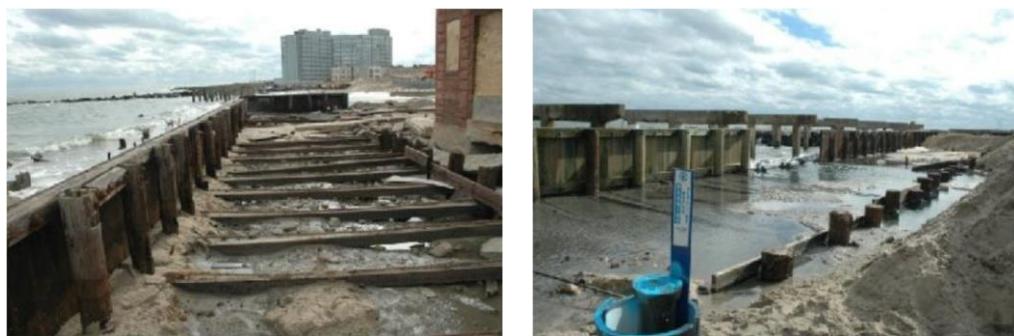
along a section of the shore in Atlantic City, NJ, were breached.. The breaches were attributed to the destruction and washing away of the timber facing . The surge and water washing through the breaches exposed the tierods and anchors (Fig. 25).

Figure 25. Bulkhead in Atlantic City, NJ: backfill soil washed away, exposing severely corroded tie rods (GEER, 2014).

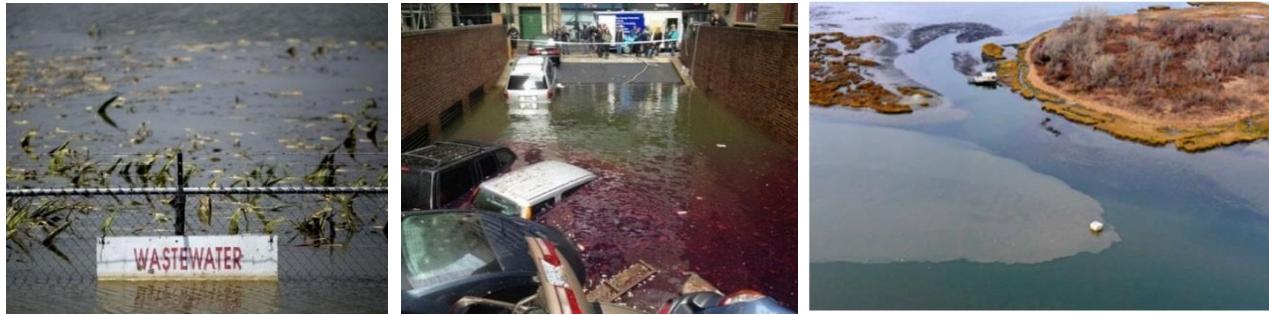
to shut down or divert sewage into waterways due to power outages and flooding (e.g., Fig. 26 shows untreated waste spilled in the LI South Shore Estuary from the Bay Park Sewage Plant in East Rockaway). GEER visited the WWTP that processes waste water from Yonkers. Founded on filled land along the east bank of the Hudson River, it experienced one of the largest overflows with 4.5M m^3 (1.2B gallons). The river frontage has a rip-rap revetment at the south and a steel seawall (Fig. 27) about 1.5 m (5 ft) higher than the north rip-rap. Normally, the plant handles daily 360 m^3 (95M gallons) of waste water; during Hurricane Irene in 2011, it processed $1,150\text{ m}^3$ (300M gallons). After Sandy, loss of gravity flow caused more than 2.8 m (9 ft) of tail water and therefore flooding of below-grade areas (Fig. 27), something that damaged equipment including boilers, the alarm system, pipes, and motors.

Figure 26. Untreated waste spilled in NY Harbor (left, photo Getty/Tama) and buried cars (middle, photo Bloomberg/Korby). Overflow from Bay Park Sewage Treatment Plant, East Rockaway (right, photo by D. Kuntz; Kenward et al., 2013).

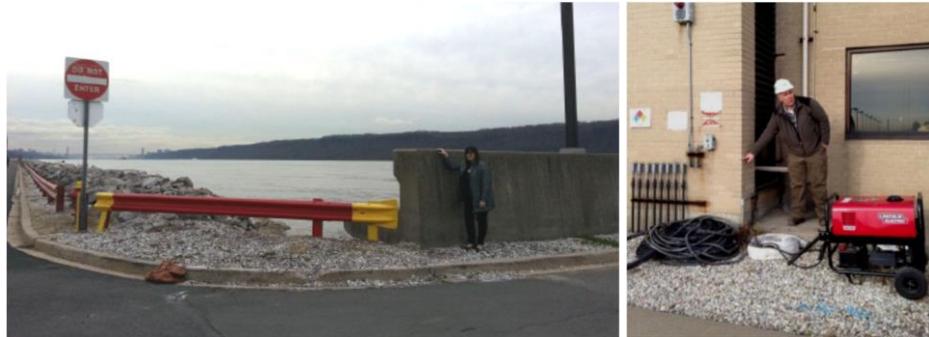
Figure 27. Yonkers Joint WWTP: junction of rip-rap revetment and seawall, looking south (left); vent grates in aeration blower building where water entered, with flood water elevation shown by plant superintendent (right); GEER (2014).

Preparedness allowed for on-site decisions that accelerated recovery to 3-4 days for primary treatment and 21 days for normal operations to resume. Planning before the storm prevented longer disruptions (e.g., sandbagging prevented flooding of the feeder, the control center, and the emergency generator), while on-site staff were properly trained to manually operate system components that failed.

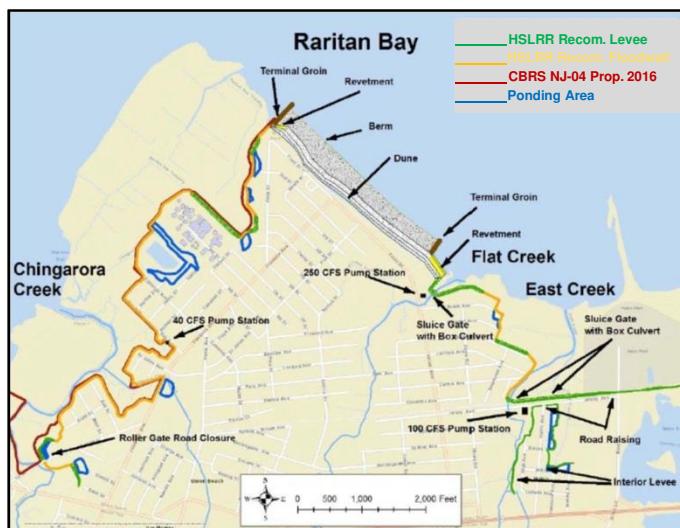
Figure 29. Union Beach plan overview from U.S. Army Corps of Engineers Limited Reevaluation Report (USACE, 2017).

The NJ State issued a report five years after Sandy with: (i) a record of damage and response; (ii) an agency-by-agency response/recovery playbook applicable to other states exposed to hurricanes; and (iii) rebuild measures co-funded by FEMA, the Departments of Interior and Housing and Urban Development (HUD), and Federal Highway Administration (FHWA), such as: Sea Bright wall, Mantoloking and Brick sheet piling, Belmar Lake Como discharge, Brigantine pump stations, Little Ferry tide gate, and Wildwood/Stone Harbor storm water/flood control. The Union Beach project in Raritan Bay (Fig. 29) would rebuild beaches and dunes and restore 100,000 m² (25 acres) of degraded wetlands to better absorb flood waters, with levees, flood walls, tide gates, and pump stations.

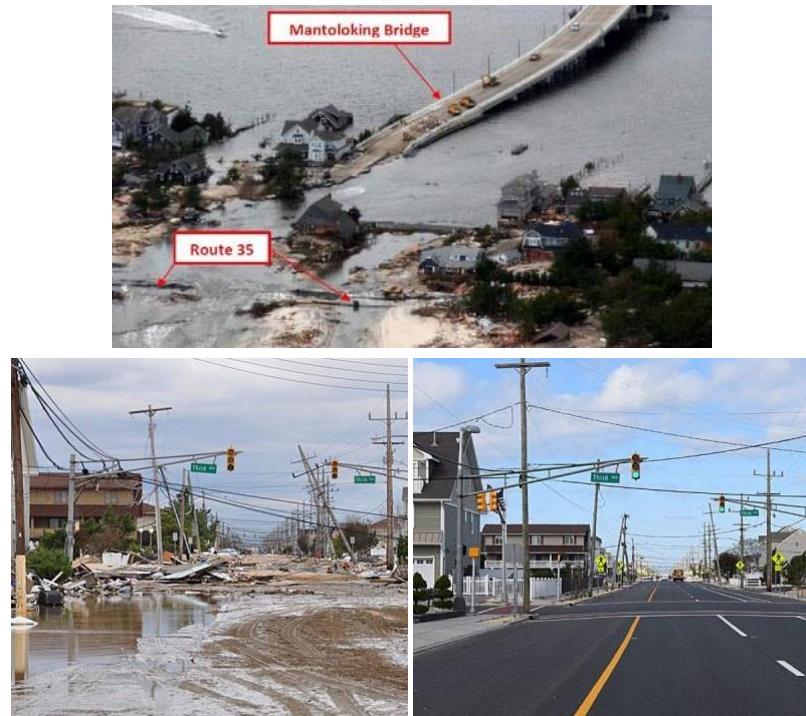
Figure 30. Rt 35 during Sandy (top); before/after photos at 3rd Ave, Ortley Beach (bottom, C. Raia, Toms River Township).

An example of a completed project is the \$340M Rt35 Reconstruction, which was a severely-damaged coastal emergency evacuation route that has since been rebuilt with state-of-the-art road construction and a thorough storm water drainage system (Fig. 30).

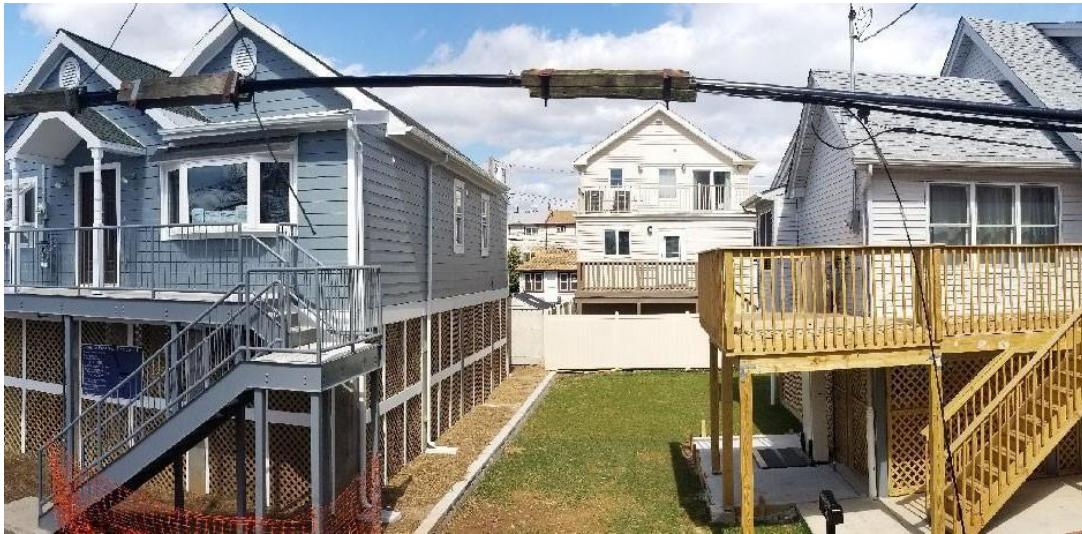
Figure 32. Build It Back elevated homes in New Dorp Beach, Staten Island (NYC Housing Recovery, 2018).

The Build It Back (BIB) program assisted 8,600 homeowners, landlords, and tenants of one- to four-unit homes affected in NYC boroughs by rebuilding homes damaged or destroyed by Sandy in the fall of 2018. The goal was to invest and create resilient neighborhoods through sustainable design, e.g. by requiring new homes to be elevated above projected sea level rise and flood heights. The program was funded by HUD's Community Development Block Grant (CDBG) to rebuild and elevate homes to current stringent flood regulations (Fig. 32) for 12,500 families. Additional support was provided to homeowners with moderate repair needs or without flood insurance, while a few low-income, households received rental assistance (HUD, 2018). Geotechnical considerations included foundations for the elevated homes designed to resist undermining by future flood events. The new foundation systems included jacked or drilled piles as well as the choice to leave open space below the structures to allow for flow.

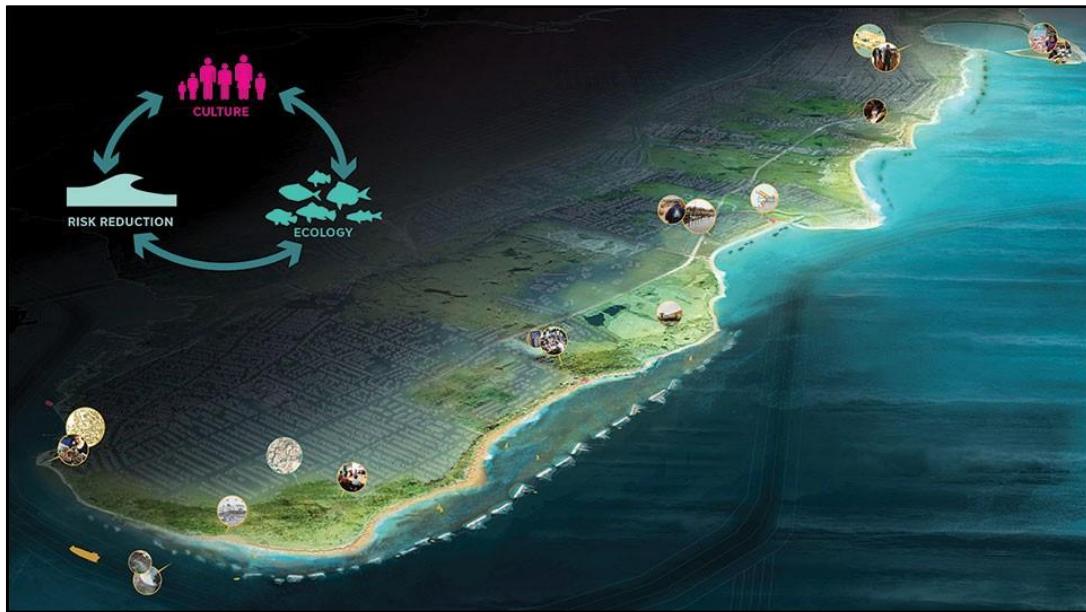
Figure 33. Living Breakwaters concept (SCAPE Landscape Architecture).

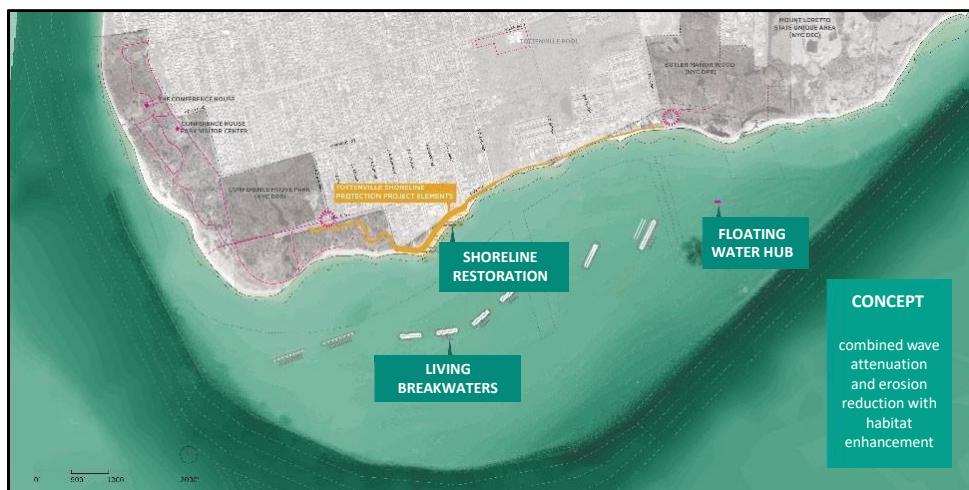
Figure 34. Living Breakwaters system: combined wave attenuation and erosion reduction with habitat enhancement.

added to the shoreline will protect vulnerable beaches, while breakwaters work to accrete beach elsewhere (Fig. 34). Similarly, in NJ, Rebuild by Design includes several projects, such as: (i) CDBG (\$380M) projects to be completed by 2022; (ii) Hudson River (\$230M) communities and critical infrastructure flood-resistance structures (e.g., N. Hudson Sewerage Authority); and (iii) protection of Meadowlands (\$150M) Little Ferry, Moonachie, Carlstadt, Teterboro, and S. Hackensack.

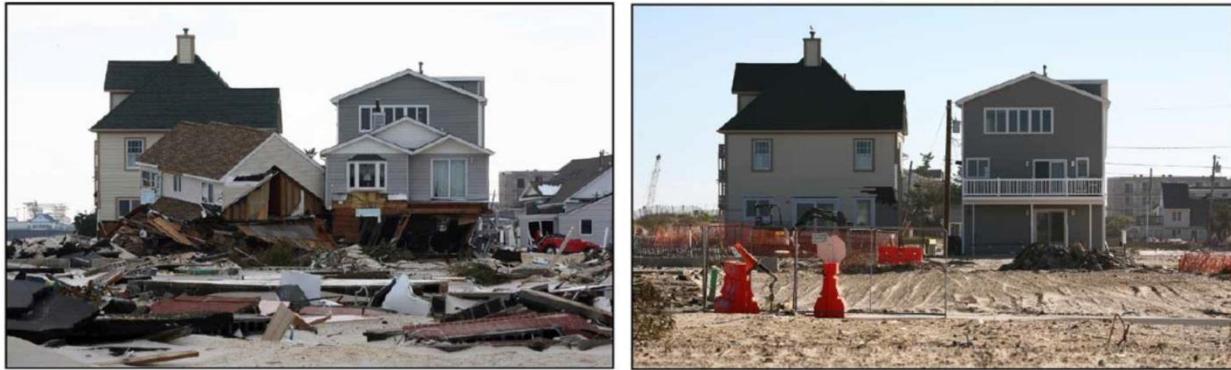
Figure 35. A home at Outely Beach, NJ, before (left) and after (right) rebuilding. Photos by NJ (2017).

In NJ, priority was given to needs for temporary housing assistance, health/social service benefits, and rental/rebuilding resources. The \$1.2B Reconstruction, Rehabilitation, Elevation, and Mitigation (RREM) program rebuilds damaged homes (Fig. 35) using post-Sandy design standards. By 2017, about 6,200 of 7,600 RREM grantees had returned to their homes while the remaining received assistance for mortgage costs or rent payment. Other homes that were flood-prone were sold by willing sellers at pre-Sandy values, allowing families to relocate through DEP's Blue Acres voluntary buyout program that is expanding to other flood-prone areas. These properties are converted to open spaces to serve as a natural buffer for future storms.
