Geotechnical Effects and a 6-Year Outlook of the 2012 Hurricane Sandy in the Eastern United States

ABSTRACT: Hurricane Sandy was the deadliest and most destructive event of the 2012 Atlantic hurricane season. It originated as a storm off the coast of West Africa that turned into a tropical wave in the southwestern Caribbean Sea, and then into a hurricane that moved slowly north along the United States East Coast. Numerous regional coastal communities and urban centers in New Jersey (NJ) and the New York City (NYC) metropolitan area experienced widespread flooding, extreme winds, and heavy damage that disrupted daily life and business in Lower Manhattan, the world's financial capital. Consequences with great geotechnical engineering interest include: (i) modification of the regional coastal geomorphology due to storm surge, with the birth of new inlets, erosion, scour of soil at the shorelines; (ii) damage in coastal communities that revealed the vulnerability of residential building foundations not designed according to modern flood protection standards; and (iii) interruption of service of buried structures and below ground infrastructure due to flood damage to non-structural com

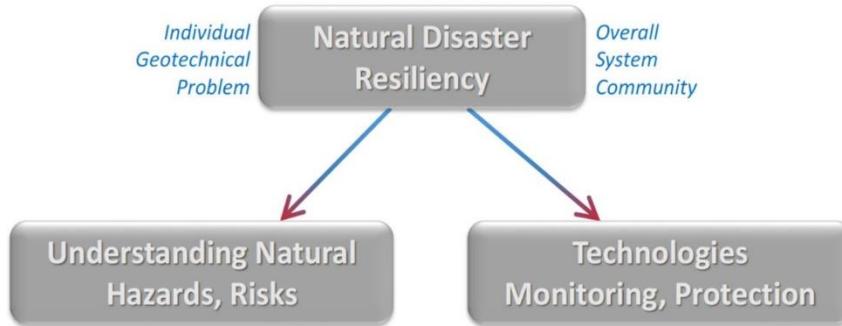
Figure 36. Framework for resilient-based design (Nikolaou et al., 2017).

and risk-based engineering framework which considers life cycle costs is needed to address both new infrastructure components and the (often aged) legacy components. A design framework as shown conceptually in Fig. 36 can address both the individual component as well as the overall system needs, while planning for cascading hazards (Nikolaou et al., 2017). The GEER-organized efforts and presentation of data highlighted key flaws, demonstrating to stakeholders and the public that geotechnical engineers should be involved early in the decision-making process after major events such as Hurricane Sandy.
