A Constructability Problem in a Deep Shoring System

ABSTRACT: The construction of deep excavations and retaining structures for the deep basements and infrastructures has frequently been implemented in İstanbul. Primary design concerns for underground construction are the protection of adjacent buildings, properties of the project site, and planned structures; thus, the appropriate selection and design of the retaining wall system are critical for the project's success. This case history presents the design and construction details of the watertight retaining wall for the seven levels of basement which required an excavation depth of up to 30.0m. Considering the presence of high groundwater level in the project area, the temporary retaining system initially consisted of secant bored piles with a diameter of 1.0m and 0.2m overlapping, supported by multilevel prestressed anchors along the entire site perimeter. During the construction of the secant piles, it was seen that the mechanical properties of the encountered rock units of Trakya Formation were better than the expected in design phase, and therefore piles could be constructed with a length of approximately 25.0m which was 10.

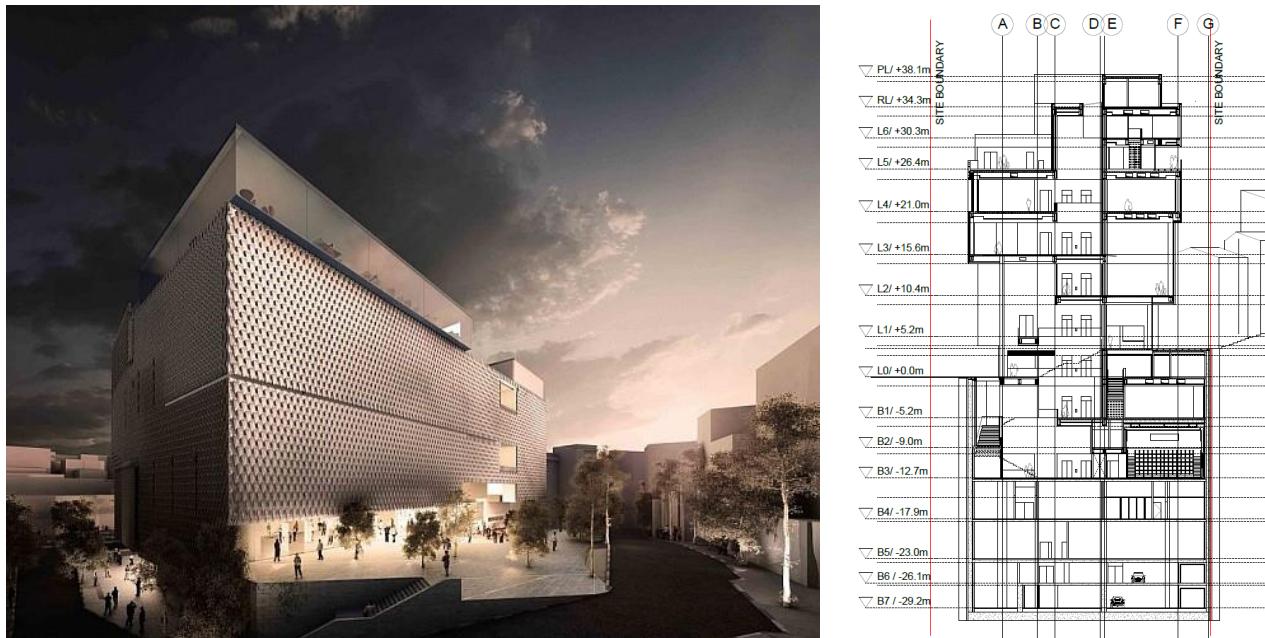
Figure 1. Architectural View and Section of Building.

The subject site is at the Dolapdere District of Istanbul, covering an area of approximately 3397.0m² with additional green areas. The project area is located at Dereboyu Street, and is surrounded by Can Eriği, Yeni Bostan, and Keresteci Ali Streets. After the demolition of the old existing building, plans are made for a contemporary gallery with 7 stories and 7 basements to be constructed. The gallery covers approximately 1214.0m² area, with 18621.0m² total construction area. According to the conveyed information the architectural ±0.00m elevation will be as +22.00m. The foundation depth is 31.2m and base elevation will be -9.15m. The architectural view and cross section of the building is given in Figure 1.

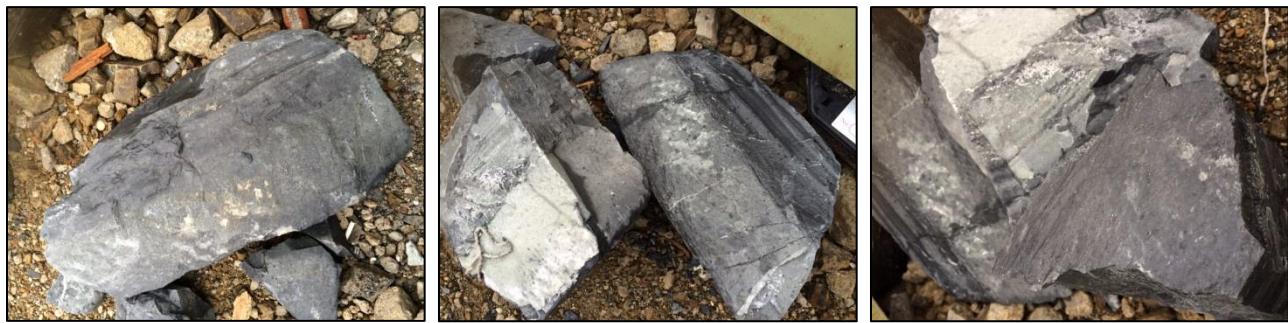
Figure 8. Encountered Diabase Units.

During the pile installation, it was observed that the strength of the Trakya Formation rock units fared better than expected, especially below the 25.0m depth (-4.6m elevation). The progress rate of the drilling unit was controlled regularly for each pile; it is shown that the progress rate was less than 1.0m/hour after 25.0m depth. Additionally, magmatic origin diabase blocks were encountered after a certain depth.

Diabase, also called Dolerite, is a fine- to medium-grained, dark gray to black intrusive igneous rock. It is extremely hard and tough and compositionally equivalent to gabbro and basalt but is texturally between them. It occurs mostly in shallow intrusions (dikes and sills) of basaltic composition. It grades to basalt when it solidifies rapidly and to gabbro when more time is provided for the crystals to grow.
