## 40 Years of Full-Scale Infrastructure Testing at a National Geotechnical Experimentation Site: Sand Site.

**Jean-Louis Briaud**, Distinguished Professor, Zachry Dpt. of Civil Engineering, Texas A&M University, College Station, Texas, 77834-3136, U.S.A.; email: [briaud@tamu.edu](mailto:briaud@tamu.edu)

**ABSTRACT:** A site at the Texas A&M University RELIS campus near College Station, Texas, was dedicated to full-scale infrastructure testing in 1978. It was designated as a National Geotechnical Experimentation Site by NSF and FHWA in 1992. The site is made of 15 m of medium dense silty sand, within which most experiments took place, underlain by a deep layer of clay shale. The water table is approximately 7.5 m deep. Over the last 40 years, many full-scale instrumented experiments on infrastructure elements have been conducted at that site. The main projects include a box culvert within an embankment, spread footings of various sizes, drilled shafts with intentional construction defects, an anchored top down retaining wall, a top down deep-soil-mixing retaining wall, post grouted drilled shafts, vibro-driven steel piles, a drilled shaft embedded in an MSE wall and pushing on it

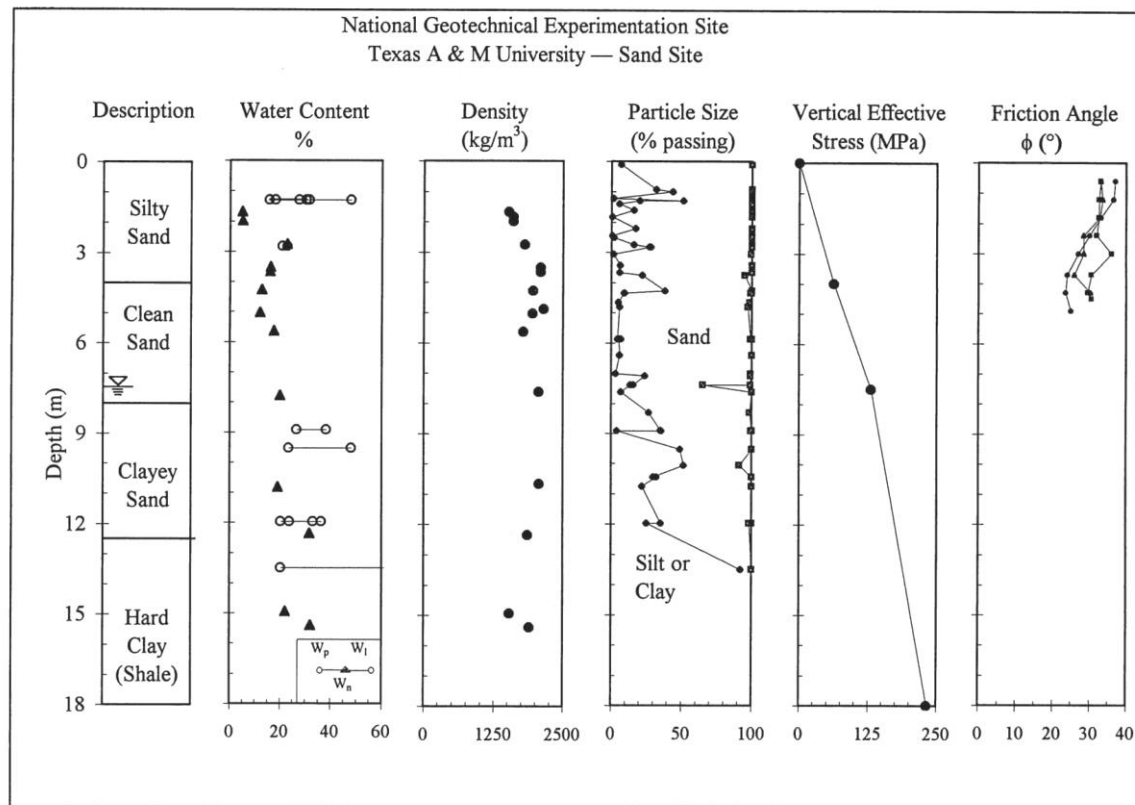
Figure 2. Laboratory test results (Briaud, 1997).

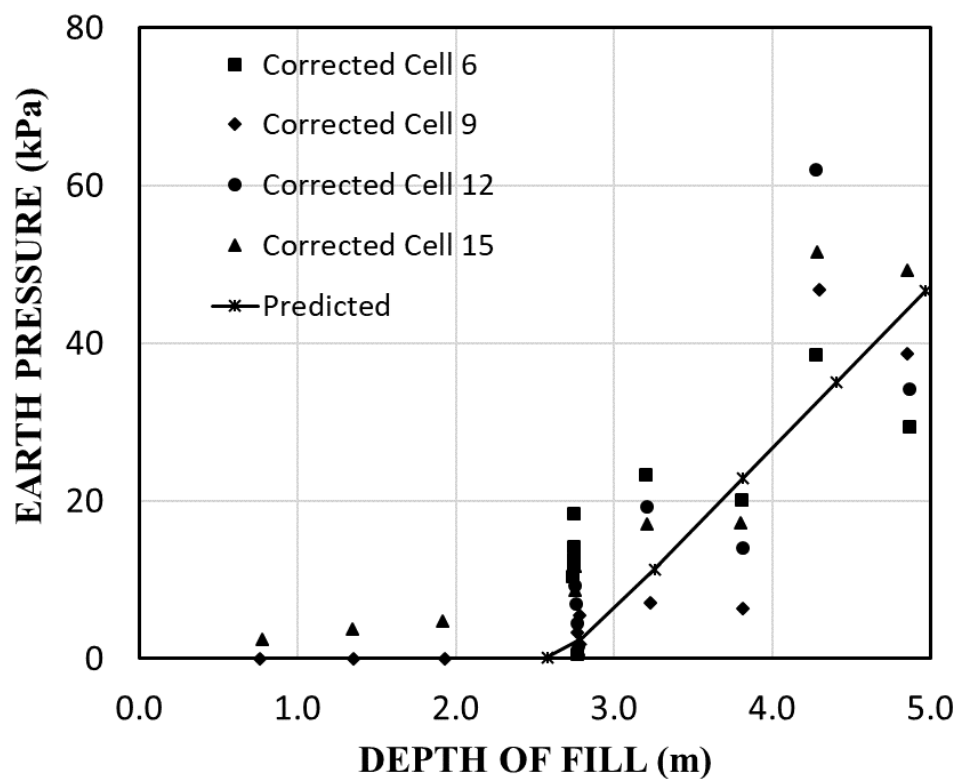
Figure 6. Pressure cell readings as a function of the fill height (after James et al., 1986).

The pressure on the top of the culvert, given by the pressure cells, increased as the fill increased in height (Fig. 6). As can be seen, the scatter is not negligible but the trend matches the total vertical stress  $\sigma$  expressed as  $\gamma z$  where  $\gamma$  is the soil total unit weight of 20 kN/m<sup>3</sup> and  $z$  is the depth of fill. This depth of fill refers to the thickness of the fill; it was zero when the fill level is near the bottom of the culvert, thus the pressure cells on top of the culvert only started to record pressure when the fill reached the top of the culvert. The pressure cell readings as the rear axle of the truck passed on top of the cells and for different depth of cover are shown in Fig. 7. Remember that the tire pressure was of the order of 550 kPa, yet the pressures on the cells placed on the roof of the culvert were much smaller than 550 kPa. In fact, they seemed to obey the stress distribution that one would have obtained from a bulb of pressure elastic approach (Briaud, 2013).

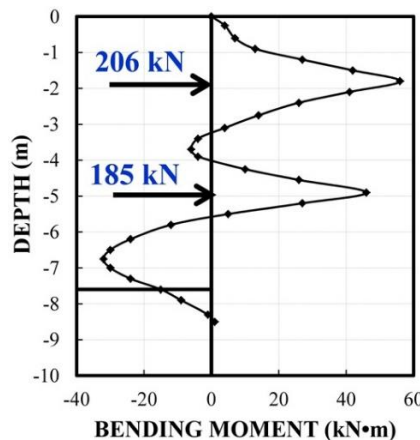
Figure 19. Wall bending moment profile at end of construction for two rows of anchors (after Chung, Briaud, 1992).

Figs. 18, 19, and 20 show the average results for the section of the wall with two rows of anchors. Fig. 18 shows the horizontal deflection profile at the end of construction, Fig. 19 shows the bending moment profile, and Fig. 20 depicts the vertical load in the soldier piles. The same results are shown for the section of the wall with the one row of anchors in Figs. 21, 22, and 23. One of the many lessons learned from this project was that to limit the horizontal deflection of a tieback wall, the wall must have good vertical capacity. Indeed, such walls are subjected to significant downdrag from the retained mass (Figs. 20, 23), which is likely to induce settlement of the facing. This settlement generates rotation around the back of the anchors and an associated horizontal movement even if the anchors properly resist the horizontal load. Another outcome was the development of P-y curves, which do well in predicting the bending moment distribution in the soldier piles. The P-y curve approach was unable to accurately predict the deflection; only the finite element method could accomplish a good fit.

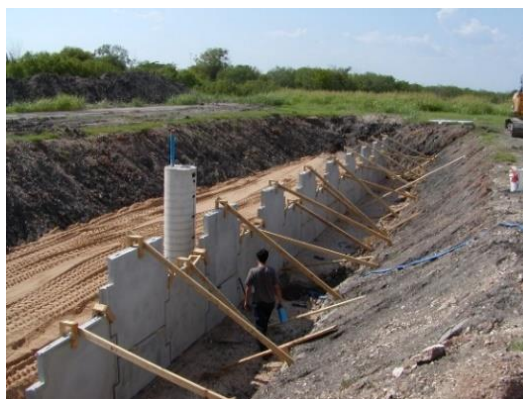
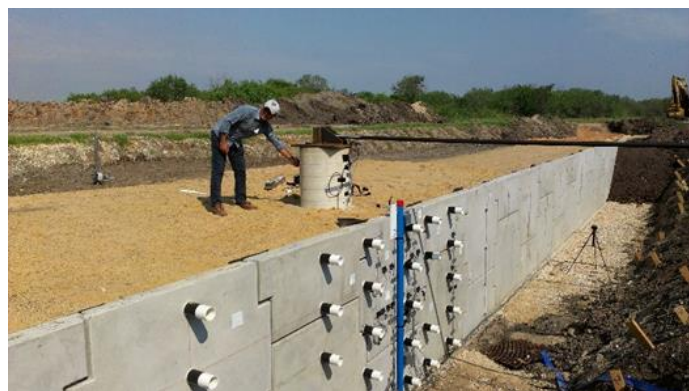
Figure 30. Construction of the MSE wall.

A 2.3 m high instrumented MSE wall was constructed and a 0.6 m diameter drilled shaft was placed behind the facing of the wall, with a clear spacing between the drilled shaft and the panel of the wall equal to 0.6 m (Figs. 30 and 31). The 5.5m long

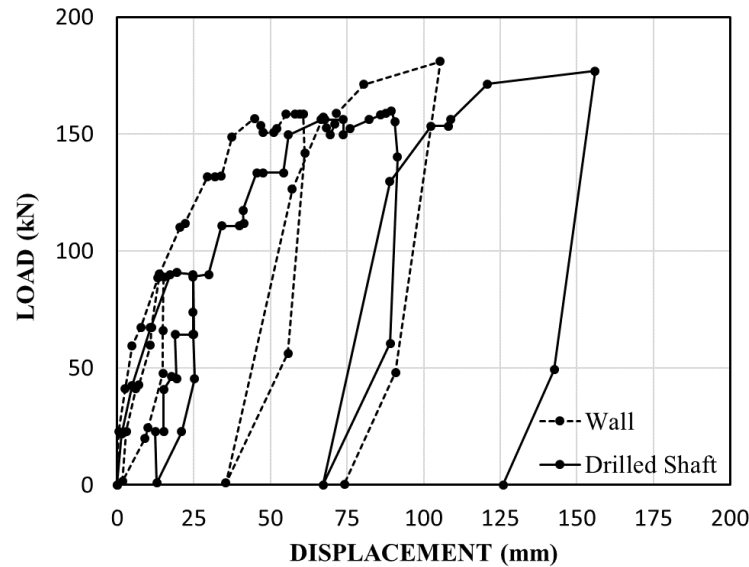
Figure 32. Measured load vs. displacement results for the drilled shaft and for the wall.

The data collected included the measurement of the horizontal load, the horizontal movement of the drilled shaft, the horizontal movement of the wall in front of the drilled shaft, and the pressure on the wall in front of the drilled shaft and on the drilled shaft. In addition, numerical simulations were conducted using FLAC 3D. All components of the MSE wall-drilled shaft system were simulated. The simulations were first calibrated against the full-scale experiment. A parametric study was then performed to identify the influence of each parameter on the MSE wall reinforcement. The load on the drilled shaft vs. the horizontal displacement of the drilled shaft, as well as the load on the drilled shaft vs. the horizontal displacement of the wall in front of the drilled shaft, are shown in Fig. 32.
