Appendix A.24:

St. Teresa's School – VsVp 57191

Liquefaction Ejecta Case Histories for 2010-11 Canterbury Earthquakes

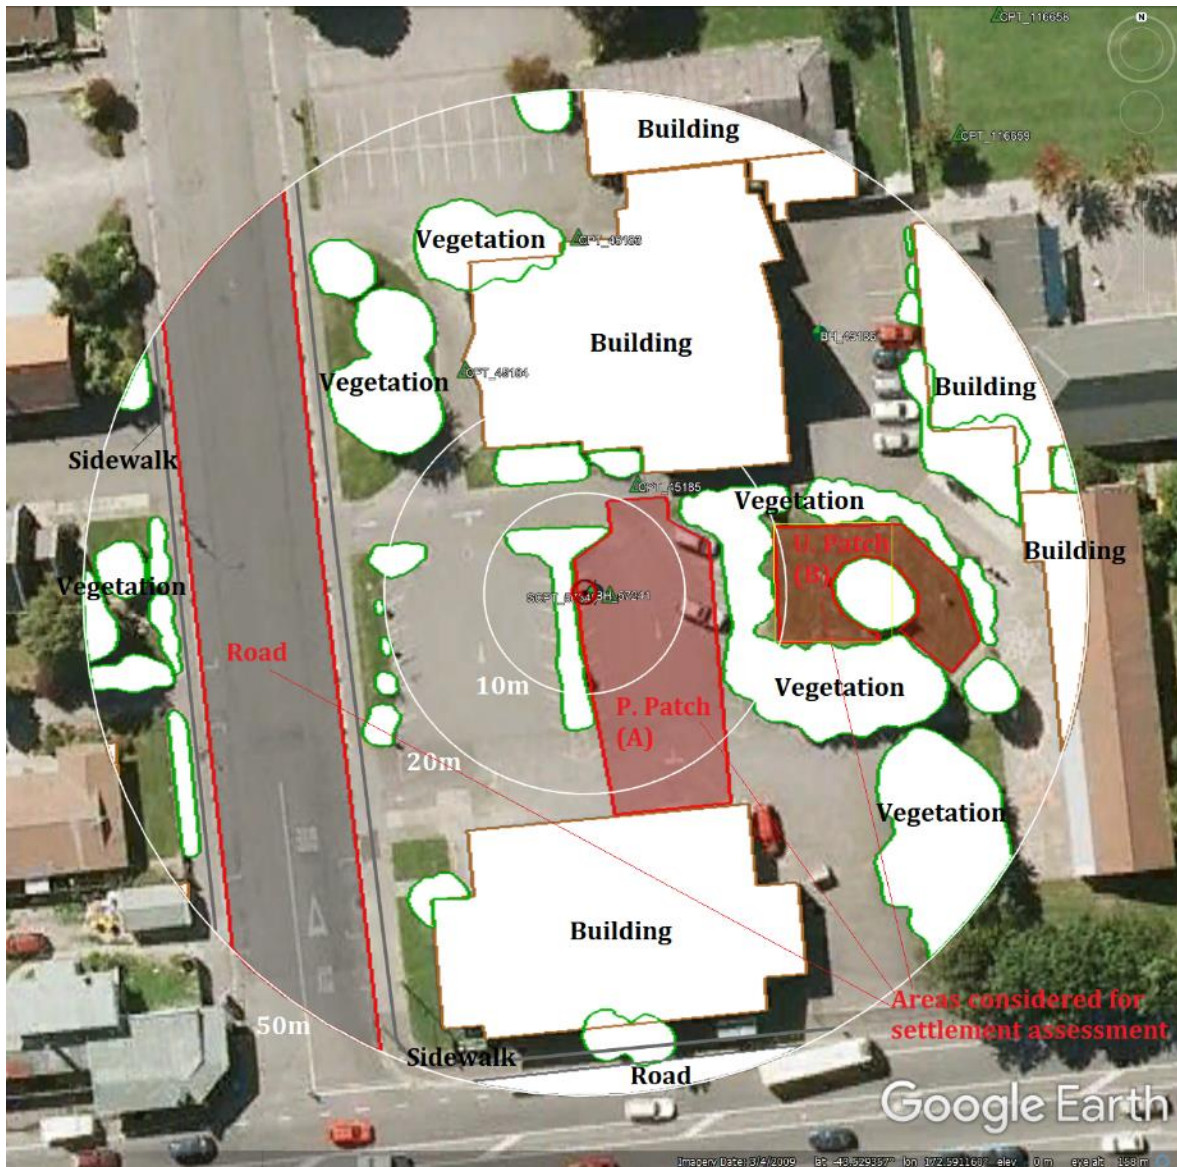
Figure 1: Site plan with areas where ejecta-induced settlement is considered.

Note 1: Two patches and the road (outlined in red) in the free field were selected for settlement assessment as areas free of vegetation and structures. Other important factors considered in the patch selection process were its proximity to a CPT, to a property subjected to addition and/or demolition of a structure, front yard/backyard alterations (e.g., ploughing, rubble, scrap), and aerial distribution of sediment ejecta. However, the LiDAR-based settlement analyses were not conducted for any earthquake event due to the evident absence of ejecta from Patches A and B and Road.

- $A_{E,thick,i}$ and $H_{E,thick,i}$ are the area and the height of a thick ejecta layer, respectively;
- $A_{E,thin,j}$ and $H_{E,thin,j}$ are the area and the height of a thin ejecta layer, respectively;
- A_T is the total assessment area for a buffer being considered (Figure 1).

Note 6: The selection of CPTs for the area considered for settlement assessment (Figure 1) is based on the proximity of the CPTs to the considered areas. In accordance with that, the following table shows CPTs that were used for the volumetric settlement analysis in *Cliq v.3.0.3.2*, a CPT soil liquefaction software developed by GeoLogismiki. (The average volumetric settlements were reported in Table 8.)

Note 7: Based on the borehole log BH 57241 (Figure 1), the groundwater table is at a depth of 4.6 m below the ground surface. The soil profile consists of (1) sandy fine to coarse gravel, GW, the fill below asphalt, to a depth of 0.25 m, (2) silt, ML, to a depth of 10.4 m, (3) silty sand, SM, to a depth of 10.95 m, (4) fine to medium sand, SP, to a depth of 11.75 m, (5) silt, ML, to a depth of 14.35 m, (6) fine sand, SP, to a depth of 15.1 m, (7) silt, ML, to a depth of 15.65 m (the end of the borehole). All soil layers (except the fill) are the Yaldhurst members of the Springston formation. Trace organics are present nearly throughout the entire soil profile. The borehole log BH 45186 (Figure 1) lists the following soil profile layers: (1) silt to a 2.5-m depth, (2) sand to a 10.2-m depth, (3) gravel to a 14.7-m depth, (4) sand to a 16.5-m depth, (5) silt to a 17.4-m depth, and (6) gravel to a 30.5-m depth.

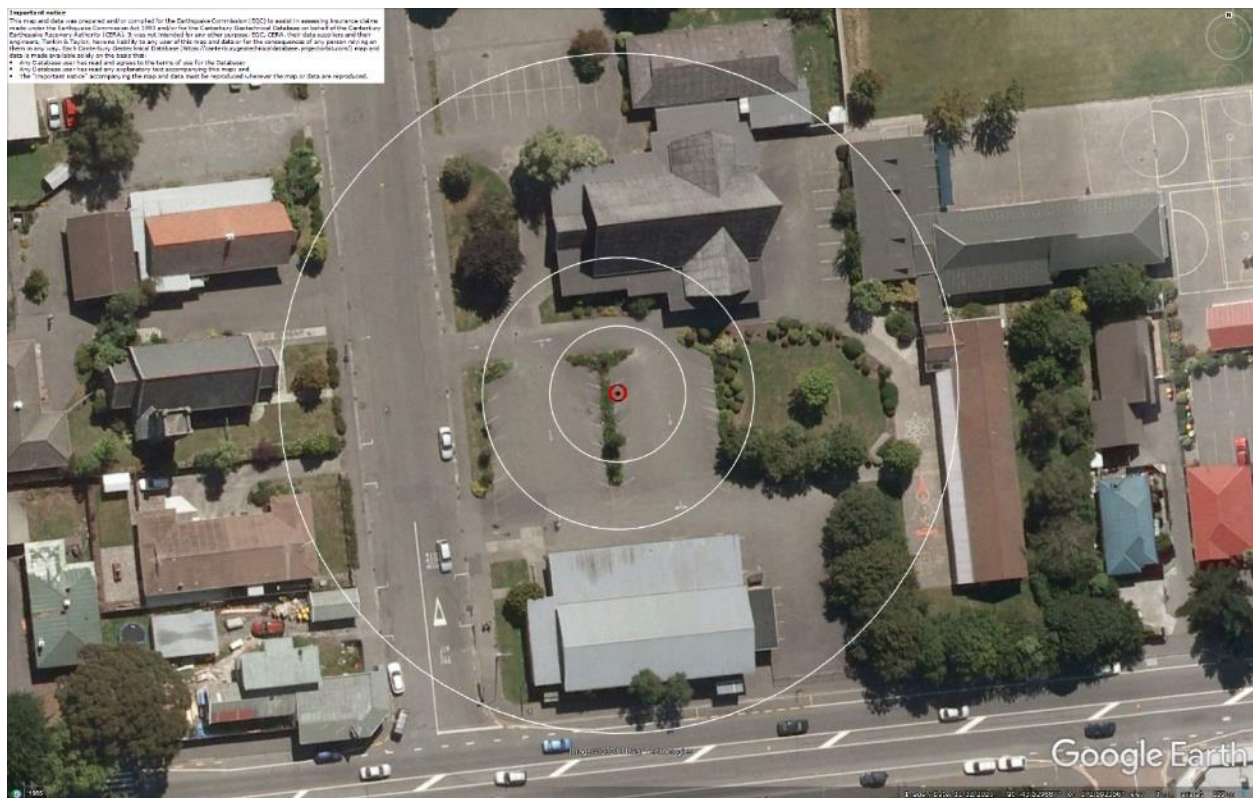
Figure 19: Aerial photograph of the site taken on Feb 24, 2011.

Note 3: The values in Table 9 are based on satellite and aerial photographs (Figures 8, 9, and 19 through 21) showing no ejecta at the site. There are no EQC LDAT property inspection reports. The ejecta-induced settlement using photographs and engineering judgment, $S_{E,P}$, is estimated as

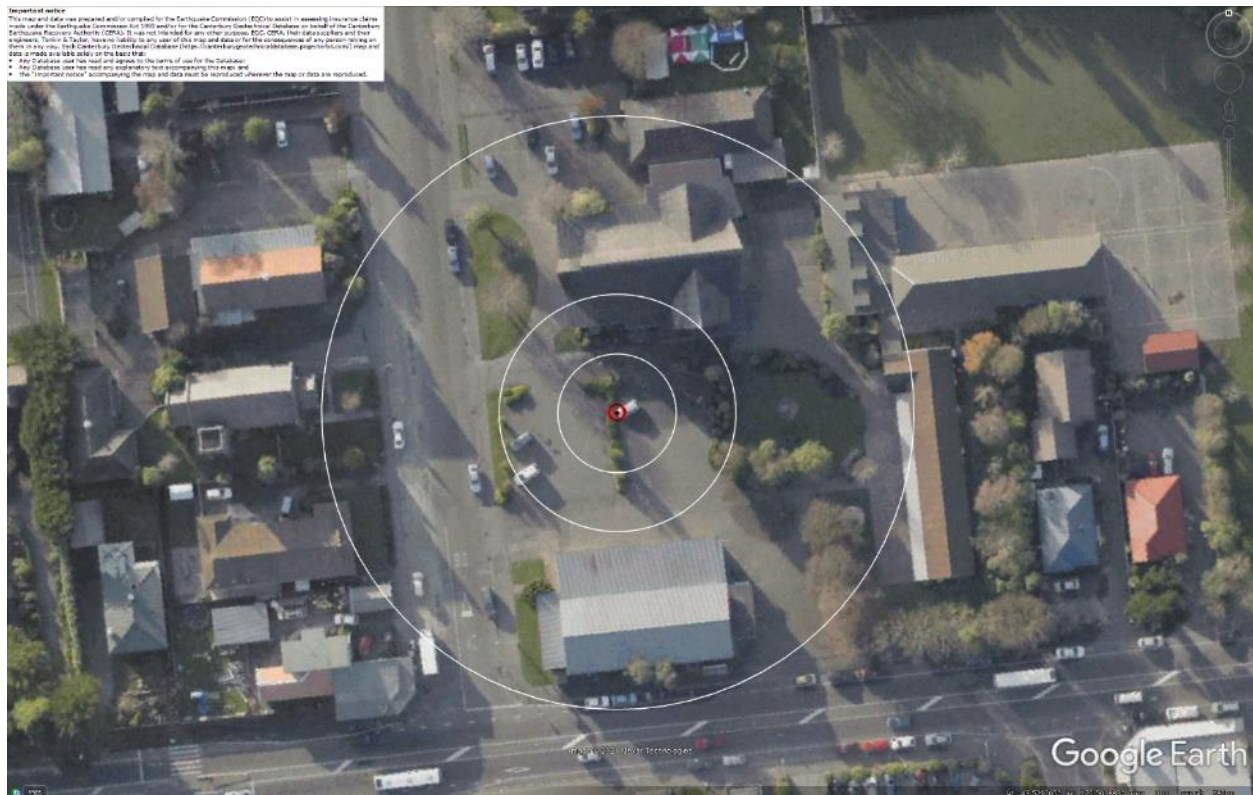
Figure 20: Aerial photograph of the site taken on June 14-15, 2011.

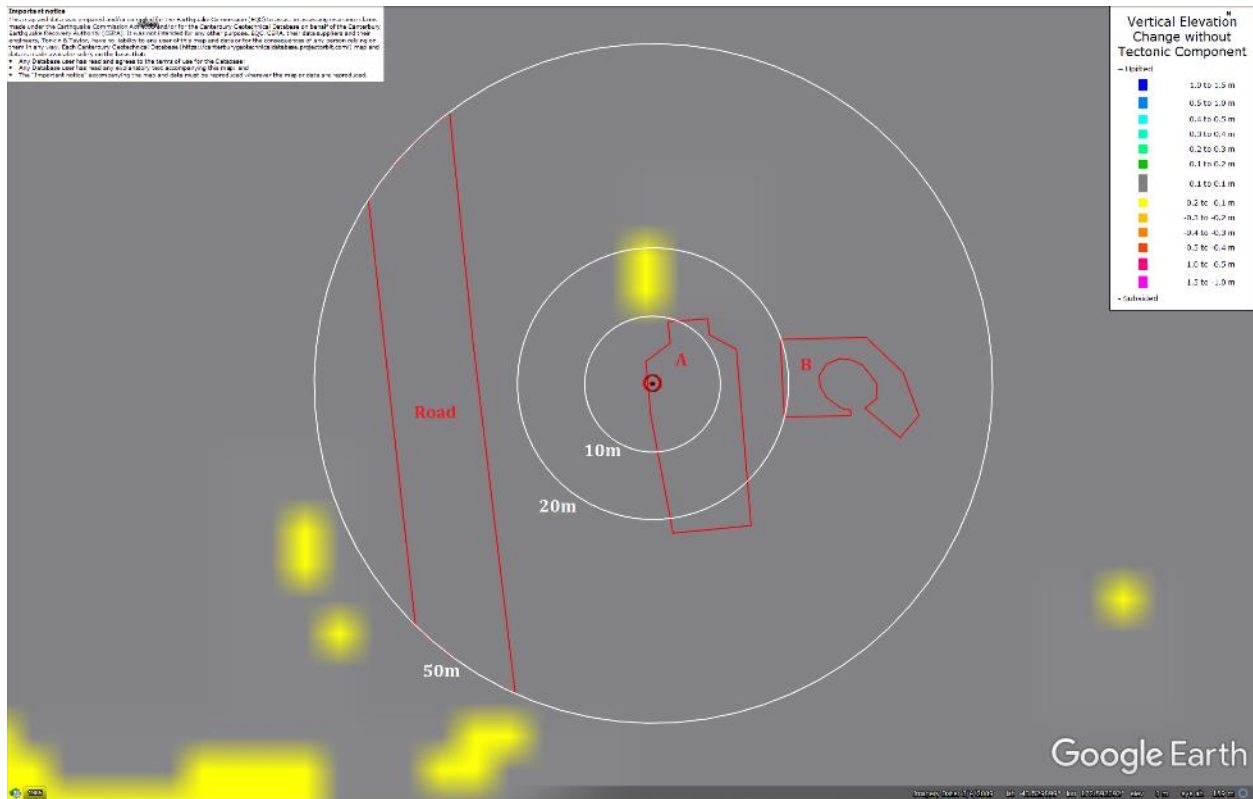
Figure 28: Ground surface subsidence without tectonic component for June 2011 Earthquake according to the LiDAR DEM.

Note 5: The LiDAR DEM ground surface subsidence without tectonic component is not available for the Sep 2010 and Feb 2011 Earthquakes.

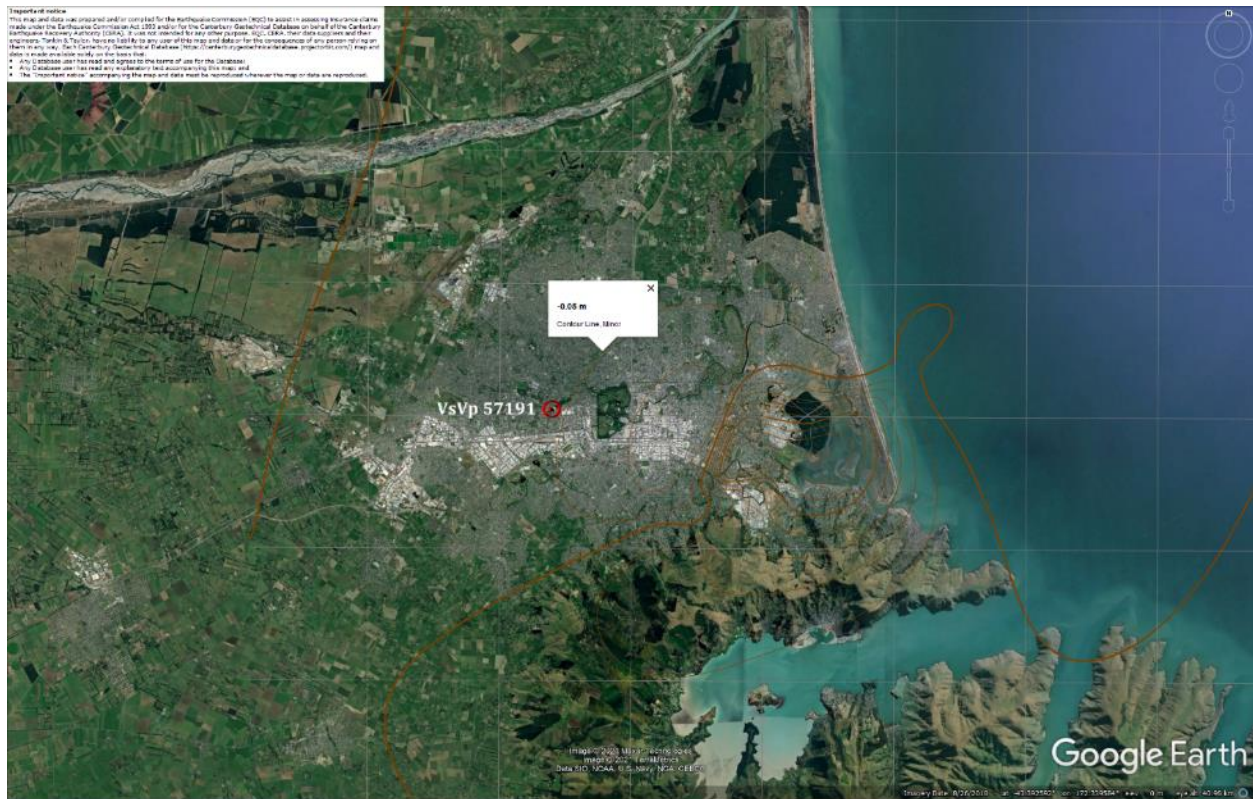
Figure 33: Vertical tectonic movements for Feb 2011 Earthquake.

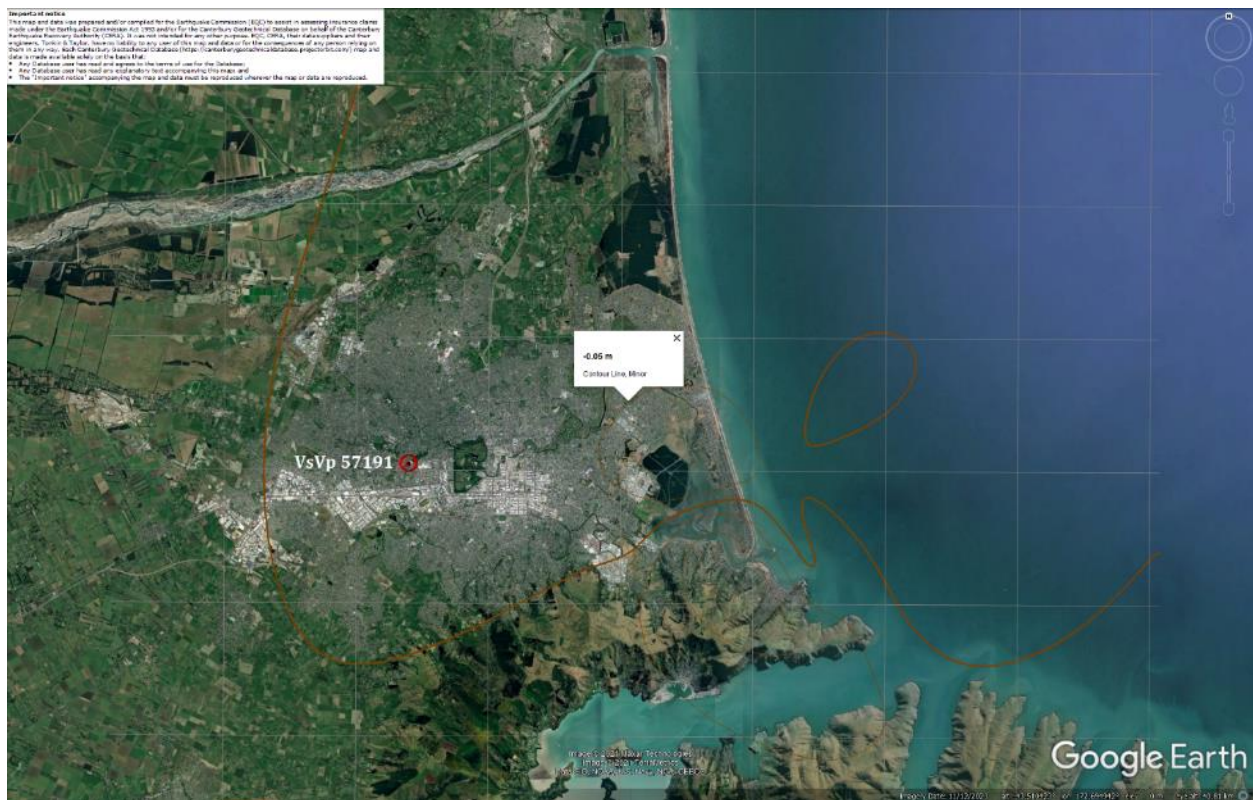
Figure 34: Vertical tectonic movements for June 2011 Earthquake.

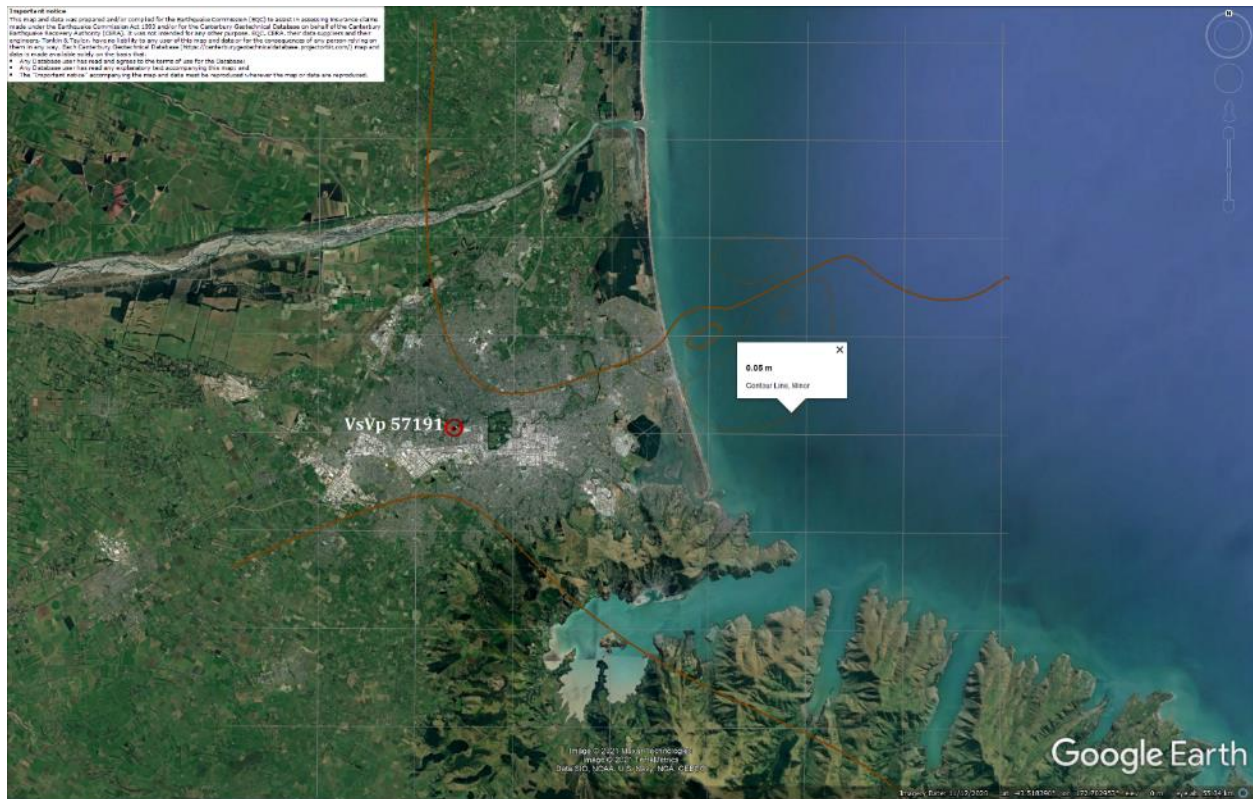
Figure 35: Vertical tectonic movements for Dec 2011 Earthquake.

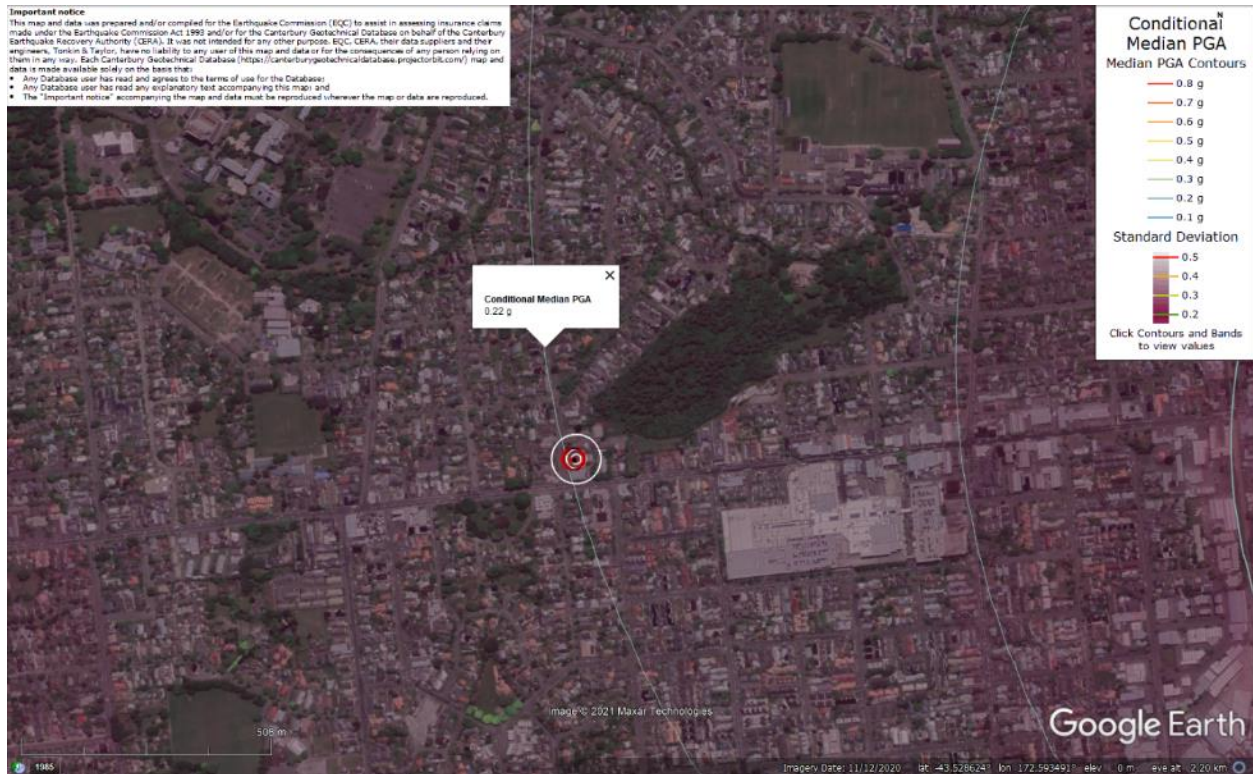
Figure 37: PGA for Sep-10 EQ (st. dev. = 0.325-0.350 ln units).

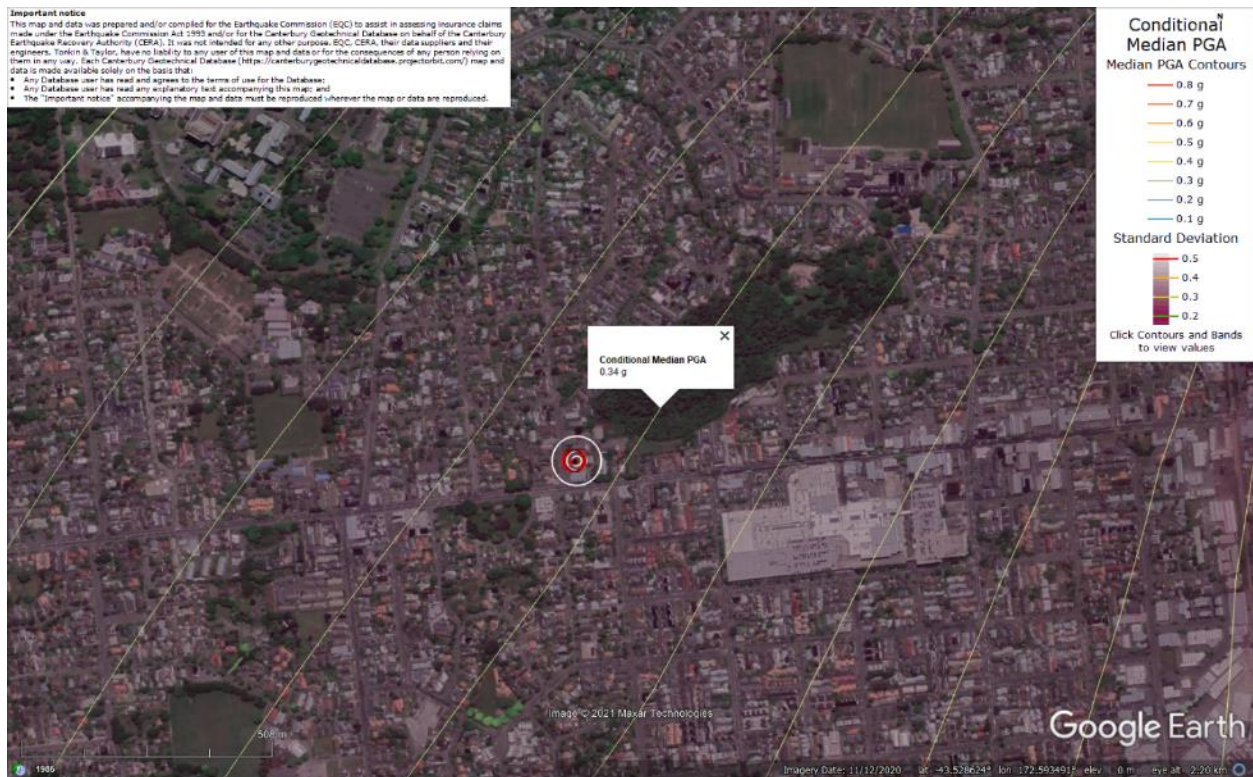
Figure 38: PGA for Feb-11 EQ (st. dev. = 0.350-0.375 ln units).
