Appendix A.31:

Mark Treffers Dr – CPT 62594

Table 1: Site Description for Mark Treffers Dr (CC LIQ 28 – CPT 62594).

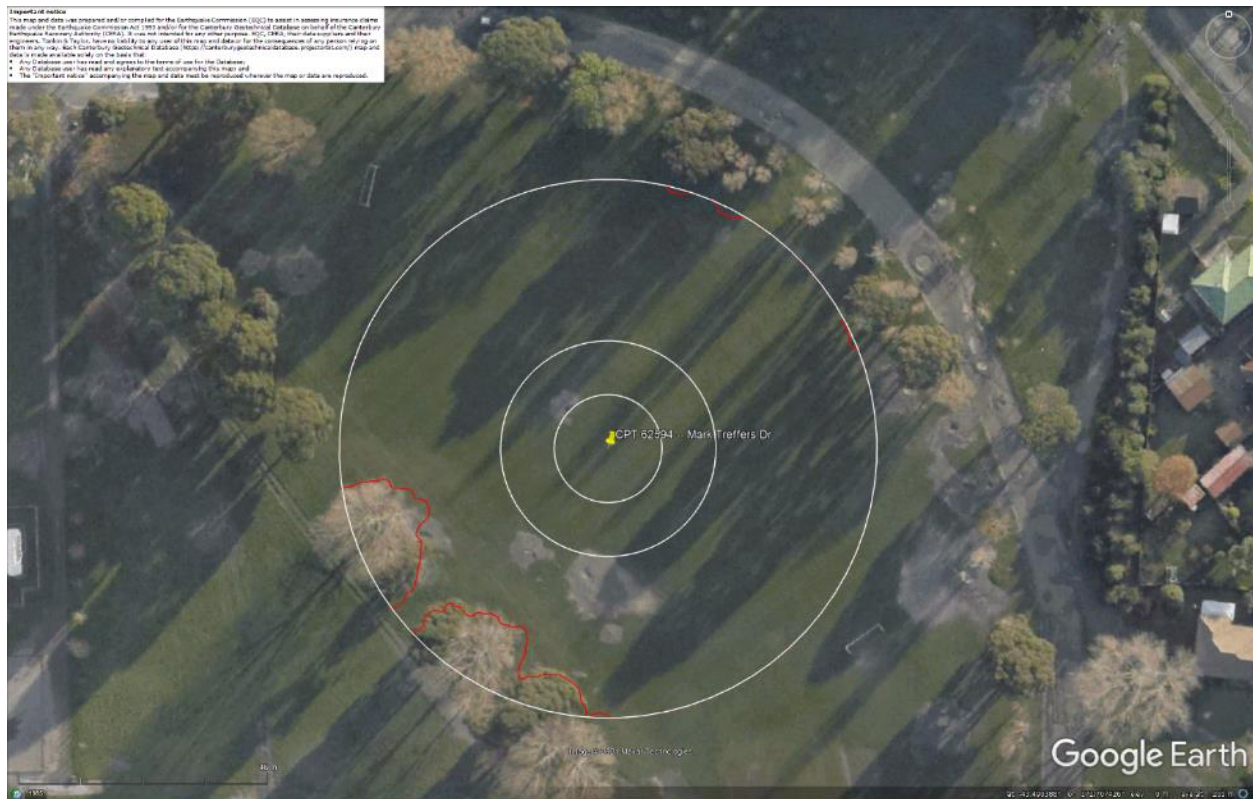
Figure 63: Aerial photograph acquired on 14-15 Jun 2011 showing ejecta at the site for Jun-11 EQ.

Note 4: The values in Table 9 correspond to the coverage area of ejecta outlined in aerial photographs (Figures 12, 13, 20, and 61-64) and the lower and upper estimates of ejecta height based on geometrical approximations. The ejecta-induced settlement using photographs and engineering judgment, $S_{E,P}$, is estimated as

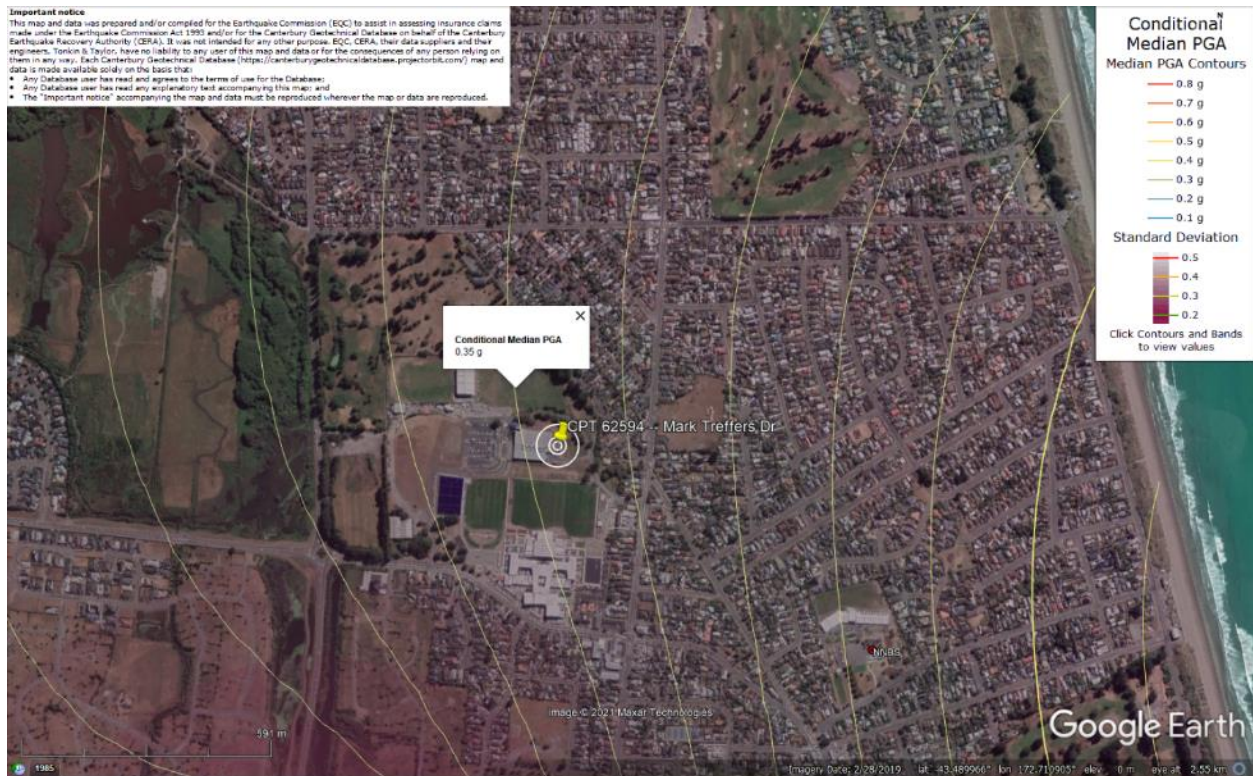
Figure 68: PGA for Dec-11 EQ (st. dev. = 0.375-0.400 ln units).
