Appendix A.38:

Rudds Rd – CPT 5687

Liquefaction Ejecta Case Histories for 2010-11 Canterbury Earthquakes

CC LIQ 67 – CPT 5687 (172.686716, -43.527755) – Rudds Rd

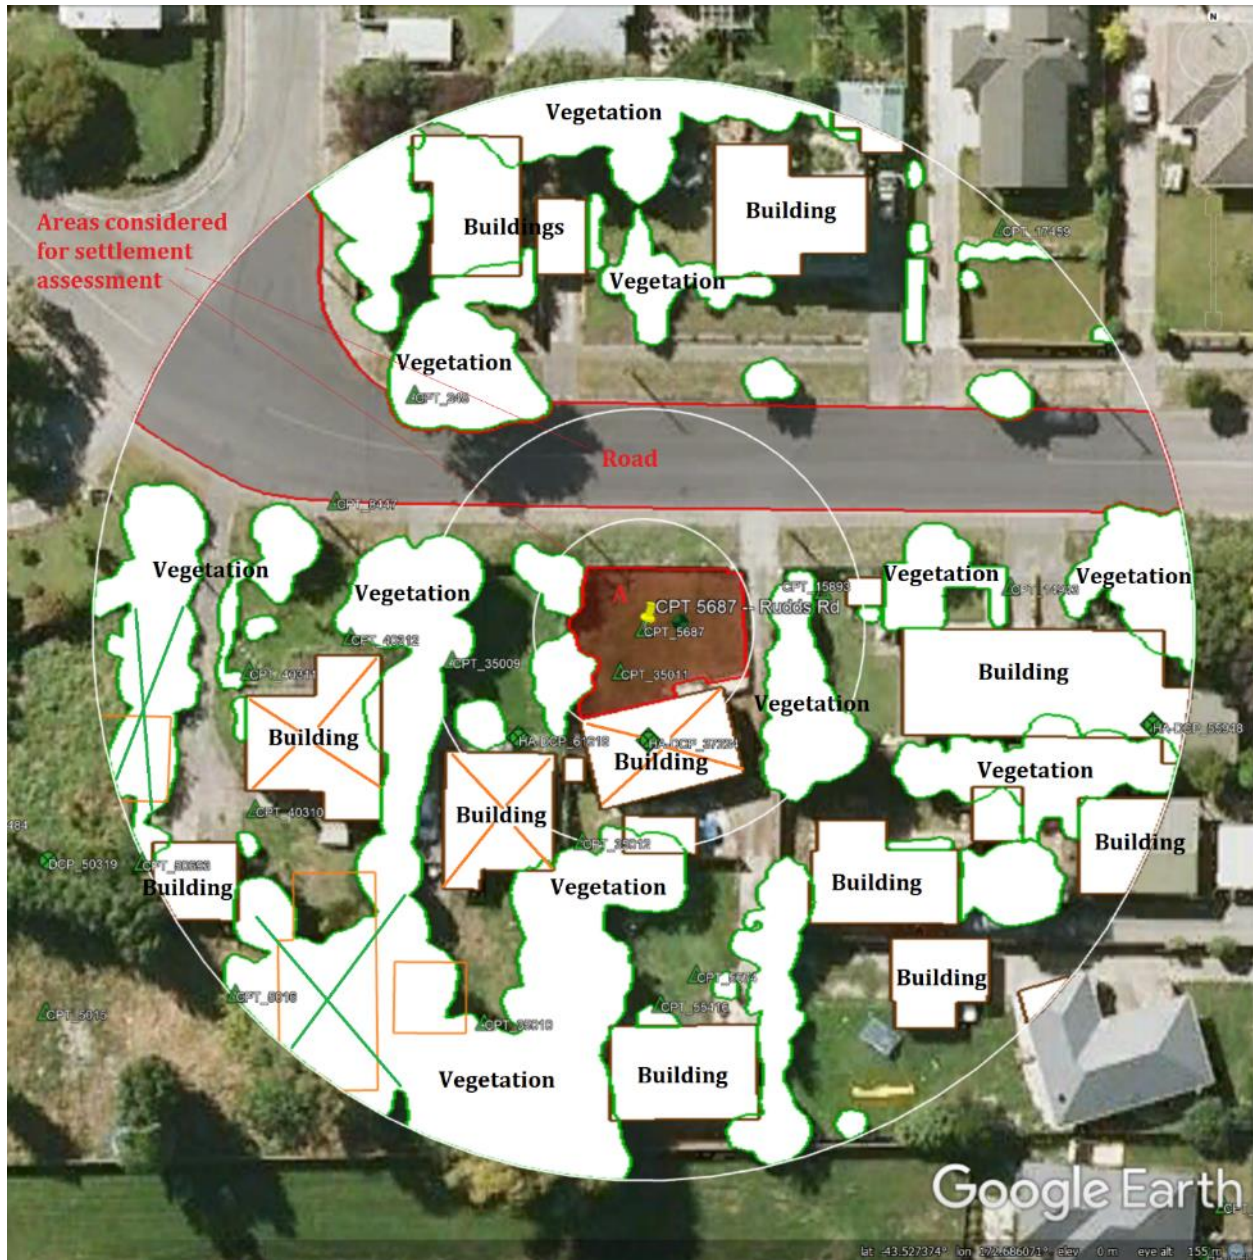
Figure 1: Site plan with areas where ejecta-induced settlement is considered.

Note 1: Patch A (outlined in red) in the free field was selected for settlement assessment as an area free of vegetation and structures. Other important factors considered in the patch selection process were its proximity to a CPT, a property subjected to addition and/or demolition of a structure, front yard/backyard alterations (e.g., ploughing, rubble, scrap), and aerial distribution of sediment ejecta. In addition, the entire portion of the road within the 50-m buffer was considered for settlement assessment. The LiDAR-based settlement analyses for Patch A were not performed for any EQ event due to the evident absence of ejecta for the Sep-10 and Dec-11 EQs and uncertainties explained in Table 2 for the Feb-11 and Jun-11 EQs. The LiDAR-based settlement analyses for Road were not performed because ejecta were not observed for the Sep-10 and Dec-11 EQs and only negligible ejecta were observed for the Feb-11 and Jun-11 EQs.

Note 3: The values in Table 9 correspond to the coverage area of ejecta outlined in aerial photographs (Figures 26, 28, 30, 46, and 47) and the lower and upper estimates of ejecta height based on geometrical approximations, ground photographs (Figure 48), and EQC LDAT property inspection reports (Figure 49). The ejecta-induced settlement using photographs and engineering judgment, $S_{E,P}$, is estimated as

- $A_{E,thin,j}$ and $H_{E,thin,j}$ are the area and the height of a thin ejecta layer, respectively;
- $W_{E,prism,n}$ and $L_{E,prism,n}$ are the width and the length of the coverage area of a prismatically shaped ejecta layer, respectively, and $H_{E,prism,n}$ is the height of a prism-like ejecta layer;
- $W_{E,pyr,p}$ and $L_{E,pyr,p}$ are the width and the length, respectively, of the coverage area of an ejecta layer shaped a triangular pyramid, and $H_{E,pyr,p}$ is the height of the pyramid-like ejecta layer;
- A_T is the total assessment area for a buffer being considered (Figure 1).

Note 5: The selection of CPTs for the area considered for settlement assessment (Figure 1) is based on the proximity of the CPTs to the considered areas. In accordance with that, the following table shows CPTs that were used for the volumetric settlement analysis in *Cliq v.3.0.3.2*, a CPT soil liquefaction software developed by GeoLogismiki. (The average volumetric settlements were reported in Table 8.)

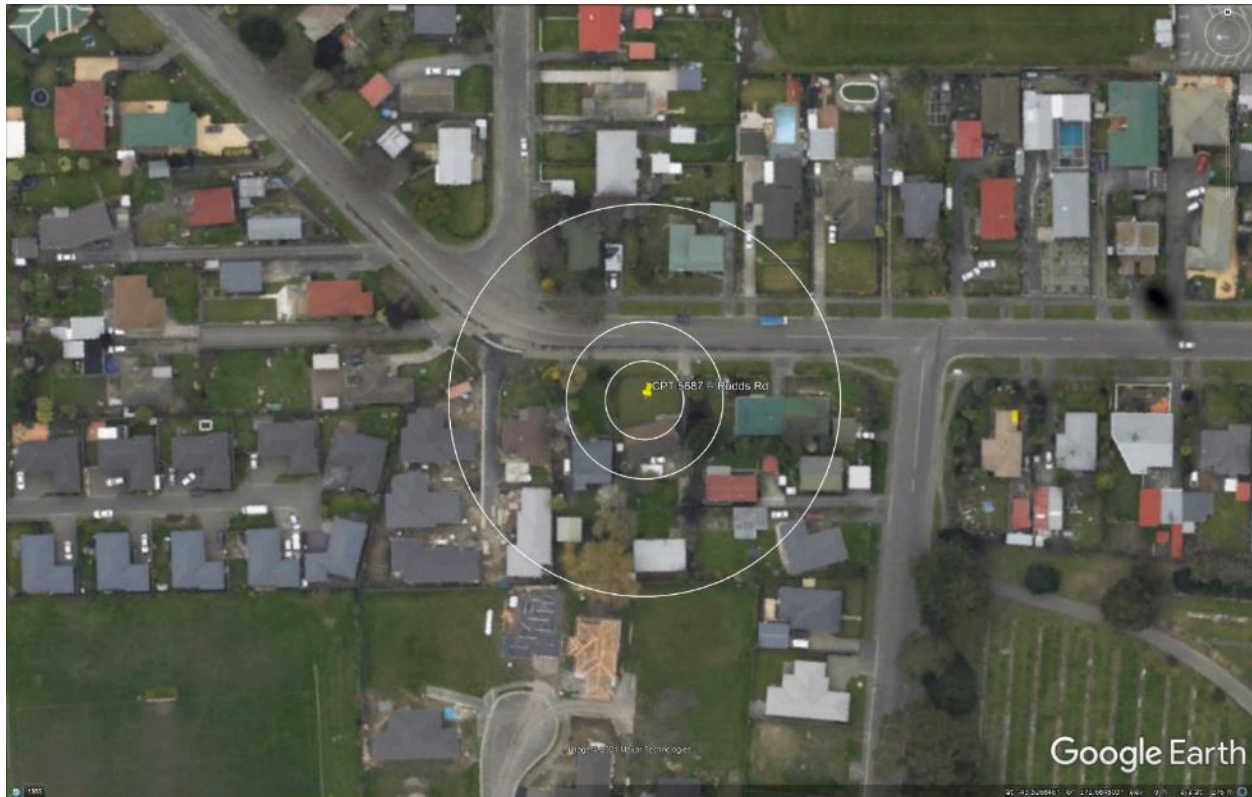
Figure 26: Aerial photograph of the site taken on Sep 4, 2010 (what appears to be a thin layer of ejecta on the road in the NW quadrant of the 50-m buffer is more likely soil that remained on the road after the building and driveway construction in the E portion of the 50-m buffer).

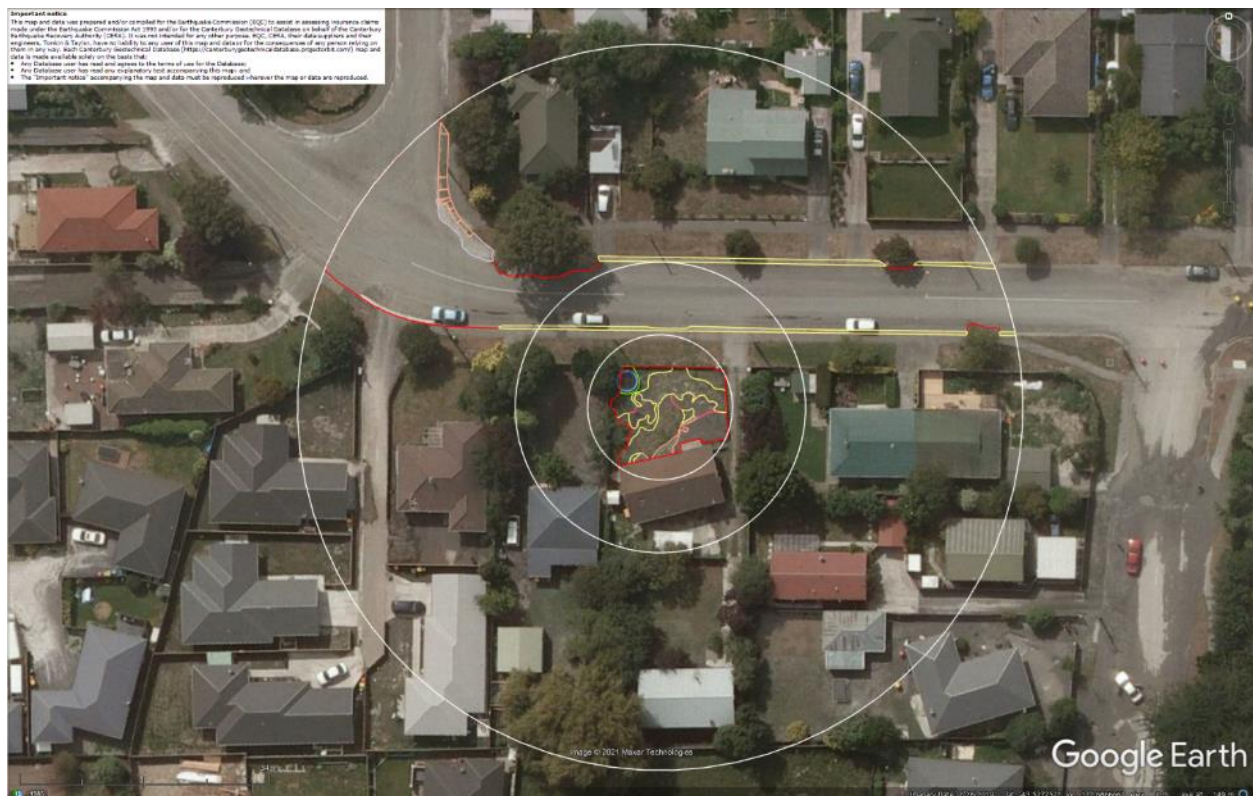
Figure 46: Aerial photograph showing the ejecta outline at the site for Feb-11 EQ.

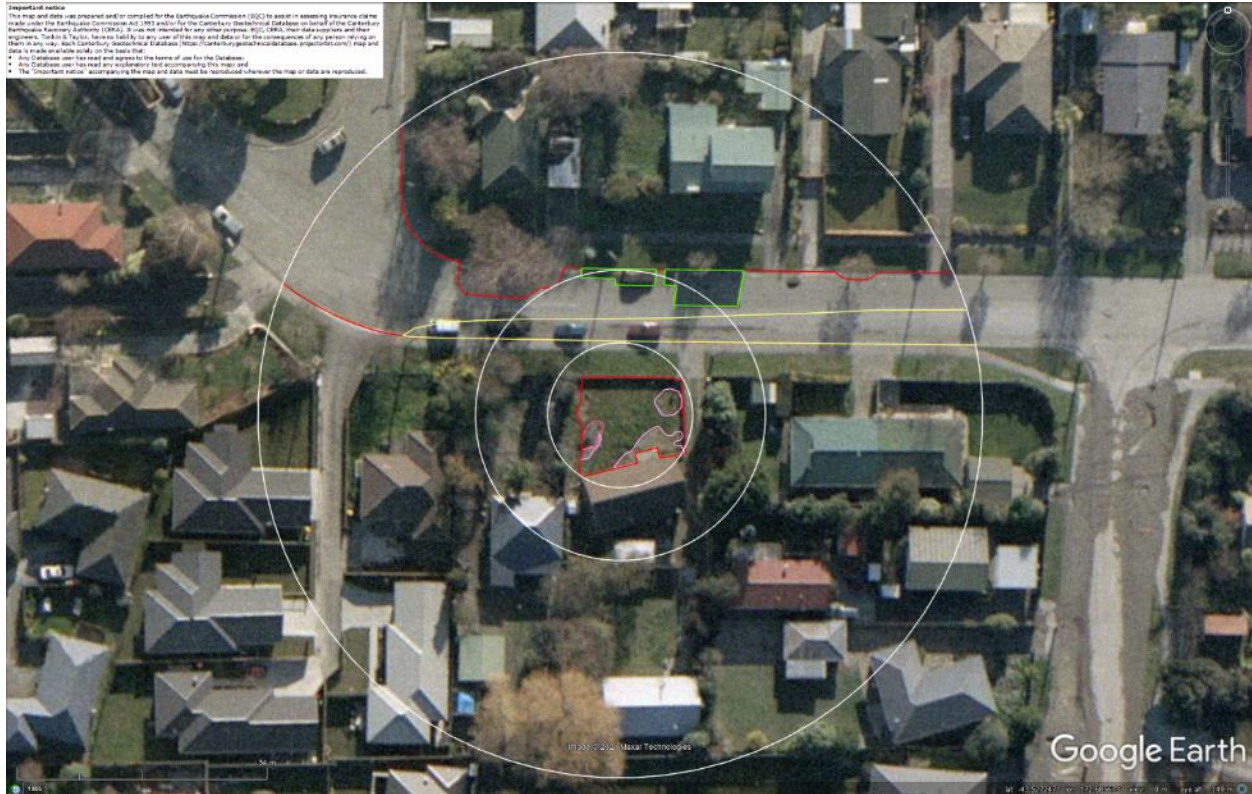
Figure 47: Aerial photograph acquired on 16 Jun 2011 showing the ejecta outline at the site for Jun-11 EQ.

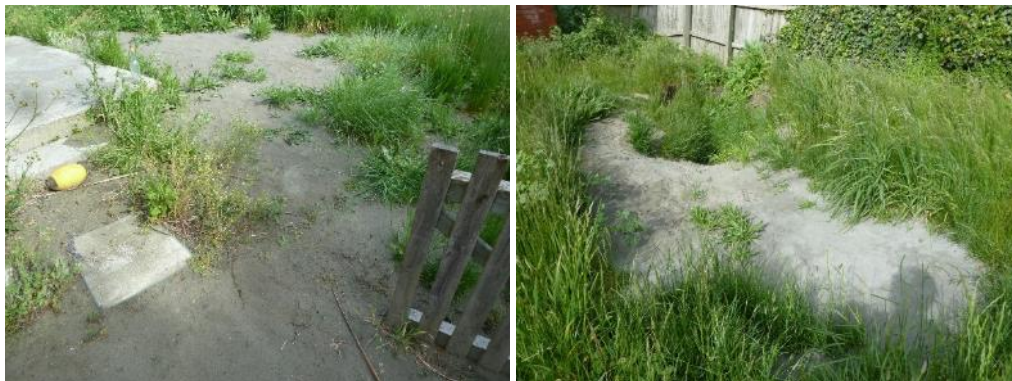
Figure 48: LDAT inspection notes for the property with Patch A (date: Nov 2011).

et al. 2014³). The LDAT property inspection report and ground photographs are available for Patch A. The ejecta height of 300 mm at one of the properties within the 50-m buffer was recorded at the time of the inspection (Nov 2011). There are no ground photographs of the road.
