Appendix A.46:

113A Palmers Rd – CPT 29740

Liquefaction Ejecta Case Histories for 2010-11 Canterbury Earthquakes

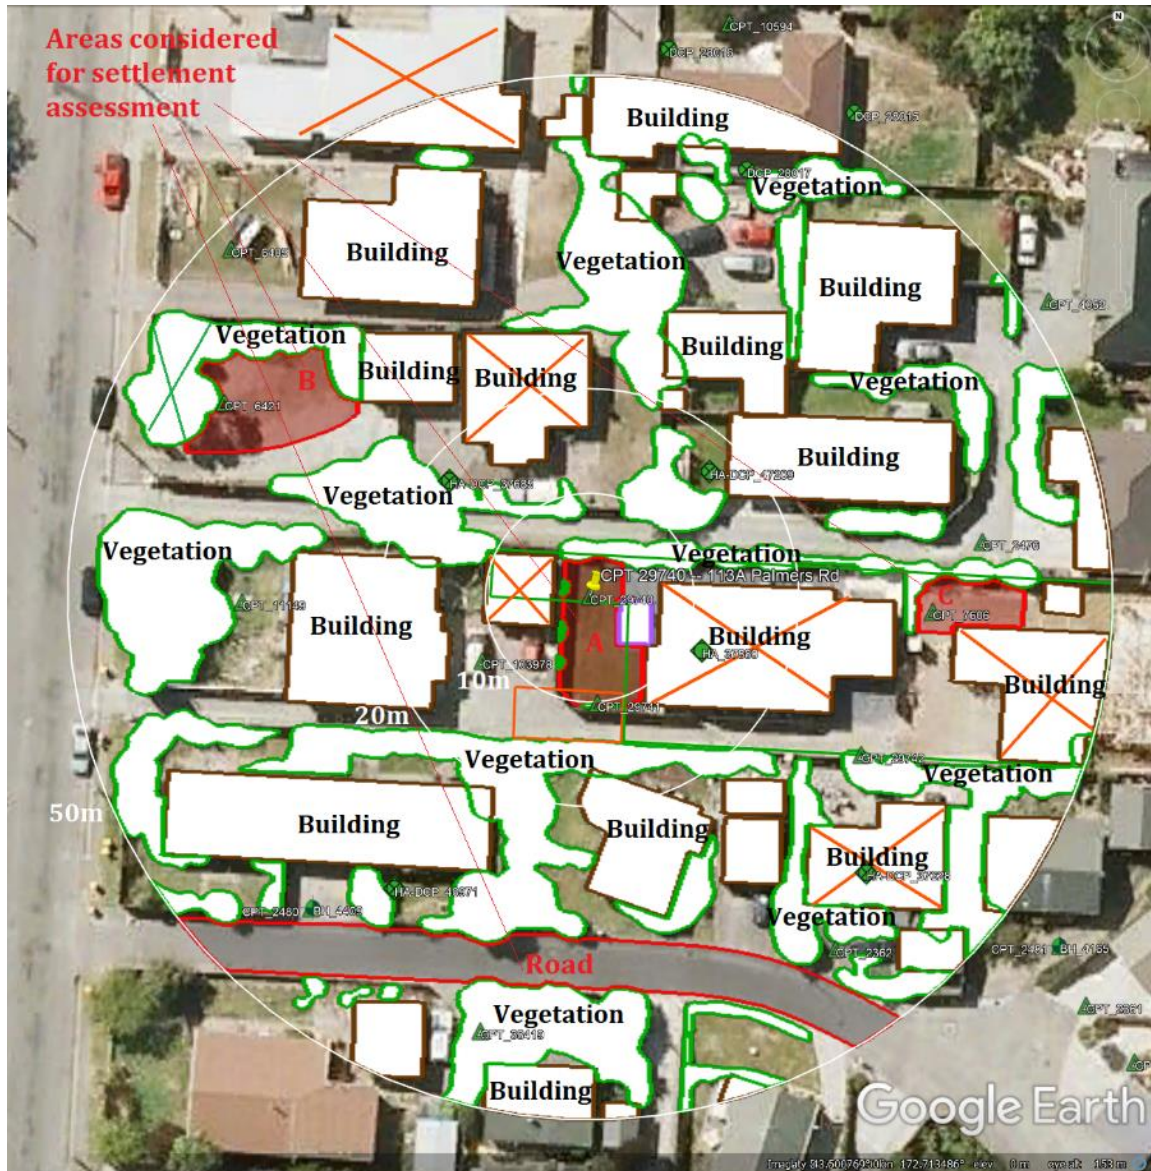
Figure 1: Site plan with areas where ejecta-induced settlement is considered.

Note 1: Patches A, B, and C (outlined in red) in the free field were selected for settlement assessment as areas free of vegetation and structures. Other important factors for the patch selection were the proximity of a patch to a CPT, a property subjected to addition and/or demolition of a structure, front yard/backyard alterations (e.g., ploughing, rubble, scrap), and aerial distribution of sediment ejecta. The entire portion of the road within the 50-m buffer was considered for settlement assessment. The LiDAR-based settlement analyses of Patch B were not performed for any earthquake event due to the evident absence of ejecta. The July 2003 LiDAR survey was not considered for the Sep-10 EQ due to the evident absence of ejecta from Patches A and C and Road (and the anthropogenic changes between the July 2003 and Sep 2010 LiDAR surveys within Patches A and C). Patch C was excluded from the settlement assessment following the June 2011 earthquake due to lateral spreading at the property, as reported by the LDAT inspection team. The Oct 2015 LiDAR survey was not considered for the Road.

Note 6: The selection of CPTs for the area considered for settlement assessment (Figure 1) is based on the proximity of the CPTs to the considered areas. In accordance with that, the following table shows CPTs that were used for the volumetric settlement analysis in *Cliq v.3.0.3.2*, a CPT soil liquefaction software developed by GeoLogismiki. (The average volumetric settlements were reported in Table 8.)

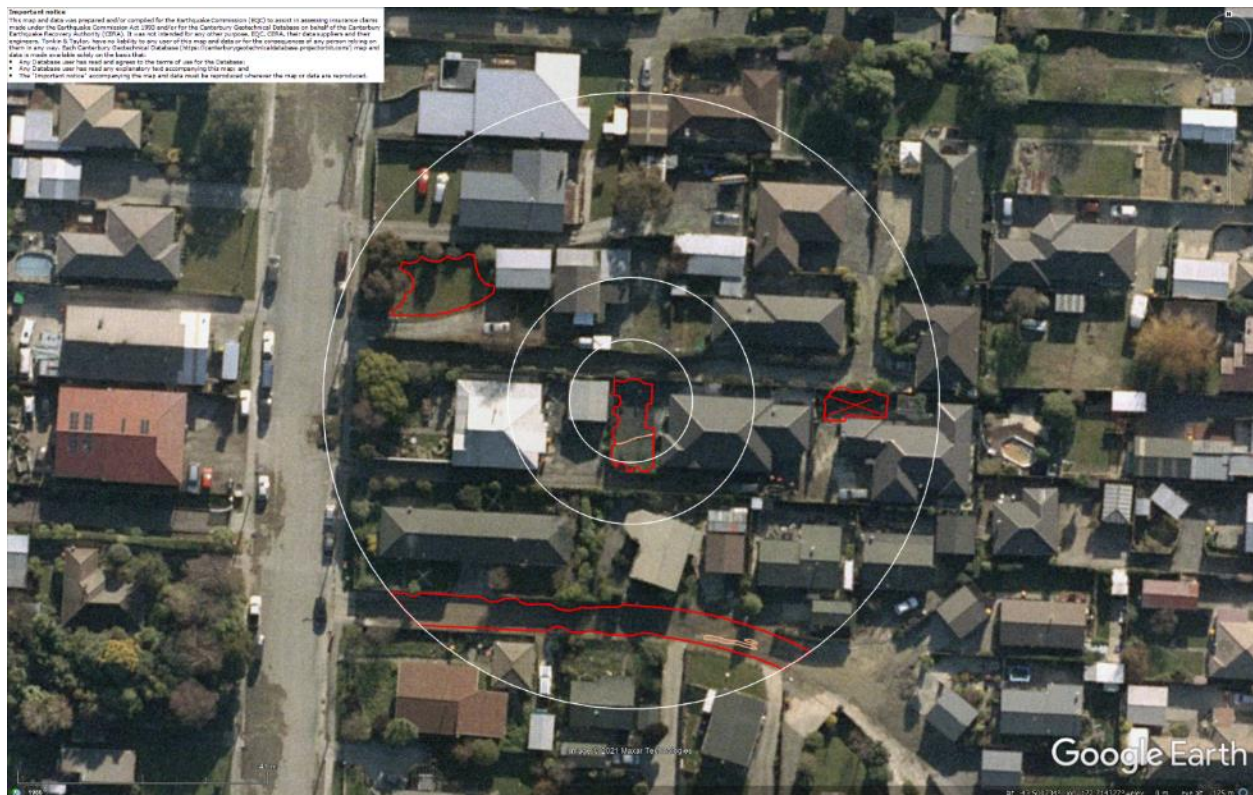
Figure 69: Aerial photograph acquired on 16 Jun 2011 showing the ejecta outline at the site for Jun-11 EQ.

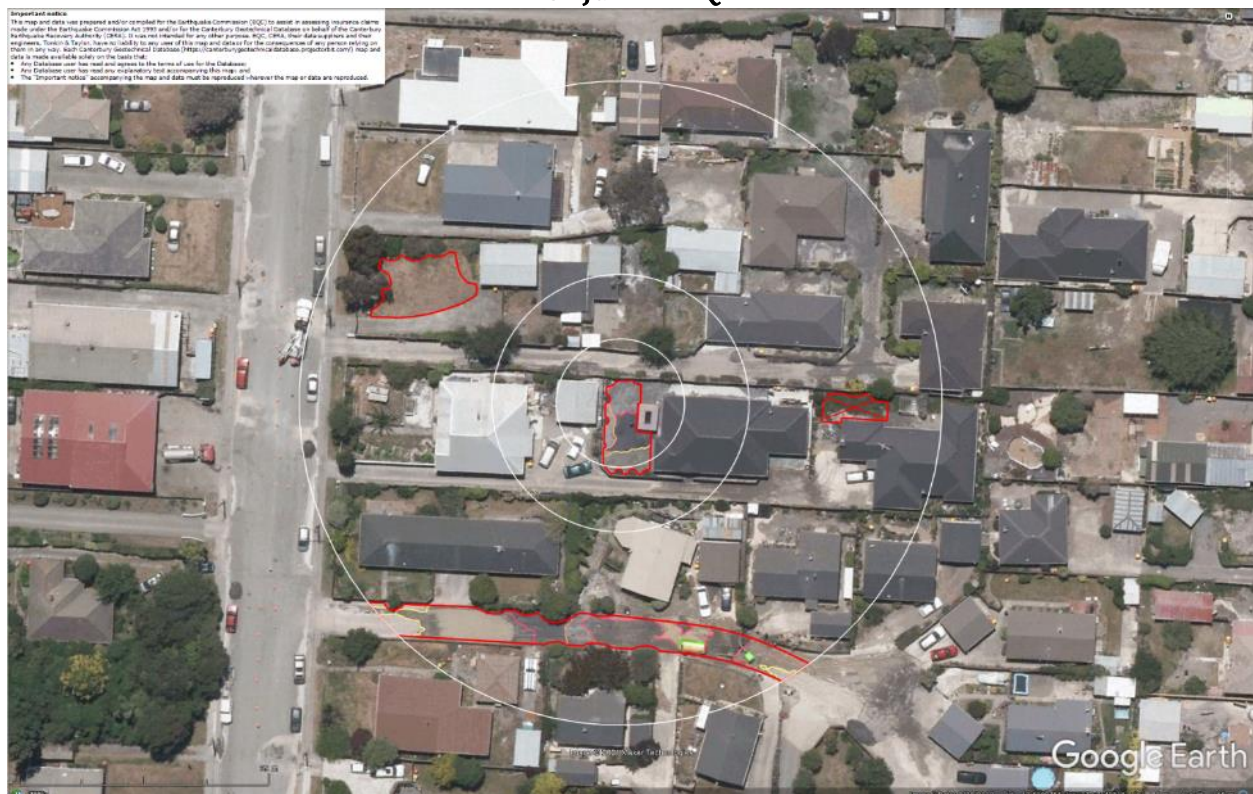
Figure 70: Aerial photograph showing the ejecta outline at the site for Dec-11 EQ.

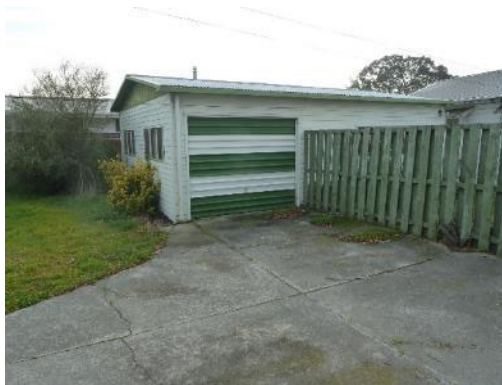
Figure 74: Ground photographs showing the property with Patch B and no ejecta within Patch B (photograph date: Nov 2011).

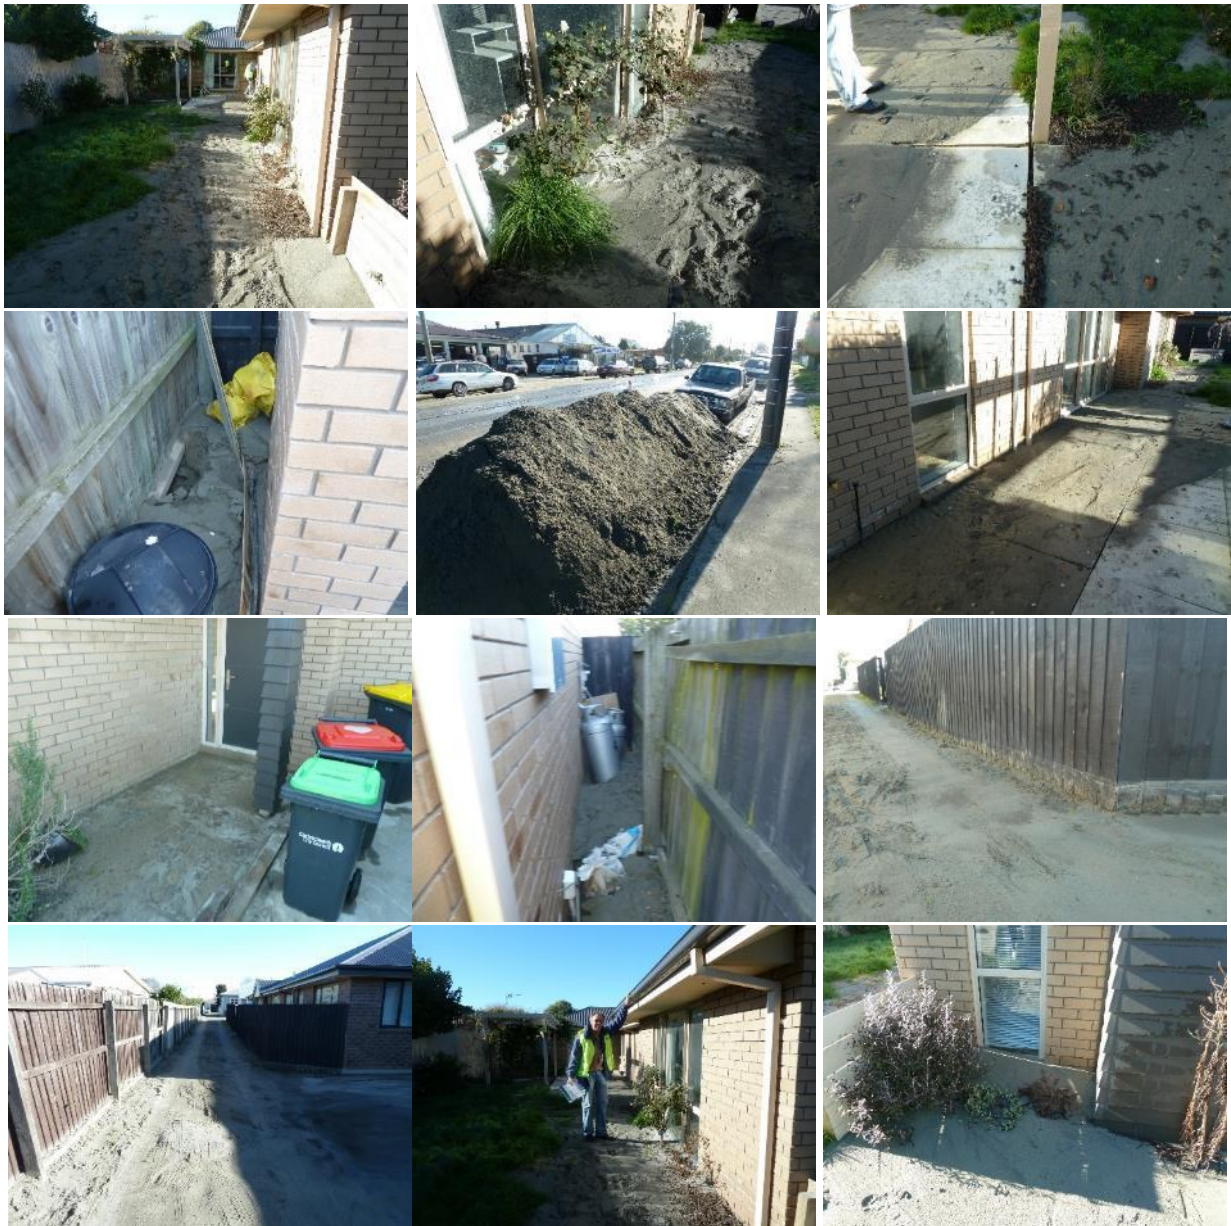
Figure 77: LDAT inspection notes for the property with Patch C (inspection date: July 2011). The Jun-11 EQ caused lateral spreading at the property. The width of the ground cracks exceeded 100 mm.

Figure 78: Ground photographs showing the property with Patch C and ejecta remnants within Patch C (photograph date: July 2011). The ground underwent lateral spreading.

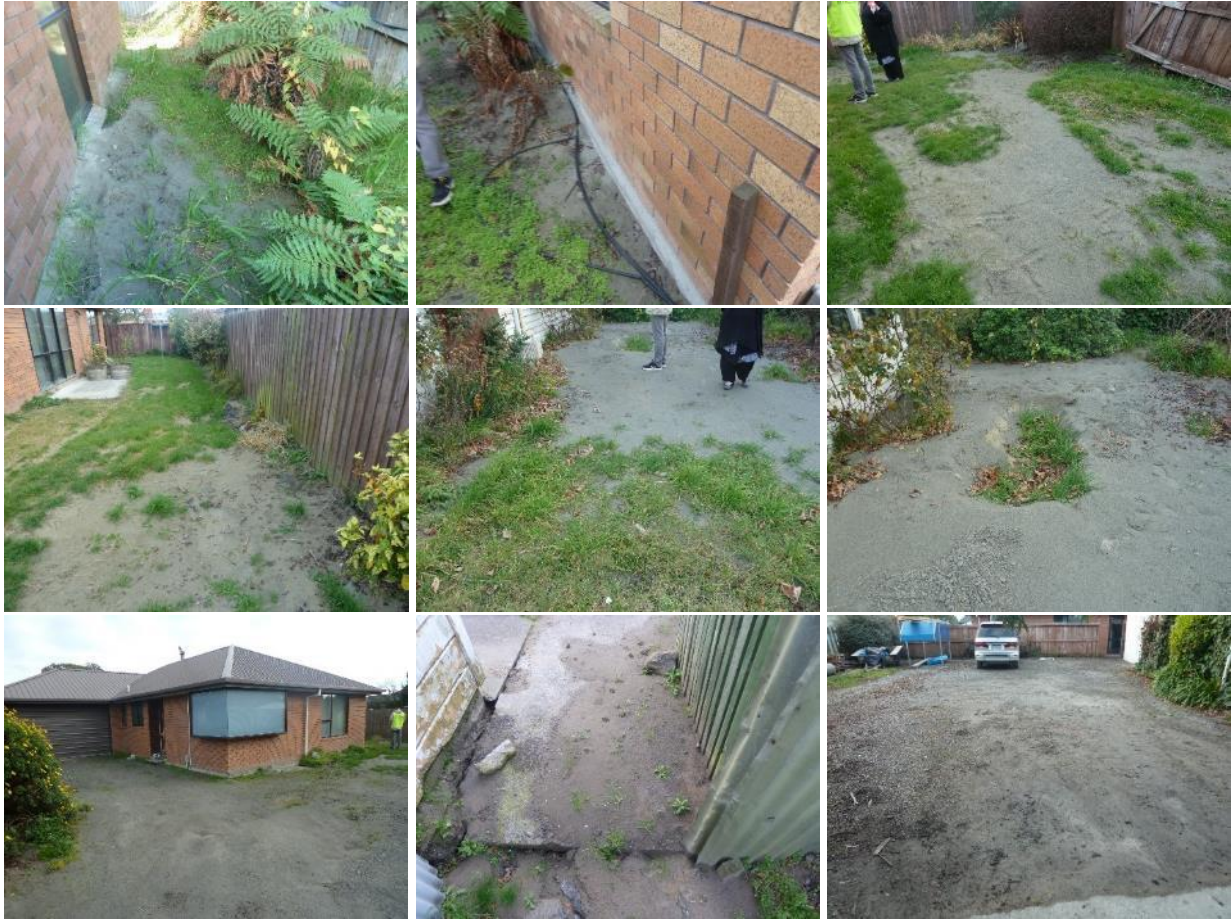
Figure 79: Ground photographs showing ejecta remnants at the properties within the 50-m buffer (photograph date: 9 June 2011).
