Appendix A.51:

Palinurus Rd 2 – CPT 62761

Liquefaction Ejecta Case Histories for 2010-11 Canterbury Earthquakes

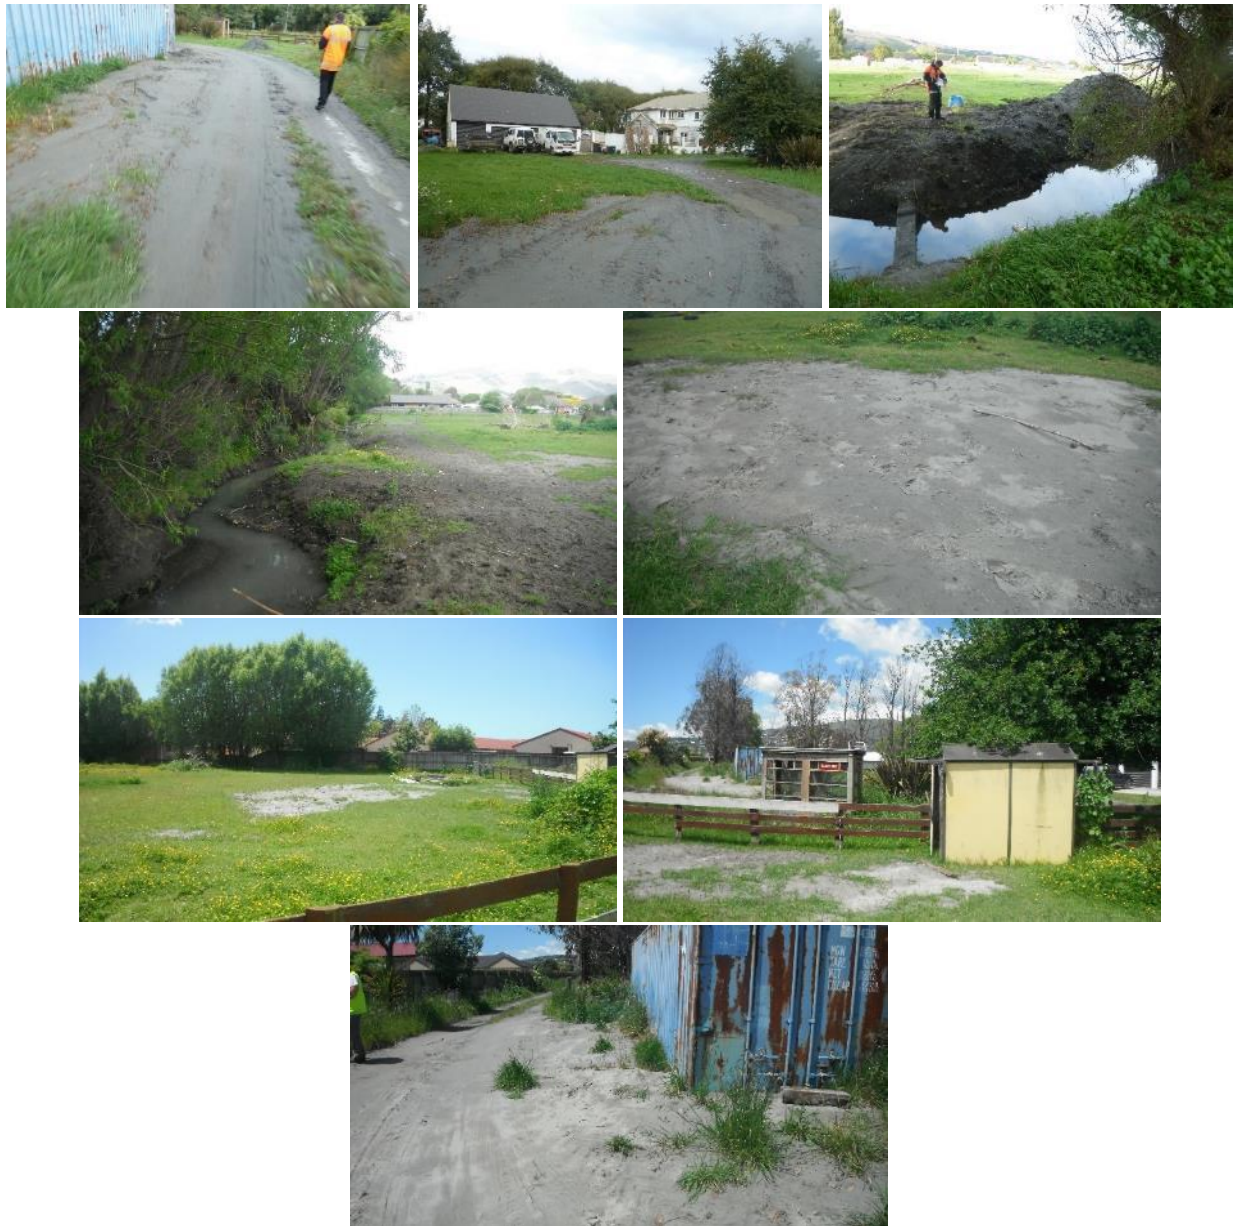
Figure 38: Ground photographs showing ejecta remnants at the property to the north, outside the 20-m buffer (photograph date: Nov 2011).

Note 3: The values in Table 9 correspond to the coverage area of ejecta outlined in aerial photographs (Figures 8, 9, 19, 19, 35, and 36) and the lower and upper estimates of ejecta height based on geometrical approximations, ground photographs (Figures 38 and 39), and EQC LDAT property inspection reports (e.g., Figure 37). The ejecta-induced settlement using photographs and engineering judgment, $S_{E,P}$, is estimated as

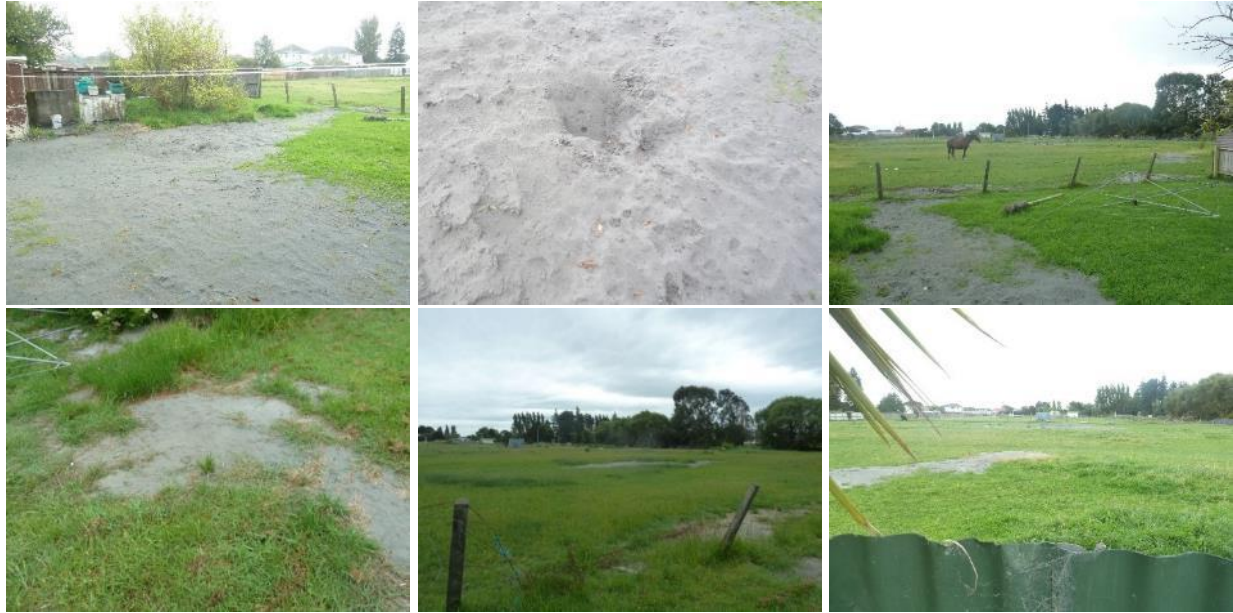
Figure 39: Ground photographs showing ejecta remnants just outside the 20-m buffer, toward the southeast (photograph date: Nov 2011).

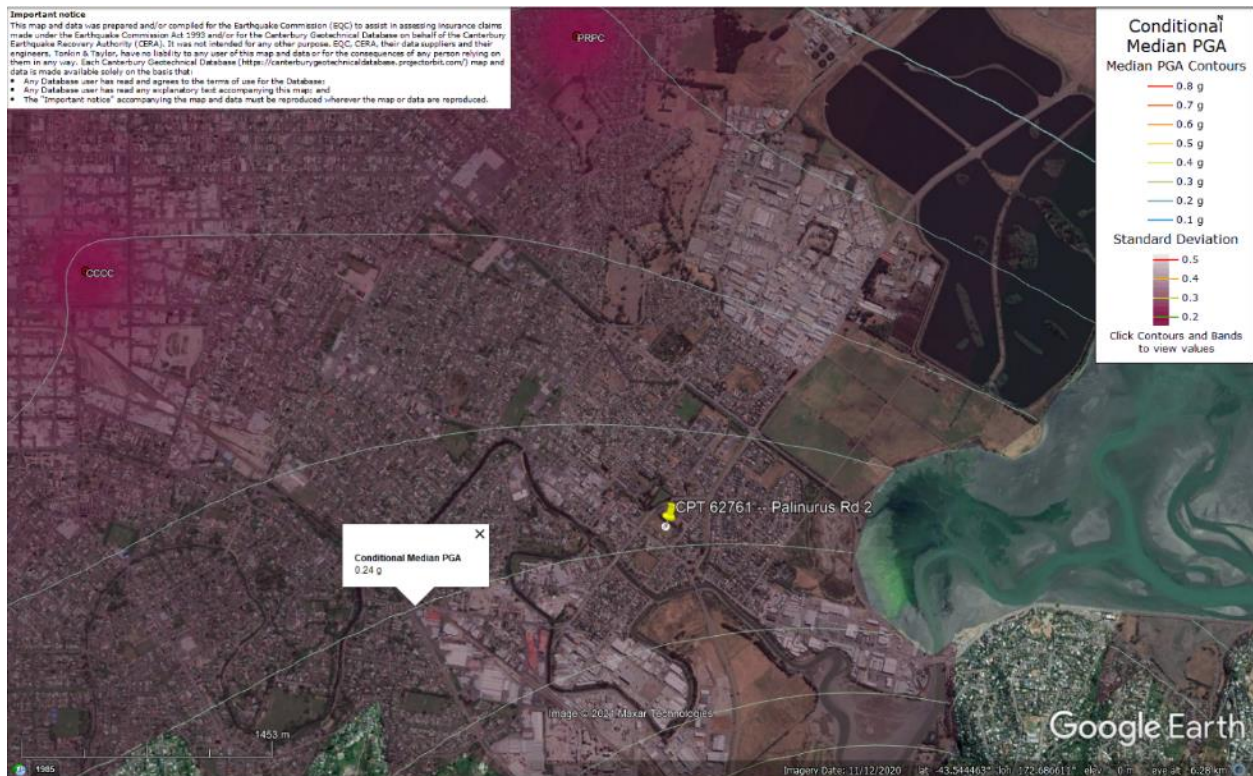
Figure 40: PGA for Sep-10 EQ (st. dev. = 0.350-0.375 ln units).

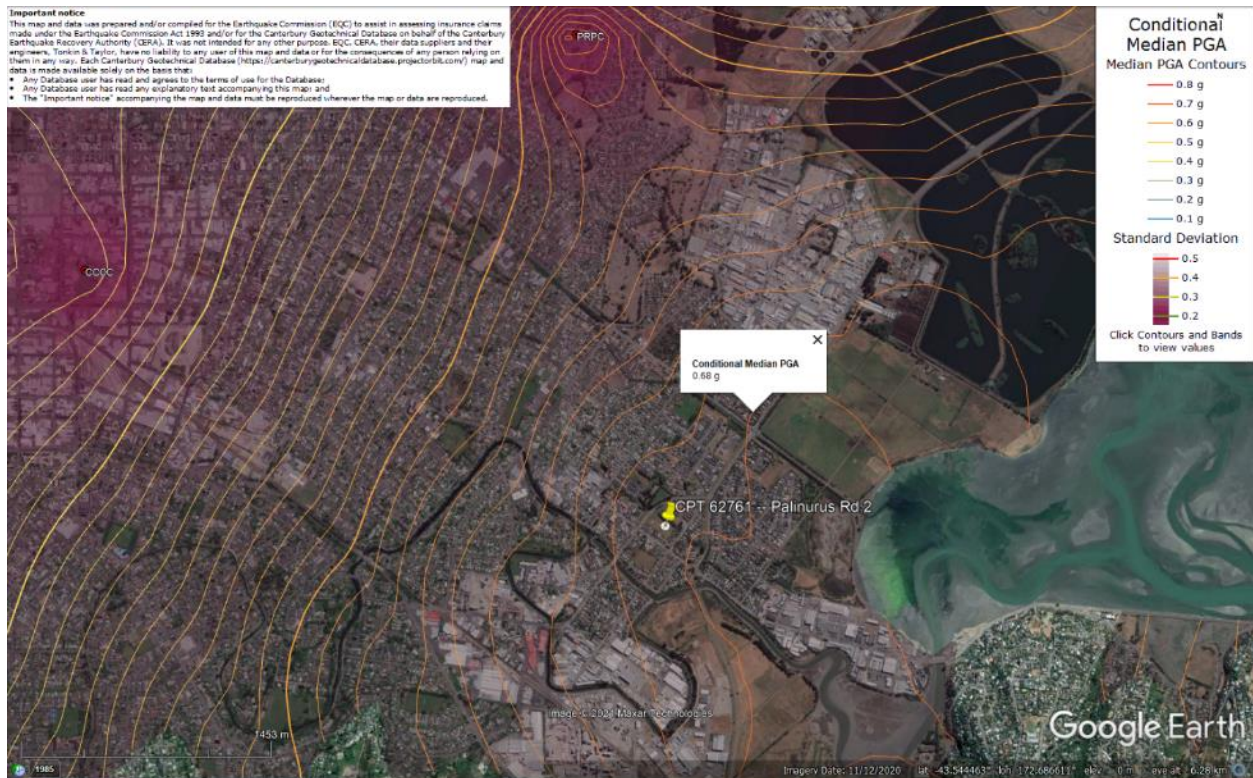
Figure 41: PGA for Feb-11 EQ (st. dev. = 0.375-0.400 ln units).

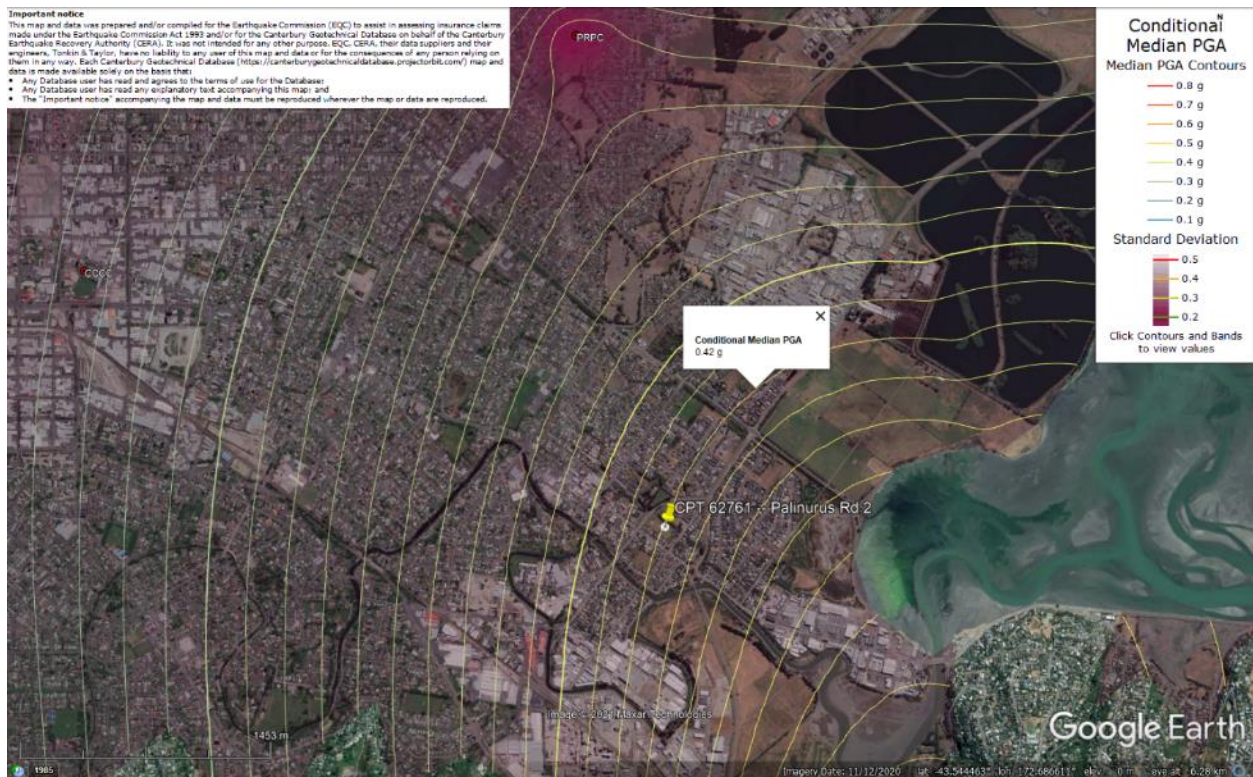
Figure 42: PGA for Jun-11 EQ (st. dev. = 0.400-0.425 ln units).
