Appendix A.52:

Nursery Rd – CPT 17262

Liquefaction Ejecta Case Histories for 2010-11 Canterbury Earthquakes

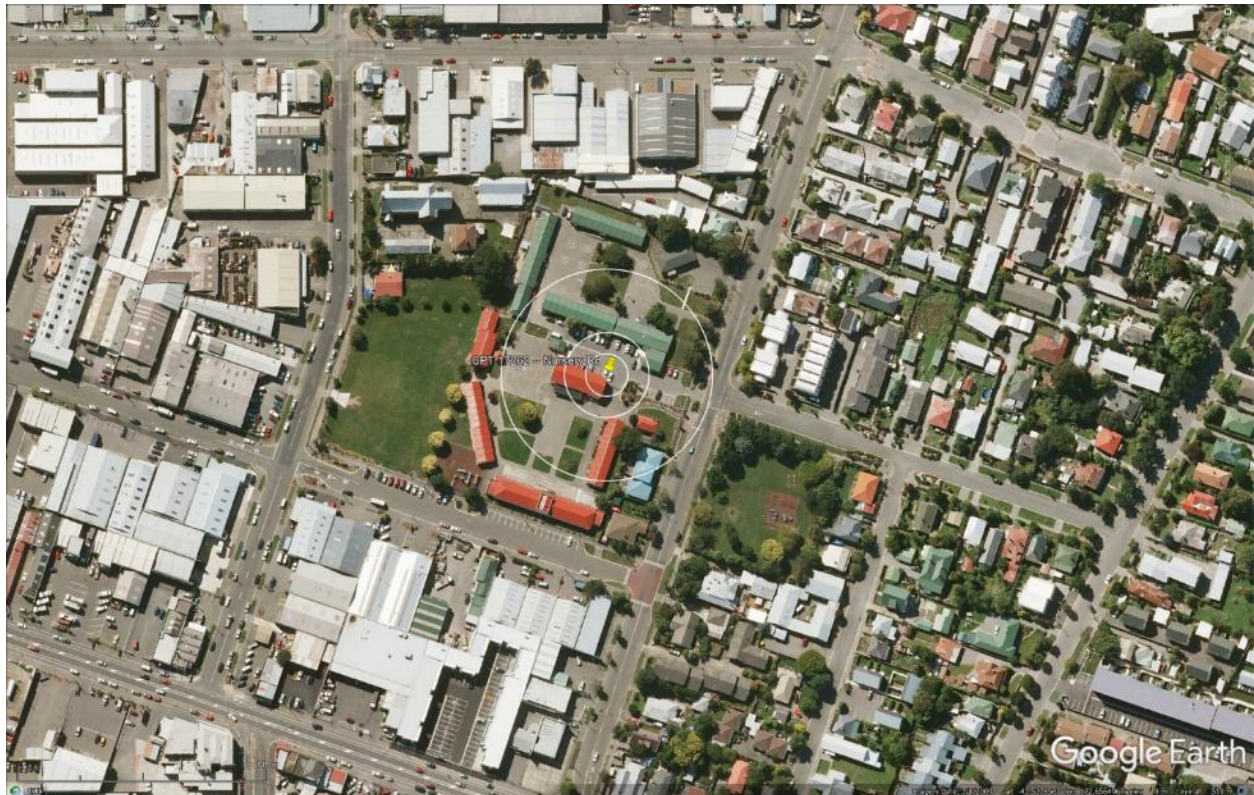
Figure 4: Position of the site relative to nearby buildings and vegetation.

Anthropogenic changes to the site between the LiDAR surveys?	No	No	No	Between Jan 2006 and Mar 2009, vegetation addition in the SE q. of the 50-m b. and renovation of buildings in the NW and SW q. of the 10-m and 20-m b. and the NW, SW, and SE q. of the 50-m b. Concrete pavement removal in all q. of all b. between 26 Feb 2011 and 28 Mar 2011. Construction fence placement around the central building between 28 Mar 2011 and 14-15 Jun 2011. Playground addition in the SW q. of the 50-m buffer between Dec 2011 and Apr 2012. Building removal from the W portion of all buffers between Mar 2014 and Aug 2014.	Pavement Removal: Orange Outline; Building Removal: Orange Crossline; Playground: Yellow Outline + White Fill
Other important factors?	Yes	Yes	Yes	Nursery Rd is in the E portion of the 50-m b. and occupies 1% of the 50-m b. There is a container in the NW q. of the 50-m buffer, speed bump in the E portion of the 20-m and 50-m b., potential speed bump in the NW q. of the 50-m b., gutter in the NW q. of the 20-m and 50-m b. and construction fence in the S portion of all b.	Road: White Fill + Gray Outline; Container: Blue outline + White Fill; Speed Bump: Pink Outline + White Fill; Gutter: Green Outline

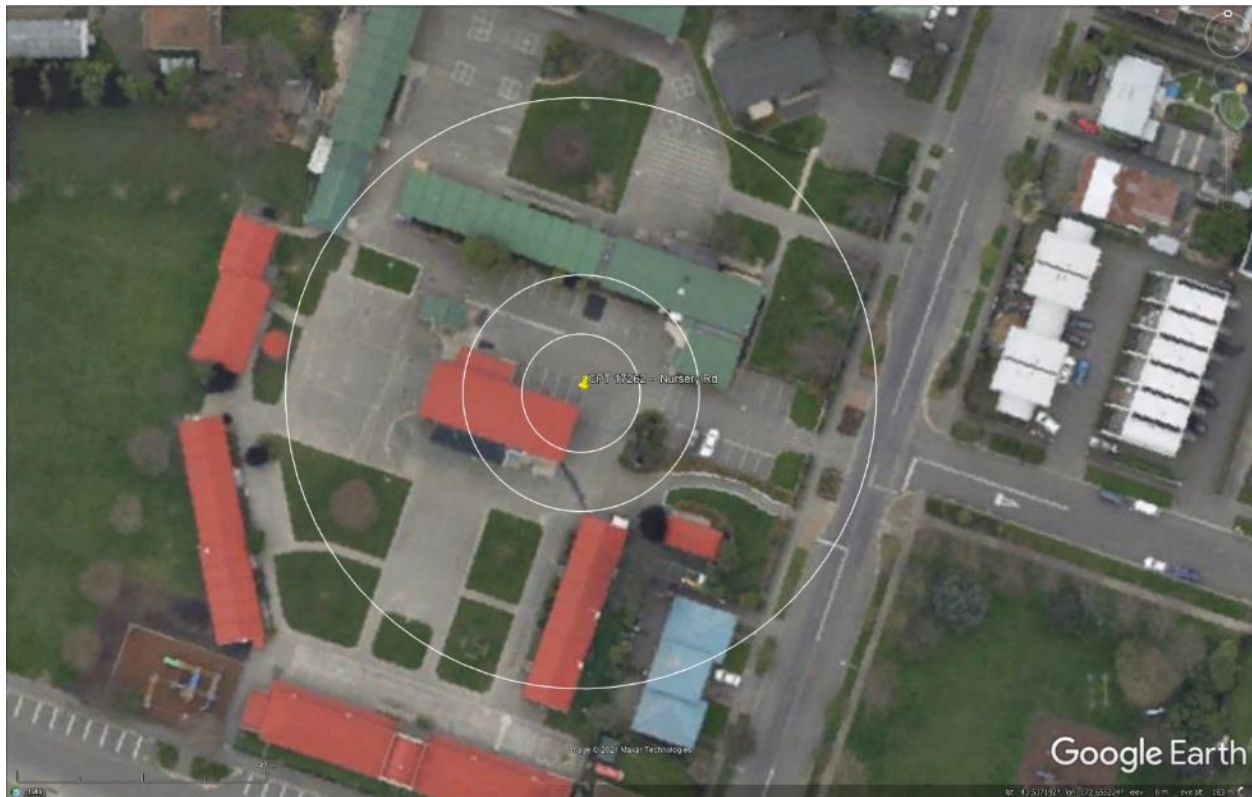
Figure 18: Aerial photograph of the site taken on Sep 4, 2010.

Note 3: The values in Table 9 correspond to the coverage area of ejecta outlined in aerial photographs (Figures 18, 20, 38, and 39) and the lower and upper estimates of ejecta height based on geometrical approximations. The ejecta-induced settlement using photographs and engineering judgment, $S_{E,P}$, is estimated as

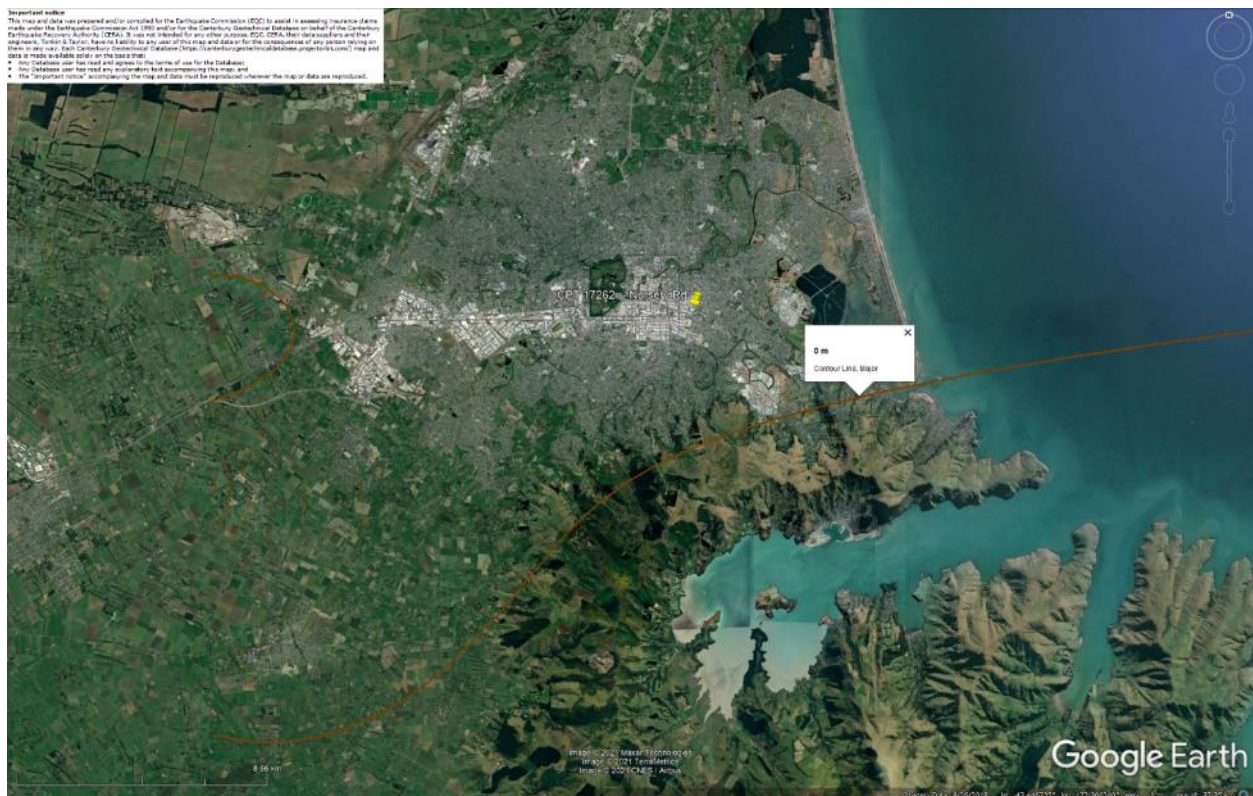
Figure 33: Vertical tectonic movements for Sep 2010 Earthquake.

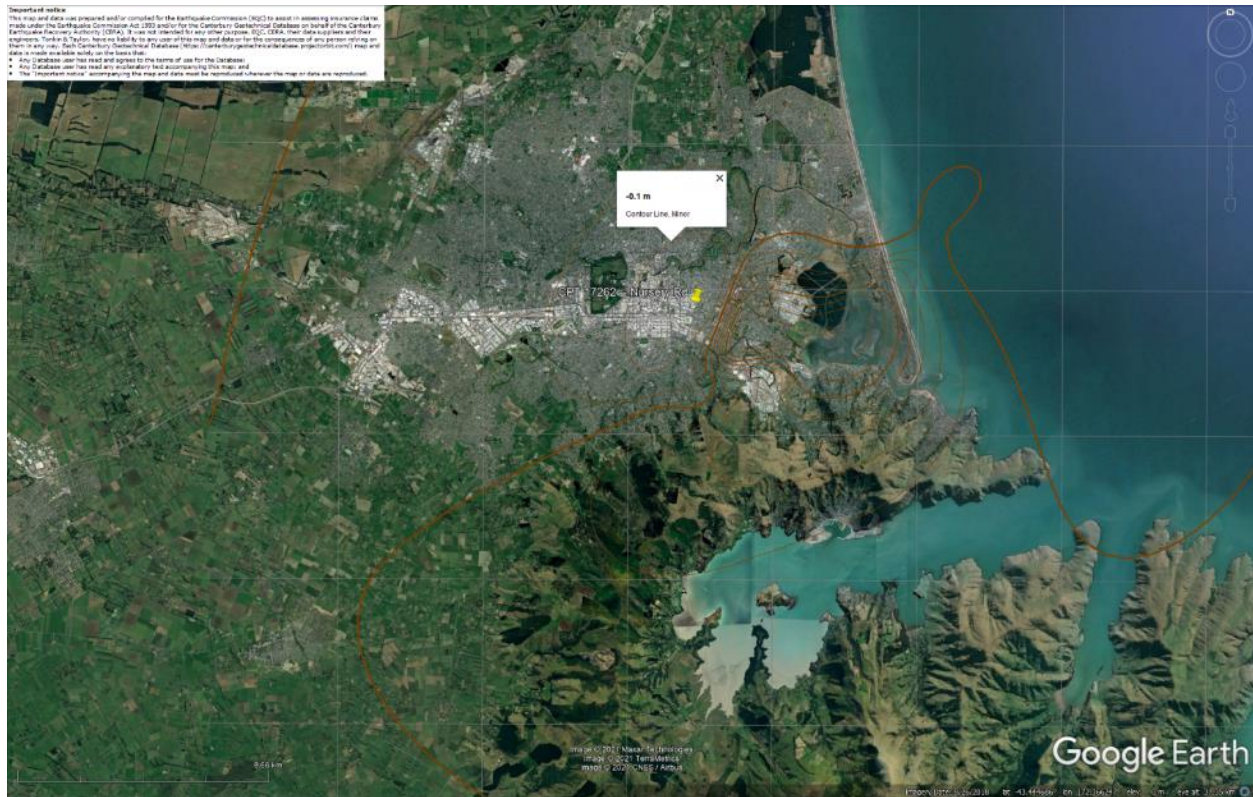
Figure 34: Vertical tectonic movements for Feb 2011 Earthquake.

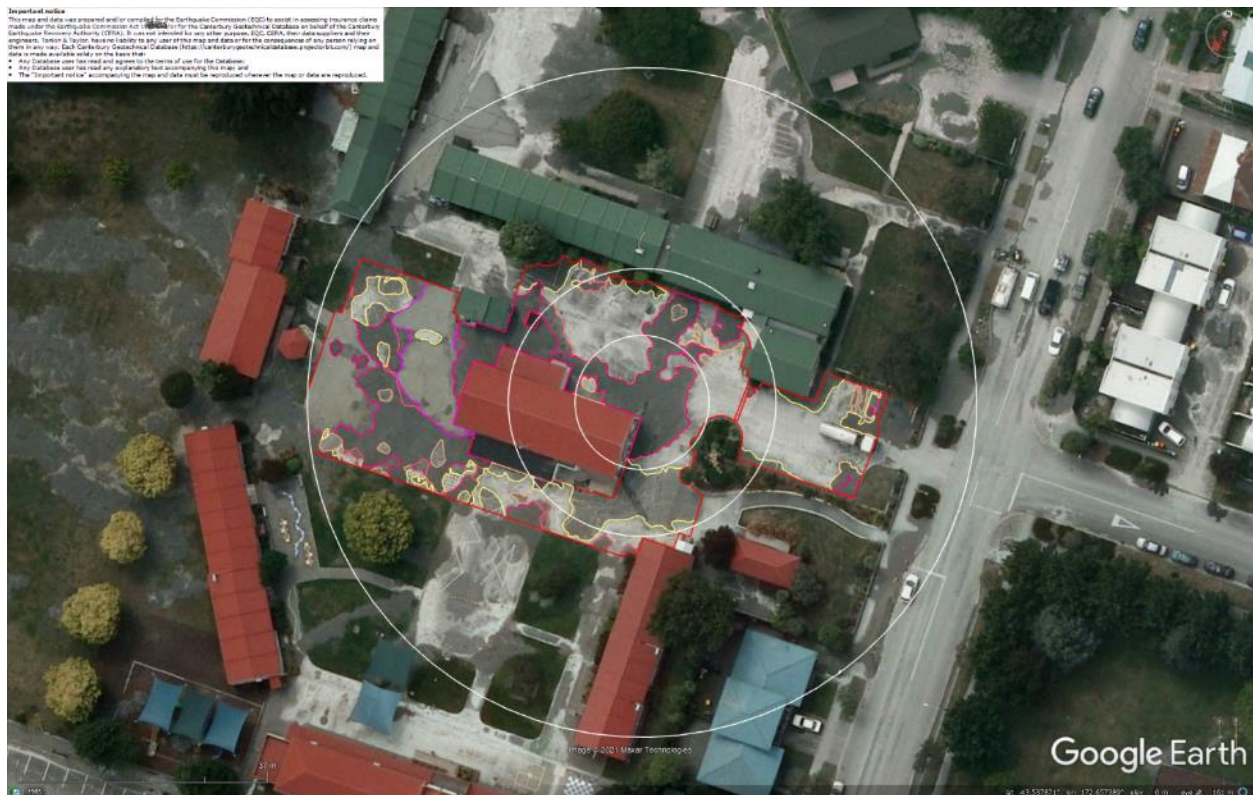
Figure 38: Aerial photograph showing the ejecta outline at the site for Feb-11 EQ.

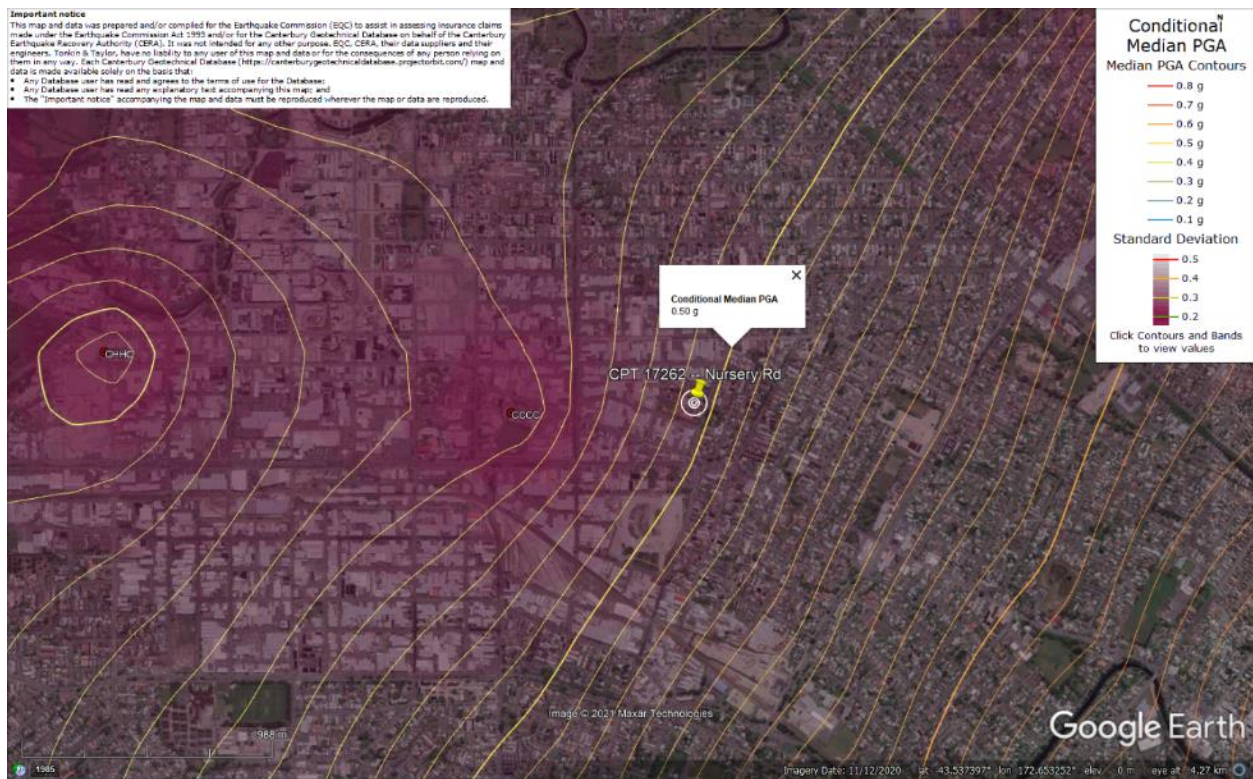
Figure 41: PGA for Feb-11 EQ (st. dev. = 0.275-0.325 ln units).

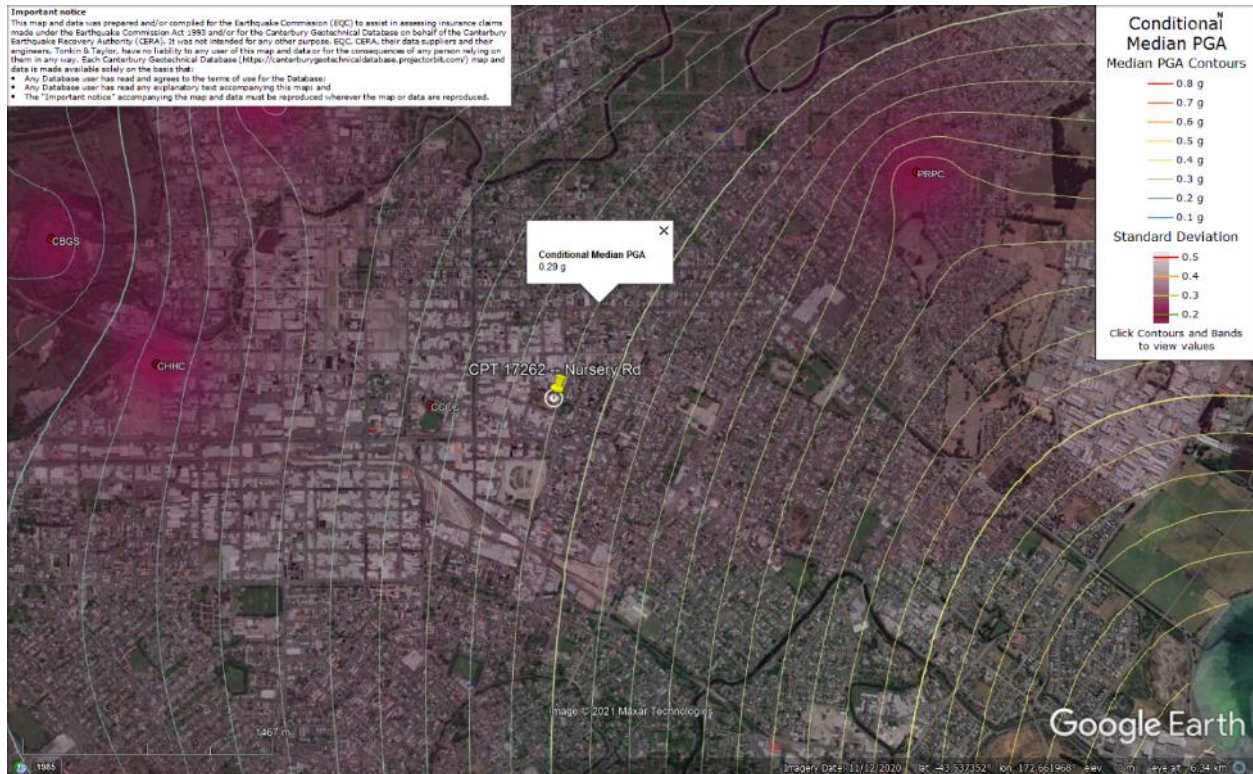
Figure 42: PGA for Jun-11 EQ (st. dev. = 0.375-0.400 ln units).
