Appendix A.57:

Armagh St – CPT 45795

Table 1: Site Description for Armagh St (CC NO LIQ 42 – CPT 45795).

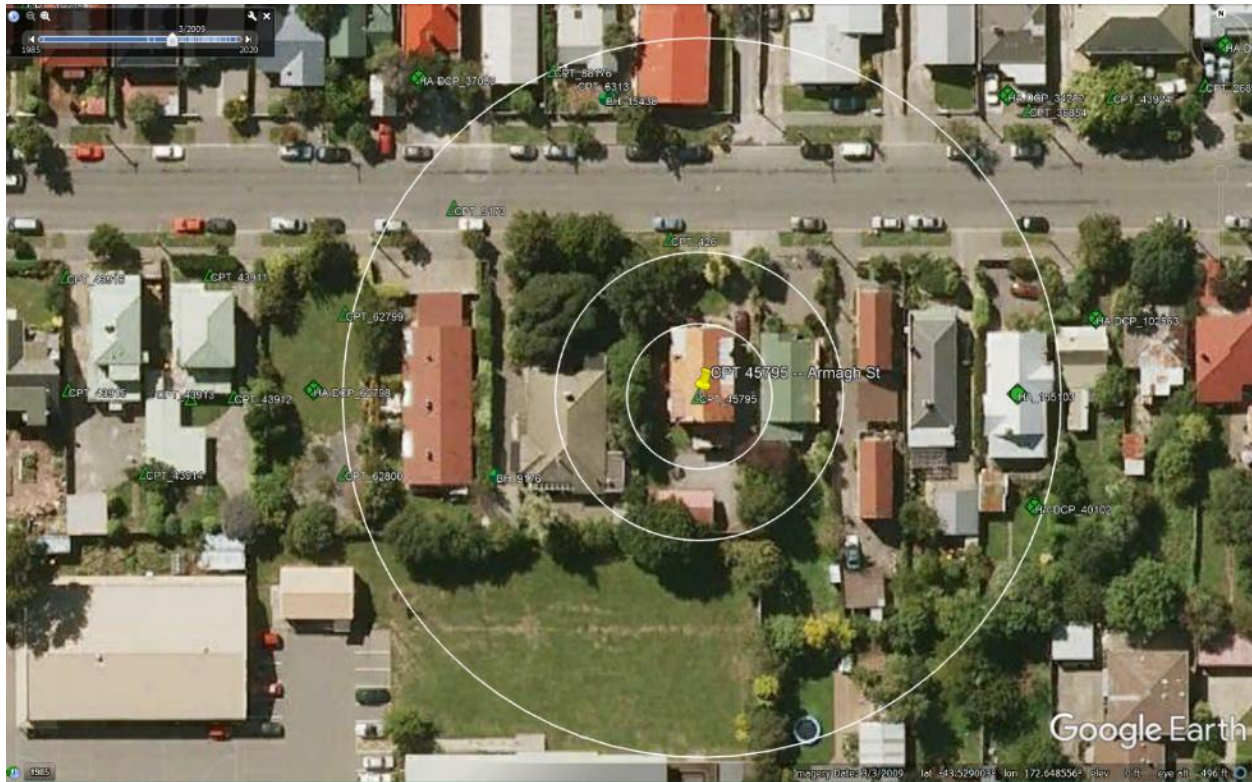
Figure 1: Site plan.

Note: Buffer is the area within a circle of a specified radius with CPT investigations done at its center (172.648678°, -43.529008°).

Note 4: The selection of CPTs for the area considered for settlement assessment (Figure 1) is based on the proximity of the CPTs to the considered areas. In accordance with that, the following table shows CPTs that were used for the volumetric settlement analysis in *Cliq v.3.0.3.2*, a CPT soil liquefaction software developed by GeoLogismiki. (The average volumetric settlements were reported in Table 3.)

Note 5: Based on the borehole logs (BH 9176 and 15438, Figure 1), the groundwater table is at a depth of 1.5 m below the ground surface. The soil profile consists of (1) sandy silt, ML, the Yaldhurst member of the Springston formation, to a depth of 1.5 m, (2) fine to medium sand, SP, the Yaldhurst member of the Springston formation, to a depth of 2.5 m, (3) silt, ML, the Yaldhurst member of the Springston formation, to a depth of 6.0 m, and (4) fine to medium sand, SP, of the Christchurch formation, to a depth of 20 m.

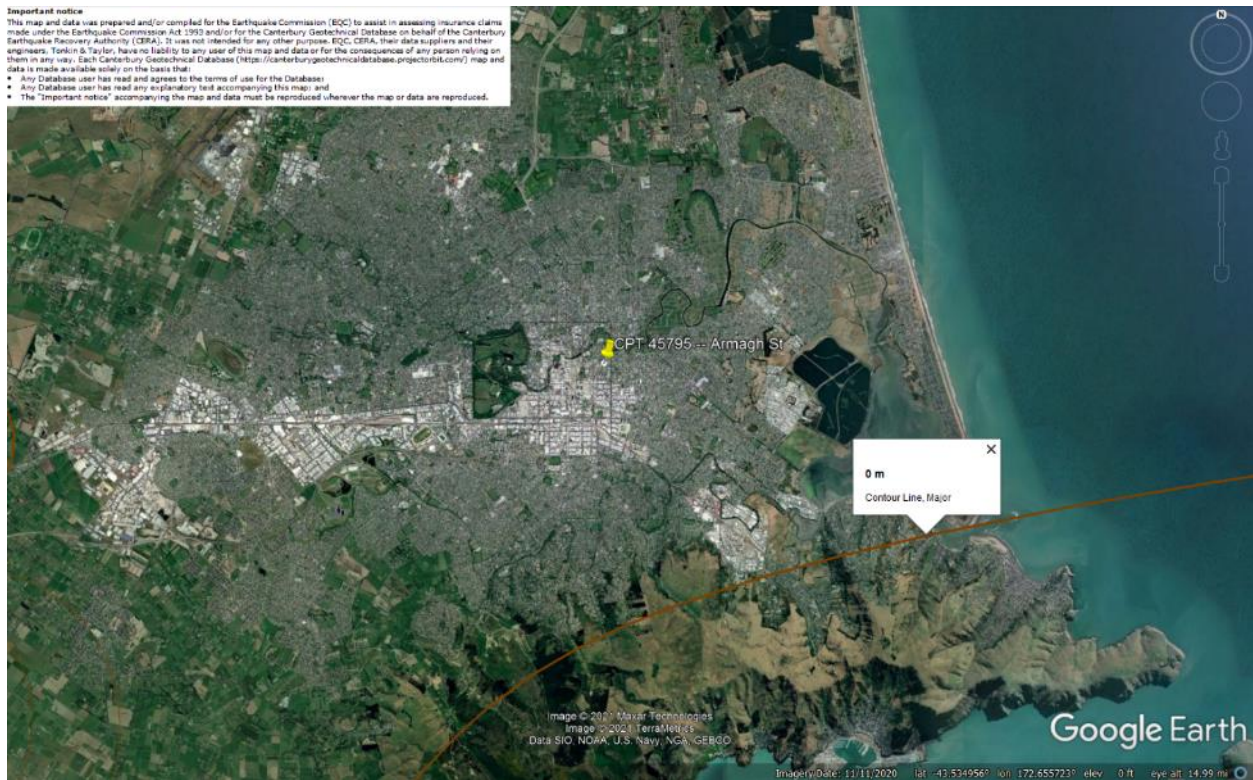
Figure 30: Vertical tectonic movements for Sep 2010 Earthquake.

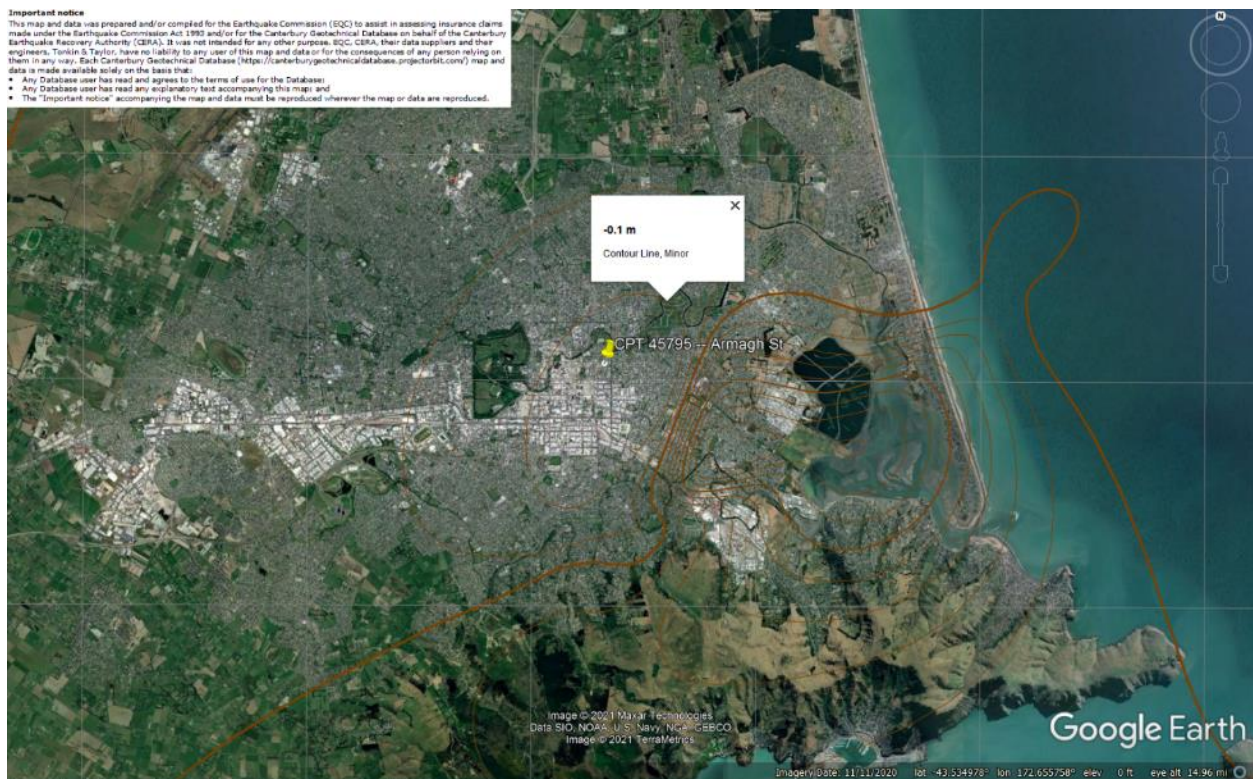
Figure 31: Vertical tectonic movements for Feb 2011 Earthquake.

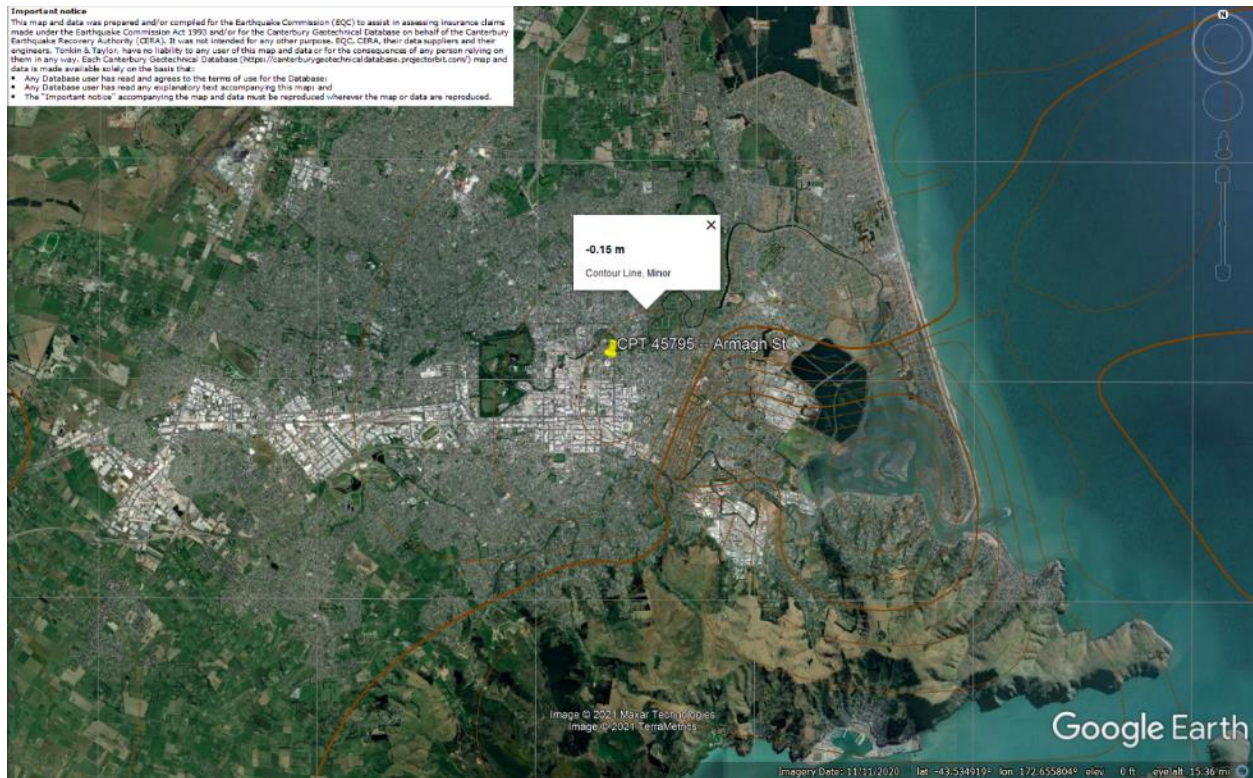
Figure 34: Vertical tectonic movements for Canterbury Earthquake Sequence.

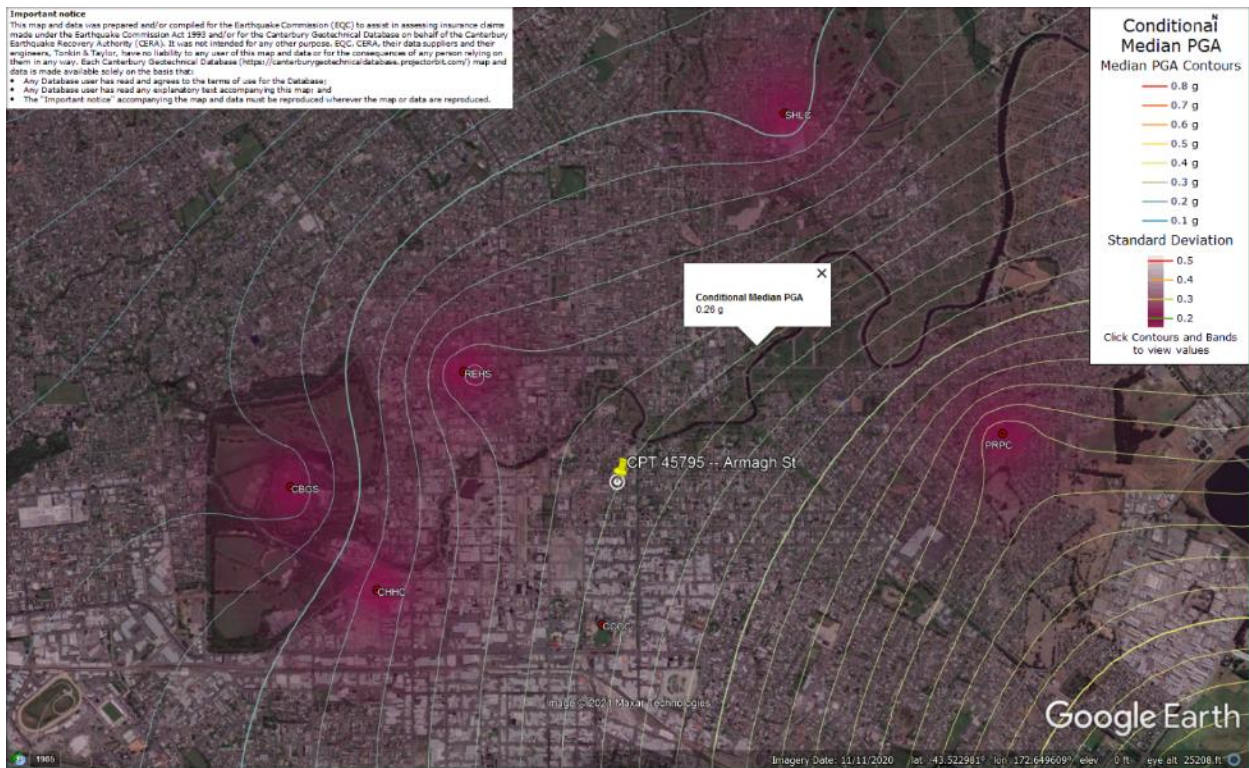
Figure 37: PGA for Jun-11 EQ (st. dev. = 0.325-0.375 ln units).
