Appendix A.61:

Marblewood Reserve – VsVp 57155

Liquefaction Ejecta Case Histories for 2010-11 Canterbury Earthquakes

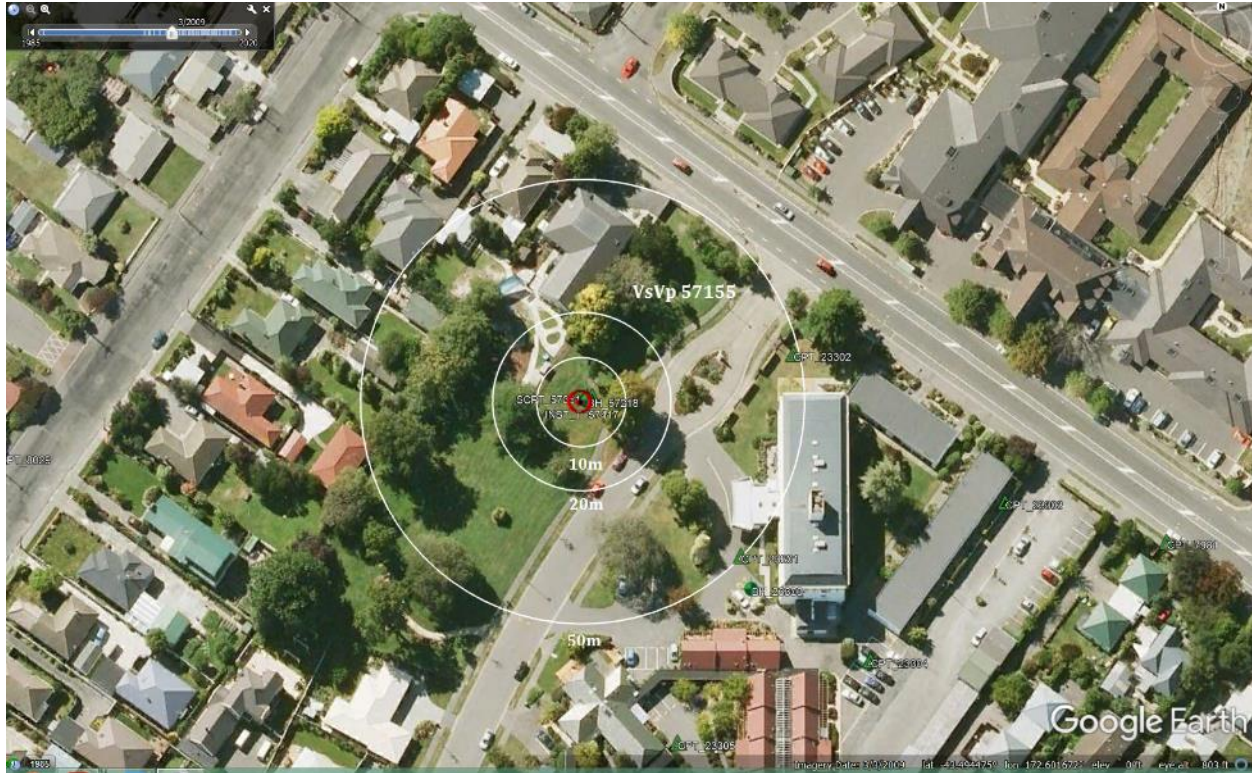
Figure 1: Site plan.

Note 4: The selection of CPTs for the area considered for settlement assessment (Figure 1) is based on the proximity of the CPTs to the considered areas. In accordance with that, the following table shows CPTs that were used for the volumetric settlement analysis in *Cliq v.3.0.3.2*, a CPT soil liquefaction software developed by GeoLogismiki. (The average volumetric settlements were reported in Table 3.)

Note 5: Based on the borehole log (BH 57218, Figure 1), the groundwater table is at a depth of 3.2 m below the ground surface. The soil profile consists of (1) organic silty, OL, topsoil to a depth of 0.65 m, (2) fine sand, SP, to a depth of 2.1 m, (3) silt, ML, to a depth of 2.35 m, (4) silty peat, Pt, to a depth of 2.5 m, (5) fine sand, SP, to a depth of 3.0 m, (6) silt, ML, to a depth of 11.3 m, (7) fine to medium sand, SP, to a depth of 11.95 m, (8) silt, ML, with minor organics to a depth of 15.65 m (the end of the borehole). All soil layers are the Yaldhurst members of the Springston formation. According to BH 23300 (~80 m to the SE from the center of the site), the ML layer is underlain by (9) fine to medium sand, SP, to a depth of 17.7 m, (10) silt, ML, with trace shells to a depth of 19.4 m, and (11) silty fine to coarse gravel, GM, to a depth of 21.5 m (the end of the borehole).

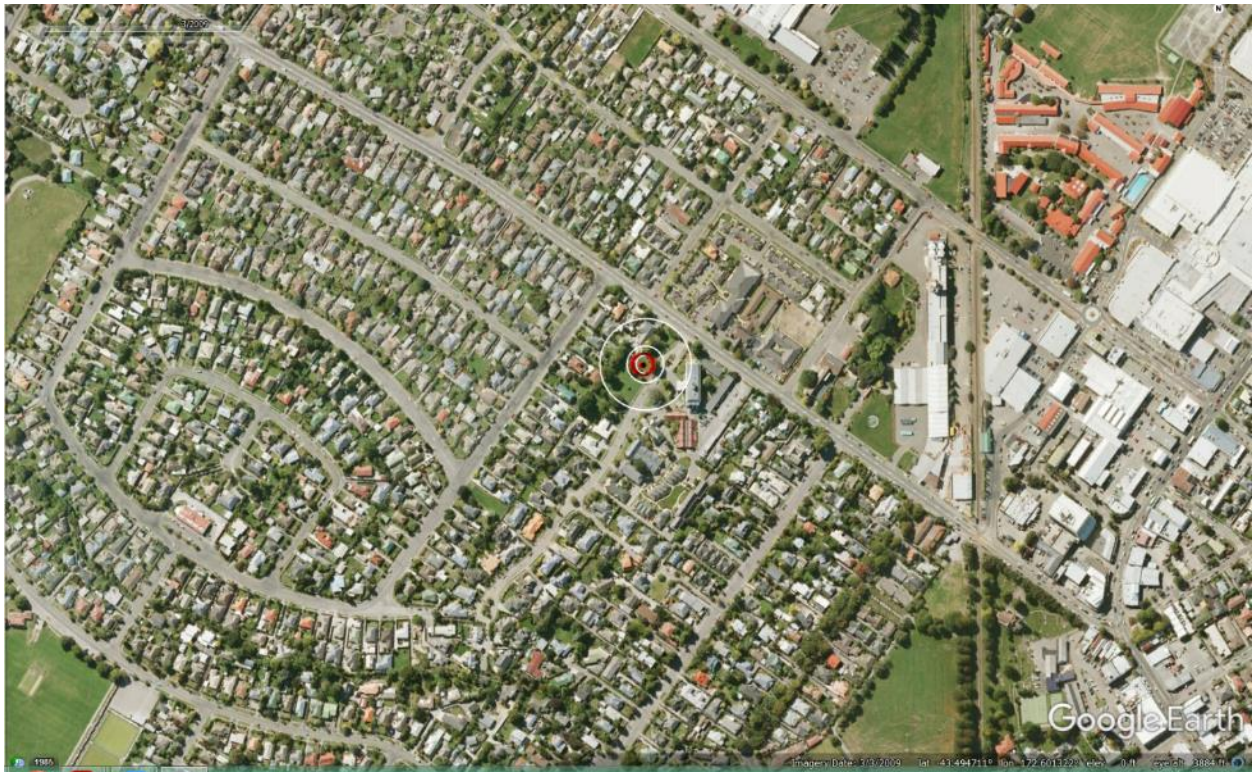
Figure 3: Position of the site relative to nearby buildings, vegetation, and free-face features.

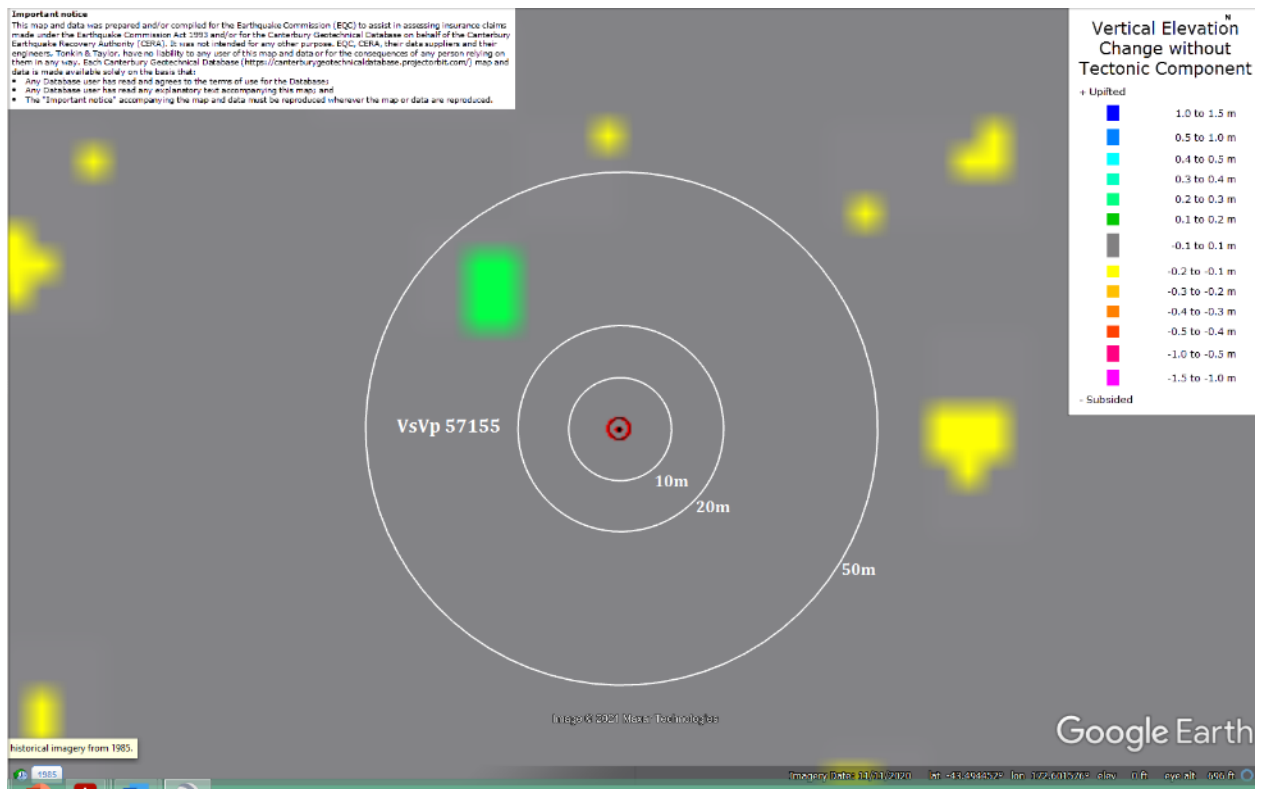
Figure 22: Ground surface subsidence without tectonic component for June 2011 Earthquake according to the LiDAR DEM.

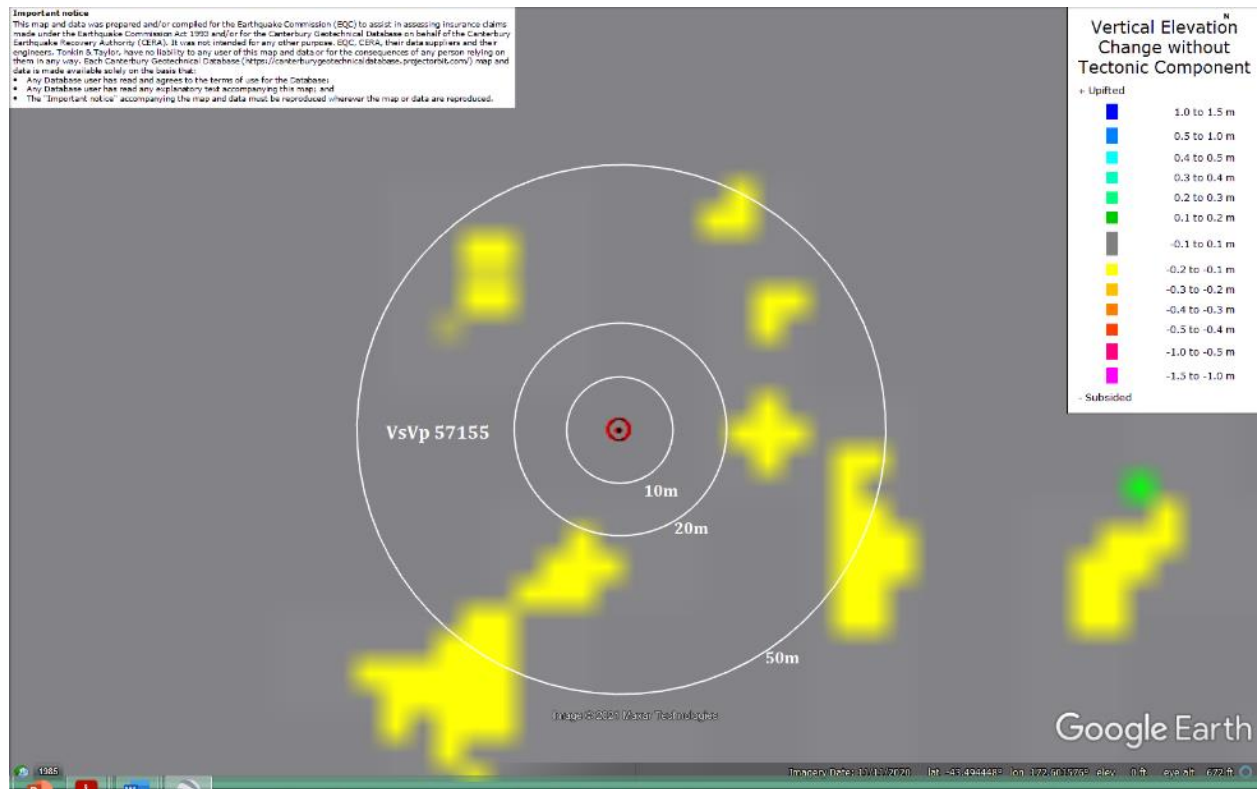
Figure 23: Ground surface subsidence without tectonic component for Dec 2011 Earthquake according to the LiDAR DEM.

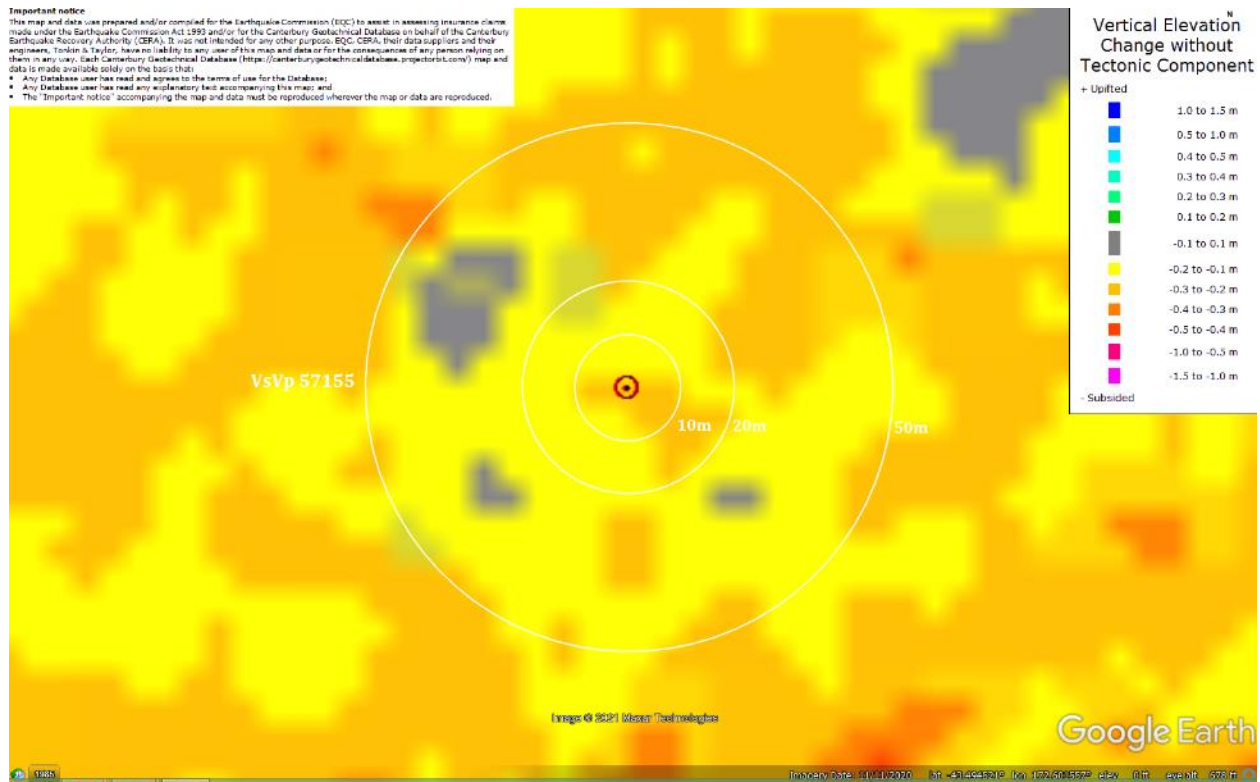
Figure 24: Ground surface subsidence without tectonic component for Canterbury Earthquake Sequence according to the LiDAR DEM.

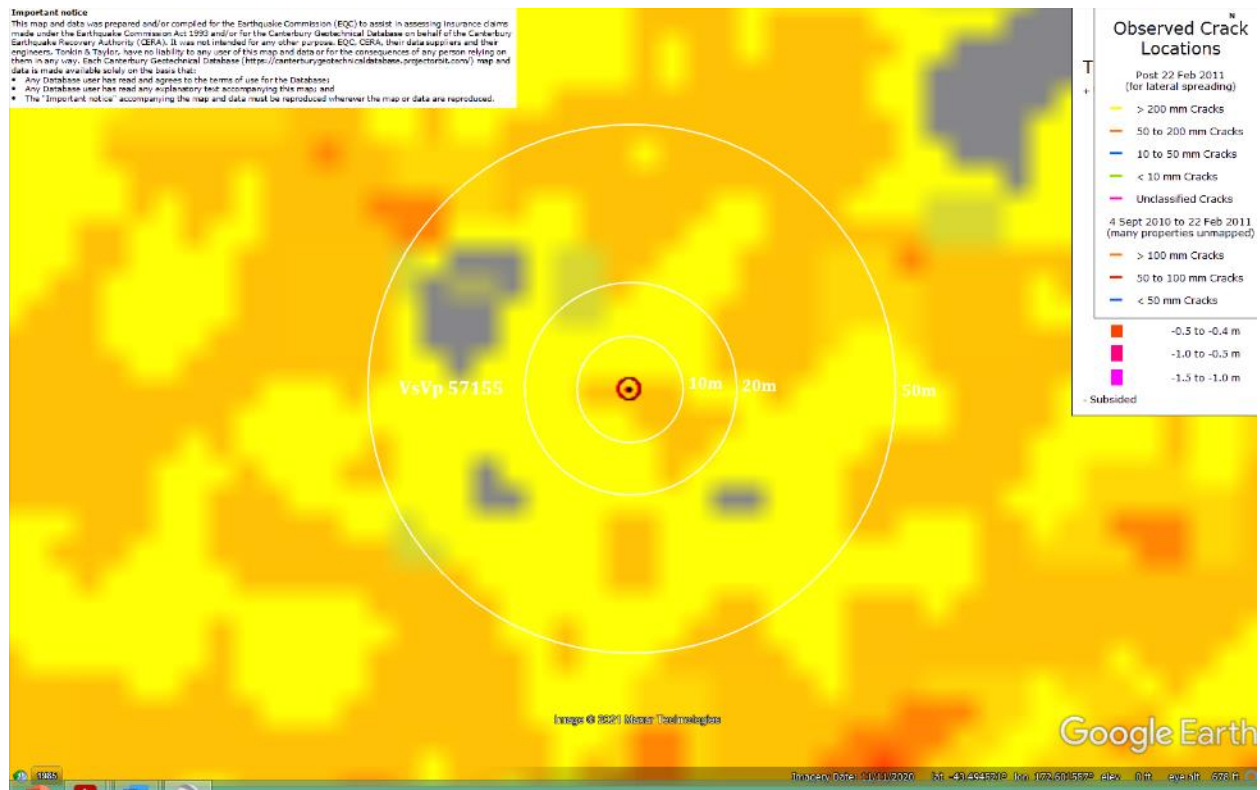
Figure 25: No lateral spreading for Canterbury Earthquake Sequence.

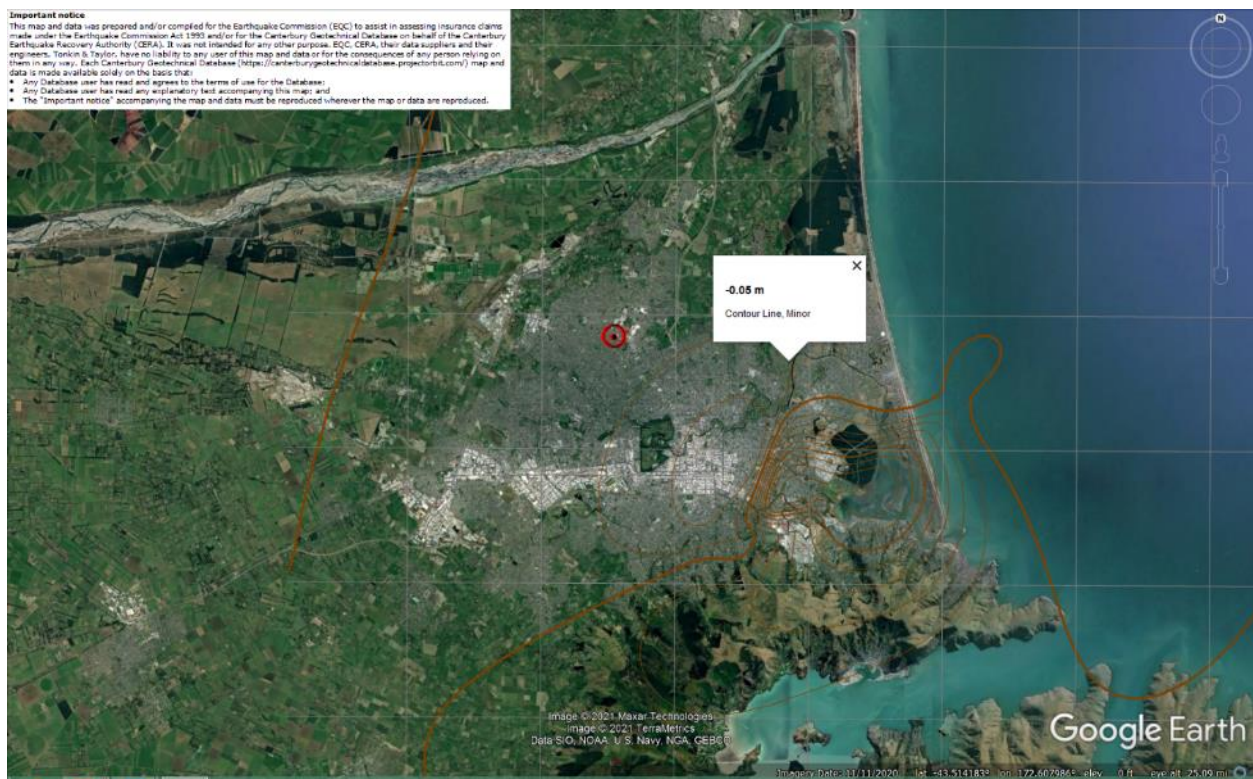
Figure 27: Vertical tectonic movements for Feb 2011 Earthquake.

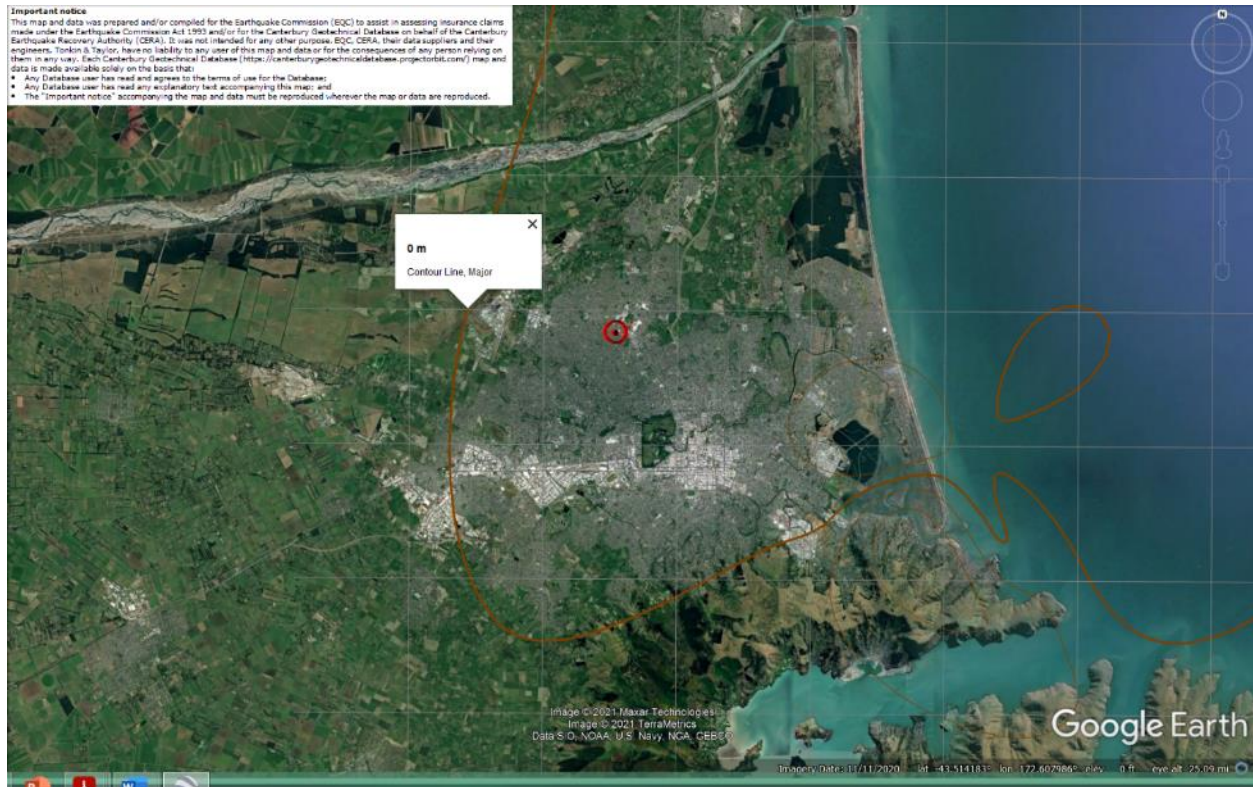
Figure 28: Vertical tectonic movements for June 2011 Earthquake.

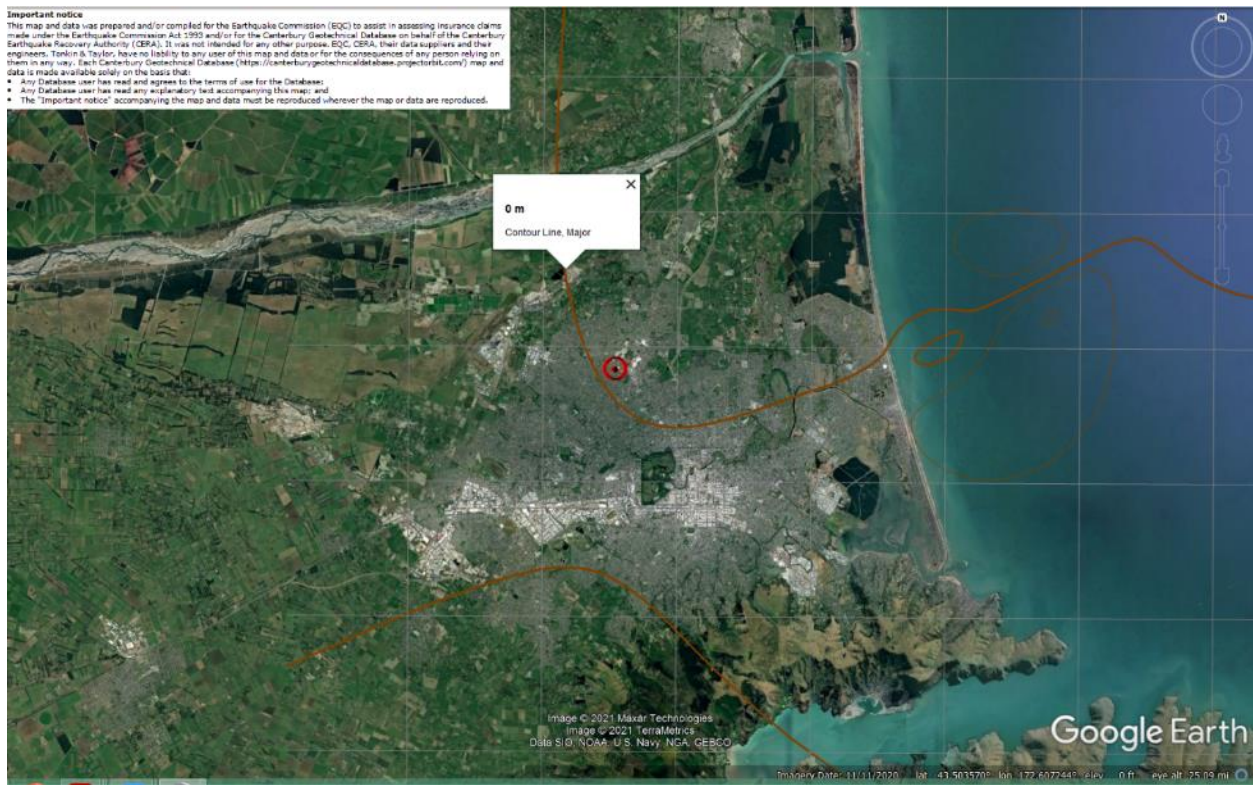
Figure 29: Vertical tectonic movements for Dec 2011 Earthquake.

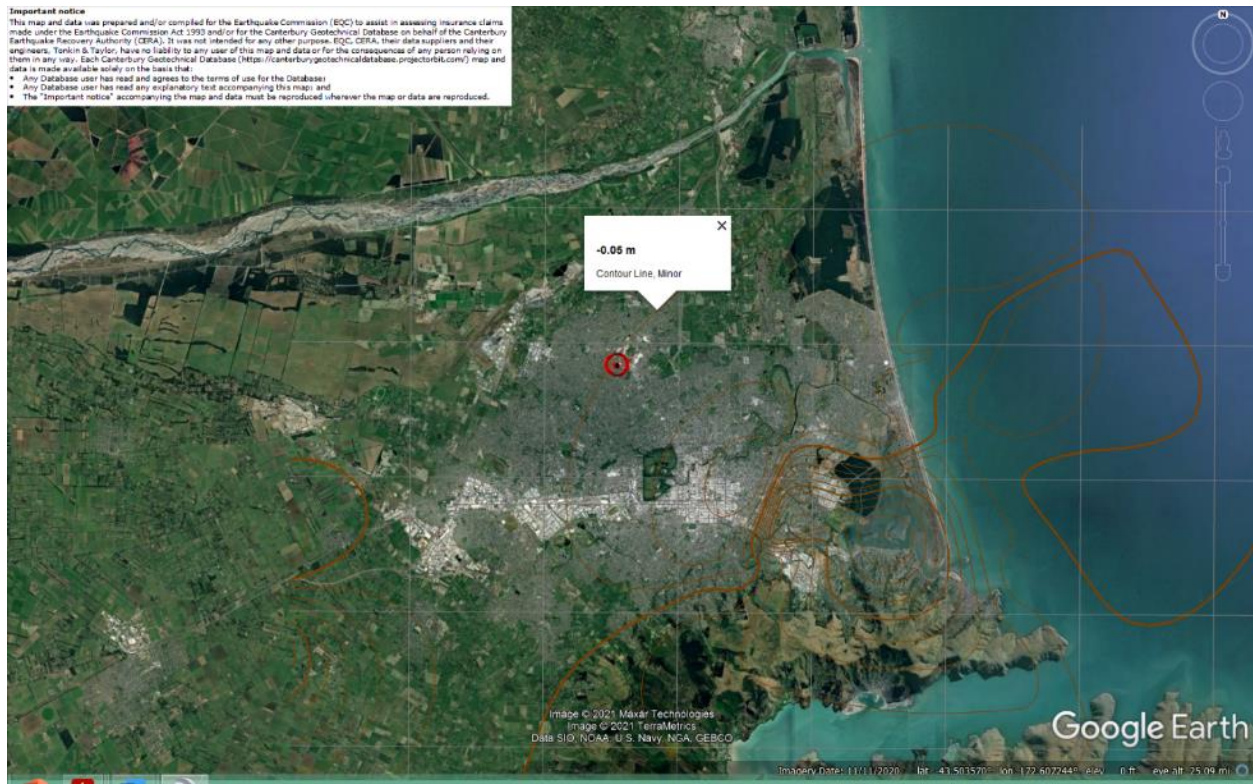
Figure 30: Vertical tectonic movements for Canterbury Earthquake Sequence.

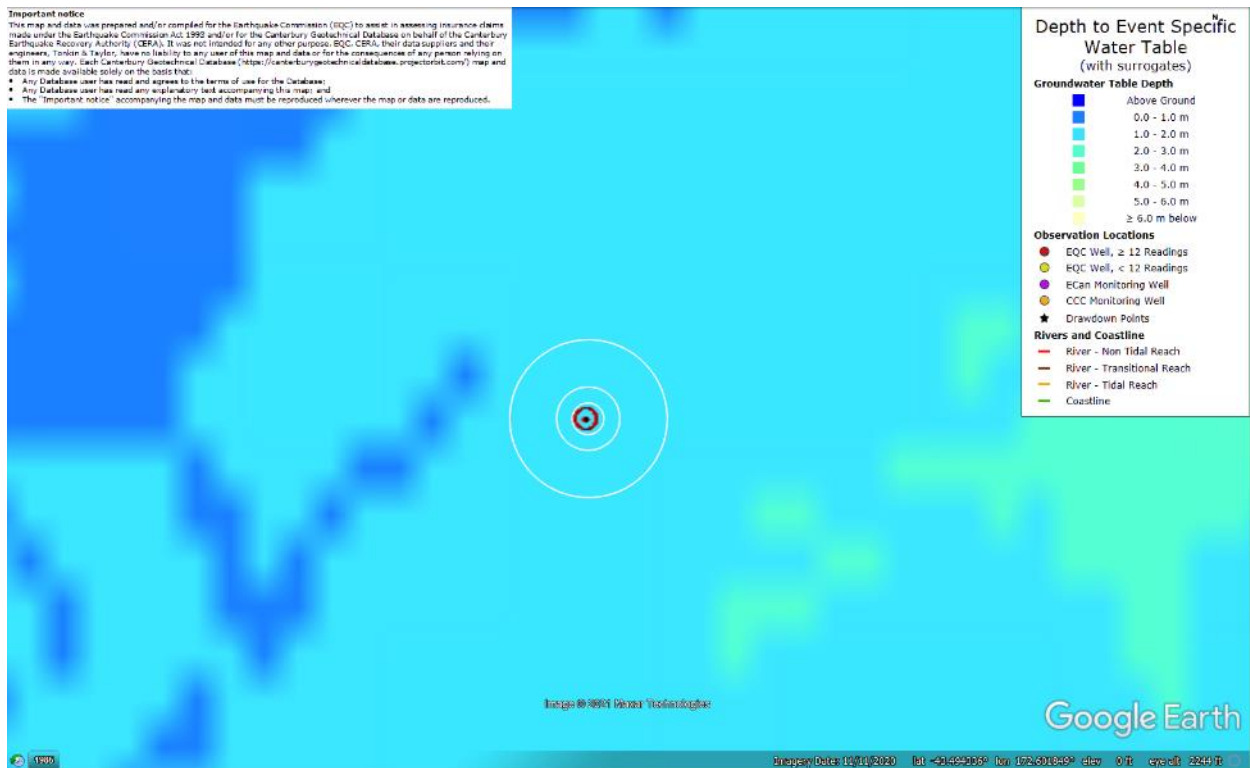
Figure 35: Depth to groundwater table for Sep-10 EQ.

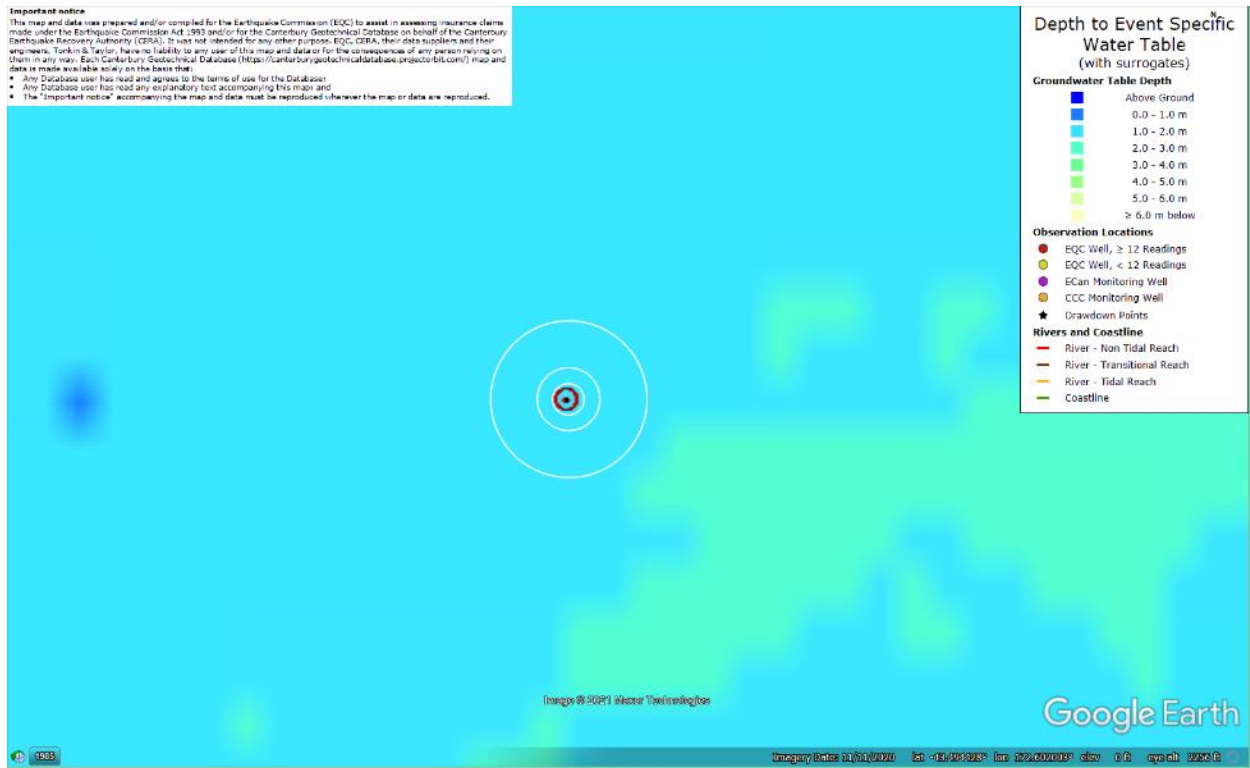
Figure 36: Depth to groundwater table for Feb-11 EQ.

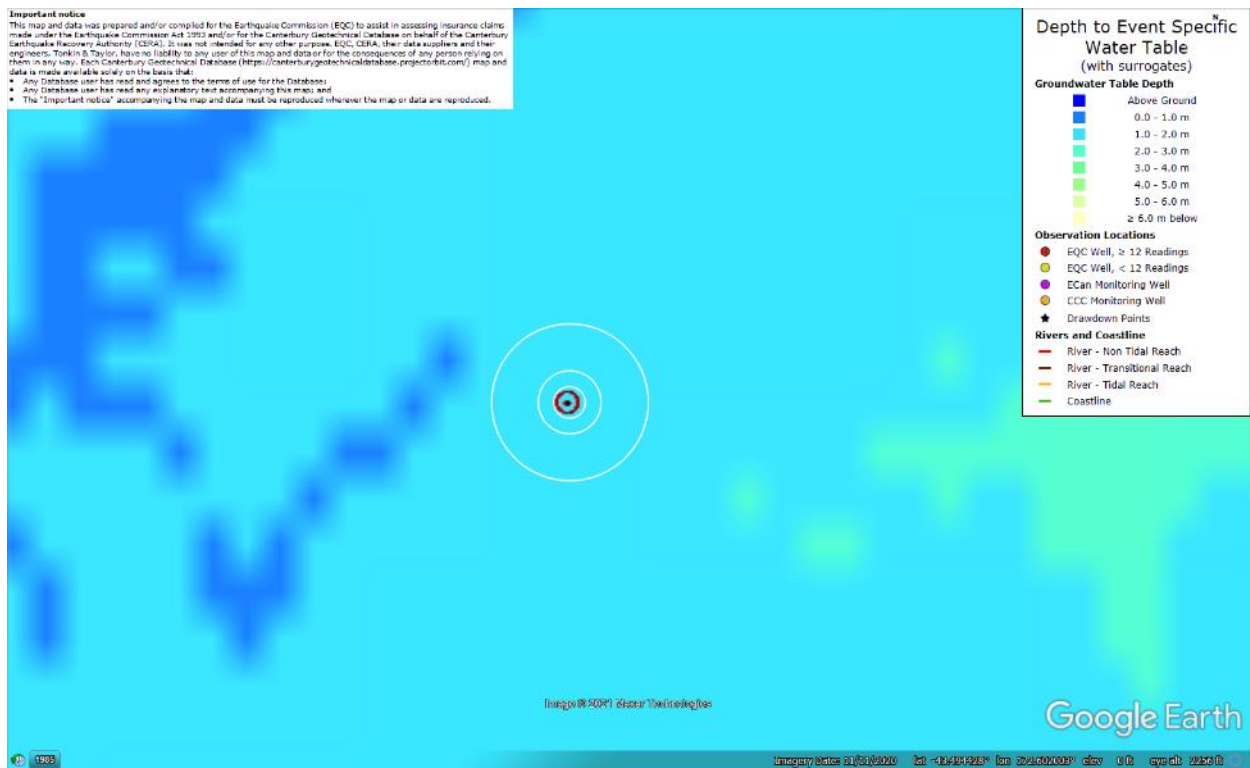
Figure 37: Depth to groundwater table for Jun-11 EQ.

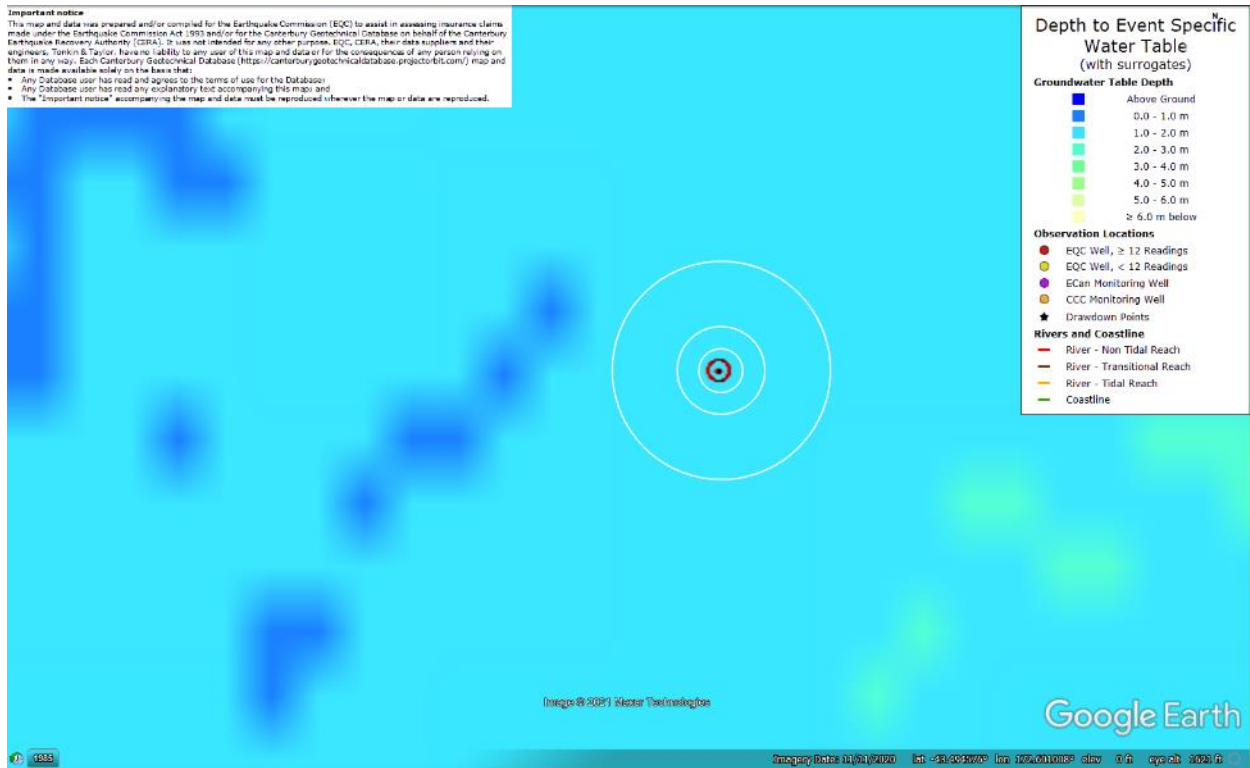
Figure 38: Depth to groundwater table for Dec-11 EQ.
