Appendix A.8:

Parnwell St and Bassett St – CPT 27709

**Table 1: Site Description for Parnwell St & Bassett St (CC LIQ 2 – CPT 27709).**

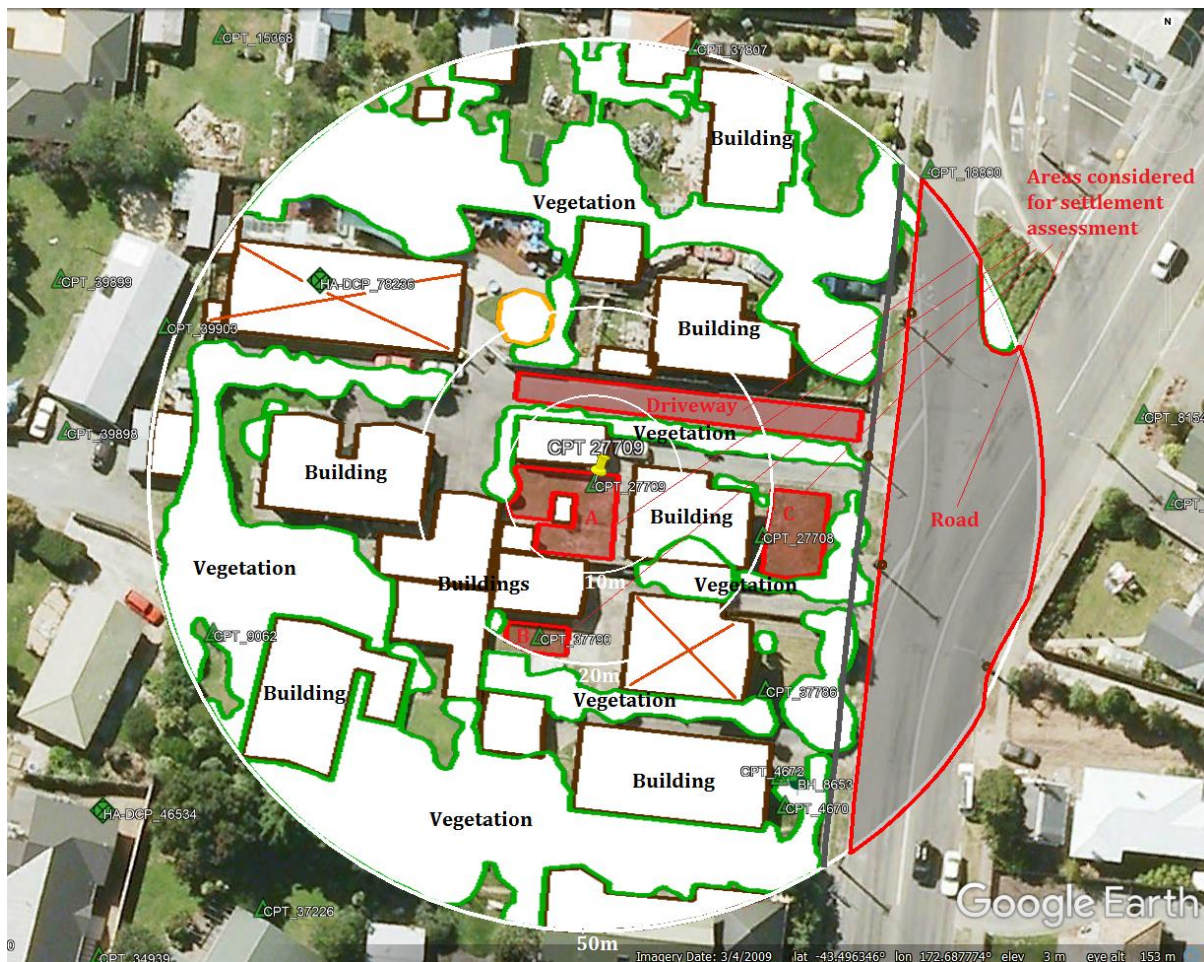
Figure 1: Site plan with areas where LiDAR survey data is considered.

**Note 1:** Four patches (outlined in red) in the free field were selected for settlement assessment as areas free of vegetation, structures, and manmade changes. Other factors that played a role in their selection were ejecta distribution and close proximity to a CPT. In addition, since significant amounts of ejecta were observed on roads in the CES, the entire road and the driveway were considered for settlement assessment. Roads as hard, relatively flat surfaces provide many ground-classified points.

**Note 7:** The selection of CPTs for the area considered for settlement assessment (Figure 1) is based on the proximity of the CPTs to the considered areas. In accordance with that, the following table shows CPTs that were used for the volumetric settlement analysis in *Cliq v.3.0.3.2*, a CPT soil liquefaction software developed by GeoLogismiki. (The average volumetric settlements were reported in Table 8.)

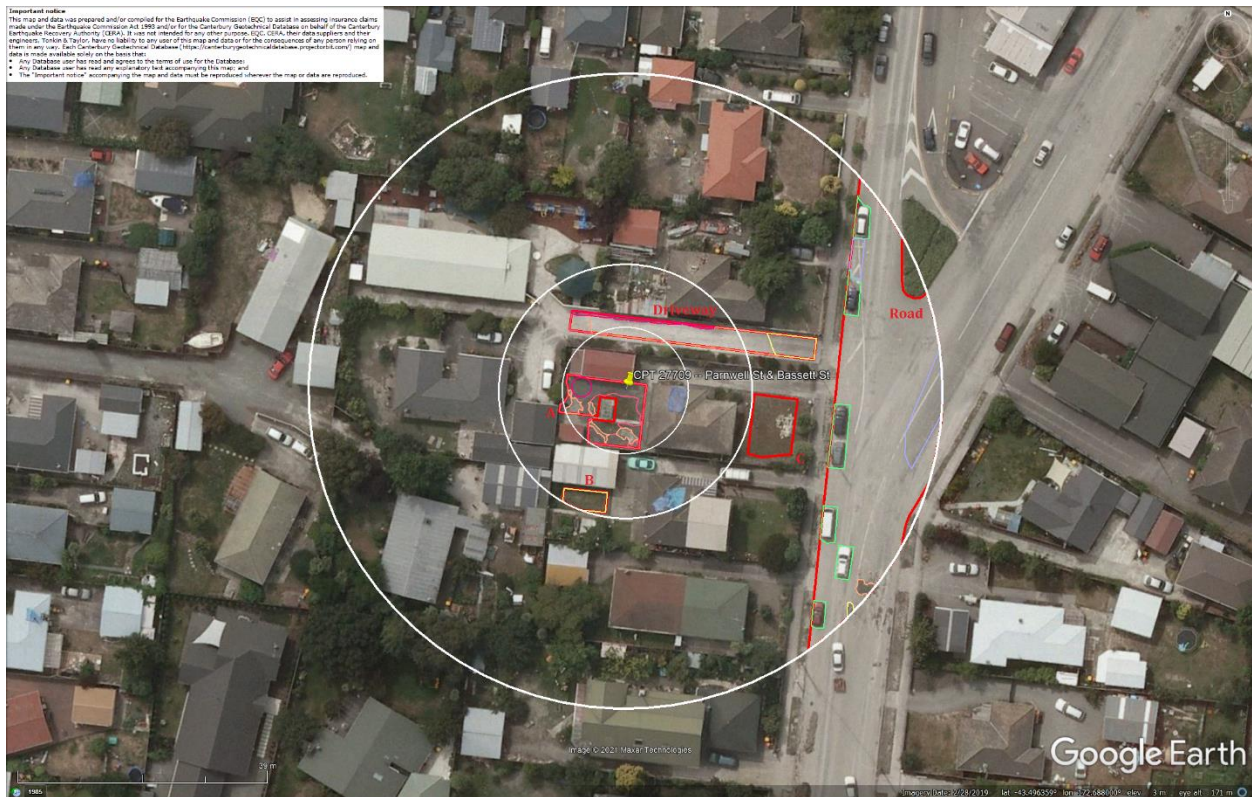
**Figure 102: Ejecta outline for Feb-11 EQ.**

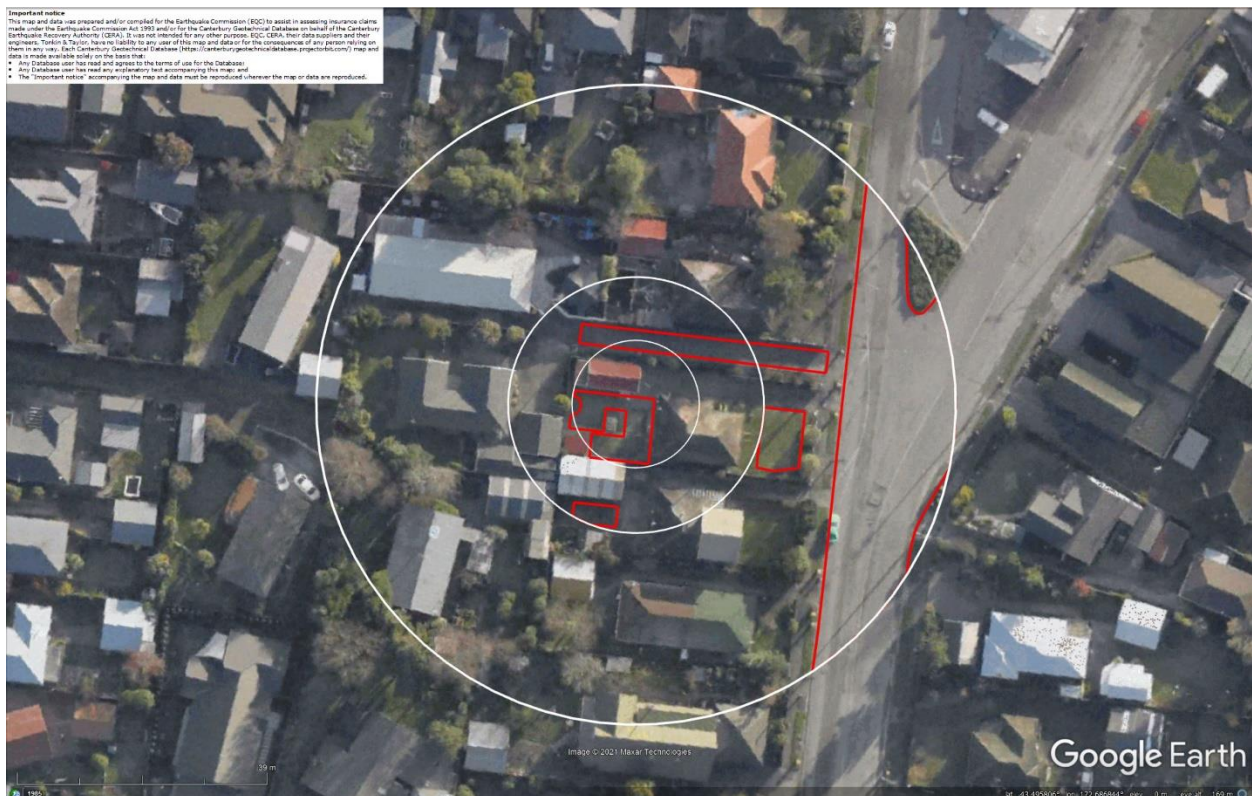
**Figure 103: Ejecta outline for Jun-11 EQ; photo acquired on 14-15 Jun 2011.**

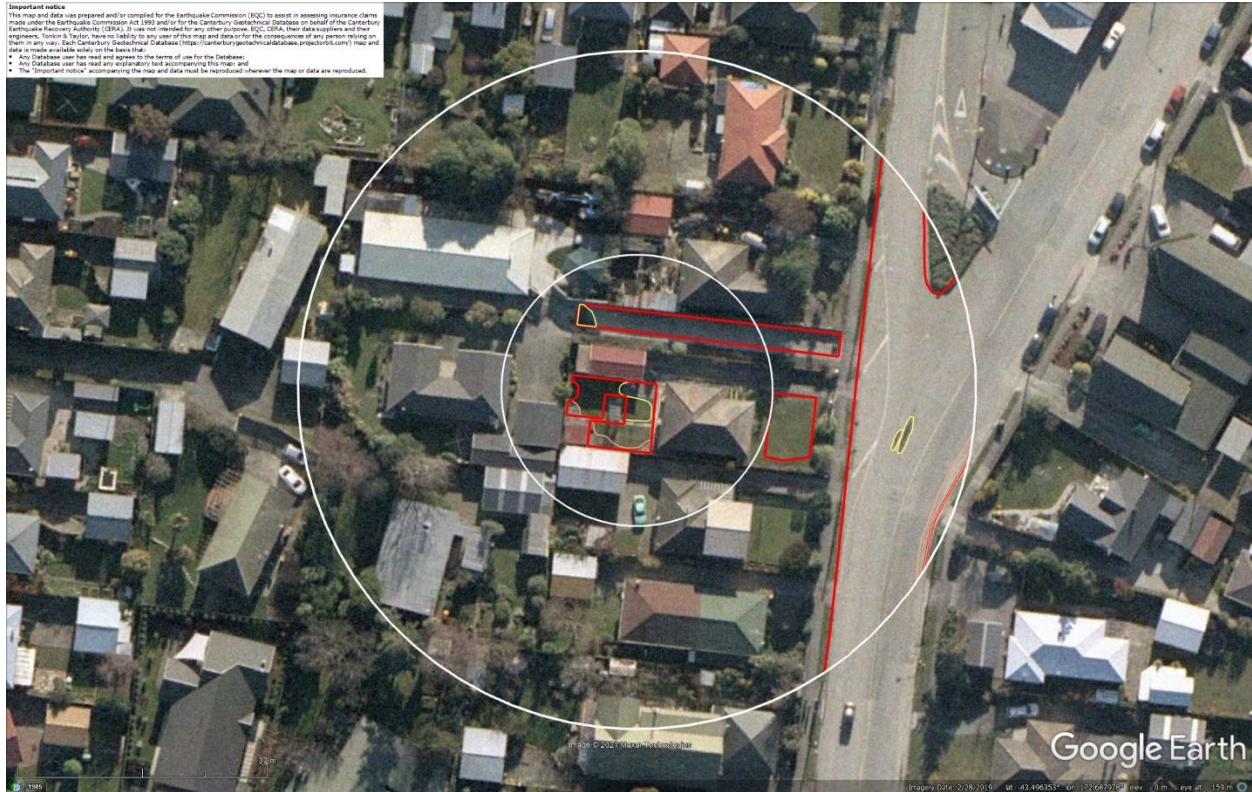
**Figure 104: Ejecta outline for Jun-11 EQ; photo acquired on 16 Jun 2011.**

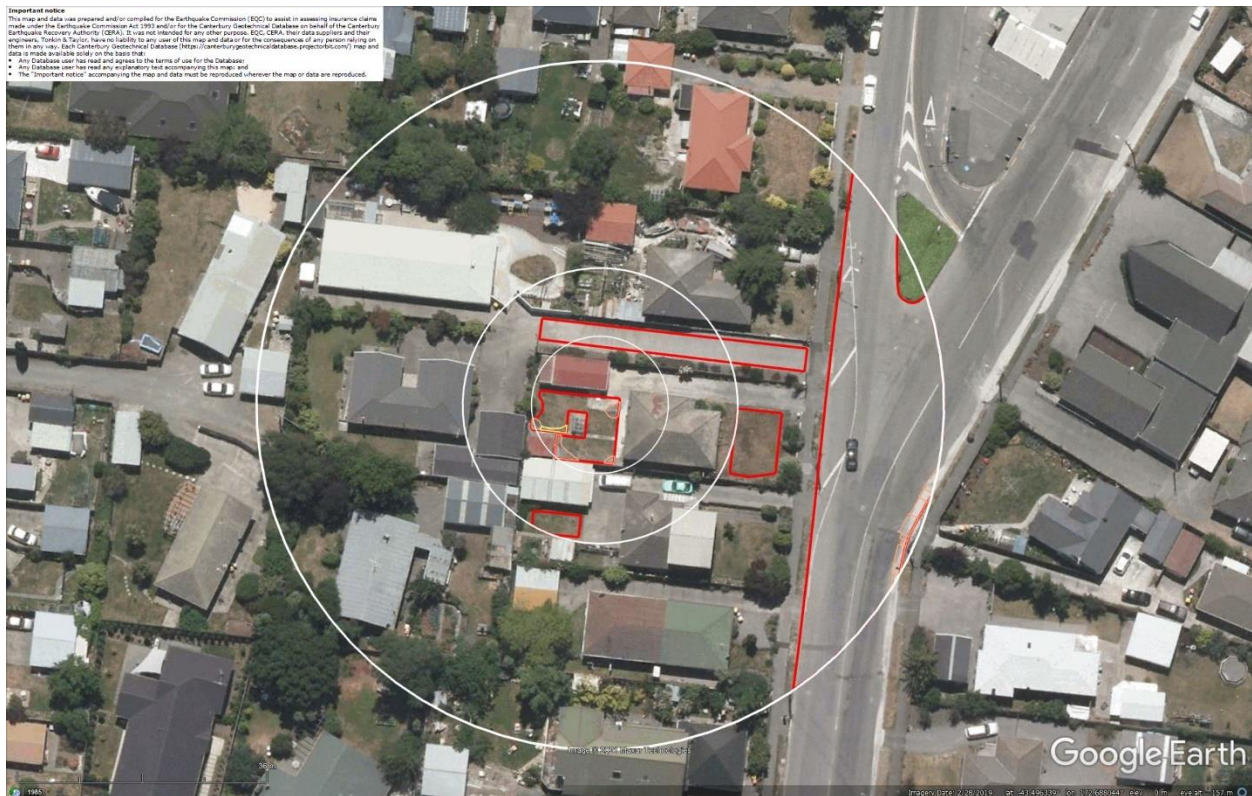
**Figure 105: Ejecta outline for Dec-11 EQ.**
