# Segmental Retaining Wall Reinforced with Geogrids, in New Hospital Works (Salamanca, Spain)

**ABSTRACT:** The construction of a new hospital, located by the river Tormes in the Spanish city of Salamanca, involved the expansion of roads and the construction of a new way of access to the complex, as well as a large retaining wall to bridge the gap between them and the river level. The project original solution was in situ foundations and precast concrete walls. However, at both ends of the alignment of Transición Española Avenue, there were several construction constraints (such as the existence of rainwater chambers for discharging into the river, a large-diameter drainage pipe at the back of the walls, communications, and gas services). The need to maintain steady access to the old hospital in service during the COVID-19 pandemic was furthermore required. The wall was founded on fills with low bearing capacity in other sections. Finally, a reinforced segmental retaining wall (SRW) was adopted as the optimum choice. It consists of concrete block (segmental) facing with a high-quality fill reinforced backfill, reinforced with polyester (PET) geogrids. The facing required a variabl

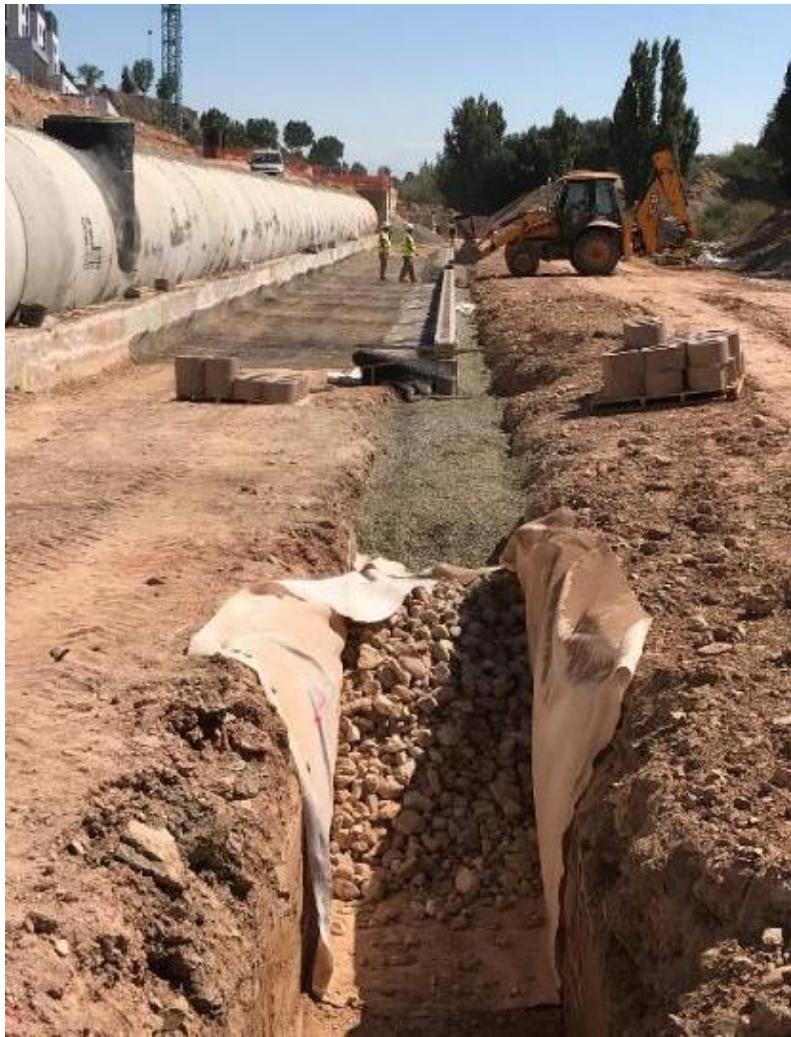
*Figure 2. Different phases of the erection of Wall 1*

To prepare the structure for foreseeable seasonal floods, a riprap was designed at the level of the wall, as scour protection of the foundations. To support the blocks on the facing, a foundation trench of approximately 1 x 1 m was built, filled with gravel, and wrapped in a non-woven geotextile filter. Behind the block face, a generous one m wide backfill of crushed gravel was installed (see Figure 2), as well as the drainpipe collector surround. Both drainage systems were completed with corrugated HDPE drainage pipes passing through the block face towards the river, arranged perpendicular to the line of the wall. Light- and medium-sized compactors were used to minimize the long-term facing deformation to reduce the lateral forces against the wall (Bathurst et al. 2010).

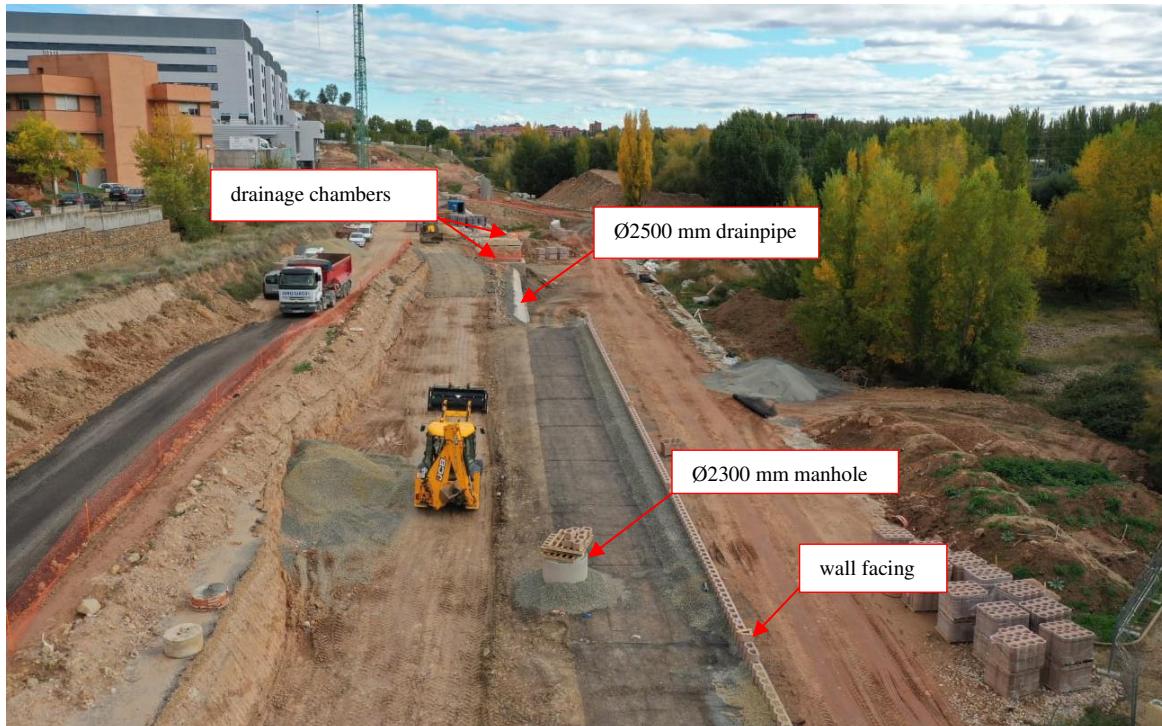
Figure 3. Wall 1 under construction (Orbe Técnicas y Medioambiente).

The last of the challenges was the geometric encounter with the existing prefabricated vertical wall. It was solved thanks to the professionalism and skill on the installers' part, bearing in mind that a face angle of the exposed face is required to make a smooth transition from 80° to 90° with steps at both at the foundation base and at the top of the blocks by varying the horizontal set back of each course. The installation company's engineers carried out a geometric fit using CAD, which was later redefined on site and each course was checked with precision.

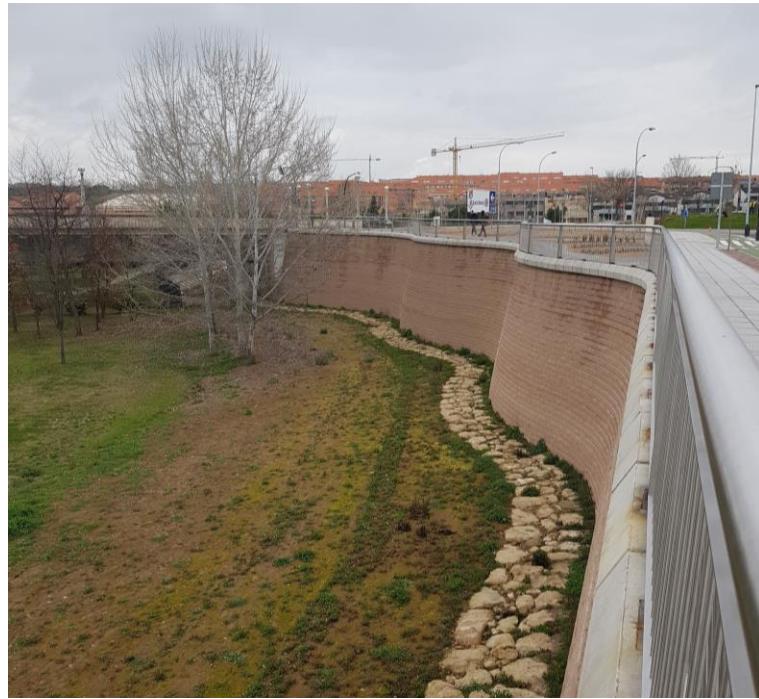
*Figure 7. Wall 1 at the present time (Huesker geosintéticos).*

owner representative engineer. In addition, a professional team of installers with more than 20 years of experience in the installation of block walls was on site, and the good results are evident (see Figure 7).
