Liquefaction and Non-liquefaction Cases from the Mataquito Bridge, Chile, after the M_w 8.8 (2010) and M_w 6.6 (2019) Earthquakes

ABSTRACT: This paper describes field investigations and soil foundation performance of the Mataquito Bridge with respect to the 2010 M_w 8.8 and 2019 M_w 6.6 Chilean earthquakes. The Mataquito Bridge was constructed at the site prior to both earthquakes using a pile foundation designed against liquefaction and lateral spreading. The foundation system performed correctly during both earthquakes, and in the case of the 2010 event it withstood surface manifestation of liquefaction and lateral spreading loads. Different liquefaction severity indices are used to assess the liquefaction hazard with data from in-situ measurements. This paper provides a collection of data (Vs, CPT, SPT) for liquefaction and non-liquefaction cases at the same site under two different levels of shaking, and valuable case history data for future triggering and severity index models. Lateral displacements are also calculated and compared with those observed on the field after the 2010 earthquake.

Reference: Moffat, R., and Moss, R. (2022). Liquefaction and Non-liquefaction Cases f

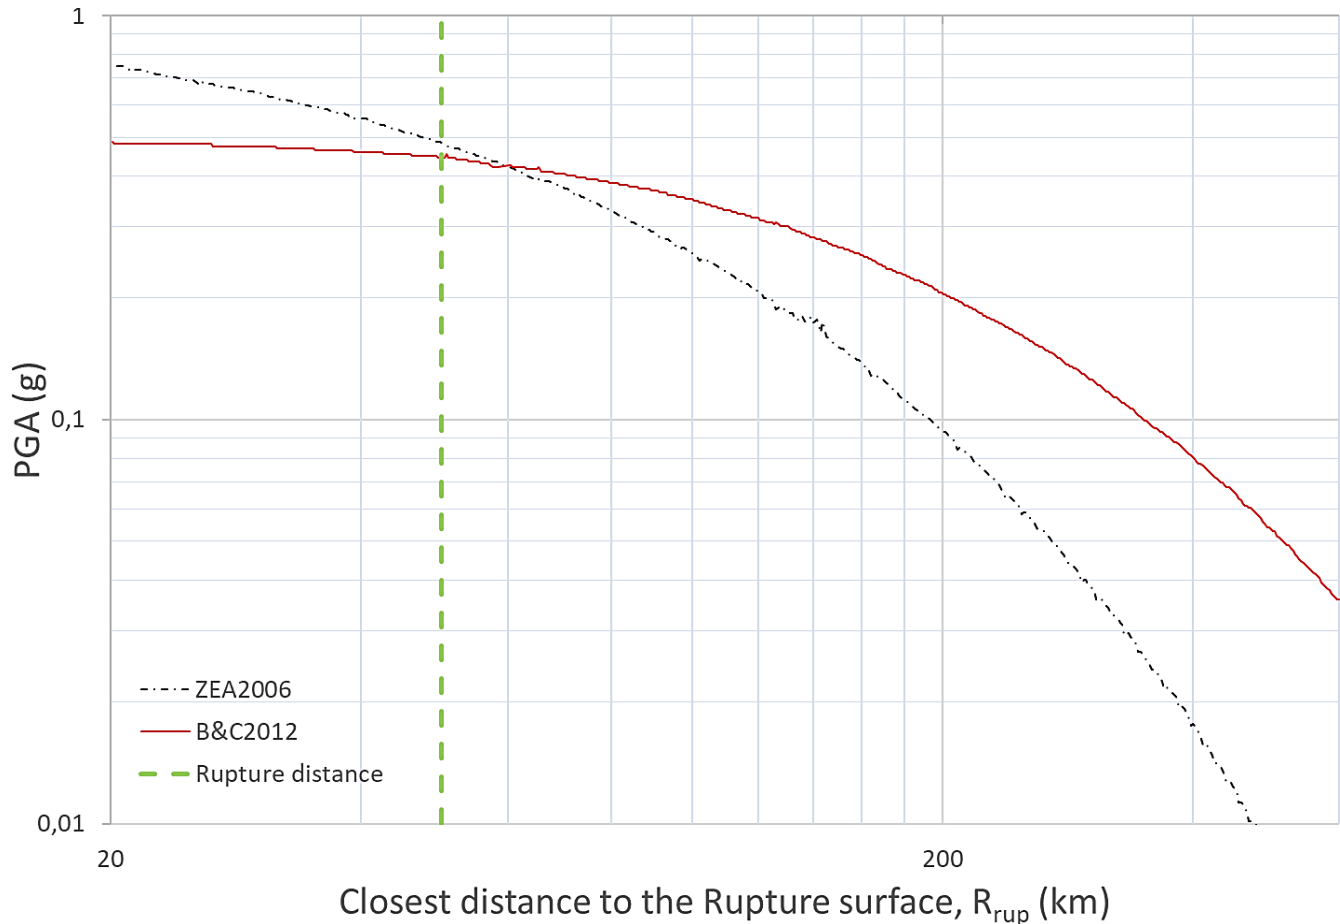
Figure 10. Attenuation relation for horizontal accelerations modified from Boroschek et al. (2012).

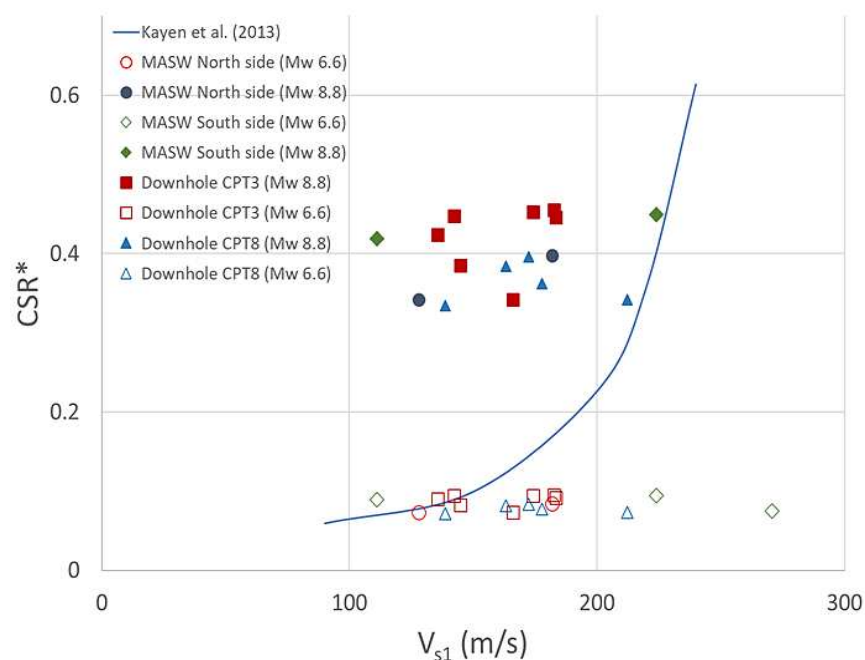
Figure 12. Liquefaction assessment using V_s from MASW and SCPT.

Liquefaction triggering was studied for both MASW profiles and downhole SCPT measurements using the procedure explained at Kayen et al. (2013). A 15% probability contour for initial liquefaction was considered as the deterministic boundary curve shown in Fig. 12. The results of this analysis, using MASW data, are shown in Fig. 12, where liquefaction is deduced from 3 m to 6 m at both sides of the river. Downhole CPT 3 is located at the south side of the bridge, and downhole CPT 8 is located at the north side. The analysis was performed for both earthquakes, where CPT 3 data was for depths between 1.5 m to 8.3 m, and CPT 8 was from 1.5 m to 6.3 m. The MASW and downhole shear wave velocity analysis seemed to correlate adequately with the observations from both earthquakes.

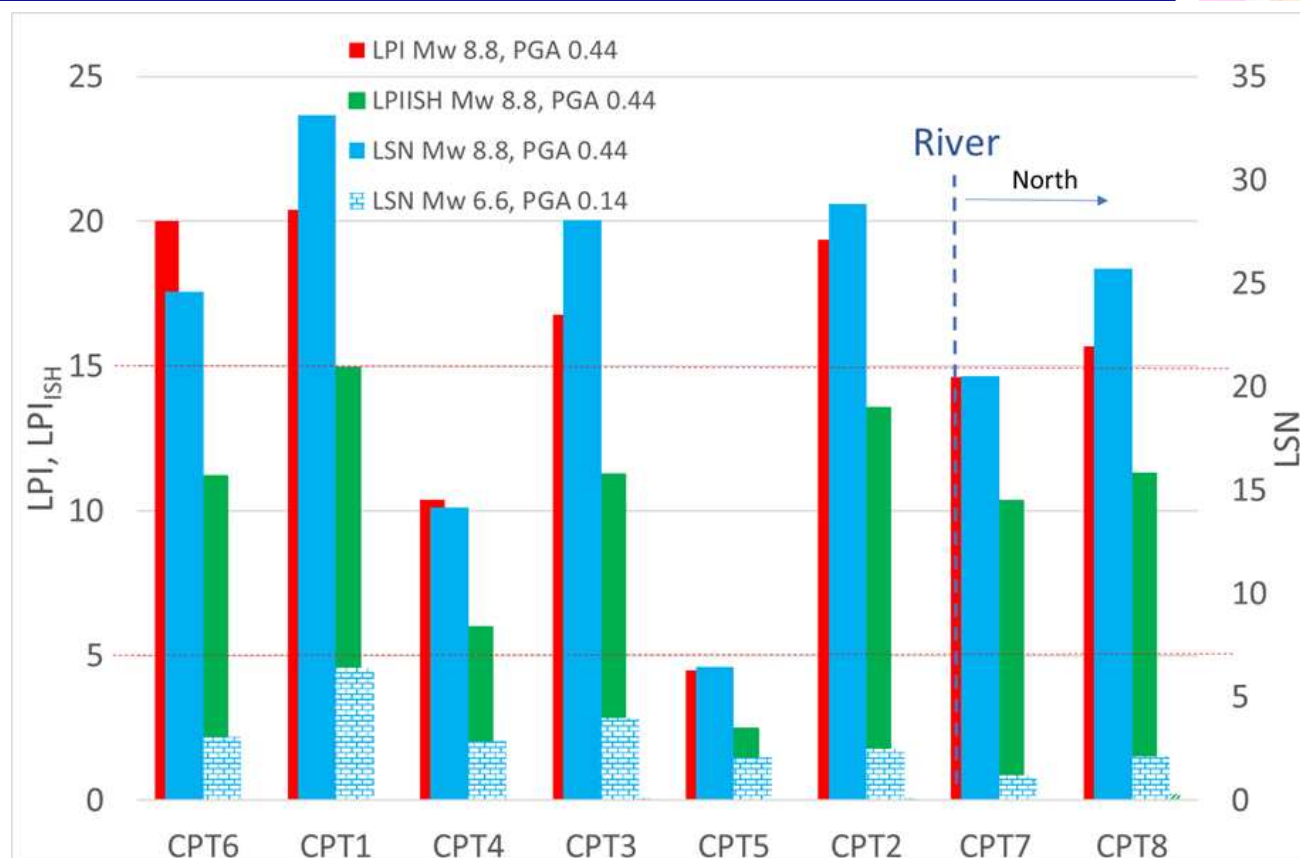
Figure 18. Liquefaction manifestation indexes; LSN, LPI, and LPI_{ISH} .

CPT data was also used to evaluate the surface manifestation, using an index such as: LPI, LPI_{ISH} , and LSN for all CPT soundings (Iwasaki et al., 1978, Maurer et al., 2015, Van Ballegooy et al., 2014). Figure 18 shows values of LSN, LPI, and LPI_{ISH} . Values of LPI and LPI_{ISH} are very sensitive when passing from the 2010 to the 2019 earthquake. According to this case history, LPI of 10 showed the liquefaction manifestation on the surface, and LPI of 0.5 did not. Calculated values of LPI and LPI_{ISH} for the 2019 earthquake were so low that they couldn't be observed in this figure. Similarly, values of LPI_{ISH} showed that for LPI_{ISH} of 6, there is liquefaction manifestation; for values lower than 0.2, however, liquefaction is not shown. On the other hand, LSN-calculated values showed that LSN above 15 liquefaction was observed—yet for values of LSN below 6.4, no liquefaction manifestation was observed.

Data from CPT 6—the CPT furthest south from the river's edge—is analyzed to show the possible variation of LPI_{ISH} with the main variables used for its liquefaction calculation, in order to check the robustness of the calculated values. A sensitivity analysis was performed for this sounding using fictional values of non-liquefaction layer (H1), fine content in depth, and PGA values to check for a possible effect of variation from the values derived from the in-situ soil exploration. The calculated average value of LPI_{ISH} was 11.2 with a standard deviation of 2.0. Similarly, for LSN, an average value of 26.4 and a standard deviation of 7.2 were obtained. For LPI, an average value of 20.0 and a standard deviation of 3.1 were obtained. Therefore, even a significant change in input values does not explain why there was no clear manifestation of liquefaction for the Mw 8.8 earthquake further away from the river's edge. One possible explanation is that the gravel layer, below the liquefied layer, and/or the ground slope are steeper further to the south from the river. And/or, this could be due to limitations of the simplified procedure used in this work to evaluate liquefaction. It has been shown that the use of the simplified method can overestimate or underestimate the potential of liquefaction as compared to a dynamic analysis of the soil. Correspondingly, assumptions such as horizontally layered soil profile, horizontal ground surface, and vertically propagating waves are not particularly accomplished at the location of CPT 6.

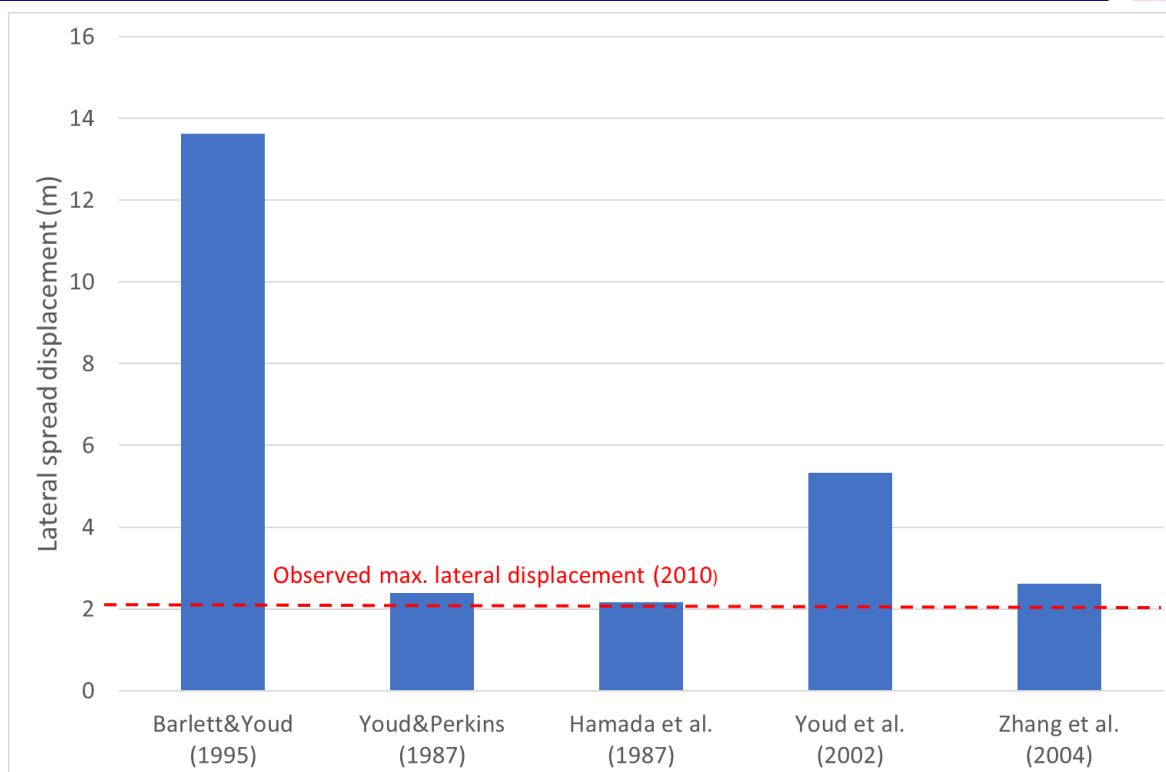
Figure 19. Calculated values of lateral displacement for different predictive models.

Lateral spreading was observed for the 2010 earthquake, as was mentioned previously in this paper. Some of the most common deterministic methods to predict lateral displacement for gently sloping ground without a free face were used to deduce this movement. There is very little data from earthquakes with values of M_w above 8.0 to compare to these methods, therefore this case is used to compare observed displacement with deduced values (as shown in Figure 19).

It is possible to observe that all methods (Zhang et al., 2002, Barlett and Youd, 1995, Youd et al., 1987, Hamada et al., 1987, Youd et al., 2002), with the exception of Barlett and Youd (1995) that was superseded by Youd et al. (2002), adequately predict the observed lateral displacement. This is consistent with what was mentioned by Youd et al. (2002), that erroneous data estimates were used on Barlett and Youd (1995). That caused this model to over-predict lateral spreading. Upper and lower layers were necessarily considered by these models to predict the observed displacement on the field. This confirms what was also aforementioned in this work: both layers must have liquefied during the 2020 earthquake.
